CASE SUMMARY

NATIONAL ACCIDENT SAMPLING SYSTEM
CRASHWORTHINESS DATA SYSTEM

PSU 75 CASE NO. 103A TYPE OF ACCIDENT Minivan Head on w/Large Pole

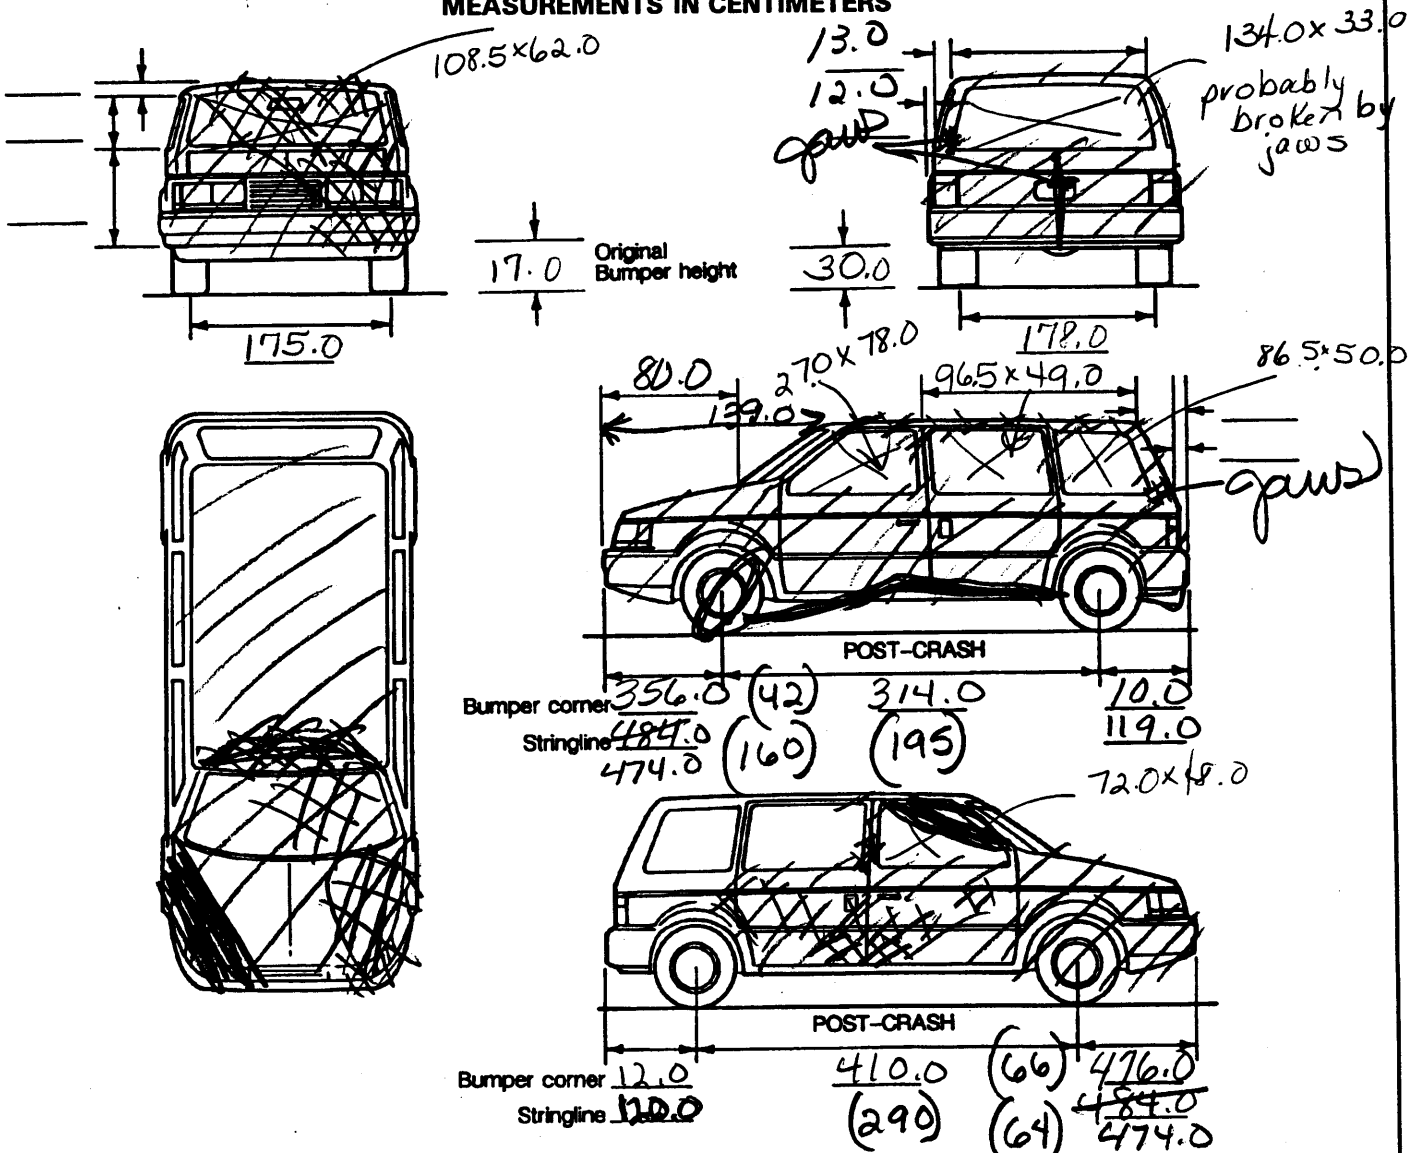
VEHICLE DAMAGE SKETCH

Specific Impact No.	Location of Direct Damage	Location of Field L	Location of Max Crush
1	(L) Front BC	All Front Bumper	C_1
2	Right Side	57.0 in back of back axle	Same

Specific Impact Number	Plane of Impact C-Measurements	Direct Damage Width (CDC)	Direct Damage Max Crush	Field L	C_1	C_2	C_3	C_4	C_5	C_6	±D
1	All Front Bmpr	82	130	104	130	61	39	24.5	12.5	9.5	-51.0
											0
	Bumper width		.5	-	.5	.5	.5	.5	.5	.5	
	F.S.		+12.0	-	12.0	1.0	2.5	2.5	1.0	12.0	
	Stands		-10.0	-	10.0	10.0	10.0	10.0	10.0	10.0	
	TAU		107.5		107.5	49.5	26.0	11.5	1.0	0	
2	Right Side	287.5	0								
1	Header to stringline		231.0								
	orig		139.0								
	TAU		92.0

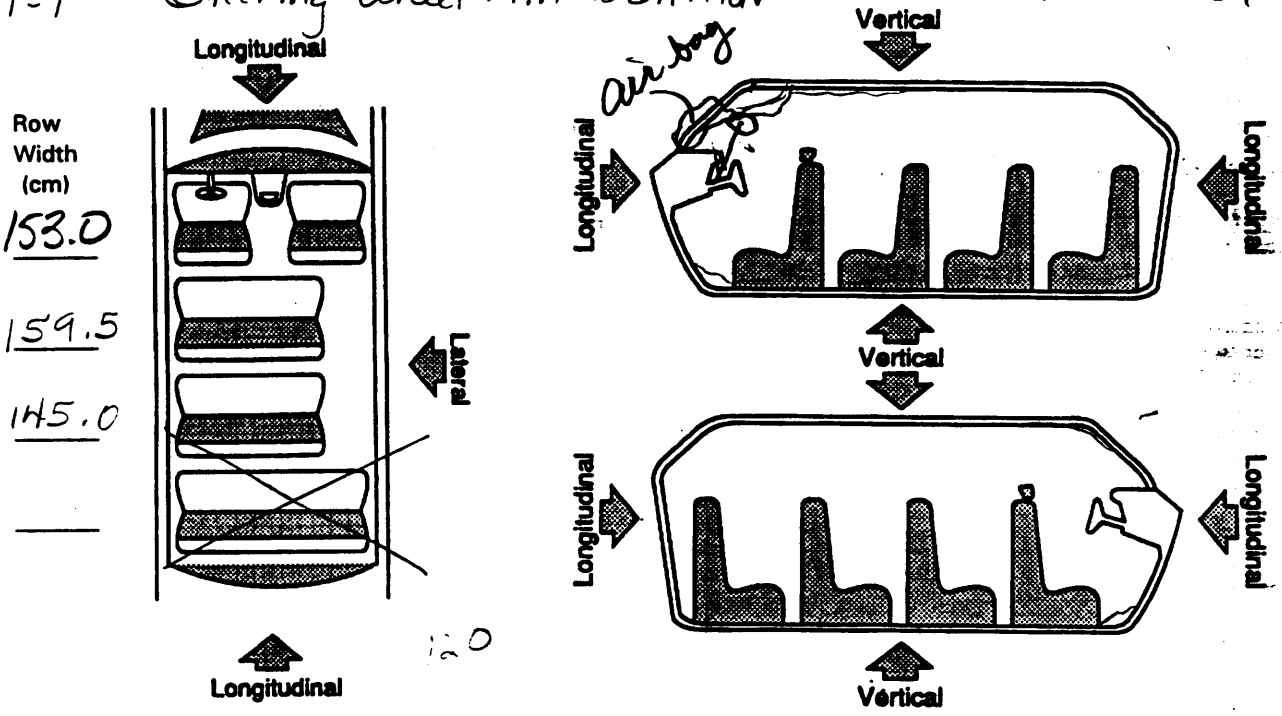
1-1 Steering Wheel rim to B. Pillar 56.0 − 20.0 = 36 ✓ Long

LOCATION OF INTRUSION	INTRUDED COMPONENT	(All Measurements Are In Centimeters) COMPARISON VALUE	−	INTRUDED VALUE	=	INTRUSION	DOMINANT CRUSH DIRECTION
1-1	Dash to B-Pillar (Bark)	75.0	−	33.0	=	42 ✓	Long.
1-2	Dash "	81.0	−	31.0	=	50 ✓	
1-1	Header "	67.0	−	11.0	=	56 ✓	
1-2	Header "	Behind rear of B-Pillar 83.5	−	6.0	=	77.5 ✓	
1-3	Header "	67.0	−	34.0	=	33	
1-1	A-Pillar to rear B-Pillar	64.0	−	29.0	=	35 ✓	
1-1	Roof Lwr to C Pillar	171.0	−	115.0	=	56 ✓	
1-2	"	171.0	−	99.0	=	72 ✓	
1-3	"	171.0	−	99.0	=	72 ✓	
1-1		Light to bottom of windowframe 55.0	−	43.0	=	12	Vert.
1-2		55.0	−	50.0	=	5	
1-3		55.0	−	46.0	=	9	
1-1	Toepan	to B. Pillar 127	−	61.0	=	66 ✓	Long.
1-2		71	−	49.0	=	22	
1-3		127	−	129.0	=	0

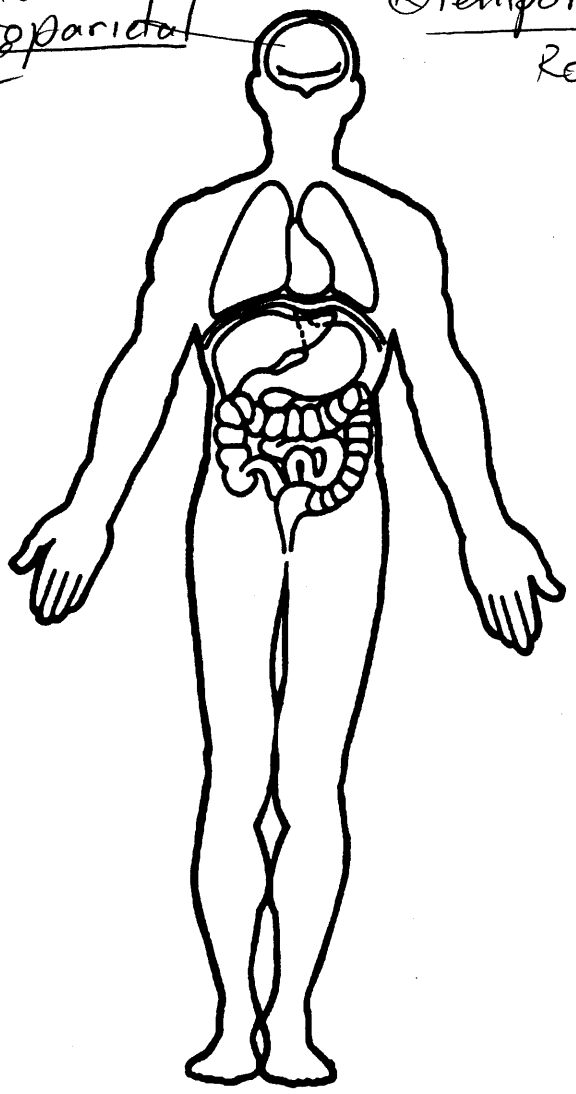
Subarachnoid hemorrhage ®temporoparietal Roof

Contusion ®temporoparietal Roof

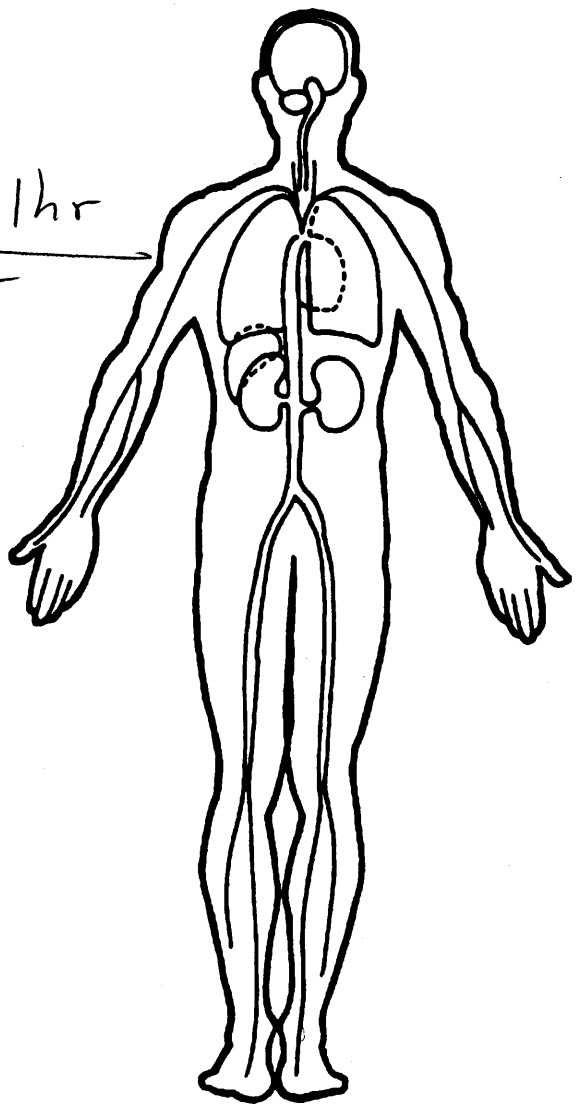
LOC < 1hr Roof
