PREPARED FOR SAFETY RESEARCH & STRATEGIES, INC.

Toyota Electronic Throttle Control Investigation

Preliminary Report

2/21/2010

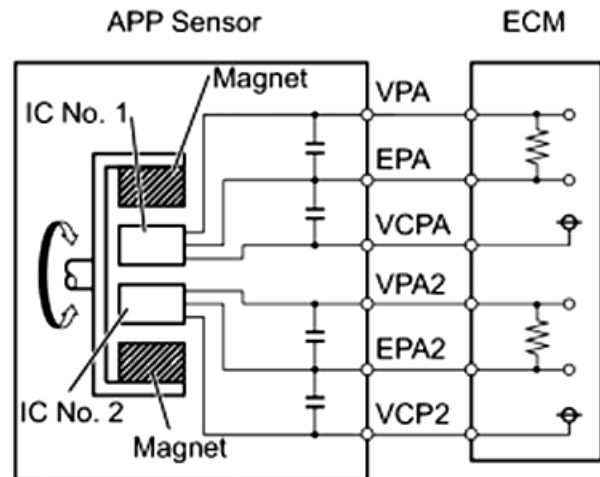
APP Sensor Circuit

Of particular interest were the APP signal inputs to the ECM. According to the Toyota TIS service information, the APP sensor is a non-contact type that uses two independent Hall-effect elements. As described, the APP sensor will have two completely separate sensing circuits: Voltage Pedal Accelerator (VPA), and Voltage Pedal Accelerator 2 (VPA2). Each sensing circuit will have a separate voltage supply circuit (Voltage Constant Pedal, or VCP), a separate ground circuit (Earth Pedal Angle, or EPA), and separate signal circuits (VPA and VPA2). The ETC system description further defines the two signal circuits as VPA (main) and VPA2 (sub). As TIS describes the circuit, the signal from VPA (main) “indicates the actual accelerator pedal opening

angle and is used for engine control” (Appendix: TIS Service Document, p. 1). Voltage limits for VPA, range from 0.4 to 4.8 Volts or more. The signal from VPA2 (sub) “conveys the status of the circuit and is used to check the APP sensor itself” (Appendix: TIS Service Document, p. 1). Voltage limits for VPA2, range from 1.2 to 4.8 Volts or more. Of important note, are the *overlapping* voltage values of the two APP signal inputs to the ECM.

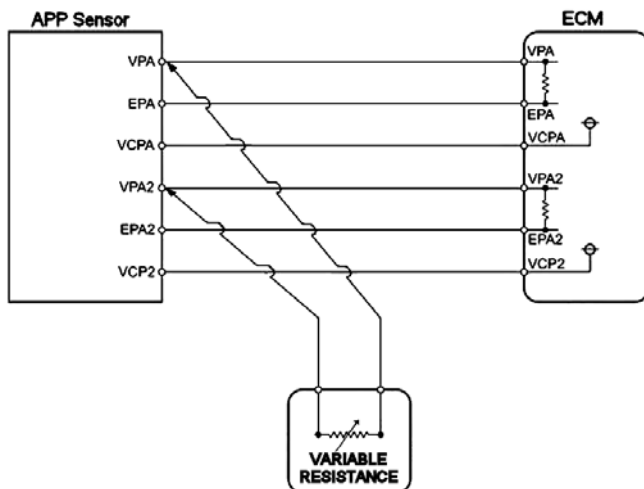
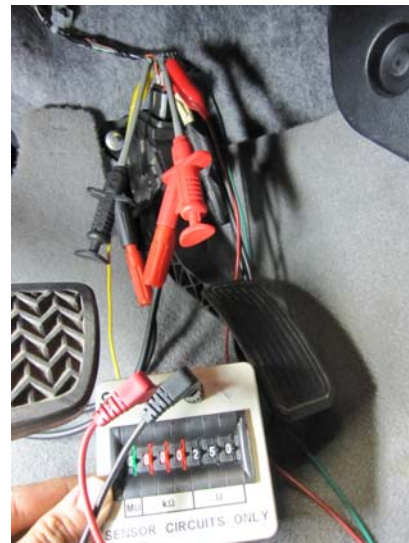
Validation testing began with DTC P2138, which is intended to detect abnormal conditions concerning the APP sensor, the ECM, and short circuits between VPA and VPA2 circuits. While monitoring APP signal voltages with the ignition “Key ON-Engine OFF” (KOEO), various resistances between the two APP signal circuits were introduced for trial. The effects of the different resistance values were recorded to determine the ECM’s actual circuit detection capabilities for this type of circuit malfunction. Ample time duration of “2.0 seconds or more” was allowed, as listed in the service literature for one trip detection logic. MIL illumination was used to signal the presence of ECM fault detection and subsequent DTC storage. It was soon realized that certain short circuit resistances between VPA and VPA2 were undetectable by the ECM. Once initial fault limitations were roughly established, “Key ON-Engine Running”(KOER) trials were conducted with similar fault detection procedures. Of particular interest was vehicle engine operation within the ECM acceptable voltage zone of a compromised VPA to VPA2 circuit short. The test vehicles generally ran well, in spite of the simulated signal circuit malfunction.

While running the engine in a VPA to VPA2 short circuit state, without MIL illumination or stored DTCs, accelerator pedal response rate and range was noted. Accelerator pedal observations were made with simultaneous brake pedal application, and without simultaneous brake pedal application. Recorded data, observations, and results were listed in detail for each specific test vehicle. To further test the absence of fault detection, experimentation was done to determine if the ECM would set a DTC with a combination of additional circuit abnormalities. Two combination tests were performed to include VPA and VPA2 shorted together (operating undetected), and circuit continuity to ground and power. The VPA and VPA2 signals operating in a short circuit state (undetected by the ECM)
