Deepwater Horizon Incident – Internal Investigation
INVESTIGATION UPDATE – INTERIM REPORT

June 08, 2010

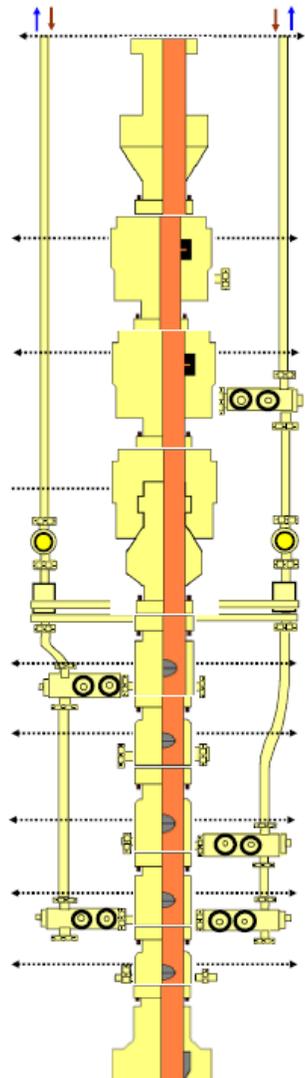
RISER ADAPTER

UPPER ANNULAR

LOWER ANNULAR

LMRP CONNECTOR

BLIND SHEAR RAM

3 1/2 TO 6 5/8 VBR Test Ram

TOP OF WELLHEAD

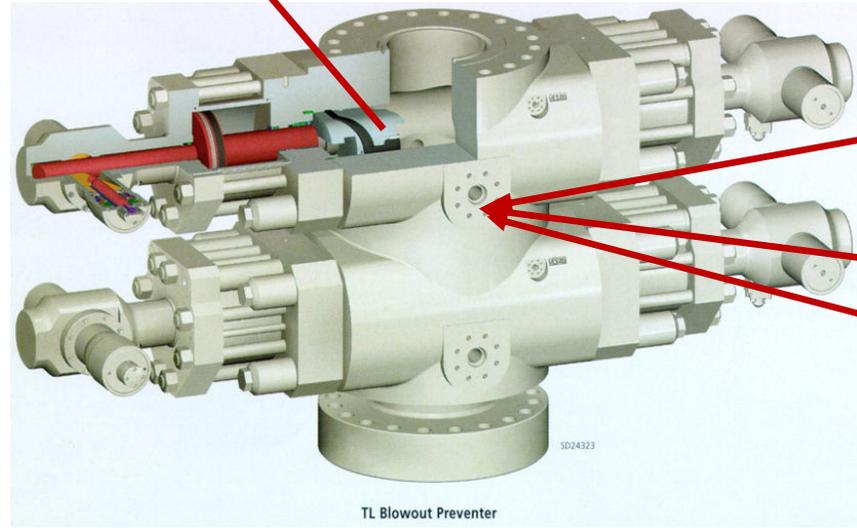
Blowout Preventer Testing

- Witness stated pieces of rubber returned in mud flow over shakers
- Estimated to be from stripping operations during well control event (~1300 ft pipe stripped)
- Expected normal wear on lower annular rubber element
- Annular passed subsequent pressure test on 10 April (250psi/3500psi)

- Full control system software review
 - ✓ *Software code requested from manufacturer for investigation*
- Review of data from ROV intervention
- Assemble 10-yr history of BOP maintenance, modifications, & upgrades
