STUDY OF DETERIORATION OF SEPARABLE ELECTRICAL CONTACTS IN SMOKE DETECTORS

Contract No. CPSC-C-93-1139

IITRI Project No. A06393

Final Report

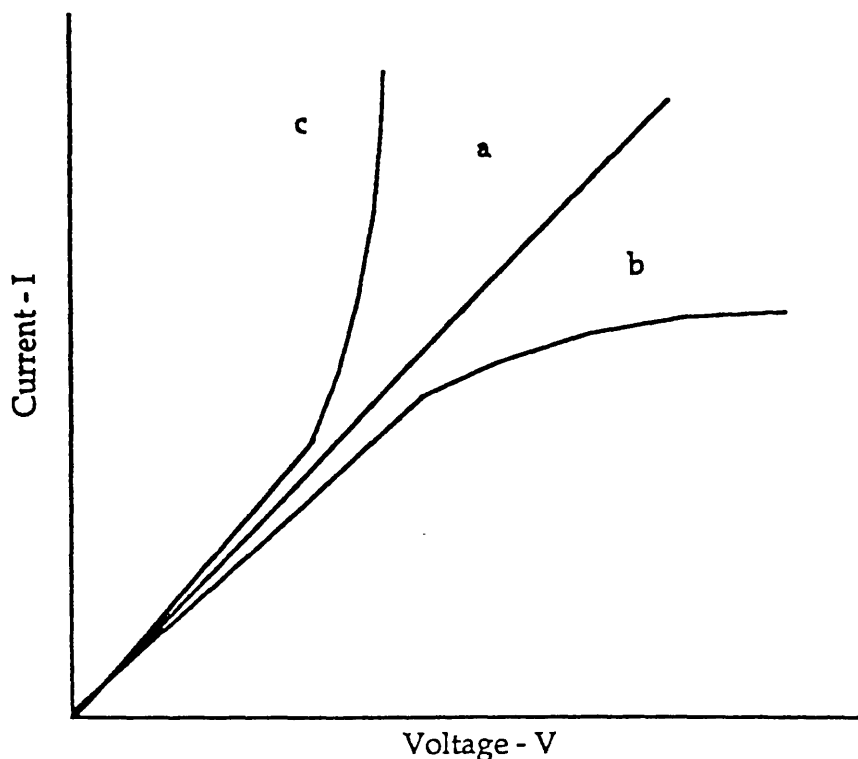
Figure 1 shows the V/I characteristics of a separable contact interface. Curve (a) is the typical, expected, purely resistive interface. Curve (b) results when there are localized hot spots caused by only a very small area of purely metal contact that creates non-linear characteristics. Curve (c) illustrates the effect of instabilities that are caused by electron tunneling through a thin oxide, sulfide or polymer layer formed by corrosion at the contact interface. The curve tracer characteristics, as would be expected with this conduction mechanism, are highly unstable. They vary between curve (c) and an open circuit (a horizontal trace) and take on a snake-like appearance.

FIGURE 1: VOLTAGE/CURRENT CHARACTERISTICS OF SEPARABLE CONTACTS

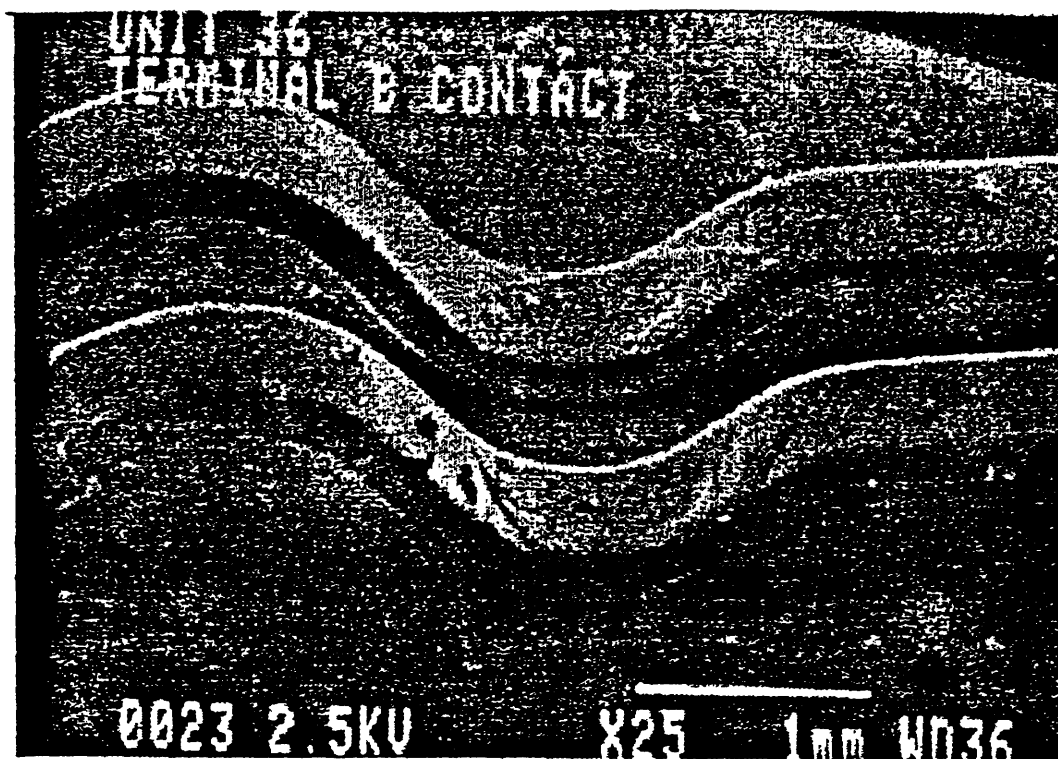
Before the four horns used to document contact area materials were encapsulated for cross-sectioning, scanning electron microscope (SEM) photographs were taken of each contact area. Representative pictures of bifurcated and dimpled contacts appear in Figures 8 and 9, respectively. Energy Dispersive Analysis by X-Rays (EDAX) surface analyses were made on each of the four horns prior to encapsulation. Table 5 summarizes the results of these analyses. Because of the relatively high beam voltages used by the SEM, the depth of the surface analyses was about 1 micron. Even with this sensitivity, both sulphur and chlorine are prominent on the units collected in the study. Sulphur was also present on the new control sample units.

FIGURE 8: SEM PHOTOGRAPH OF A BIFURCATED CONTACT

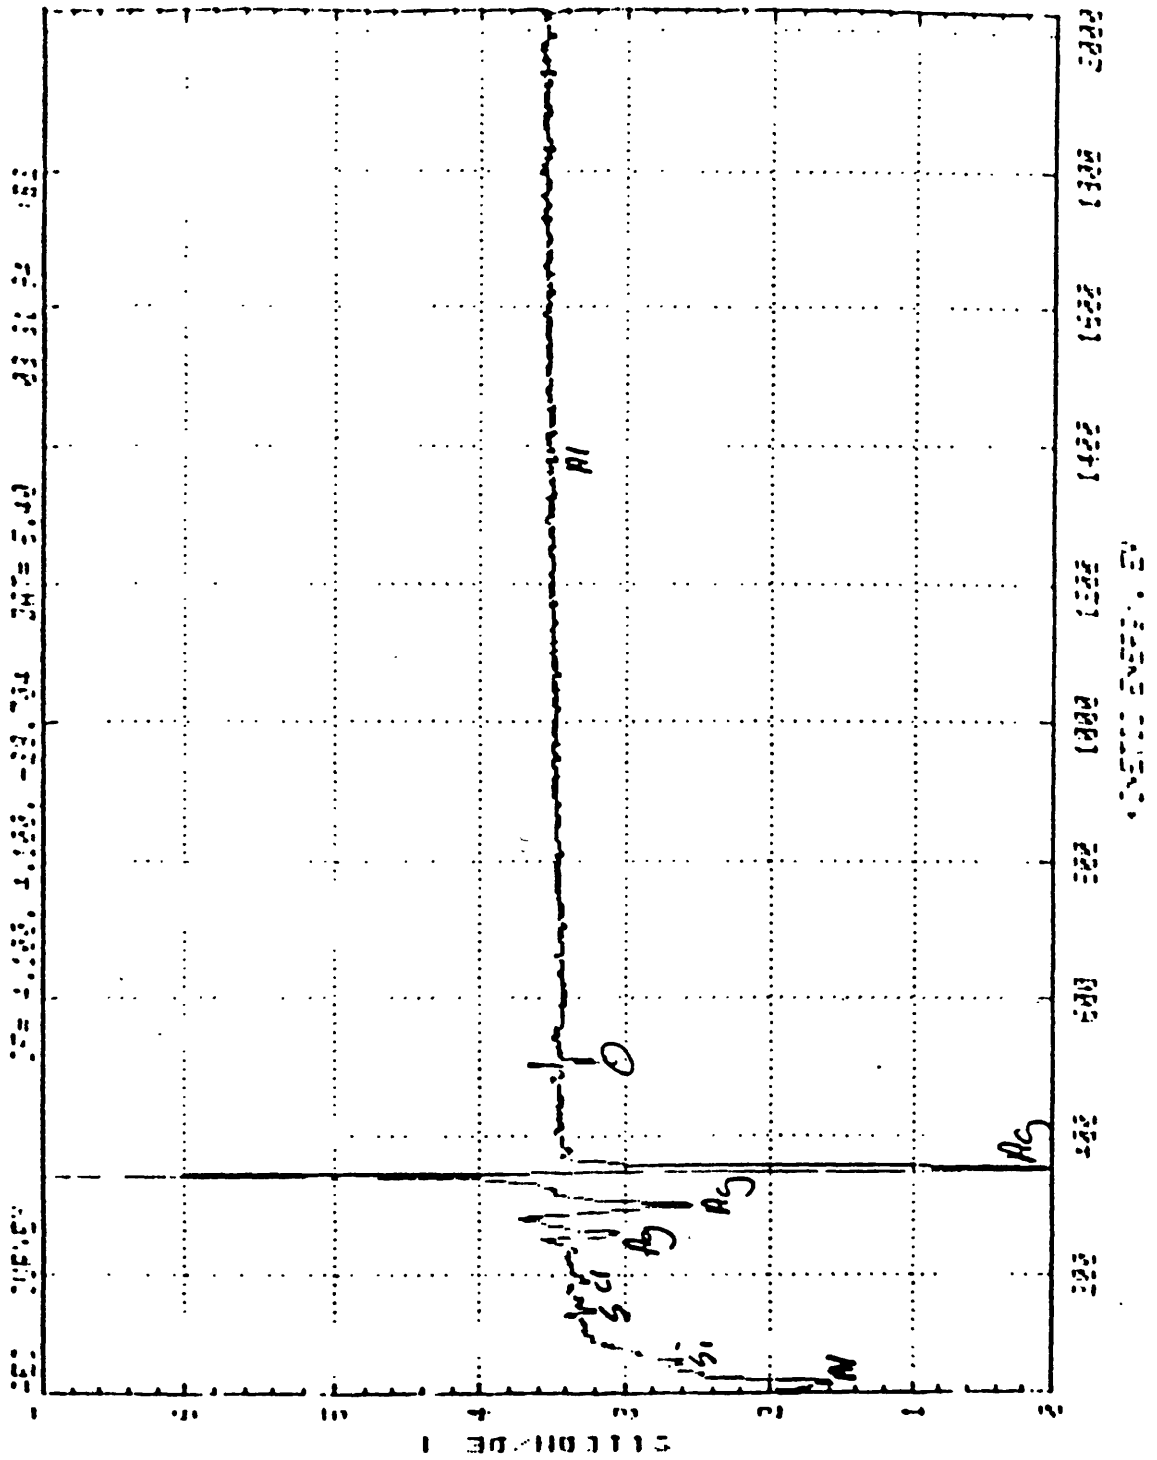
As shown in Figure 23, the pre-sputtering surface analysis on terminal S of horn X shows only a slight trace of sulphur. Both silicon and chlorine have higher levels than the sulphur. Horn X which was exposed to both gases was selected for this testing because it should have had the thickest layer of contamination and to confirm the EDAX surface analysis on horn C (Figure 21). Comparison of this data with the Table 5 EDAX test results of field units, which identified significant levels of sulphur, shows that the UL 217 test environment does not represent field conditions.

FIGURE 24: AUGER DEPTH PROFILE OF SAMPLE X, TERMINAL S

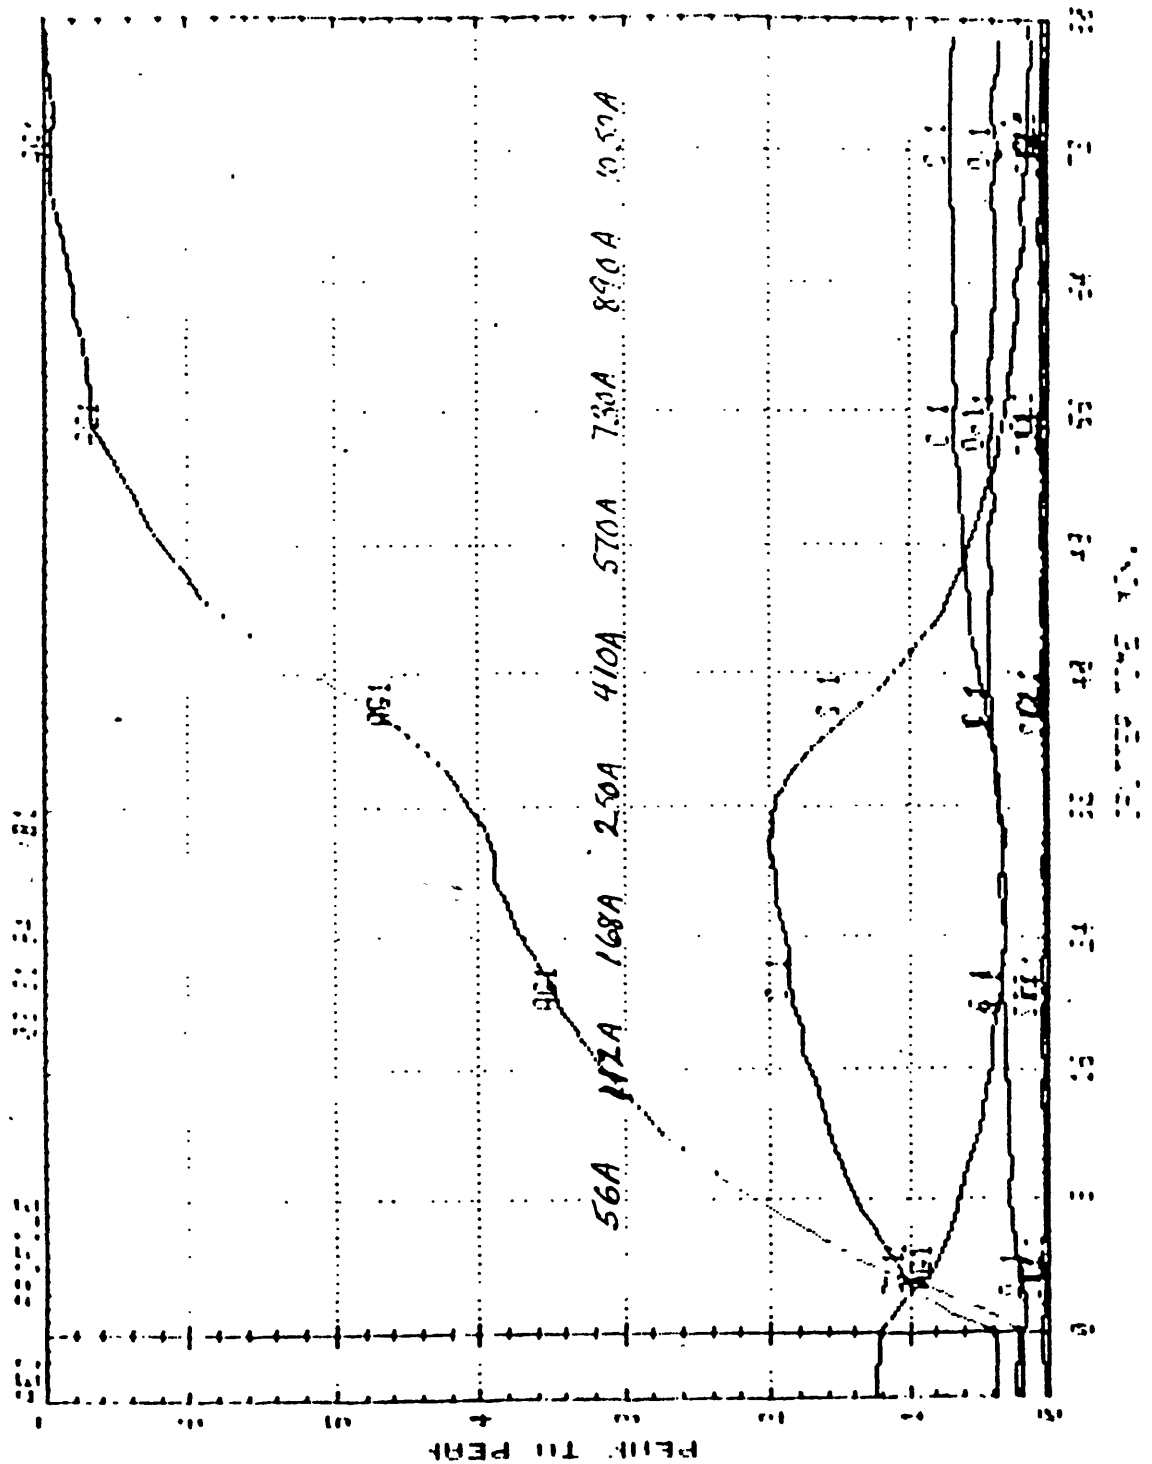
FIGURE 25: AUGER ELEMENTAL SURVEY AFTER PROFILE OF SAMPLE X, TERMINAL S

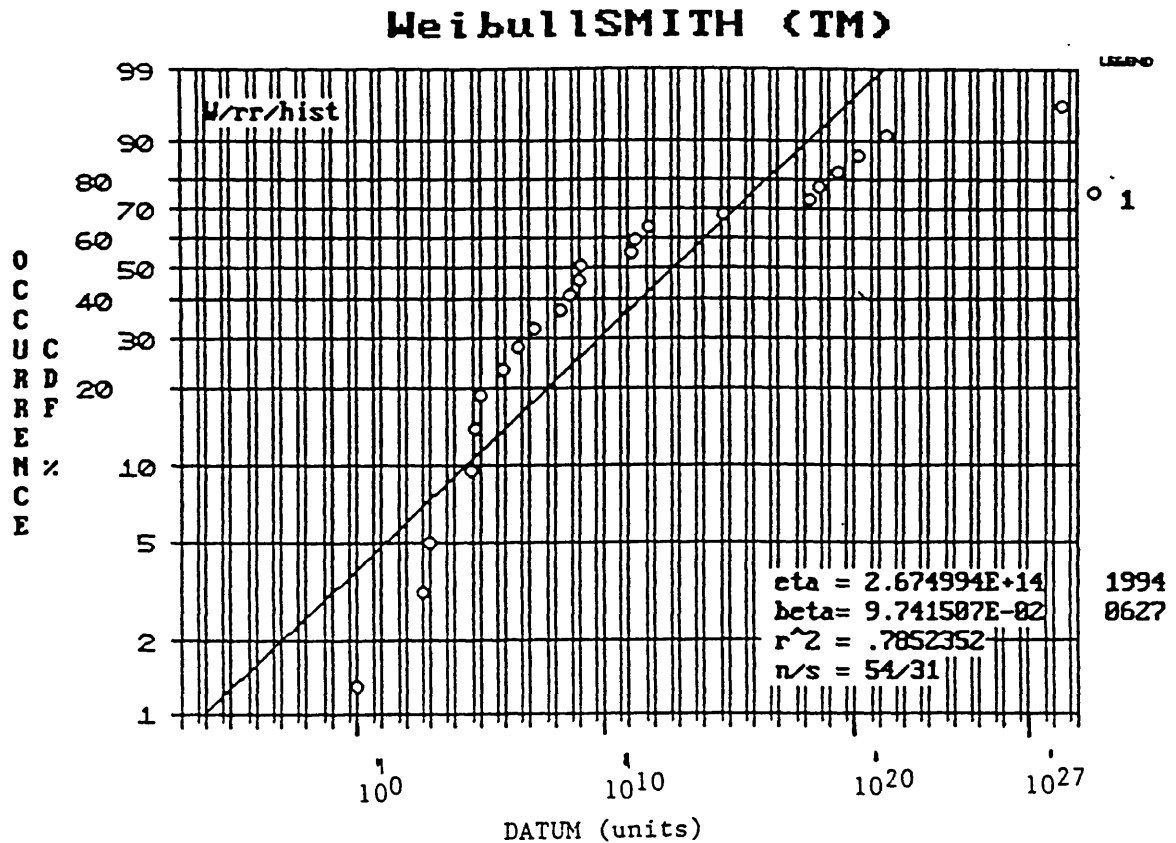
These times to failure were then plotted on Weibull paper to determine the characteristic life (η) and the shape parameter (β). Figure 26 presents the Weibull plot for this data with the addition of the five actual failures, and indicates $\eta = 2.7 \times 10^{14}$ and $\beta = .097$.

This methodology extrapolated the observed resistance change over the 2000 cycle test to a number of cycles that might be expected to cause contact failure. This extrapolation distance, however, is very large and thus there is little confidence that the predicted cycles to failure is accurate. This is especially true given the highly variable behavior of the contact resistances. It is interesting to note, however, that for the 22 contacts exhibiting monotonically increasing resistance values, the exponents (x) were all less than one. This indicates that the rate of increase in contact resistance decreases with an increasing number of cycles.

FIGURE 26: WEIBULL PLOT OF PREDICTED CYCLES TO FAILURE

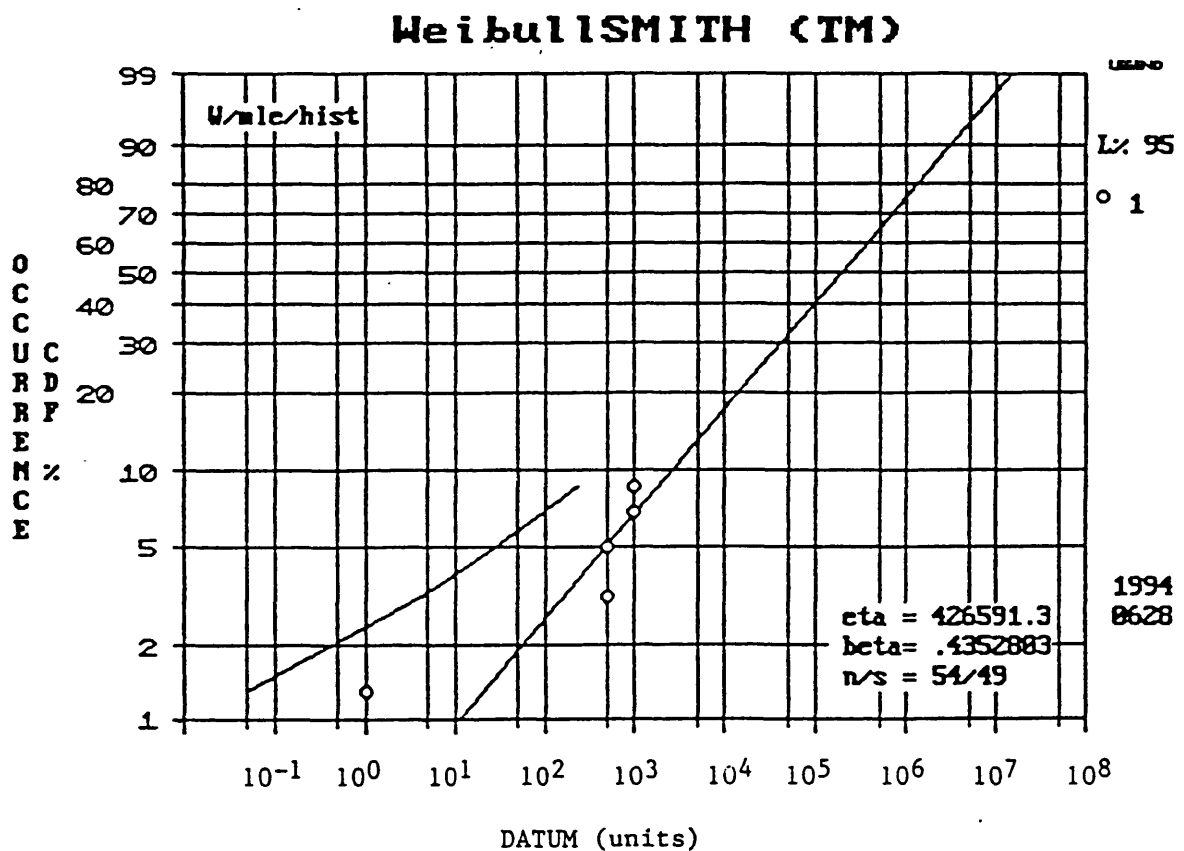
The second methodology also utilized Weibull Analysis, but only considered the three infinite resistance contacts (16B, 41B and 42S) and the two contacts greater than 2500 ohms (28F, 34B) as true failures. All other contacts were considered survivals after 2000 cycles. The three infinite resistance failures were observed at 0, 500 and 1000 cycles and the two greater than 2500 ohms were at 500 and 1000 cycles. Figure 27 is a Weibull plot of this data with the lower 95% confidence level.

analyzed was between 0 and 1. This indicates that the rate of resistance change slows as the number of cycles is increased. The remaining 36 contacts exhibited randomly fluctuating or decreasing resistance values. One of the objectives of this analysis was to determine if wearout characteristics were evident based on the limited data taken. From the analysis, there is no evidence of wearout based on the very low beta values observed. Values greater than one indicate wearout characteristics (failure rate increasing in time) and values less than one indicate infant mortality characteristics (failure rate decreasing in time). All of these observations are consistent with fretting corrosion.

FIGURE 27: WEIBULL PLOT (WITH LOWER 95% CONFIDENCE LEVEL)
