**Analysis of Fatal Incidents Associated
With Window Covering Cords (1996-2002)**

November 2004

Caroleene Paul
U.S. Consumer Product Safety Commission
Directorate for Engineering Sciences
Division of Mechanical Engineering
4330 East West Highway
Bethesda, MD 20814

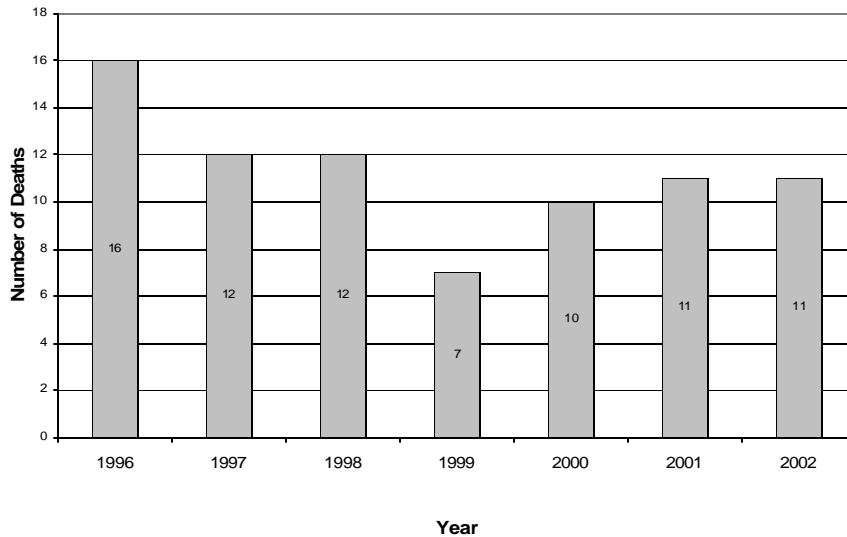
Figure 2. Fatal Incidents Associated with Window Covering Cords (1996-2002)

There were 79 fatal incidents associated with window covering products reported to CPSC from January 1996 through December 2002, for which in-depth investigations could be completed. The number of incidents by year of occurrences is shown in Figure 2 below:

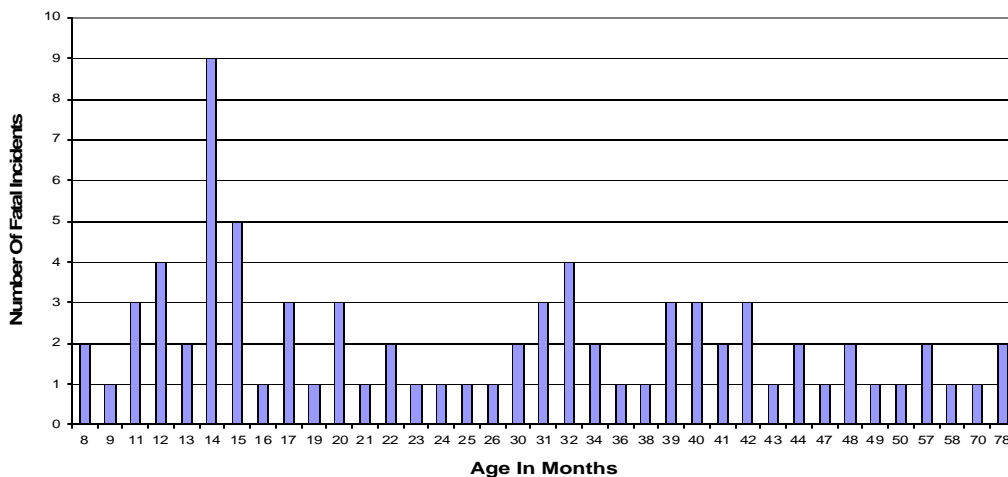
Figure 3. Age of Victims in Fatal Window Covering Incidents (1996-2002)

As seen in Figure 3, window covering incident victims ranged in age from 8 months to 78 months. The children involved most frequently were those in the 12-15 month range, but children up to 6.5 years of age were also entangled in window covering cords.
