## **Carpenter School Bus Advisory** **June 2003**

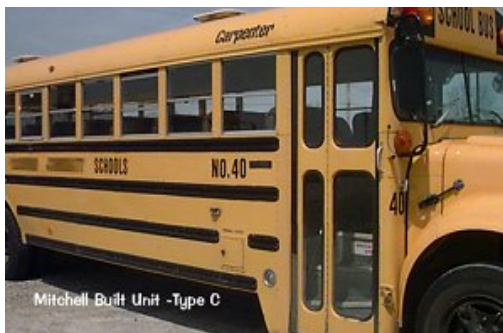
**Figure 1: Mitchell built type “C”**

1. The buses in question are Carpenter Type “A” “B” “C” and “D” school buses built in Mitchell, Indiana, prior to the plant closing in late 1995. It appears that the buses built at Carpenter’s Richmond, Indiana plant do not have similar problems.
2. There are noticeable differences between the rub rail locations for the two Carpenter plants. The rub rail at the floor line in all buses made at the Mitchell plant is interrupted at the wheel openings. The rub rail at the floor line in all buses made at the Richmond plant is continuous and is located just above the wheel opening. If the 6 digit body number starts with the number 4, then the bus was built in the Richmond, Indiana plant and utilized full length body bows.
