**TYPE A**

**ACCIDENT INVESTIGATION**

**JULY 15, 2004**

**HANFORD 200 EAST AREA**

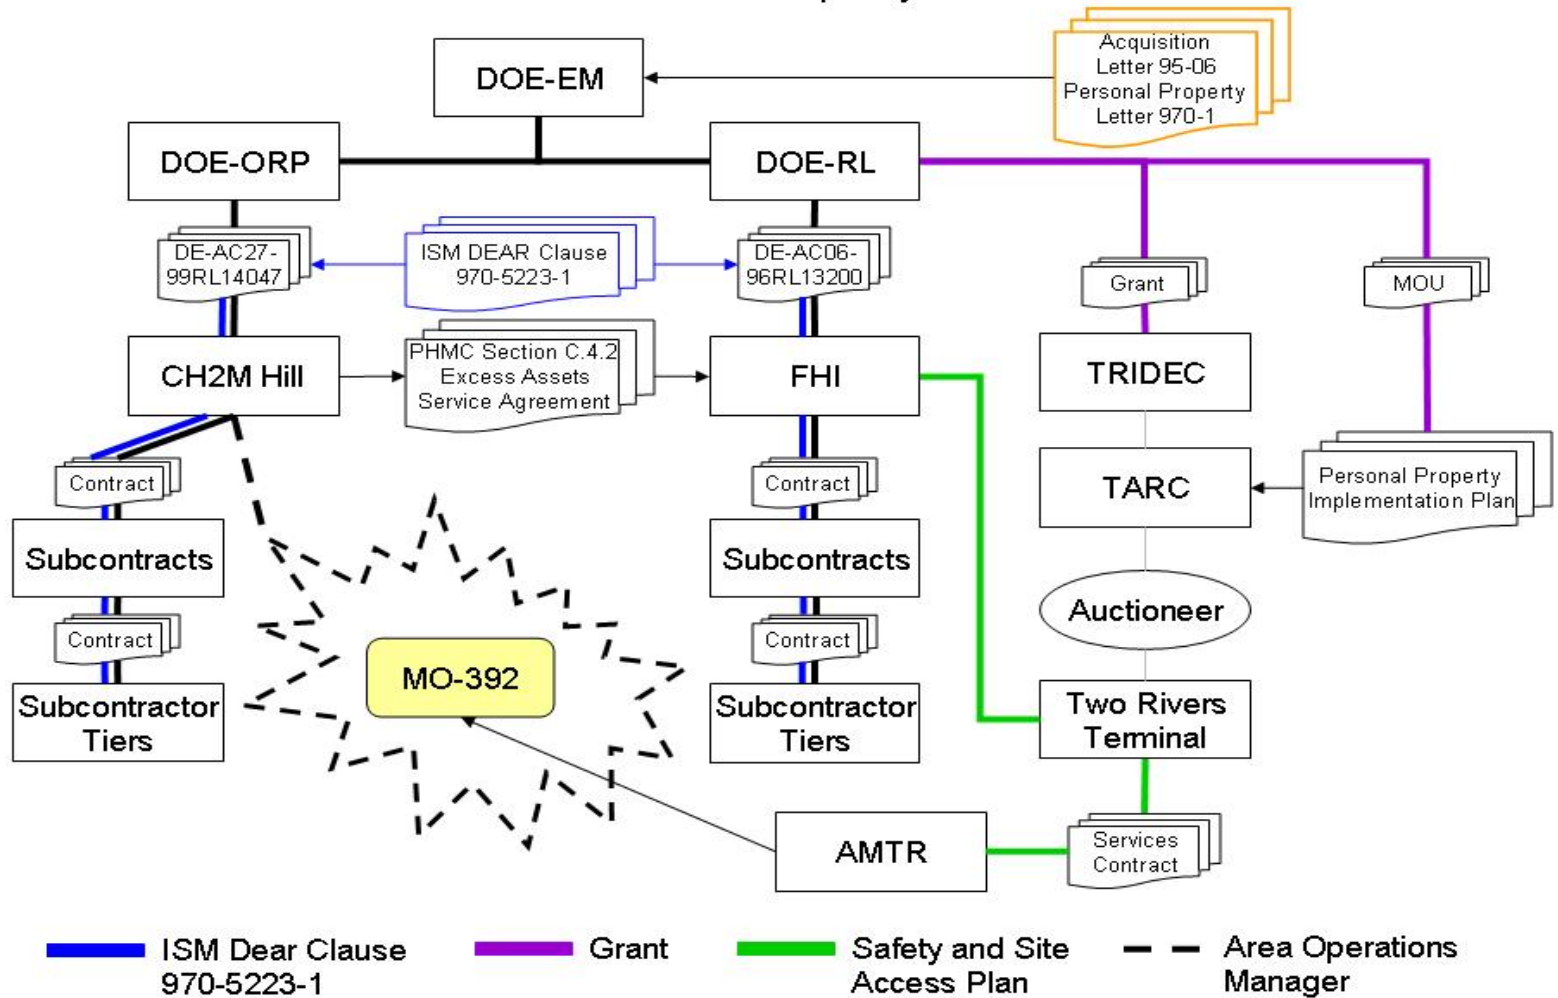
The relationships depicted in Figure 3-1 are discussed below. A DOE-RL grant established TRIDEC as the CRO in 1994. In 1999, DOE-RL and TARC (as the directed representative of the CRO [TRIDEC]), established a Personal Property Transfer Implementation Plan. The plan was set to expire in five years (June 2004) and was not renewed prior to that date. The Personal Property Transfer Implementation Plan implements the provisions in Personal Property Letter 970-1, which states DOE will transfer property to the CRO and move it to an area controlled by the CRO. As discussed in Section 3.1.1, all involved parties have been negotiating a revision to the Personal Property Transfer Implementation Plan. DOE-RL, FHI, and TARC were operating to the draft Personal Property Transfer Implementation Plan without formal procedures.

DOE-RL and FHI used informal procedures to establish and manage safety for CRO related work performed on site. DOE-RL and FHI accepted the performance of unstructured work on the Hanford Site.
