U.S. CHEMICAL SAFETY AND HAZARD INVESTIGATION BOARD

# INVESTIGATION REPORT

## DUST EXPLOSION

### WEST PHARMACEUTICAL SERVICES, INC.

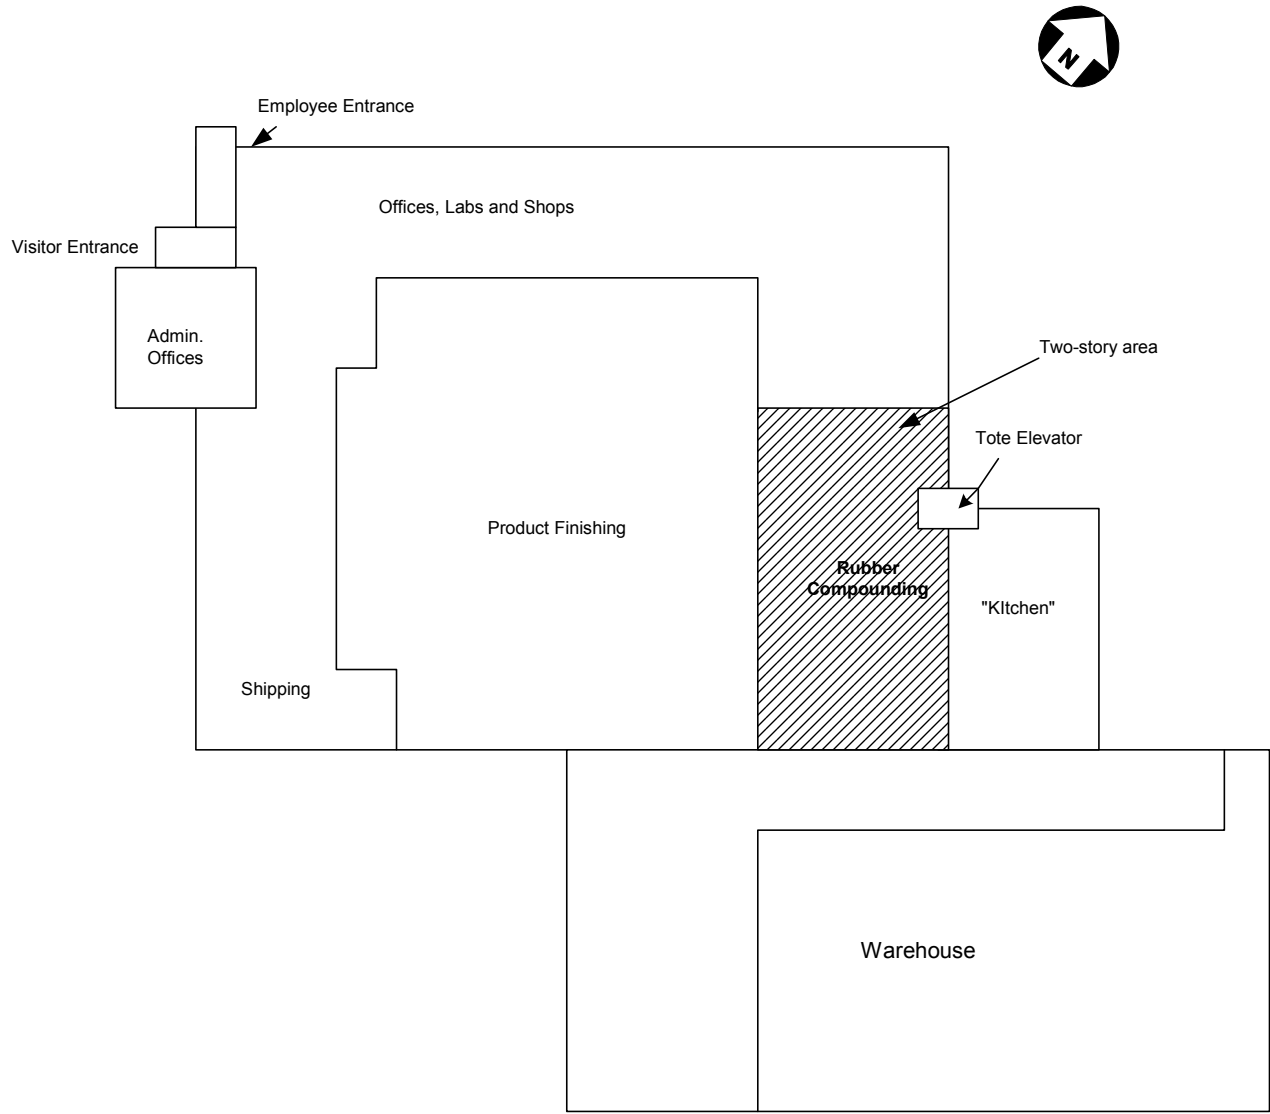
Figure 1. Layout of West Pharmaceutical Services Kinston facility.

Fires began to develop throughout the facility. The explosion broke feeder lines to the fire sprinkler system, disabling it. The largest and most persistent fire—which burned for 2 days—developed in the warehouse (Figure 1) and involved the large volume of stored baled and strip rubber. Some of the rubber continued to smolder and flare up for about a week.

Rubber and other raw materials were stored in a warehouse southeast of the kitchen and compounding area (Figure 1). The thermal effect from the explosion likely reached this area, igniting incipient fires. Eventually, the entire warehouse was fully engulfed in flames. Heat from the fire caused most of the steel framing to yield and collapse.

West stored mineral oil—a Class IIIB combustible liquid—in two 7,000-gallon plastic tanks and two 300-gallon plastic tanks located inside the building, near the warehouse (Figure 1). The tanks were surrounded by dikes. However, because the tanks were installed before North Carolina adopted IFC, there was no legal requirement for West to seek approval of the local authority. Although the Kinston facility had a sprinkler system, as required by NFPA 30, it was rendered inoperable due to damage from the explosion. As discussed earlier, the mineral oil tanks released their combustible contents following the initial explosion and fire—at which point, the liquid added additional fuel to the fire in the ACS warehouse.
