# In-Place Detection of Decay in Timber Bridges-An Application of Stress Wave Technology

Roy F. Pellerin and Jeff A. Lavinder (Authors), Washington State University  
Robert J. Ross and Robert H. Falk, USDA Forest Products Laboratory  
Norbert Volny, Volny Engineering

A study was recently conducted to assess the technical feasibility of using stress wave nondestructive evaluation methods to locate decayed members in timber bridges.

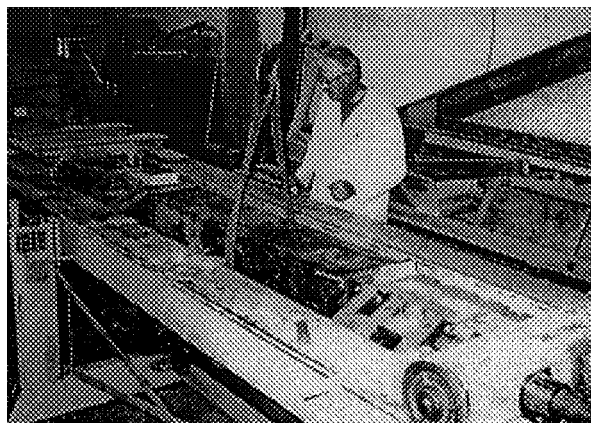
**Figure 8—Column compression test**

All but four of the columns were loaded to failure in compression. The setup for the compression test can be seen in Figure 8. Figures 9 and 10 show the top and bottom, respectively, of column 5 before testing. Before the compression test was performed, the ends were squared. The top of the column can be seen to have extreme rot in the center and only a shell of good wood holding the column together. Creosote penetration of the column top was minimal. The bottom of the column did not show any visual signs of severe decay. However, the stress wave analysis showed that the entire column was decayed.

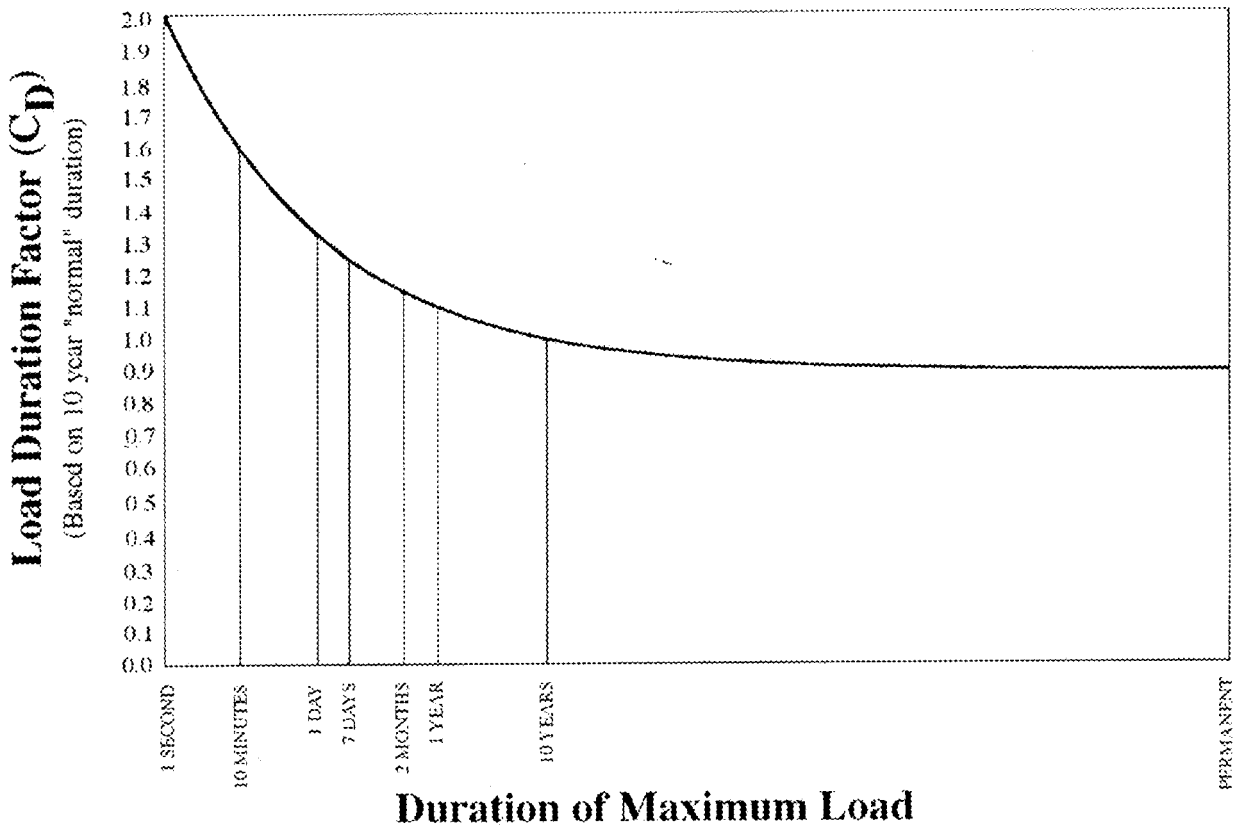
Figure 14—Load duration factors for various load duration (NDS 1991)

The columns were loaded until failure. Column 5 failed abruptly (Figure 13) at an ultimate load of 37.5 kips. The National Design Specifications (NDS 1991) Supplement tabulates compression parallel-to-grain values for Douglas-fir Larch as 700 psi for No. 2 grade in Table 4D. Adjusting for loading rate and changing the tabulated fifth percentile to the median value, the capacity should be 258 kips. The load duration factor can be calculated from Figure 14 (National Design Specifications 1991). The columns' low capacity is a direct result of the extensive decay in the column. Decay had completely deteriorated the interior of the column. Figure 15 shows column 5 after the compression test.
