Research Paper FPL-RP-550

Field Performance of Timber Bridges

7. Connell Lake Stress-Laminated Deck Bridge

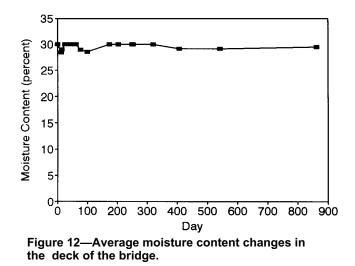
The trend in the average measured moisture content of the Connell Lake bridge is shown in Figure 12. As shown, the laminations were initially installed at a moisture content greater than 30 percent and remained at approximately the same level for the entire monitoring period. Thus, the moisture content was above the fiber saturation point (FSP), which is generally accepted as 30 percent but can vary from 25 to 30 percent (FPL 1987). Above the FSP, changes in moisture content do not cause dimensional changes in wood. However, dimensional changes do occur when the moisture content drops below the FSP. For stress-laminated bridges, changes in moisture content below the FSP are important because moisture loss causes wood shrinkage and subsequent bar force loss. Typically, the moisture content of a stresslaminated deck installed above the FSP gradually decreases towards an equilibrium moisture content (EMC) for the site.
