**OVERSEAS PRESENCE**

**Conditions of Overseas  
Diplomatic Facilities**

Statement of Jess T. Ford  
Director, International Affairs and Trade

Highlights of [GAO-03-557T](#), testimony before the Senate Foreign Relations Committee

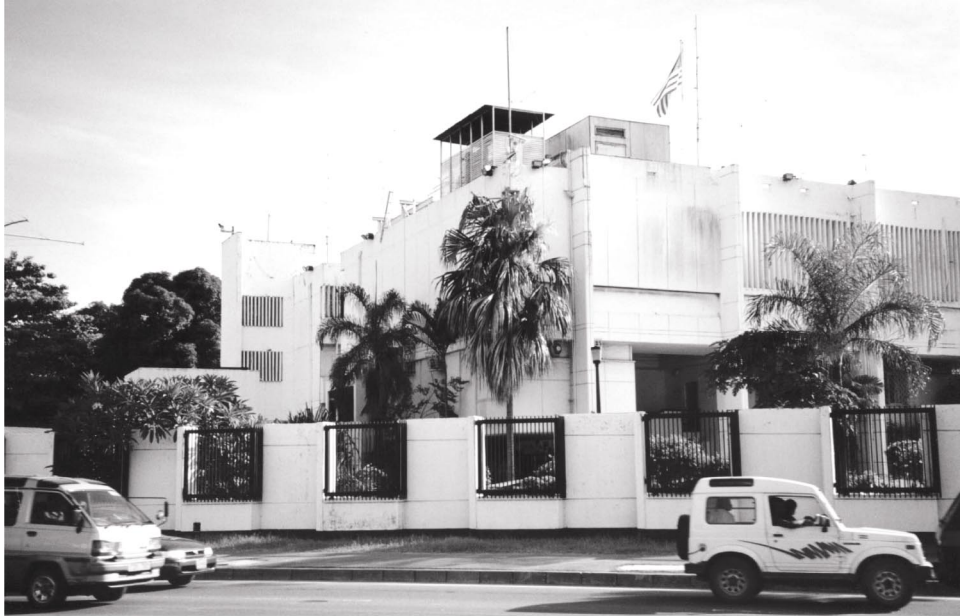
**Figure 1: U.S. Embassy in Tanzania, before the August 7, 1998, Terrorist Attack**

In the 1998 bombings, terrorists attacked the U.S. embassies in Nairobi, Kenya, and Dar es Salaam, Tanzania. These large-scale truck bombings killed more than 220 people, including 12 American U.S. government employees and family members, 32 Kenyan national U.S. government employees, and 8 Tanzanian national U.S. government employees. In addition, the bombings injured more than 4,000 Kenyans, Tanzanians, and Americans.<sup>5</sup> Figures 1 and 2 show pictures of the embassy in Tanzania before and after the bombings.

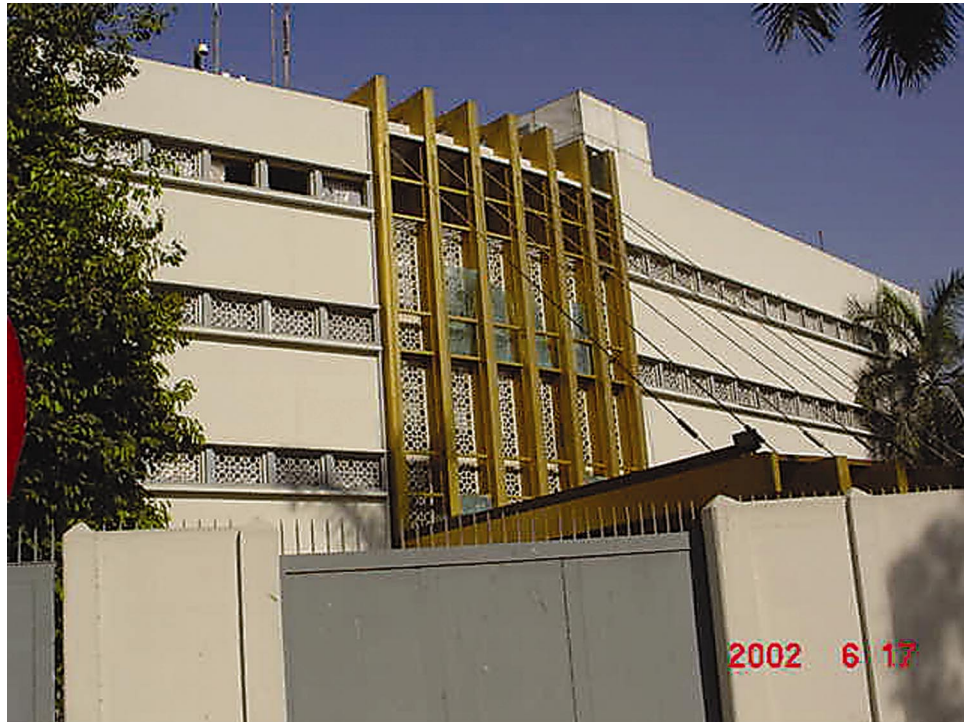
**Figure 3: U.S. Consulate, Karachi, Pakistan, after Car Bomb Attack of June 14, 2002, Showing Little Damage to the Building**

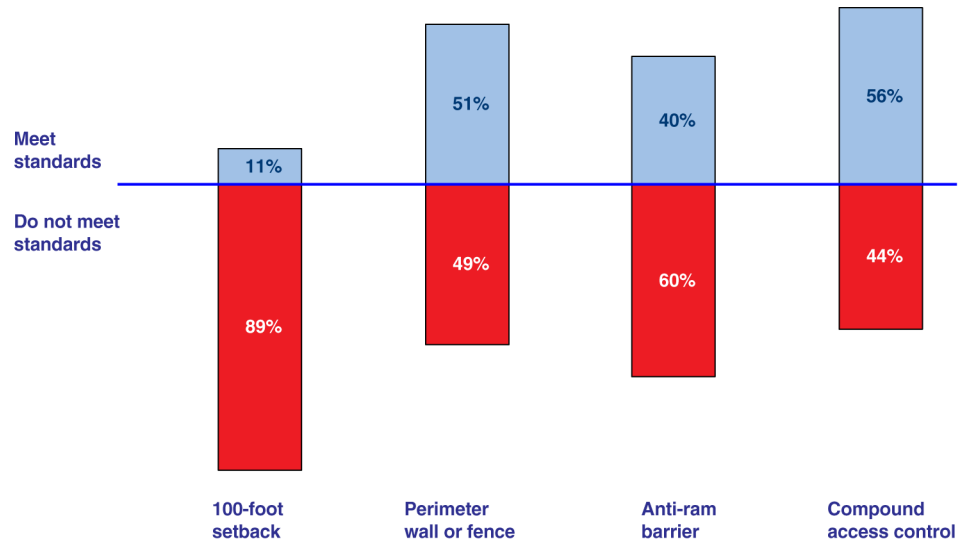
**Figure 4: Percentage of Primary Facilities that Meet or Do Not Meet Key Physical Security Standards**

As shown in figure 4, only 28, or 11 percent, of the primary buildings meet the 100-foot setback standard. More than half of the primary buildings have less than 15 feet of setback—these buildings are virtually perched on the street. Figure 6 is an example of a post with limited setback.

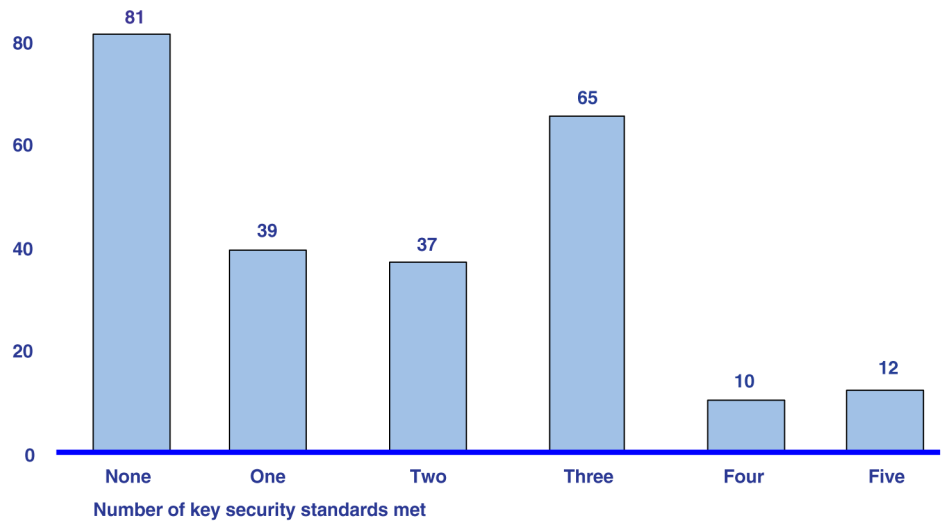
**Figure 5: Number of Physical Security Standards Met by Primary Facilities**
