**FY01**

**Department of the Interior  
Aviation Accident Review**

# Mesa Verde NP, CO

## Bell 206L-1

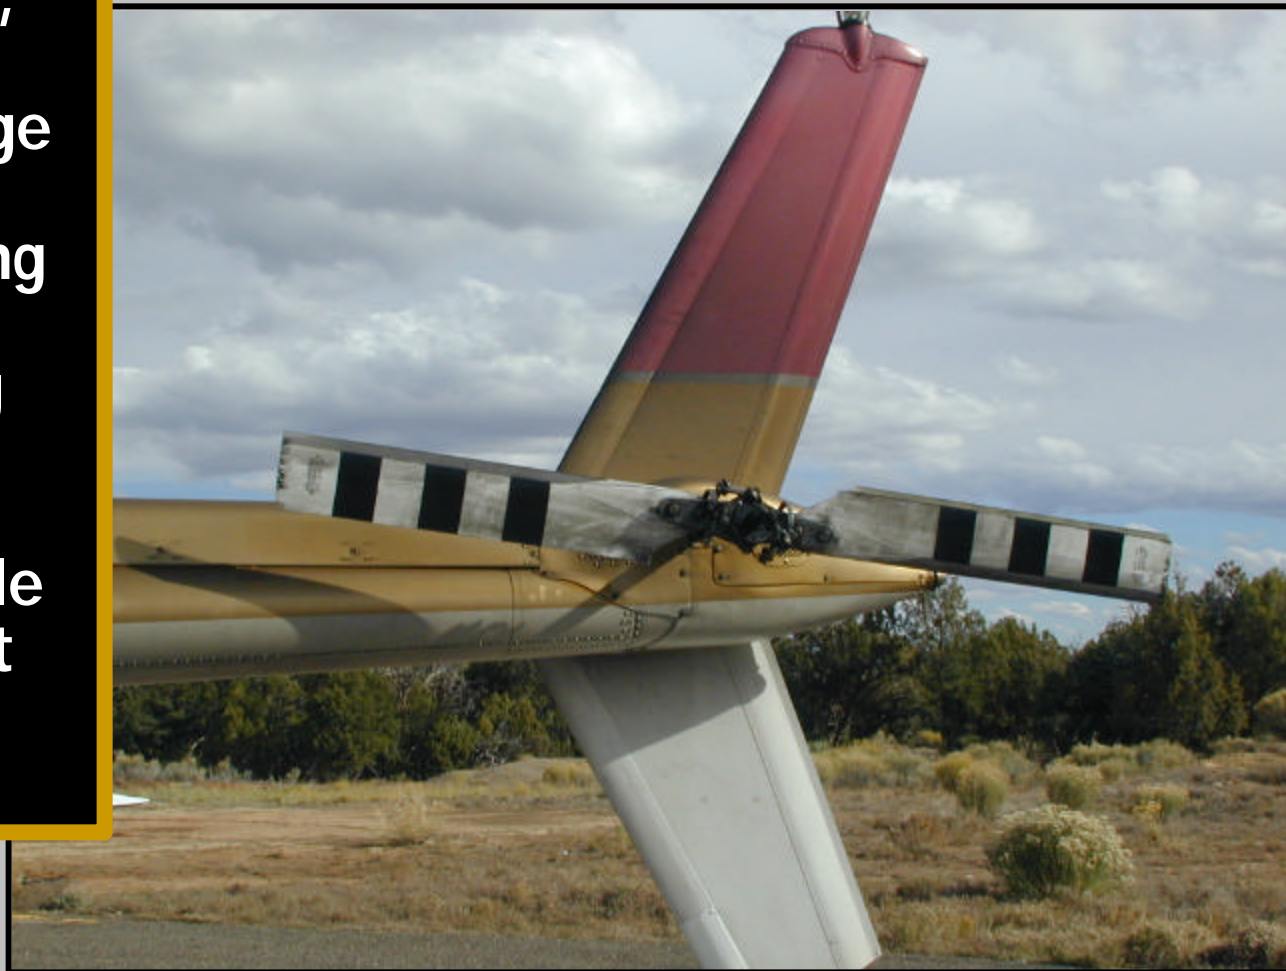
**A Bell 206L-1 helicopter, N613, sustained substantial damage when a tail rotor blade failed during approach to a helicopter landing pad.**

**Trailing edge de-bonded**

Trailing edge de-bonded

Only 1 of 4 gearbox attaching points remained intact

- The manufacturer's use of improper materials, and inadequate quality control of the tail rotor blades during the manufacturing process, which resulted in fatigue failure of the blade.

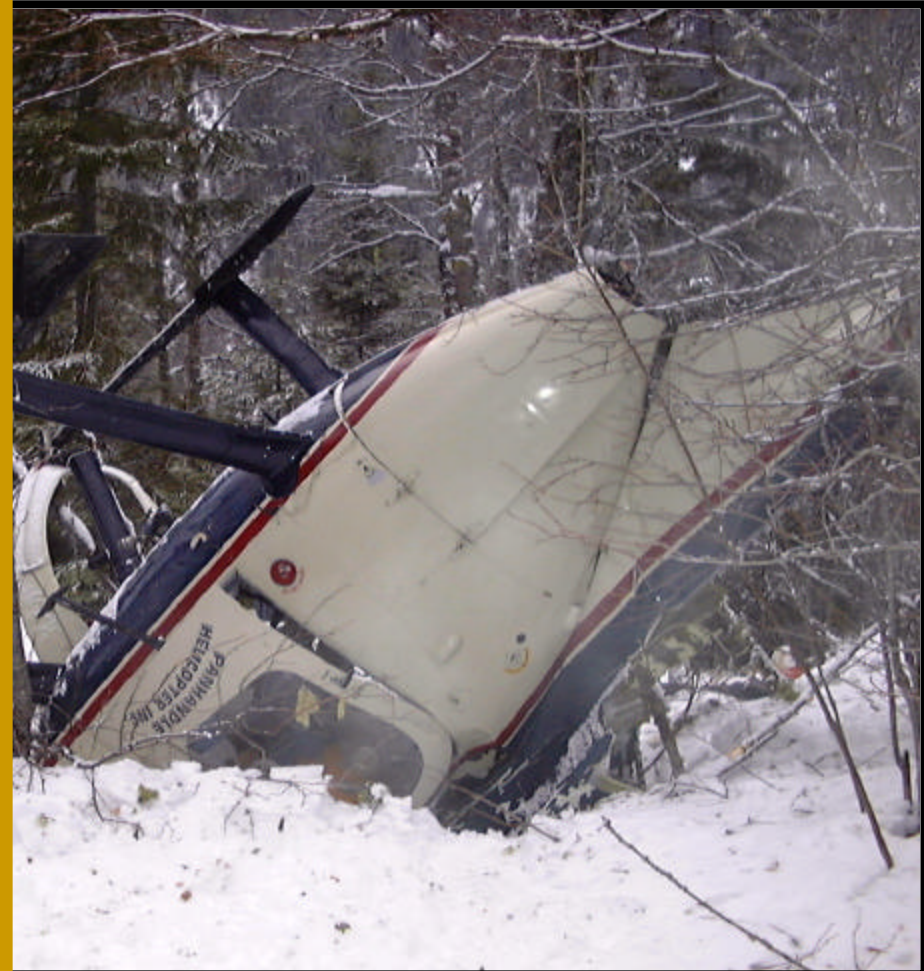
During an Idaho Fish and Game Department mission to find and track mountain lions the helicopter collided with a tree (snag) and crashed.

The pilot, sitting in the left seat was making a right, descending turn to begin a search track when the impact occurred.

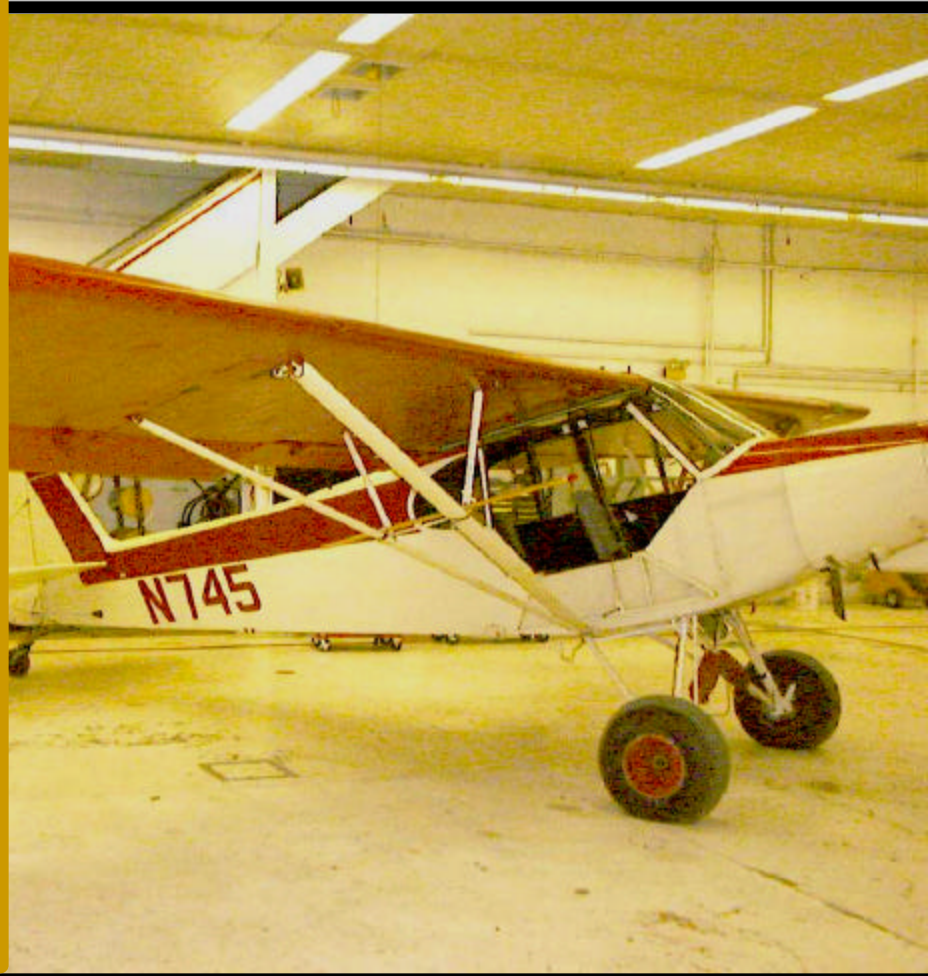
A tundra tire equipped PA-18, N 745, sustained substantial damage during a downwind landing at the King Salmon airport, AK.

Following a visual inspection the pilot elected to fly the damaged aircraft to Anchorage.

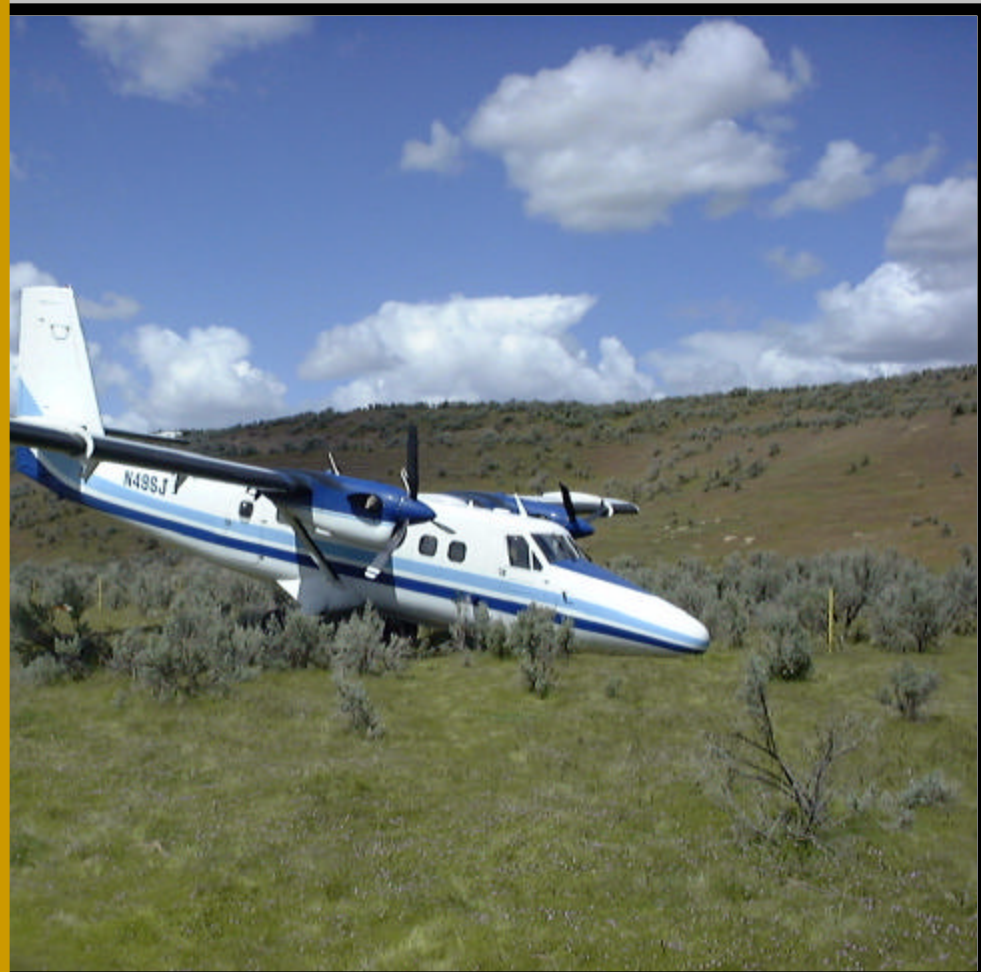
A Twin Otter, N49SJ, operated as a public use flight, was substantially damaged when the aircraft veered off the runway at Star, Idaho, and collided with the terrain.

According to the NTSB metallurgical analysis of the nose steering cable revealed evidence of pre-existing metal fatigue.

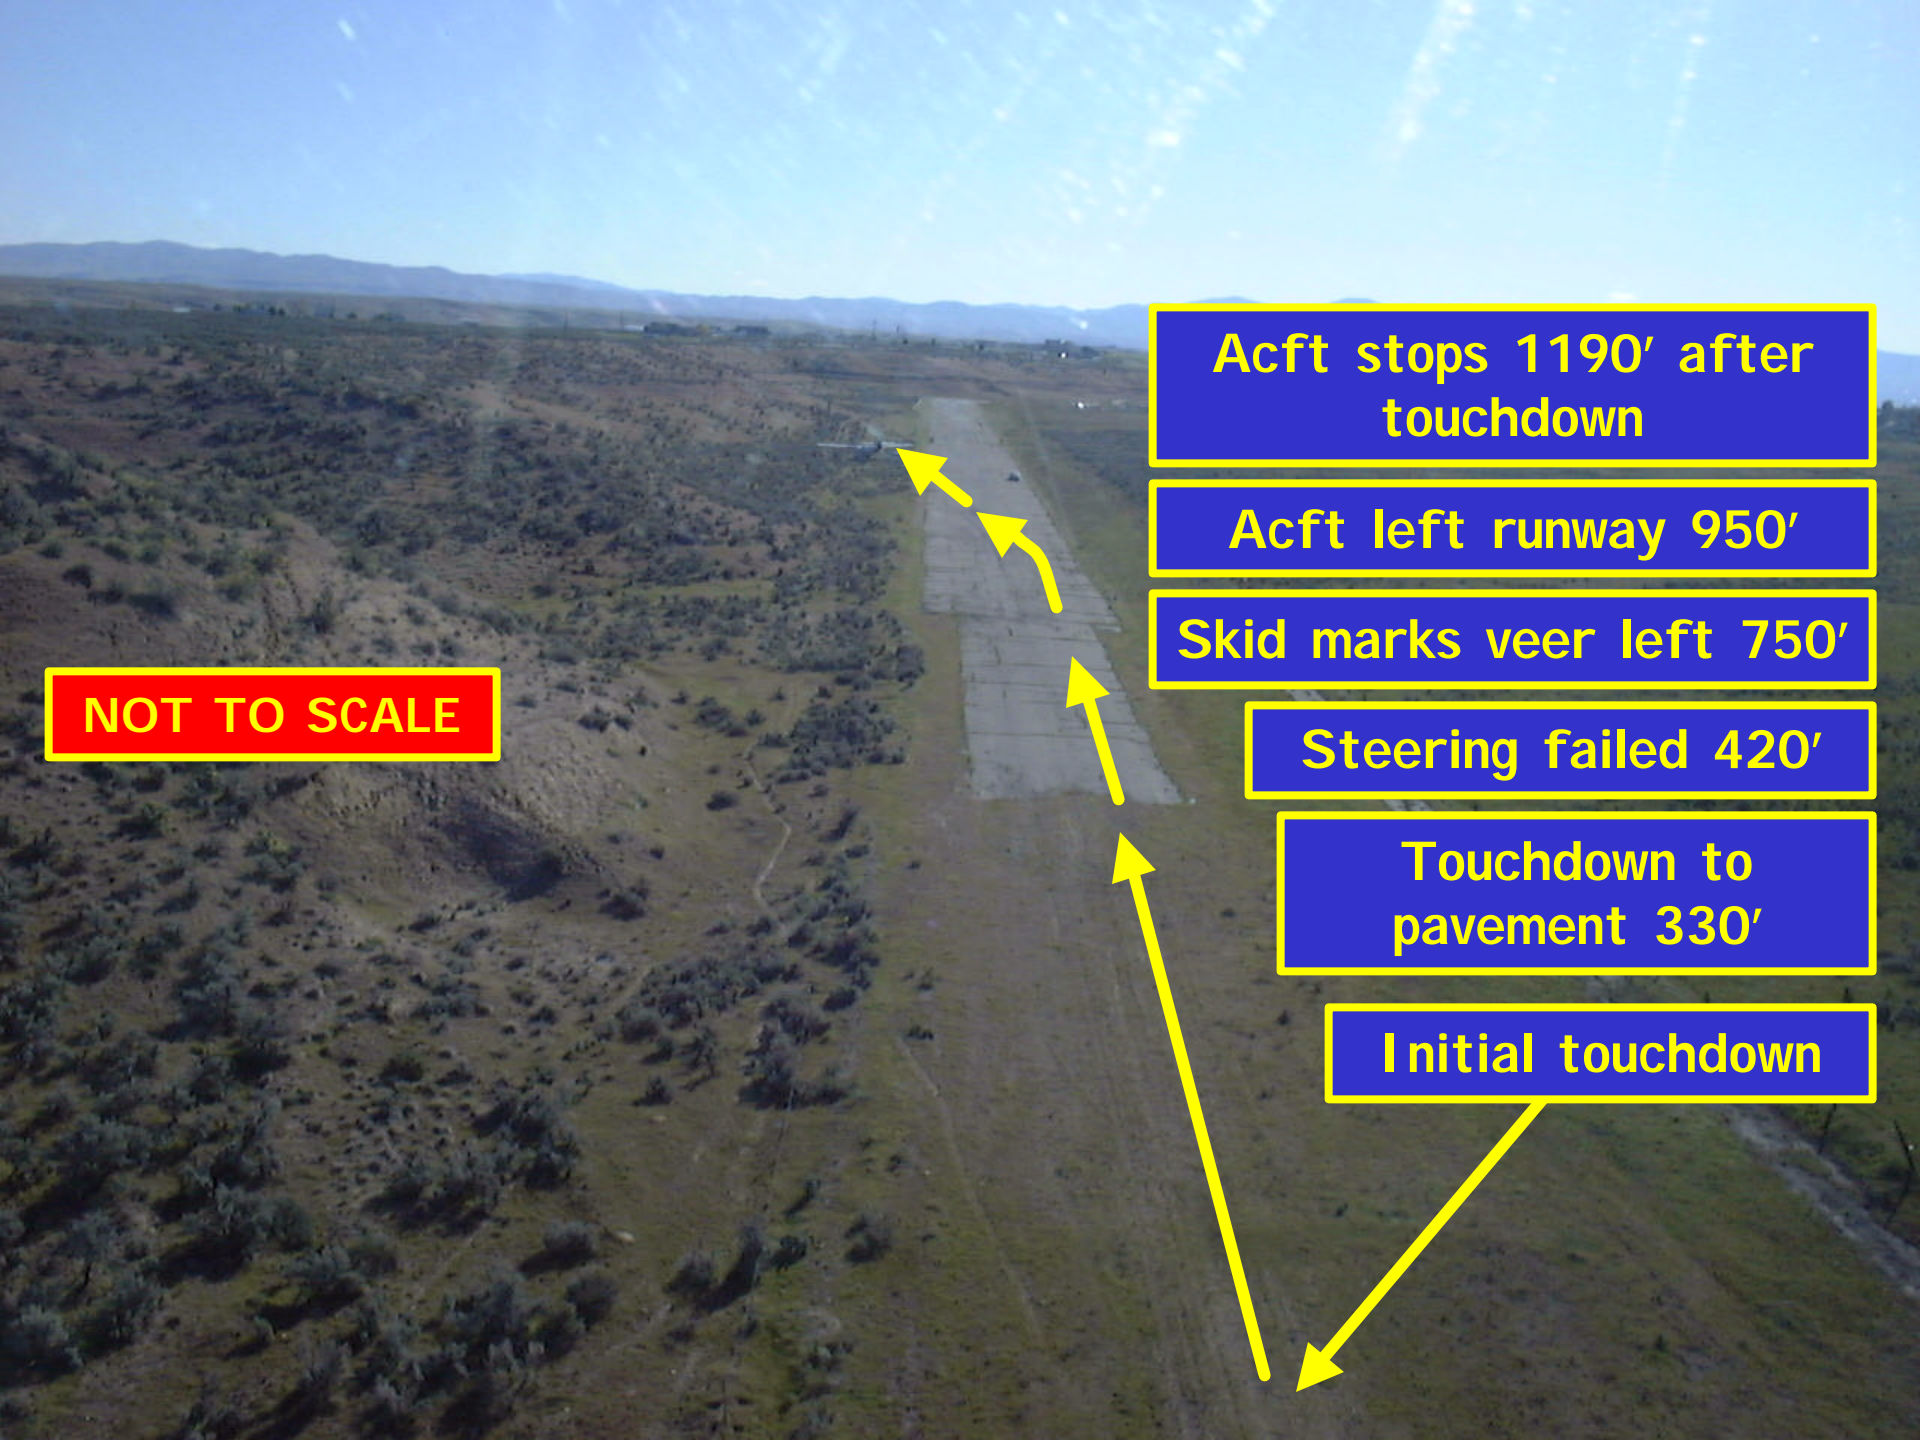
**Acft stops 1190' after touchdown**

**Acft left runway 950'**

**Skid marks veer left 750'**

**Steering failed 420'**

**Touchdown to pavement 330'**

**Initial touchdown**

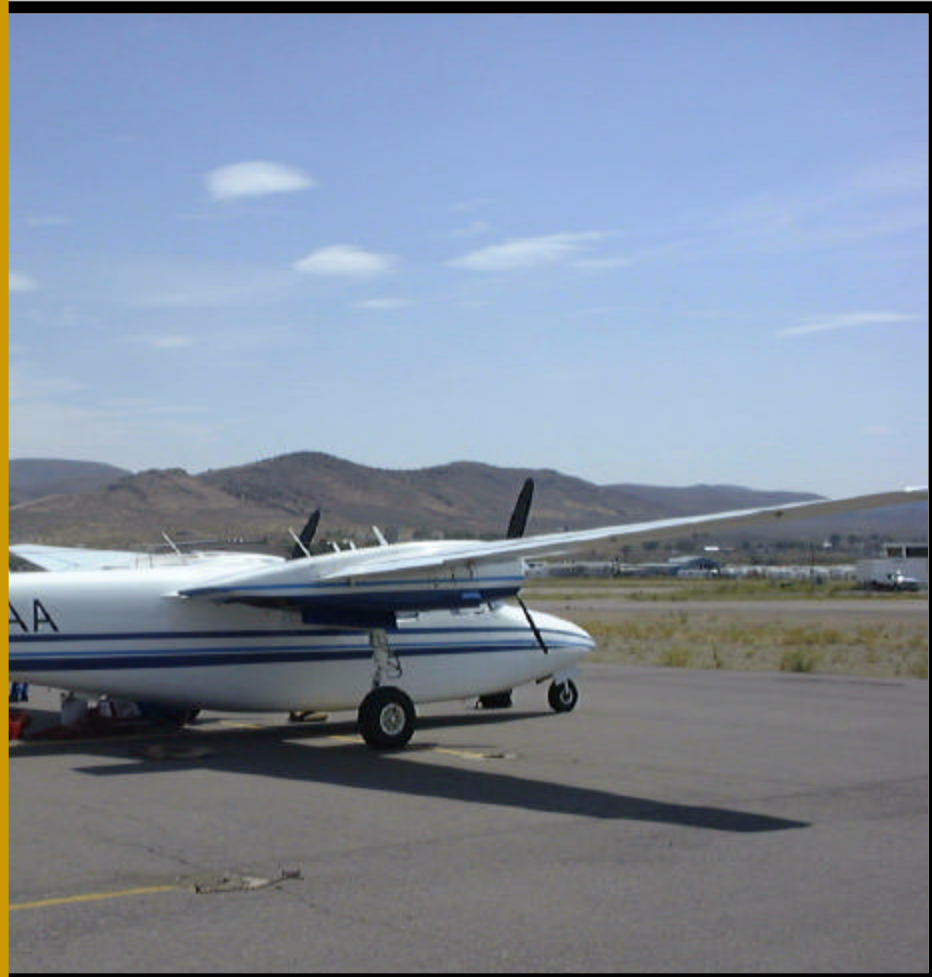
**An Aero Commander 500, N975AA, operated as a public use flight, was substantially damaged when both main landing gear collapsed on landing.**

**Analysis of the landing gear is being conducted but the investigation was hampered by the premature disassembly of components by the operator.**

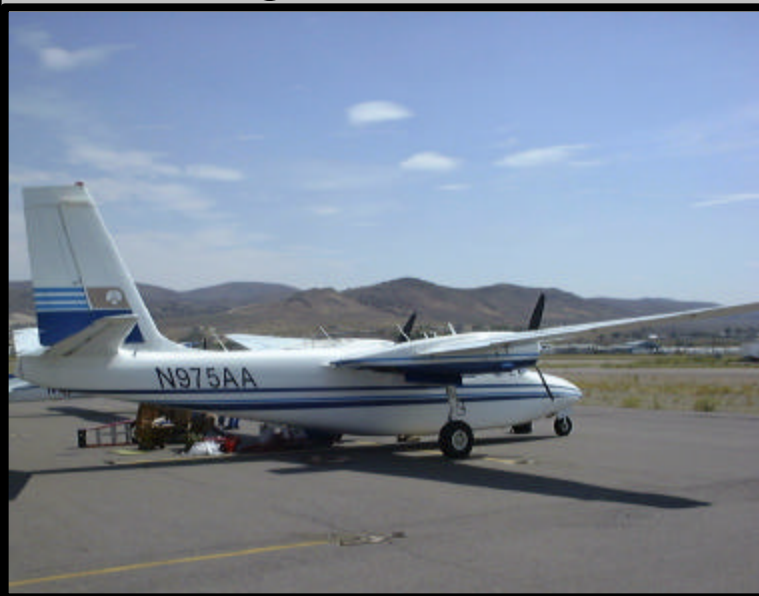
## **Issue**

After the mishap the aircraft was moved and partially disassembled prior to the arrival of investigators

- How can we improve post accident responses?
  - Providing aircraft security
  - Prohibiting tampering with evidence
  - Taking Photographs
  - Segregating witnesses and taking initial statements
