# Mech

The Naval Safety Center's Aviation Maintenance Magazine

Vol. 2, No. 8, Oct – Dec '99

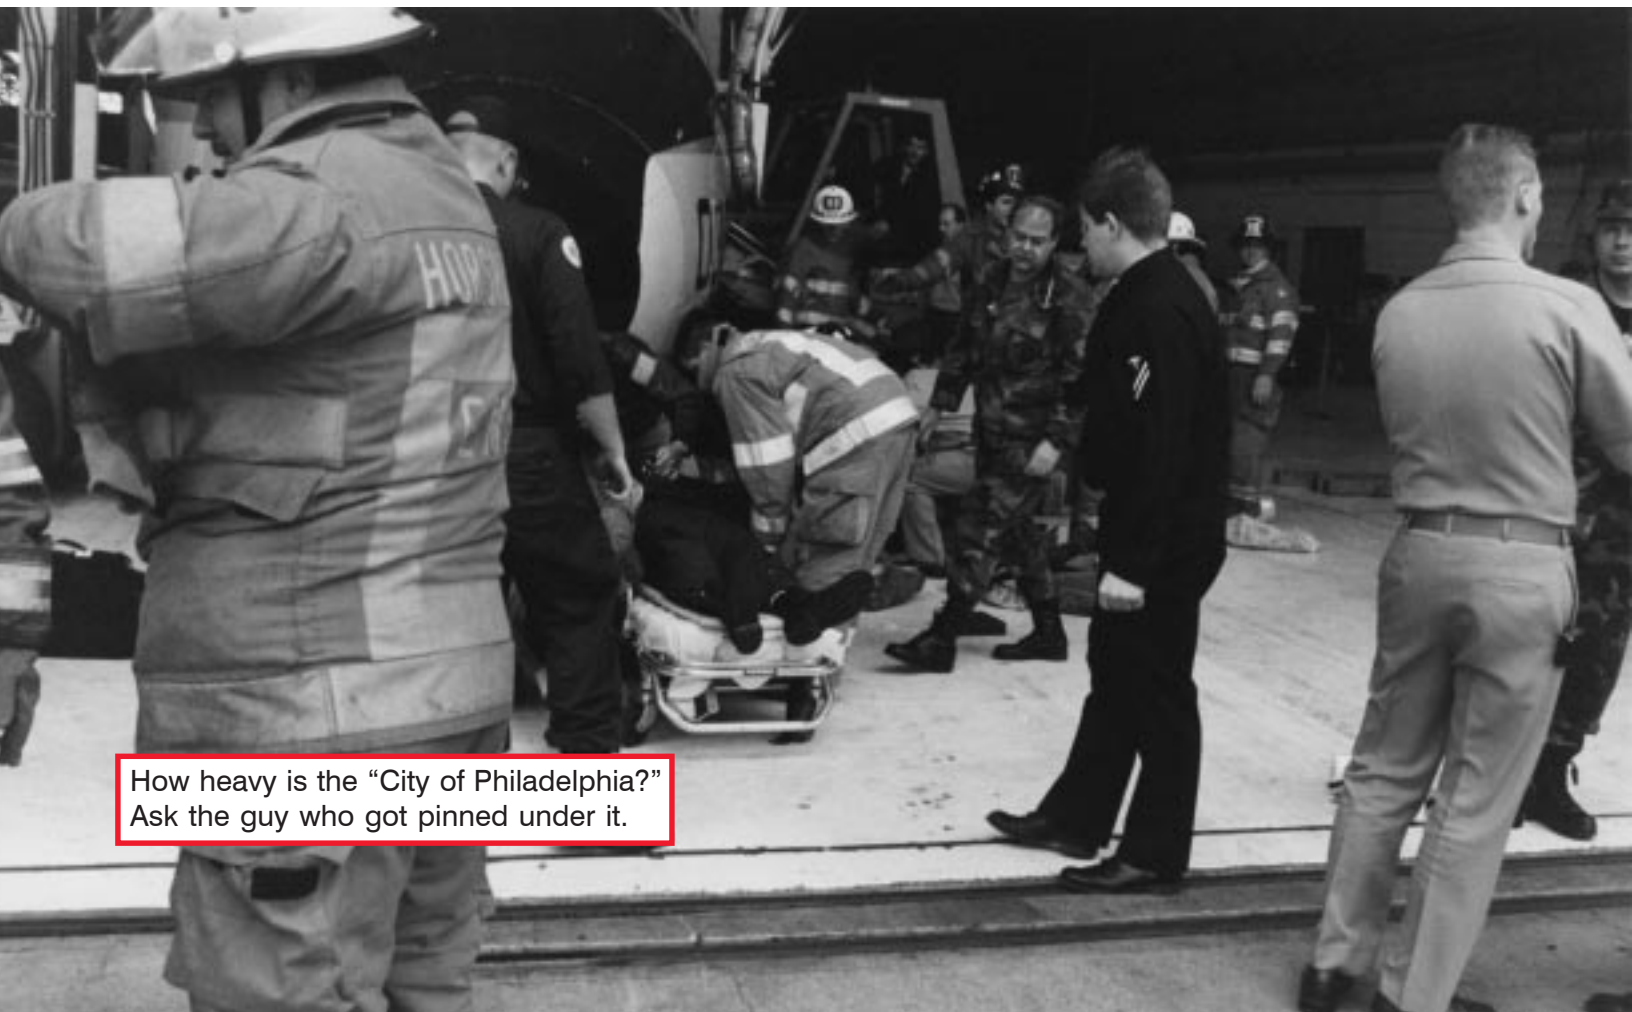
How heavy is the "City of Philadelphia?" Ask the guy who got pinned under it.

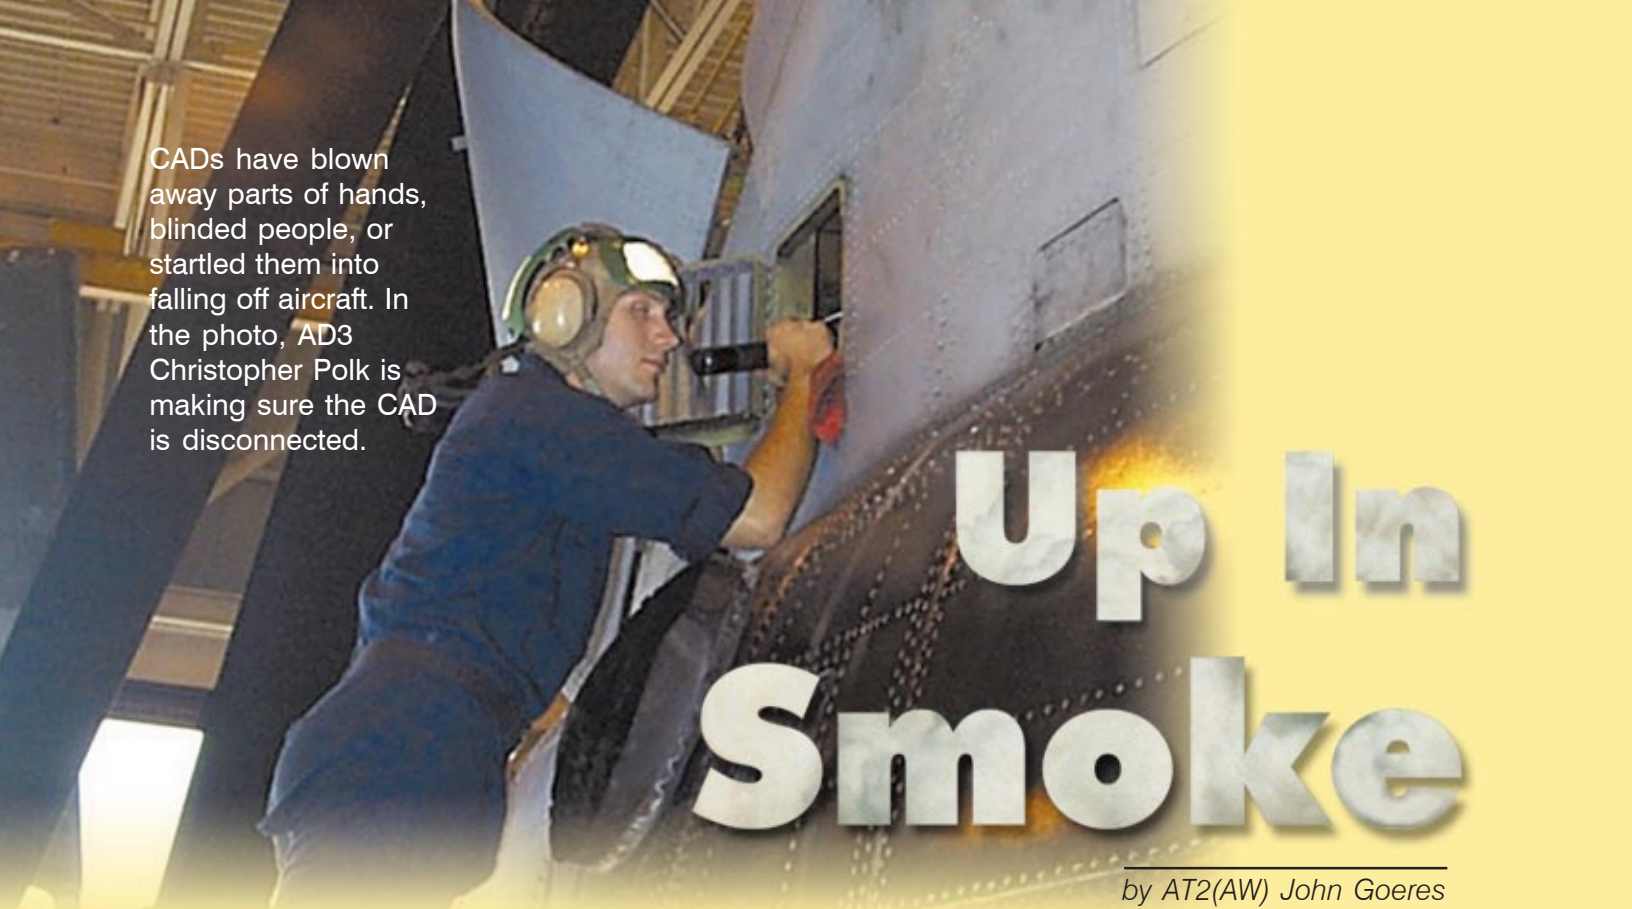
CADs have blown away parts of hands, blinded people, or startled them into falling off aircraft. In the photo, AD3 Christopher Polk is making sure the CAD is disconnected.

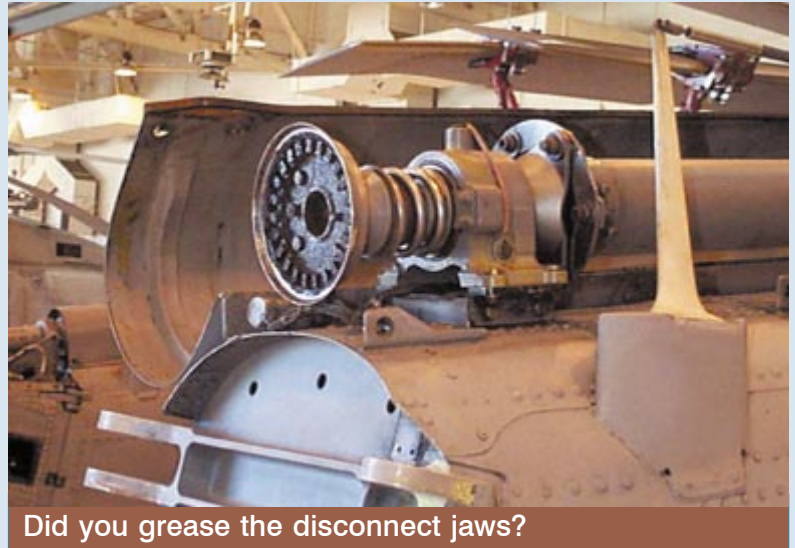
Did you grease the disconnect jaws?

I was the main person at fault because I didn’t inspect what I’d signed for. My shortcut could have cost people their lives or caused extensive damage to the aircraft. Still, it cost the squadron a lot of man-hours and parts to replace the couplings that had been damaged from operating without grease.
