OFFICE OF SURFACE MINING
REPORT ON OCTOBER 2000
BREAKTHROUGH AT THE BIG BRANCH SLURRY IMPOUNDMENT

Martin County Coal Corporation
Big Branch Slurry Impoundment
Martin County, Kentucky

March 2002

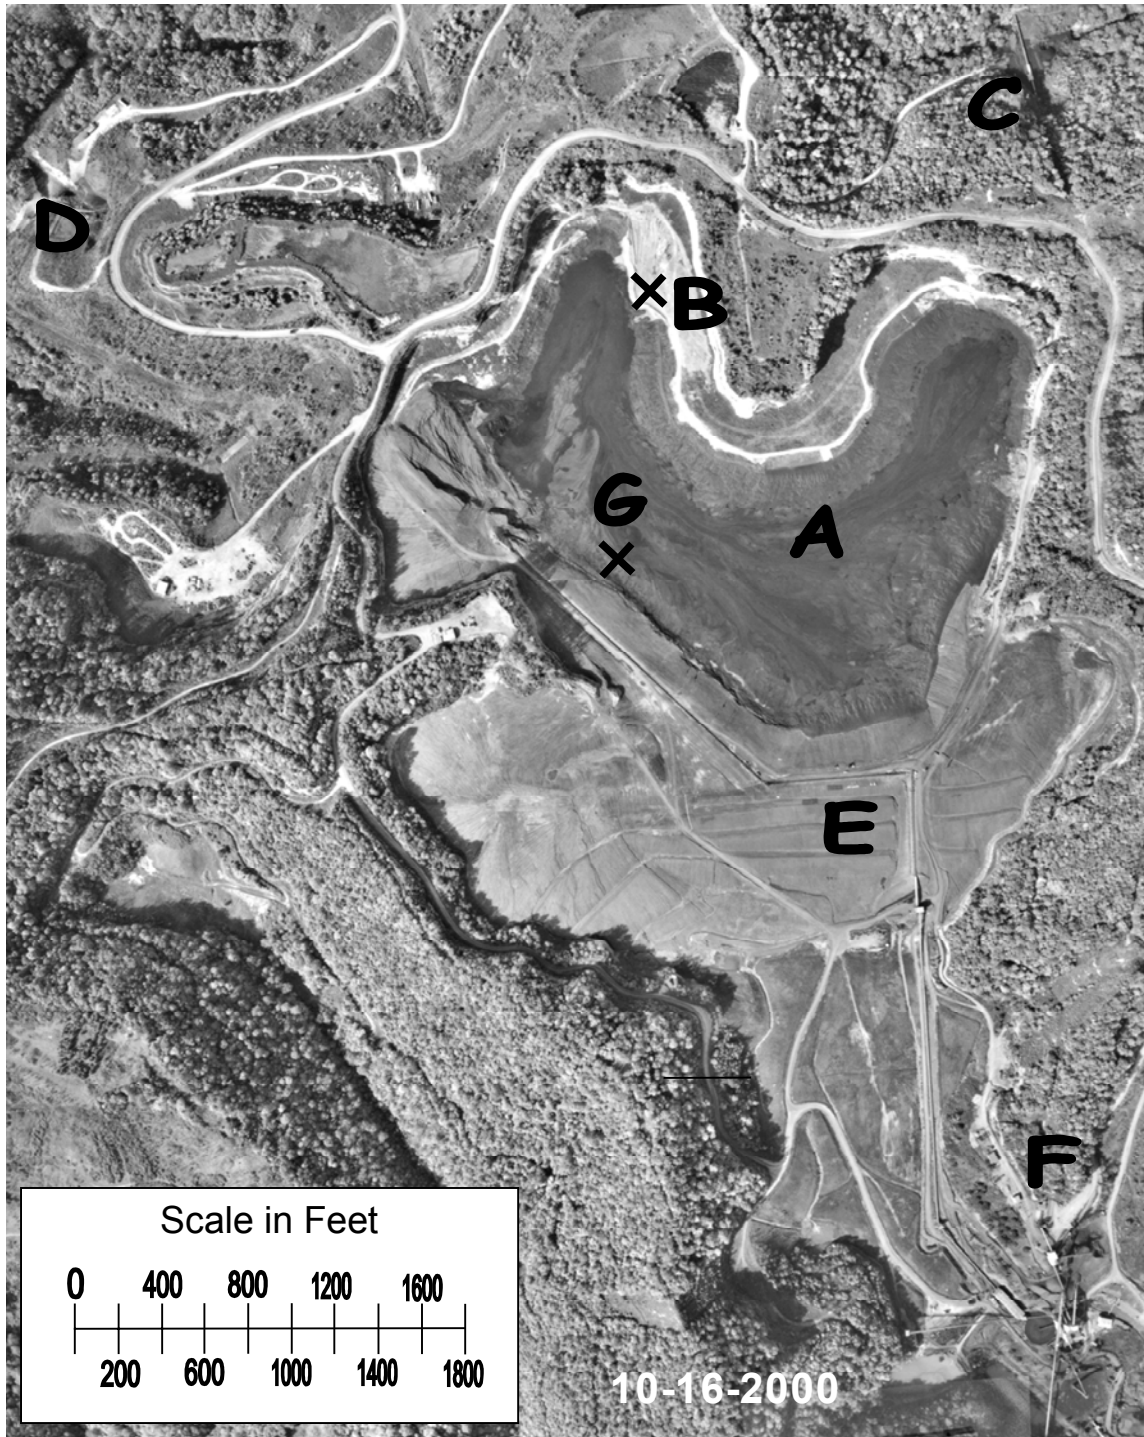
On October 11, 2000, a combination of coal slurry and water from the Martin County Coal Corporation (MCCC) Big Branch slurry impoundment in Martin County, Kentucky, broke through into an underground mine adjacent to the impoundment, consequently discharging into the receiving streams (Figure 1 [Page 2] and Photo 1 [Page 3]). The purpose of this study, performed by the Office of Surface Mining (OSM), U.S. Department of the Interior, was to evaluate the conditions and sequence of prior events primarily to determine the probable breakthrough mechanism. Also, OSM evaluated other factors, such as designs and approvals, which could have contributed to the 2000 breakthrough. To achieve this, OSM examined documentary evidence of MCCC's activities in and near the impoundment over a period of 30 years.

Photo 1. Aerial Photograph of Big Branch Slurry Impoundment - October 16, 2000. Source: Photo Science, Inc. A) Impoundment. B) 2000 breakthrough location. C) Number 2 North Mains Portals. D) South Mains Portal. E) Embankment (dam). F) Preparation plant. G) 1994 breakthrough location.

On May 22, 1994, as the pool level reached 28 feet above the Coalburg coal seam, a major breakthrough into the underground mine occurred at the southwest side of the impoundment (Figures 2 and 3 [Pages 4 and 17] and Photo 1 [Page 3]). An unusual amount of water from the underground mine was observed in Big Branch at about 11:30 p.m. The exact location of the impoundment breakthrough was not discovered until about 2:55 a.m. on May 23, 1994. Emergency repairs were started at 3:30 a.m., and the flow was stopped at 6:30 a.m.

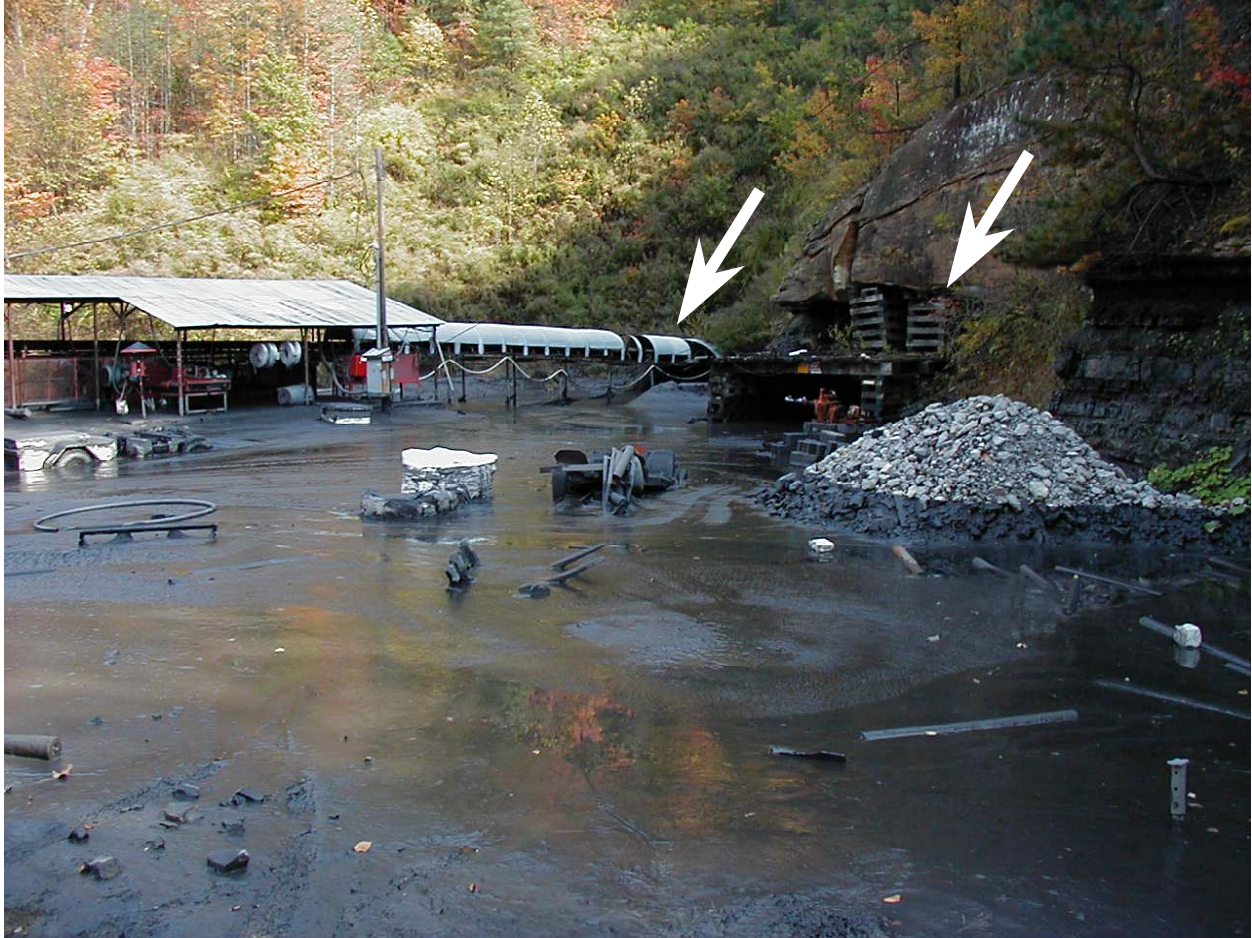
Photo 4. Number 2 North Portals - October 16, 2000. Source: OSM.

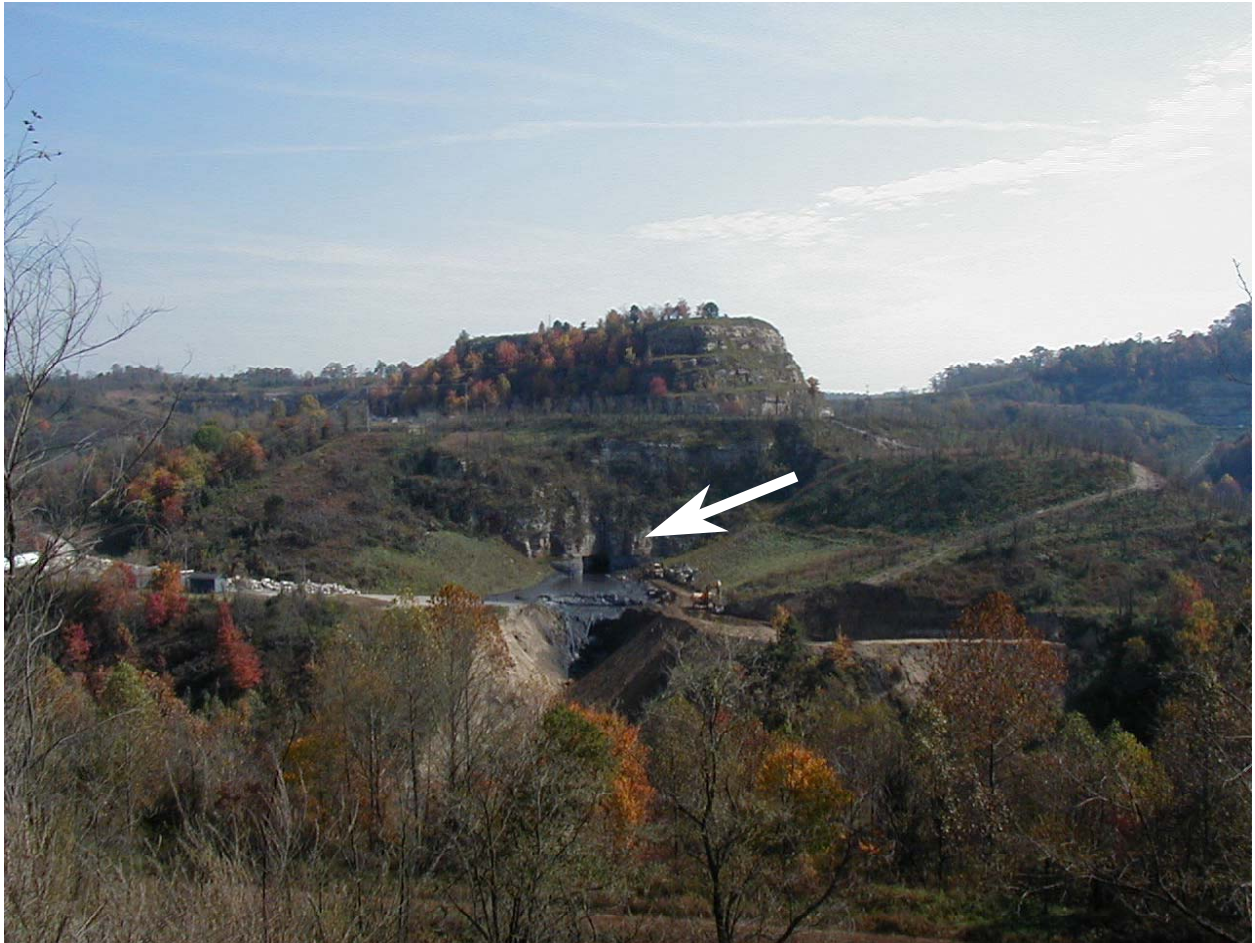
Photo 5. South Mains Portal - October 16, 2000. Source: OSM.

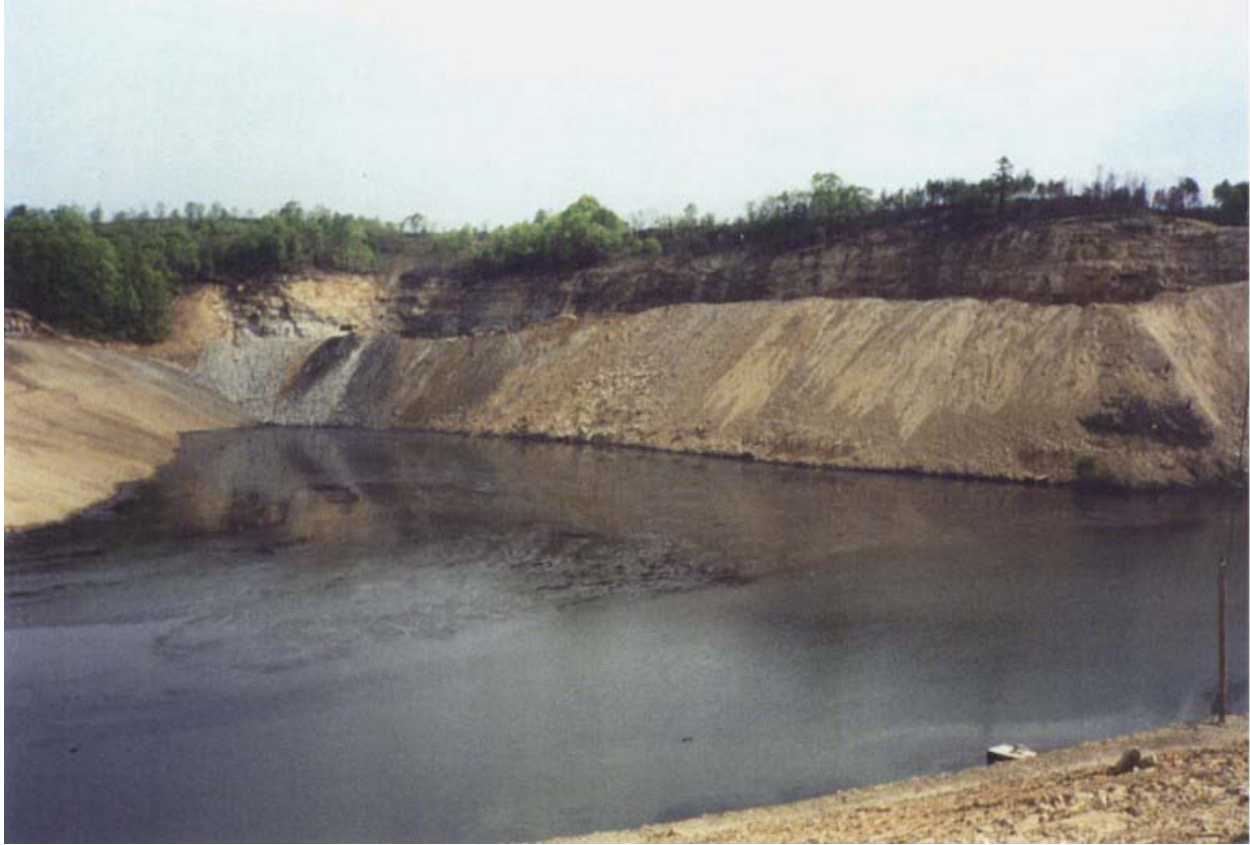
Photo 13. Seepage Barrier by 2000 Breakthrough (During Construction) - June 8, 1995. Source: GAI. The 2000 breakthrough area is located at the left-center of the photo. Pool elevation 1,001 feet msl. Mine roof elevation 973 feet msl.
