# UNITED STATES COAST GUARD

INVESTIGATION INTO THE CIRCUMSTANCES  
SURROUNDING THE SINKING OF THE  
UNINSPECTED FISHING VESSEL

## ARCTIC ROSE

OFFICIAL NUMBER 931446, IN THE BERING SEA ON  
APRIL 2, 2001, WITH ONE PERSON DECEASED AND  
FOURTEEN PERSONS MISSING AND PRESUMED DEAD

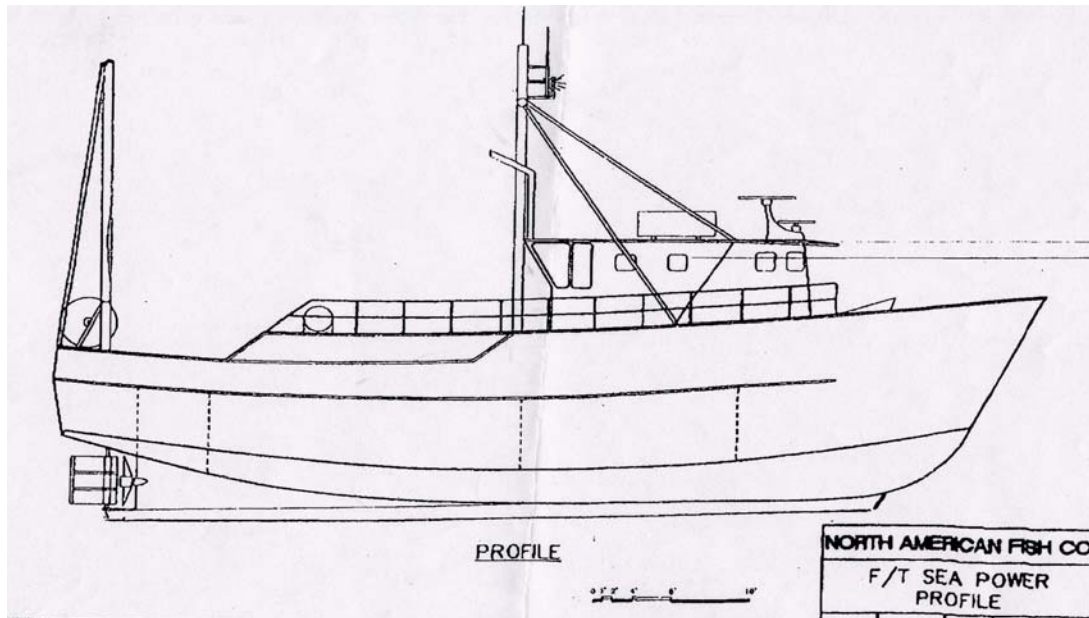
Figure 1  
Profile drawing of ARCTIC ROSE

- a. General. The ARCTIC ROSE was a ninety-two foot fishing vessel, western rigged with the pilothouse forward and trawl deck aft with a large “A” frame gantry at the stern which operated primarily in the Gulf of Alaska and Bering Sea. The vessel operated as a H & G processor. The catch was deheaded and gutted in preparation for freezing and packaging in the processing space.

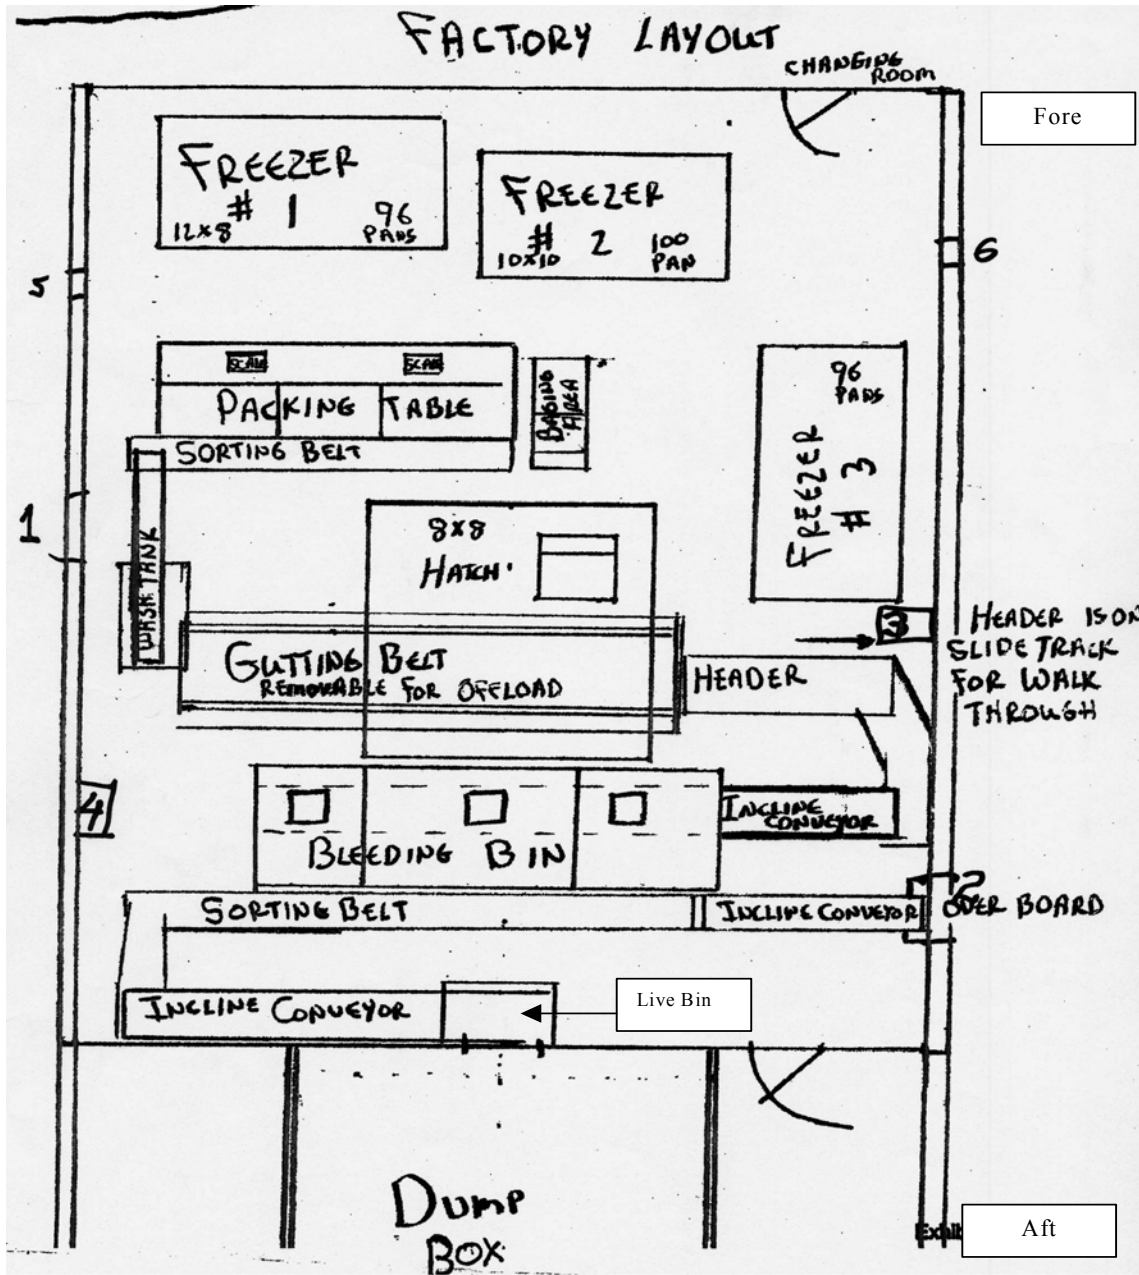
Figure 4  
Drawing of Processing Space

- 6) Lazarette. This space was the aft-most space of the vessel, which contained the vessel's hydraulic double ram steering gear system.
- c. Main Deck (Processing) Area. The processing area contained all the equipment for processing the fish as seen in Figure 4. The catch passed from the deck to a live bin through a hydraulically operated sliding hatch on the aft bulkhead. The fish were sorted according to keepers and bycatch. The bycatch was placed on a conveyor belt and discarded through a chute. The target species were taken by conveyor belt to the deheading machine. Once deheaded, the fish were taken via conveyor belt to the cleaning area. There the fish were

- 5) Processing Space. This space contained the equipment for processing fish as shown in Figure (4).

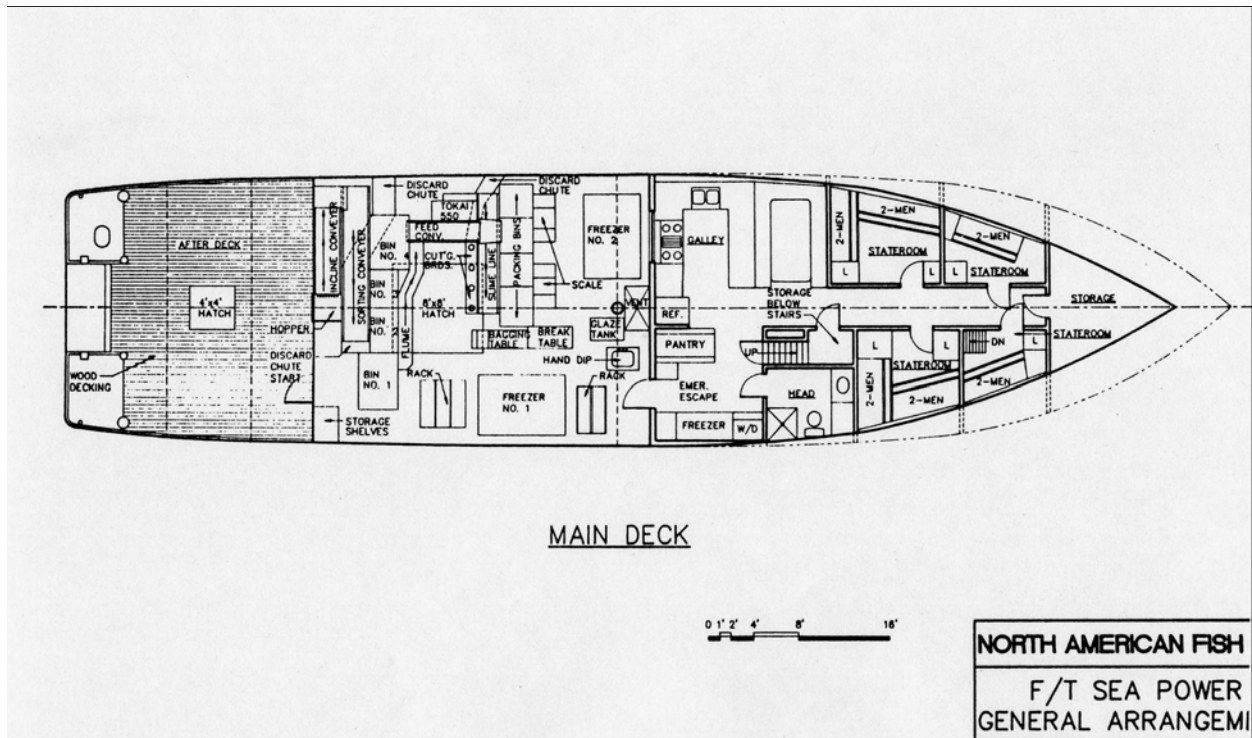
- 1) Dry Stores. A small dry storage space was located at the stem of the vessel. Plans (see Figure 5) show this space as a stateroom, but testimony provided to the Marine Board indicates the space was used for dry stores.

Figure 5  
Main Deck Drawing (Disregard Processing space and refer to Figure 4 for correct details)

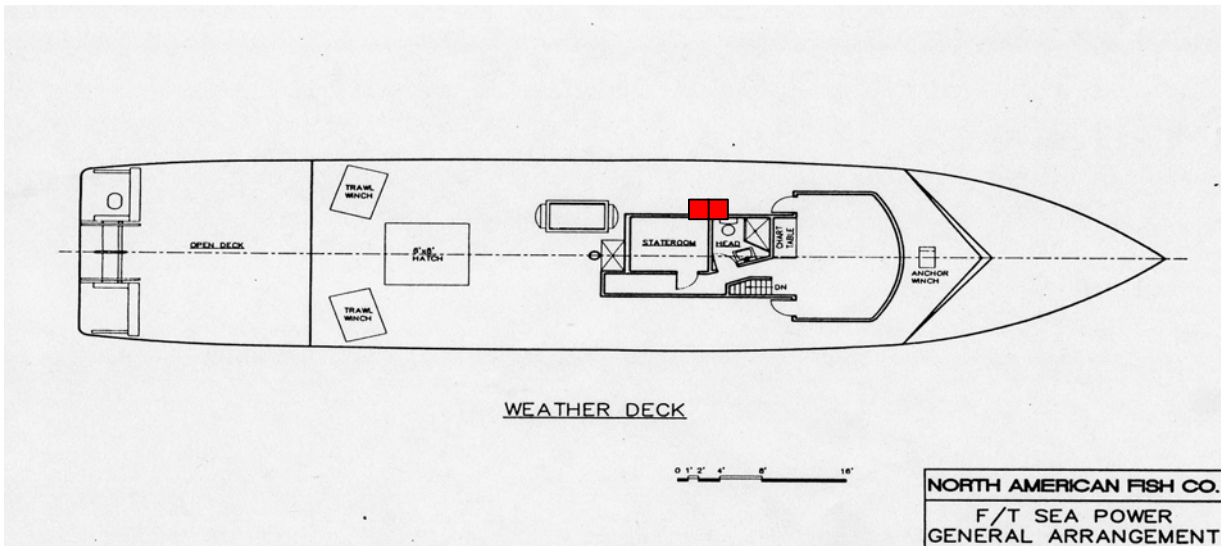
Figure 6  
 Drawing of weather deck  
 The red boxes are the proximate location of the wooden boxes

Captain Rundall's body was located within the debris field in a properly donned immersion suit. The immersion suit was full of water. The immersion suits were stowed in a wooden box at the port side of the pilothouse level on the weather deck (see Figure 6). Seven empty immersion suits were recovered by the vessels on scene, all of which were found out of their storage bags.

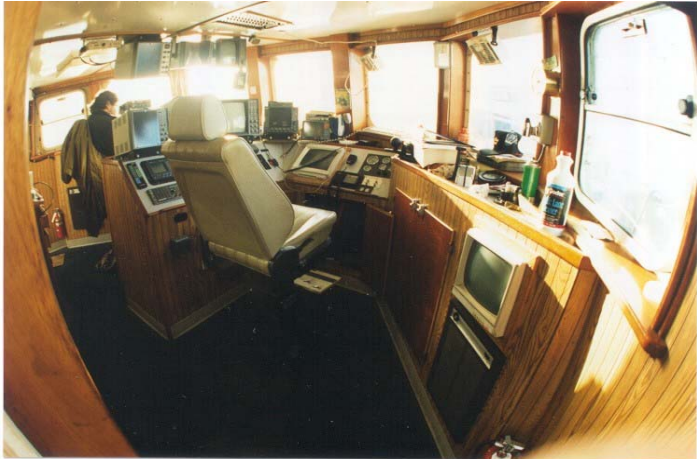
Figure 7  
 View of the primary steering station aboard F/V TENACITY (1996)

f. Pilothouse and Weather Deck. The pilothouse had three helm stations. The primary steering station was located on the starboard side of the pilothouse, a second station was positioned amidships, and the third station was facing aft which was used for deploying and retrieving trawl gear. Portside, just aft of the pilothouse door, were two wooden boxes. One was used to store spare gear and the other to store the immersion suits, which were stowed inside their bags. Each box was secured shut by a hasp or latch. Aft of the pilothouse was the master’s cabin. Just aft of the cabin was an open deck used for mending nets. A small pedestal deck crane with associated controls and port and starboard trawl winches were located at the aft end of this deck. This crane was used for loading provisions and unloading cargo.

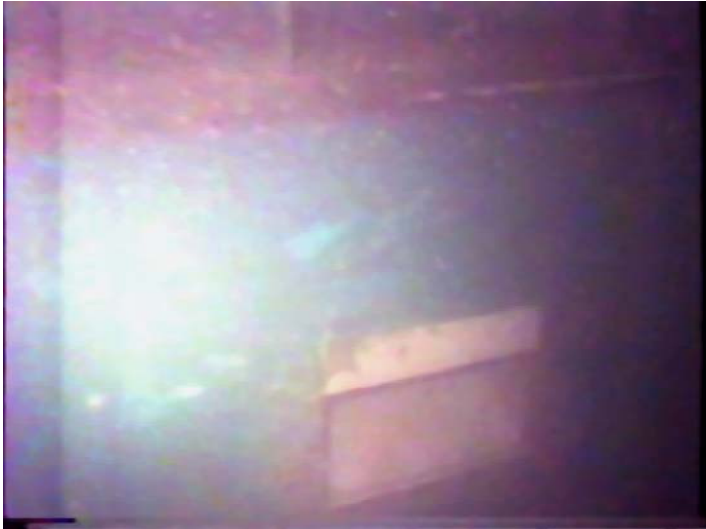
Figure 10  
 Partially open overboard  
 discharge chute on  
 starboard side of ARCTIC  
 ROSE (2001)

h. Watertight/Weathertight Doors and Hatches. There was a six-dog weathertight door located on the starboard side that opened out to the trawl deck, and a slide hatch located on the aft bulkhead of the processing space. The sliding weathertight chute on the aft bulkhead

facilitated the movement of the catch from the dump box to the processing space. The overhead of the processing space had a weathertight hatch used to offload product. The processing space had six sideshell openings. A small manhole with a raised coaming was located in the top of the deck hatch, which was fitted with a non-watertight or weathertight plywood cover. A weathertight door provided access from the processing space to the mudroom. Access to the engineroom was via a flush deck trunk. A hatch cover was not fitted over the engineroom trunk. There was a watertight door between the engineroom and auxiliary machinery space and a non-watertight hatch between the engineer's stateroom and the auxiliary machinery space. The Jensen Marine Consultants (JMC) issued stability booklet required this watertight door to remain shut at all times except when used for passage. This same book required all openings for scrap and fish chutes in the processing space bulkhead to be kept closed at all times except when used while processing fish.

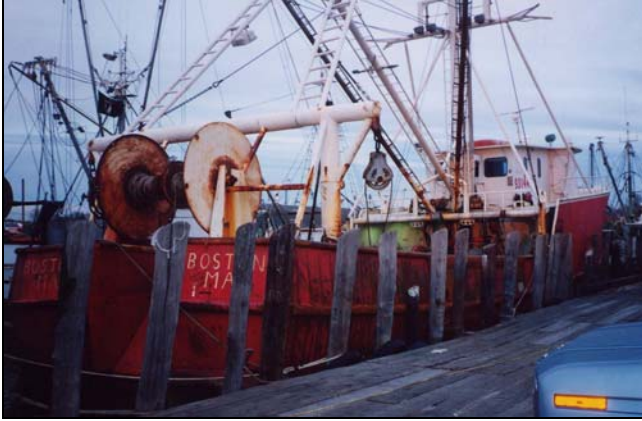
Figure 12  
Photo of SEA POWER (1990)

- a. Shrimp Boat. The ARCTIC ROSE was originally constructed at Covacevich Boat Works in Biloxi, Mississippi by Mr. John Van Nguyen as a gulf shrimper and named SEA POWER. Due to a lack of plans it is unknown what construction methods were employed and it is unknown as to whether the vessel was constructed in accordance with a recognized standard.

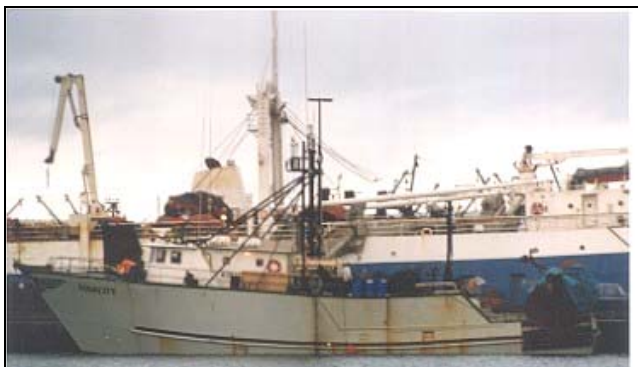
- c. Catcher-Processor Boat – Second Owner and Operator. In 1991, Dr. Kusum and Dr. D.K. Stokes (North American Seafoods) purchased the SEA POWER. That year the vessel was modified to work in the H & G and freeze industry at SEA-FAB Inc., in Pascagoula, Mississippi. A shelter deck was extended aft from the house on the main deck (above the waterline) and consumed approximately two thirds of the aft working deck. This new space was equipped with fish processing equipment. A gantry and net reel was added at the stern for trawl operations. The existing live fish hold was converted to a cargo hold. The cargo hold was insulated with a spray-on urethane foam and equipped with a refrigeration system. A concrete deck was poured to level the deck and serve as insulation from the shaft alley that runs through the cargo hold. Mr. Bruce Culver, Naval Architect, reviewed the changes and conducted an inclining experiment on December 11, 1991 once the majority of work was complete. Mr. Culver issued a stability book to the owner, which incorporated the processing space as part of the vessel's watertight envelope. As such, the processing space was required to be weathertight whenever the vessel was underway. The vessel departed Pascagoula to work off the Oregon/Washington coast and transited to India for a brief period to engage in trawling operations. After the failed India excursion, the vessel operated in the Gulf of Alaska and Bering Sea waters.

Figure 13  
Port view of TENACITY (1996)  
Note addition of processing space  
on main deck.

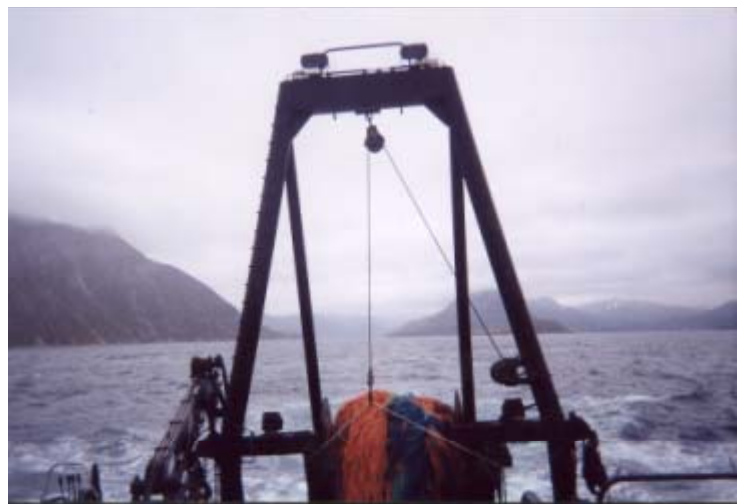
Figure 15  
Photo of "A" frame gantry  
(2001)

- e. Third Owner, Additional Modifications. The TENACITY was purchased by Arctic Rose LLC in March of 1999 and changed its name to the ARCTIC ROSE on June 25, 1999. In May 1999, the vessel was moved from Tippet Marine shipyard's waterside facility to the marine railway at Marine Fluid Systems in Seattle, Washington where a 13,600 lb keel shoe was welded to the exterior of the vessel. The old gantry was removed and a new larger "A" frame gantry was installed. Six inch pipe guards were installed on the upper deck to center the trawl net. A Cummins generator was installed in the engine room. A refurbished propeller and intermediate shaft were machined and installed. The original shafts were removed by SCANSEA personnel and could not be located.

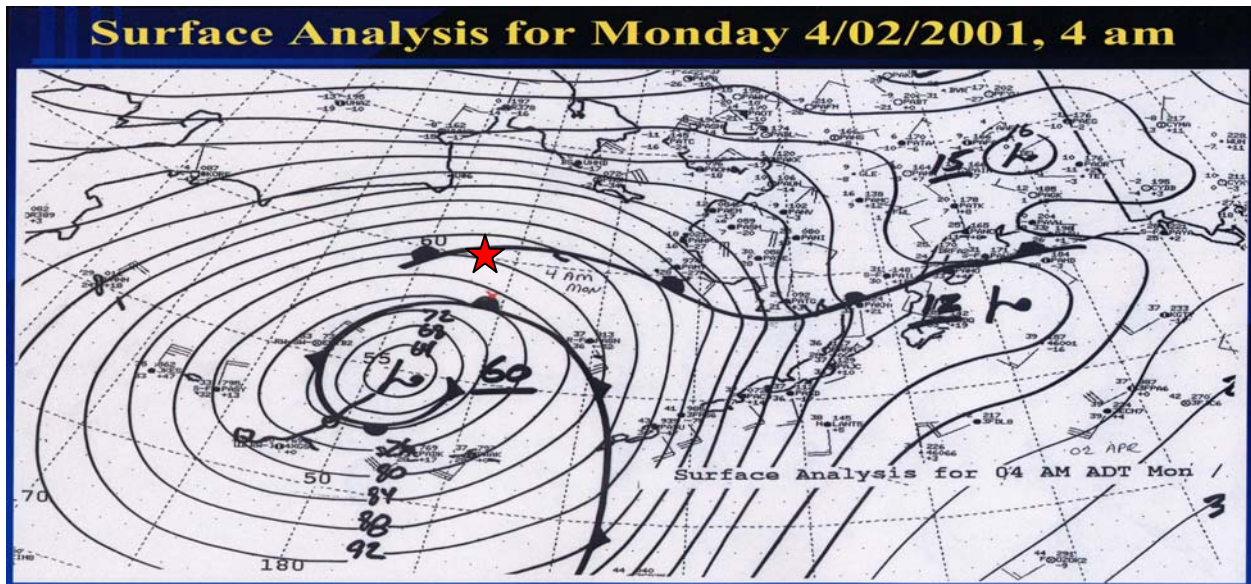
This forecast was revised using the 176° W longitude line as the boundary separating the two for the new forecast zones. East of the 176° longitude line a new forecast was issued at 2000 Sunday, April 1, 2001 valid through 1700 April 2, 2001 predicting a Gale Warning with southeast winds increasing to 45 knots, and seas 15 - 20 feet.

Figure 19  
National Weather Service Surface Analysis for 4am April 2, 2001  
The red star marks the approximate position of the ARCTIC ROSE

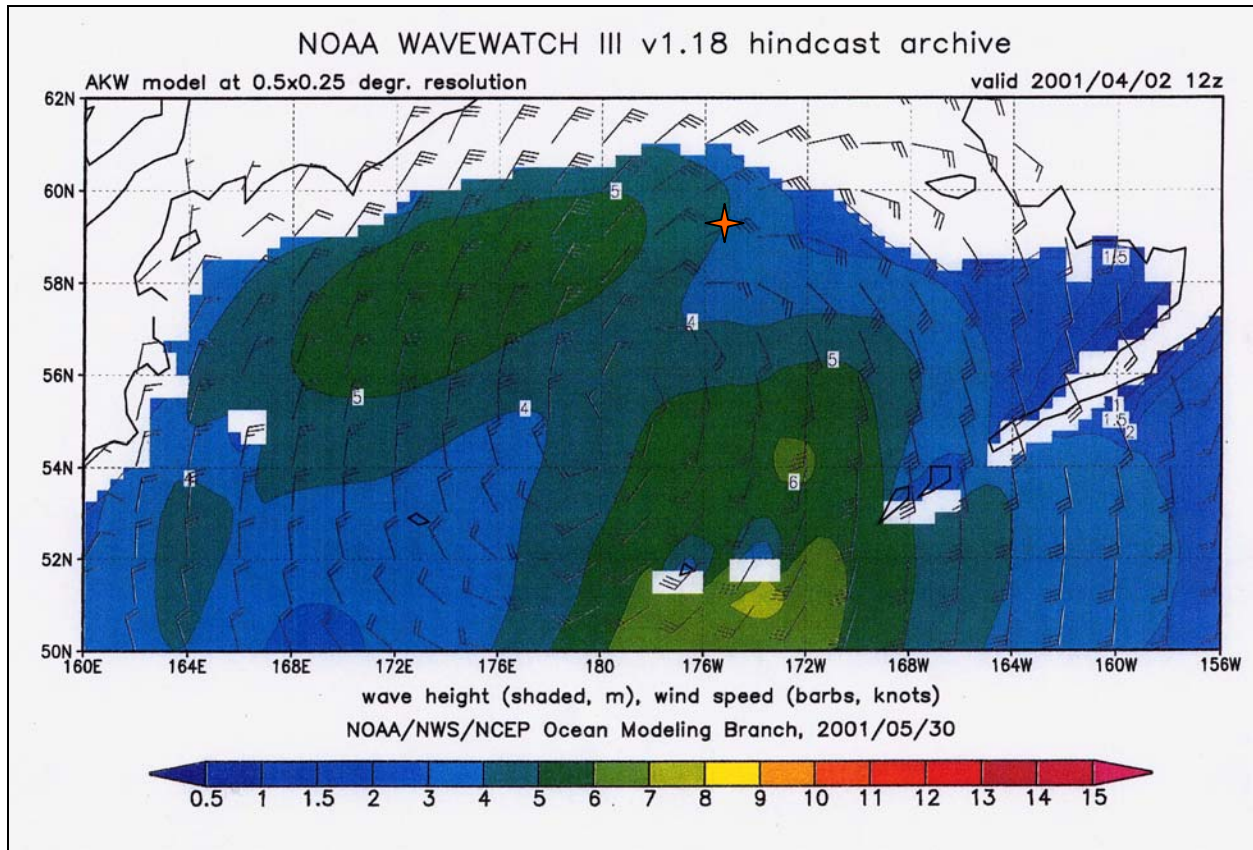
The NWS generated a hindcast (Figure 20) of the weather in the vicinity of the sinking based on weather reports from Coast Guard and other commercial sources operating in the vicinity of the sinking. Their analysis indicates a significant weather event occurred at the ARCTIC ROSE's last known position. A weather phenomenon known as a Triple Point, which is an area of a frontal system where a cold, warm and occluded front join together and is usually associated with severe weather, passed over the ARCTIC ROSE's position. It is highly probable, based on the Triple Point, the vessel experienced three distinct weather patterns within a brief period of

Figure 20  
National Weather Service Hindcast for 4am April 2, 2001.  
The orange star is the approximate position of the ARCTIC

The NWS hindcast shows the weather was worse than forecasted. In testimony provided to the Marine Board, Dr. Robert Hopkins of the NWS indicated that waves could reach significant heights of 24 feet and could be accompanied by sustained winds of up to 45 knots.

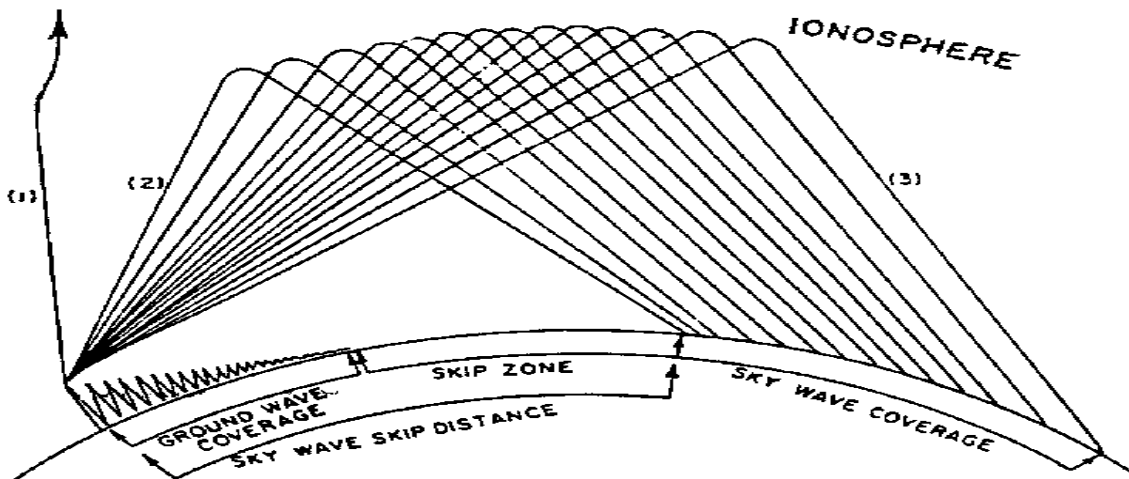
Figure 21  
Graphic depiction of a Skip Zone

A HF propagation report, which is an indicator of the likelihood of successful communications, for a 24-hour period was prepared by CWO Kimmel of COMSTA for the period from 1600 on April 1, 2001 to 1600 on April 2, 2001. The interpretation of the 4125 KHz frequency propagation report shows a six hour window, 0100 to 0700 on April 2, 2001, of the 24 hour period when COMSTA Kodiak would have been able to communicate with the area of the Bering Sea where the EPRIB from the ARCTIC ROSE transmitted. It was estimated there was an eighty percent probability that COMSTA Kodiak would have heard a radio MAYDAY from the EPRIB's position. CWO Kimmel added that given the location of the EPRIB, there is a good chance that ALASKAN ROSE was outside of the St. Paul Island HF antenna "skip zone" and would have heard HF communications. HF communications are restricted by the characteristics of the ground and sky waves. Ground waves are low energy waves that can cover only a short distance over ground and sky waves are high energy, traveling great distances as they bounce off the earth's surface and the ionosphere. Normally, close-in communications are restricted by a phenomenon known as the skip zone which exists between where the ground wave ends and the first skywave comes in. The extent of the skip zone varies in area depending on frequency, location, season and time of day.

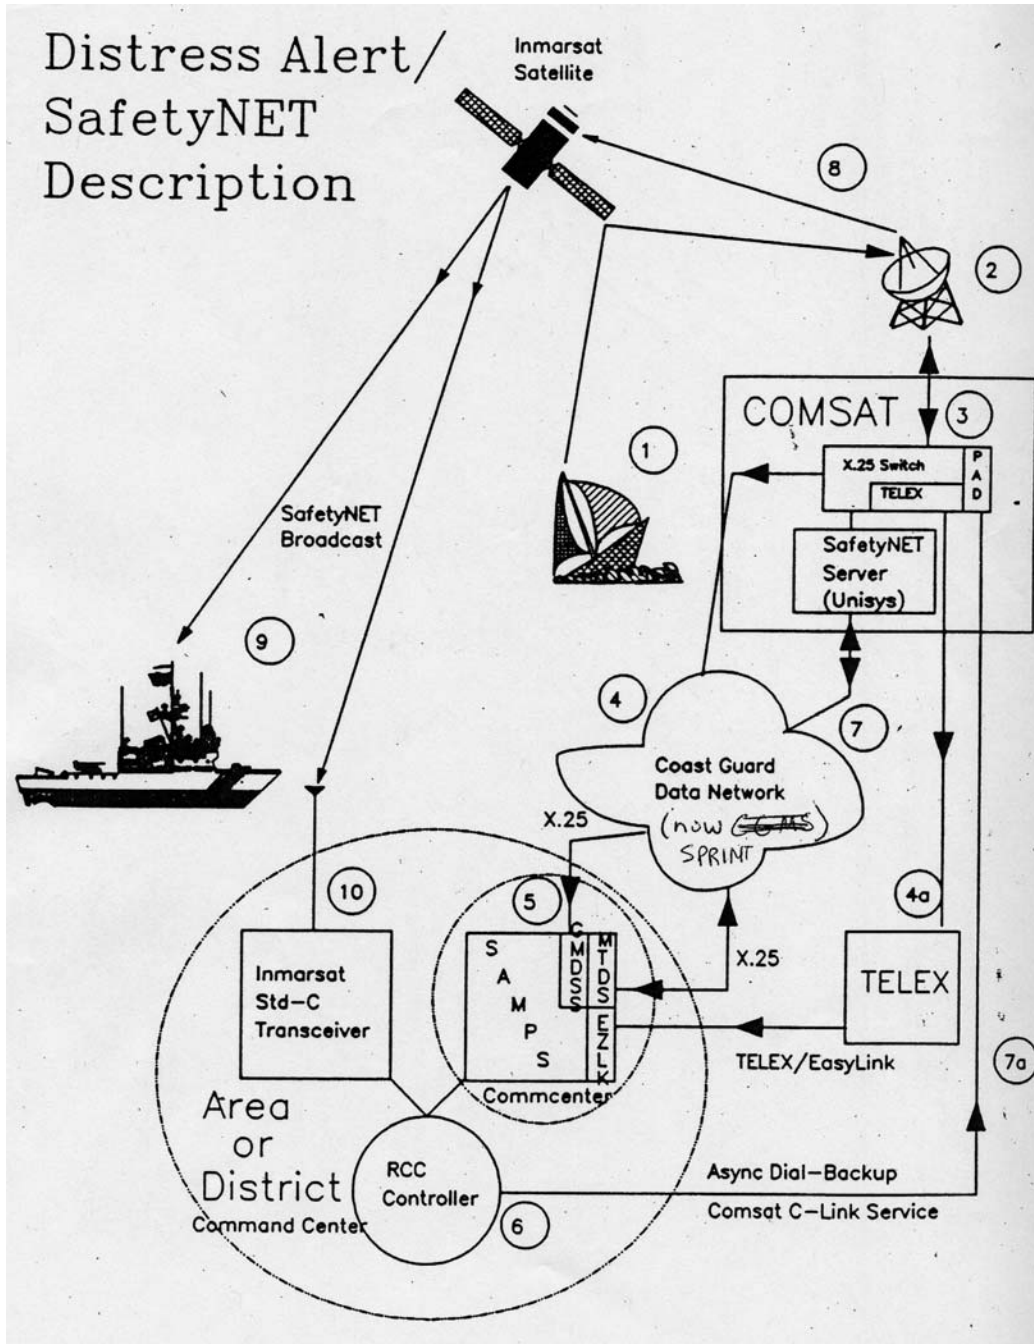
Figure 22  
Diagram of SafetyNET Network

The INMARSAT-C system aboard the ALASKAN ROSE did not have an audible or visual alarm to notify the watchstander of an incoming urgent broadcast. The user would have to go from the steering station to the INMARSAT-C unit and download the messages. Each

message would have to be viewed prior to deleting it from the queue. The system operator has to program the INMARSAT-C system to receive messages based on the location of the terminal to avoid overloading the system with excessive messages from other broadcast stations. Mr. John Nelson provided testimony to the Marine Board indicating the ALASKAN ROSE did receive countless messages from Russia but did not receive the distress message until several hours after it was sent by D17 RCC.

Recommendation 7: In reviewing the overall SafetyNET system, the Marine Board found that there are no requirements for INMARSAT-C use on fishing vessels. This reduces the effectiveness of an important link of the GMDSS system. The Marine Board recommends requiring fishing vessels operating beyond the boundary line to be GMDSS compliant. The Marine Board understands a “one size fits all” requirement may not be the right solution and recommends Commandant evaluate the possibility of a regulation that has a regional approach tied to vessel operations, number of persons on board, duration of voyage, and distance offshore. The FCC and Coast Guard should partner during the development of these regulations.

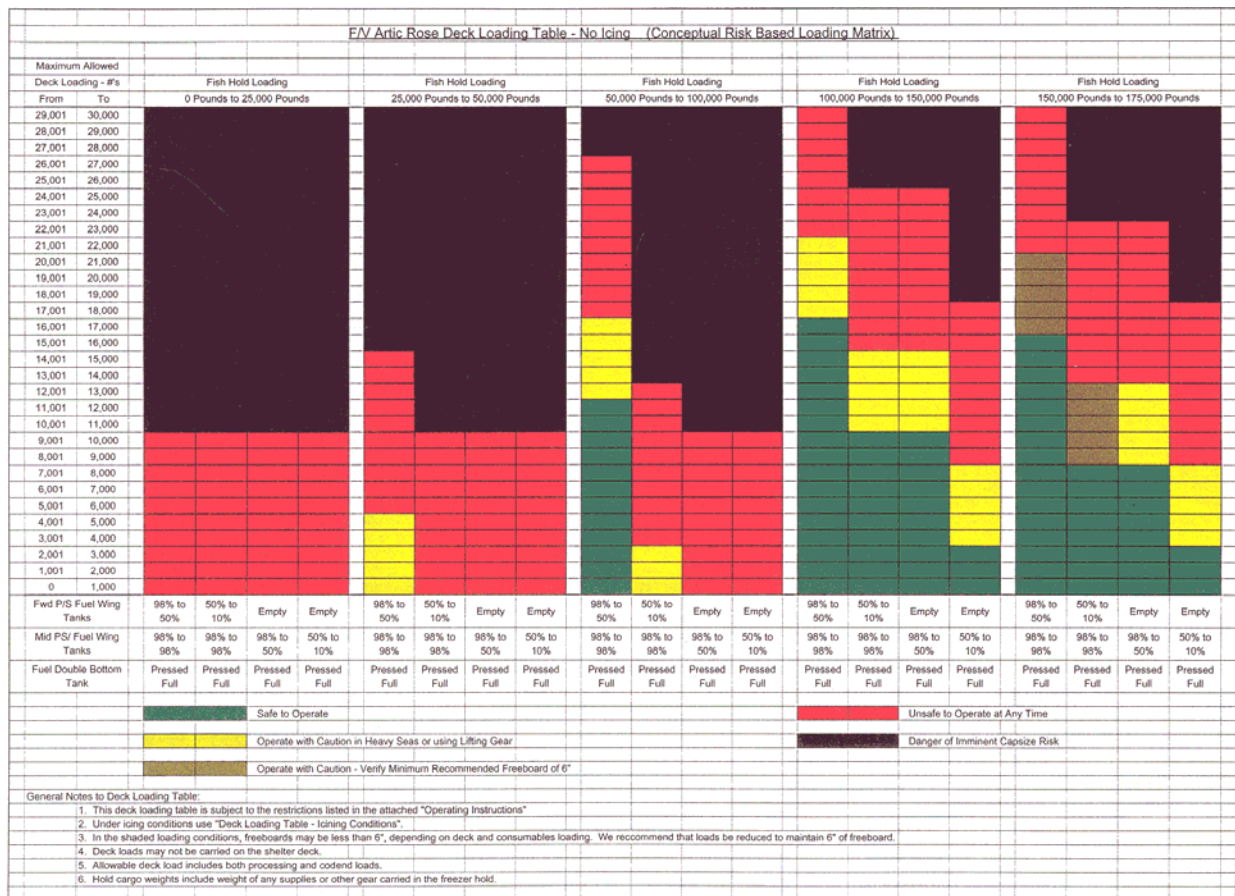
Figure 24  
SNAME graphic stability chart

The SNAME work group is promoting a format that presents stability information and operating guidelines in a color graphic which is easy to understand.

This format provides the vessel's operator and crew with a quick visual reference to make an informed decision for safe operations without having to perform stability calculations.

Recommendation 10: The Coast Guard should encourage the use of color graphic displays within a stability booklet that are easily understood by mariners such as the one under development by SNAME.

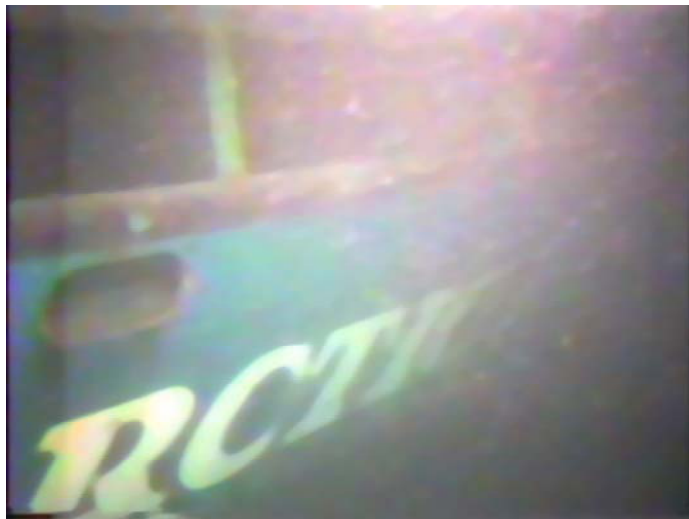
Figure 28  
Photo of  
Arctic Rose  
(2001)

water. Shortly thereafter, the Board received its first look at the vessel, which was sitting upright on the sea floor in 73 1/3 fathoms, or 428 feet, of water in the location 58° 56.22 minutes North latitude and 175° 53.10 minutes West longitude. The location is approximately 200 miles northwest of St. Paul Island, Alaska. The ROV was maneuvered slowly up the port side of the hull and revealed the name – ARCTIC ROSE. The ROV

made several passes along the port bow and port side of the pilothouse. Multicolored polypropylene lines used to mend the trawl net had unraveled from their cardboard spools and were floating above the wreck. As the ROV maneuvered around the wreck, several lines were sucked into the ROV's impellers and entangled it. Efforts to free the ROV resulted in the ROV's umbilical cord parting and the loss of the ROV.

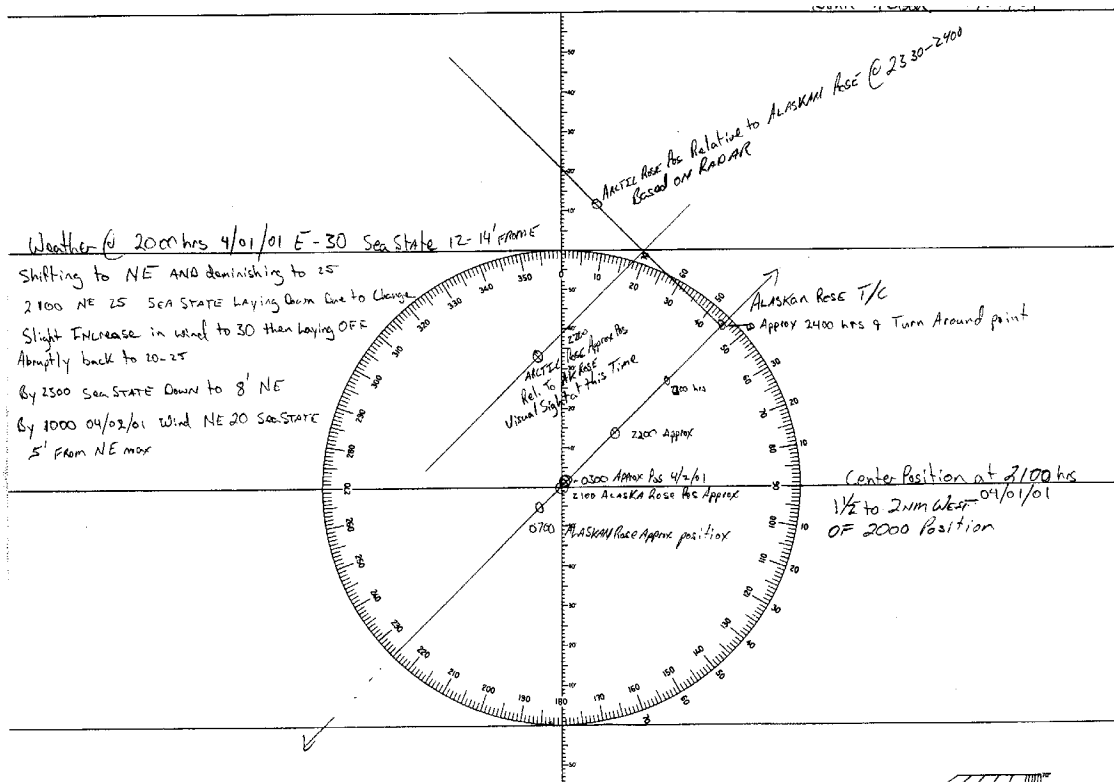
Figure 31  
 Universal plotting sheet depicting relative position and heading of ARCTIC ROSE on April 1 and 2

The Marine Board conducted an analysis of the ARCTIC ROSE's position based on testimony provided by Mr. John Nelson, the EPIRB position and Captain Rundall's stated intent to remain in the area to begin fishing on the morning of April 2<sup>nd</sup>. Trawling vessels will give each other a wide berth to prevent their tow wires or nets from becoming entangled. The ARCTIC ROSE was maintaining a position to the northwest of the ALASKAN ROSE. At the time of the last sighting, the ARCTIC ROSE was moving away from the ALASKAN ROSE. The ALASKAN ROSE was running on a track line from Northeast to Southwest to maintain their position to fish at first light.

The Marine Board established a vessel heading of 315° T with a relative position of twelve miles northwest of the ALASKAN ROSE and making a turn to port at the approximate time of the casualty.

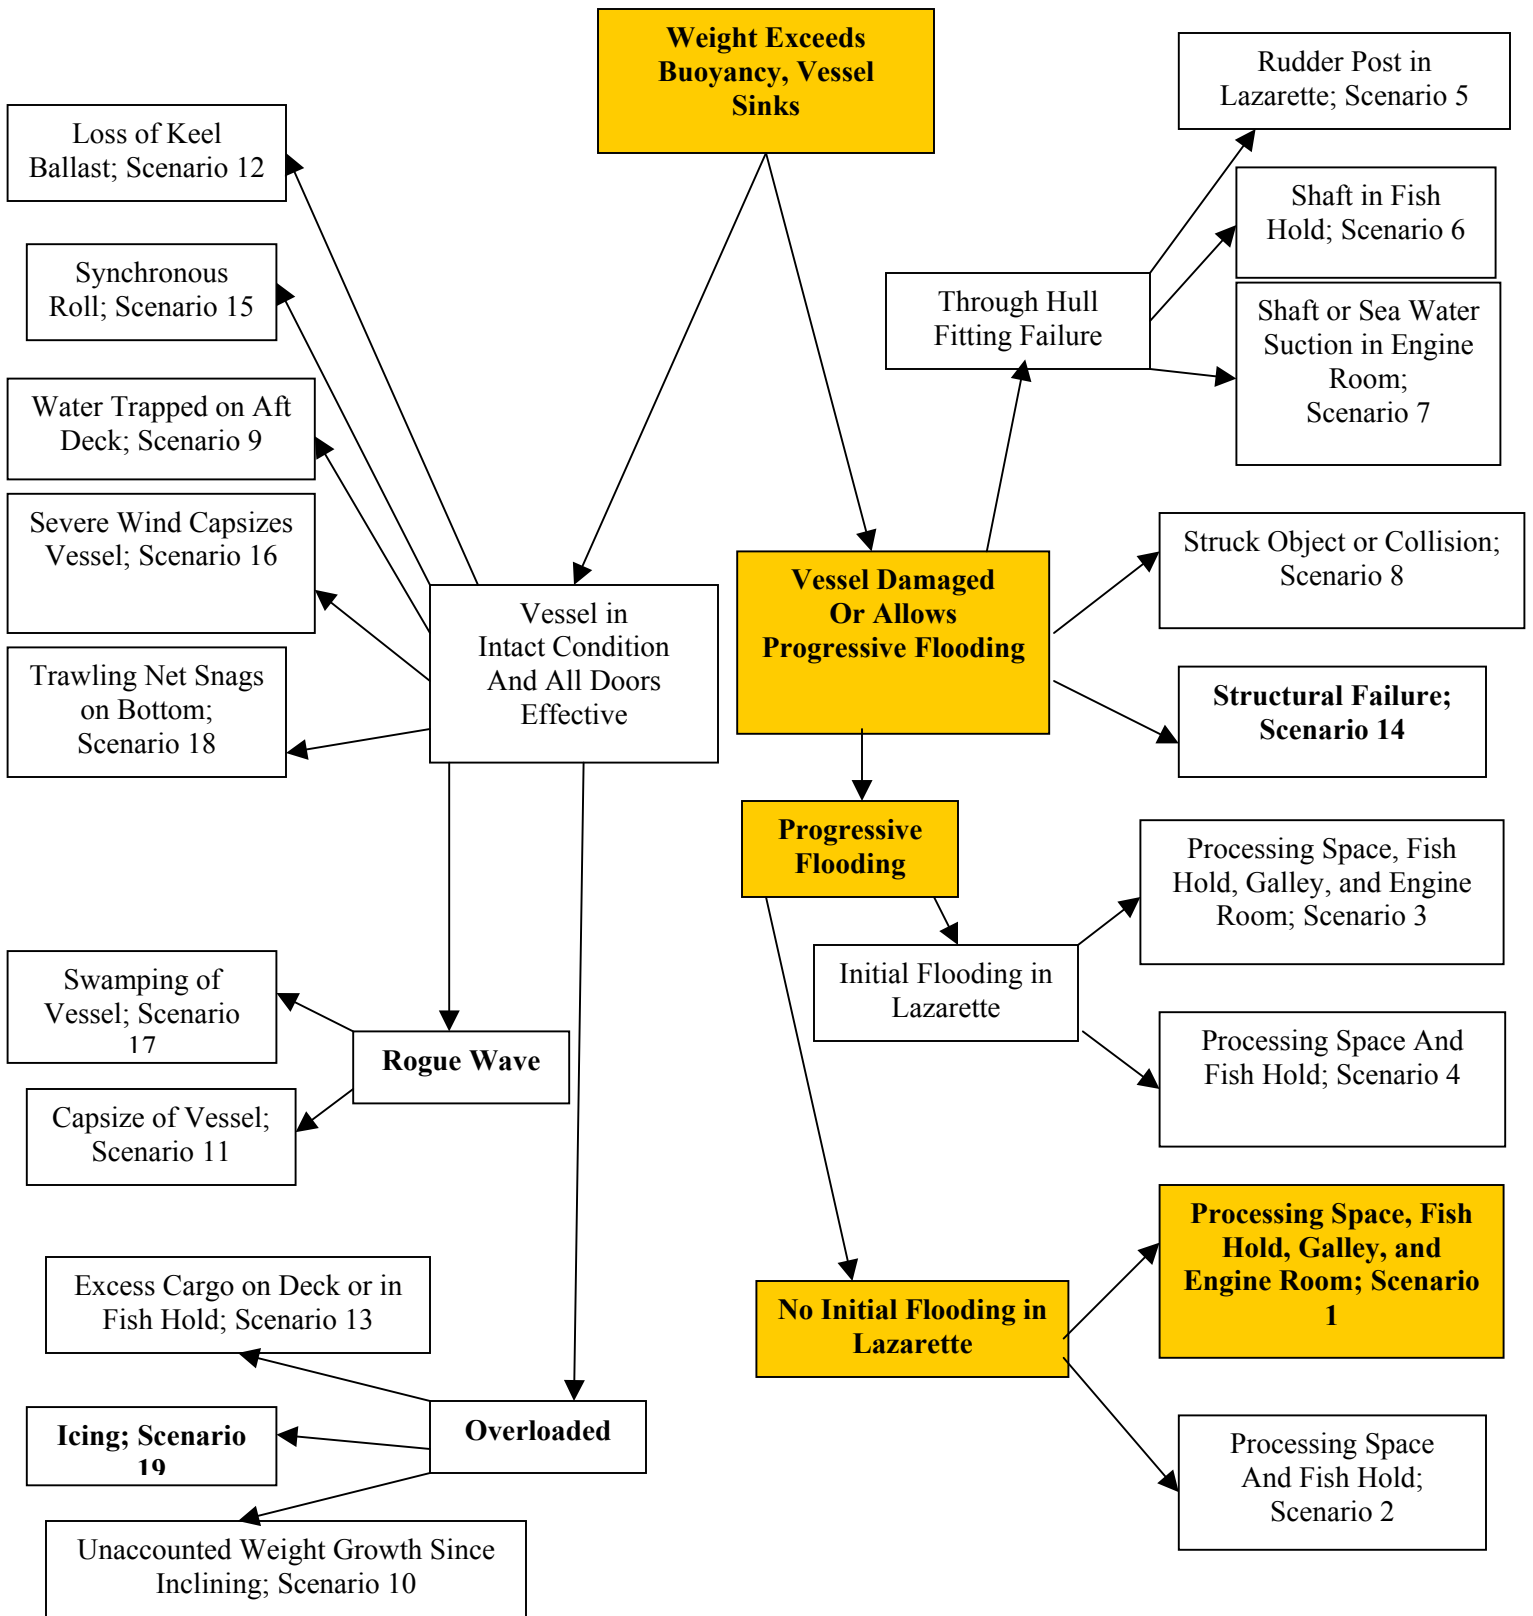
## **SCENARIO 1**

### **PROGRESSIVE FLOODING INTO PROCESSING SPACE, FISH HOLD, GALLEY, AND ENGINE ROOM**

7. Based on the ARCTIC ROSE's rapid loss of positive stability and reserve buoyancy, the ROV video showing the aft door to the processing space open, testimony on the lack of watertight integrity above the main deck, and the arrangement of the vessel, it is most likely that progressive flooding of the processing space, fish hold, engine room, and galley was the cause of the loss of the ARCTIC ROSE.

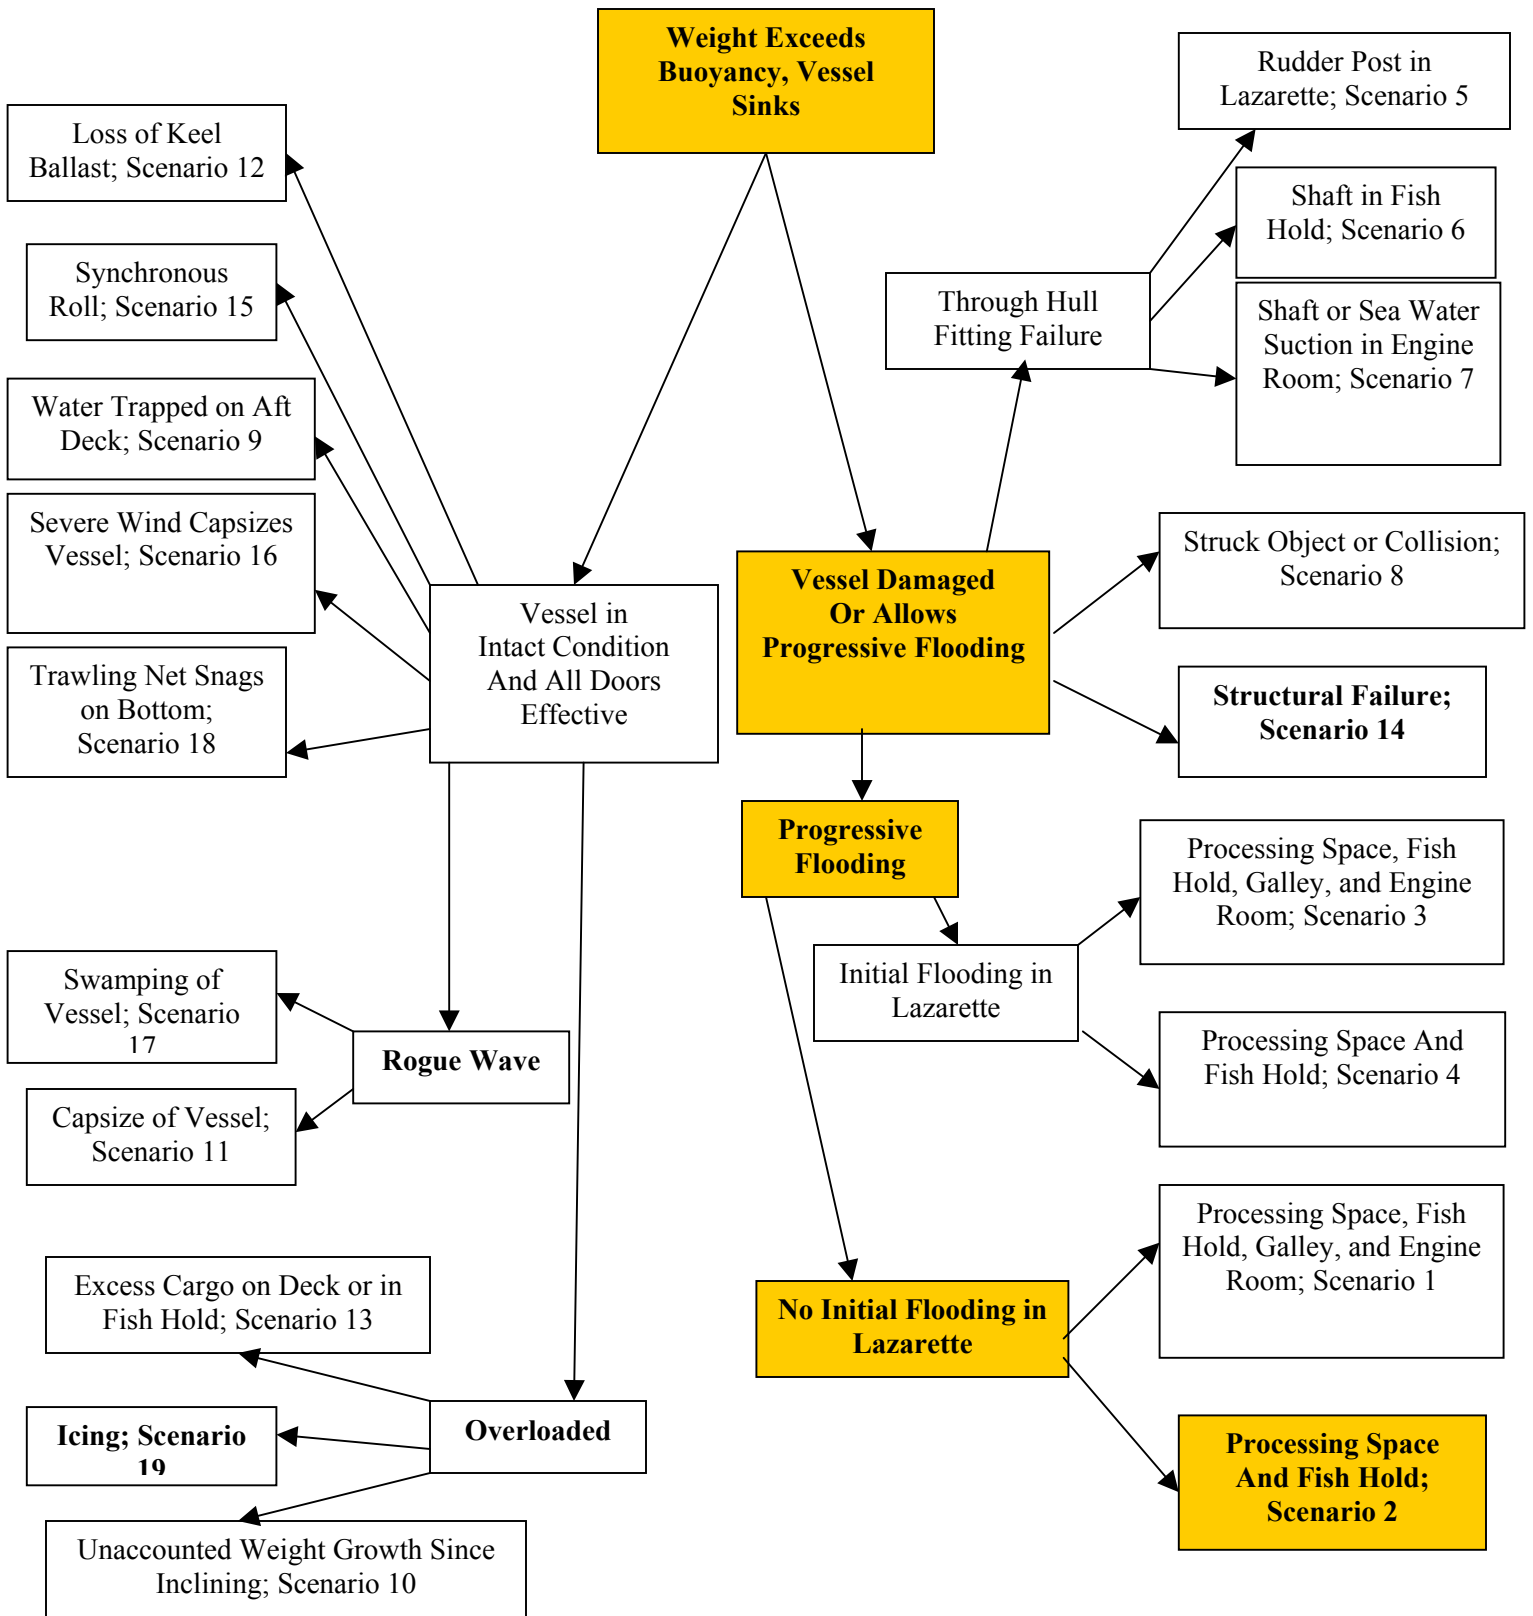
## SCENARIO 2

### PROGRESSIVE FLOODING INTO PROCESSING SPACE AND FISH HOLD

7. Based on the ARCTIC ROSE's rapid loss of positive stability and reserve buoyancy, the ROV video showing the aft door to the processing space open, testimony on the lack of watertight integrity above the main deck, and the arrangement of the vessel, it is likely that progressive flooding of the processing space and fish hold could have caused the loss of the ARCTIC ROSE. However, progressive flooding of the processing space and fish hold only is not the most likely scenario, because the non-weather-tight doors leading into the changing room, engine room, and galley would have had to prevent any water entry. Testimony provided to the Marine Board indicated this weather-tight door from the processing space to the mudroom was always open. The loss of reserve buoyancy of the processing space and fish hold alone would probably not be enough to sink the vessel.
