# UNITED STATES COAST GUARD

INVESTIGATION INTO THE CIRCUMSTANCES  
SURROUNDING THE SINKING OF THE  
UNINSPECTED FISHING VESSEL

## ARCTIC ROSE

OFFICIAL NUMBER 931446, IN THE BERING SEA ON  
APRIL 2, 2001, WITH ONE PERSON DECEASED AND  
FOURTEEN PERSONS MISSING AND PRESUMED DEAD

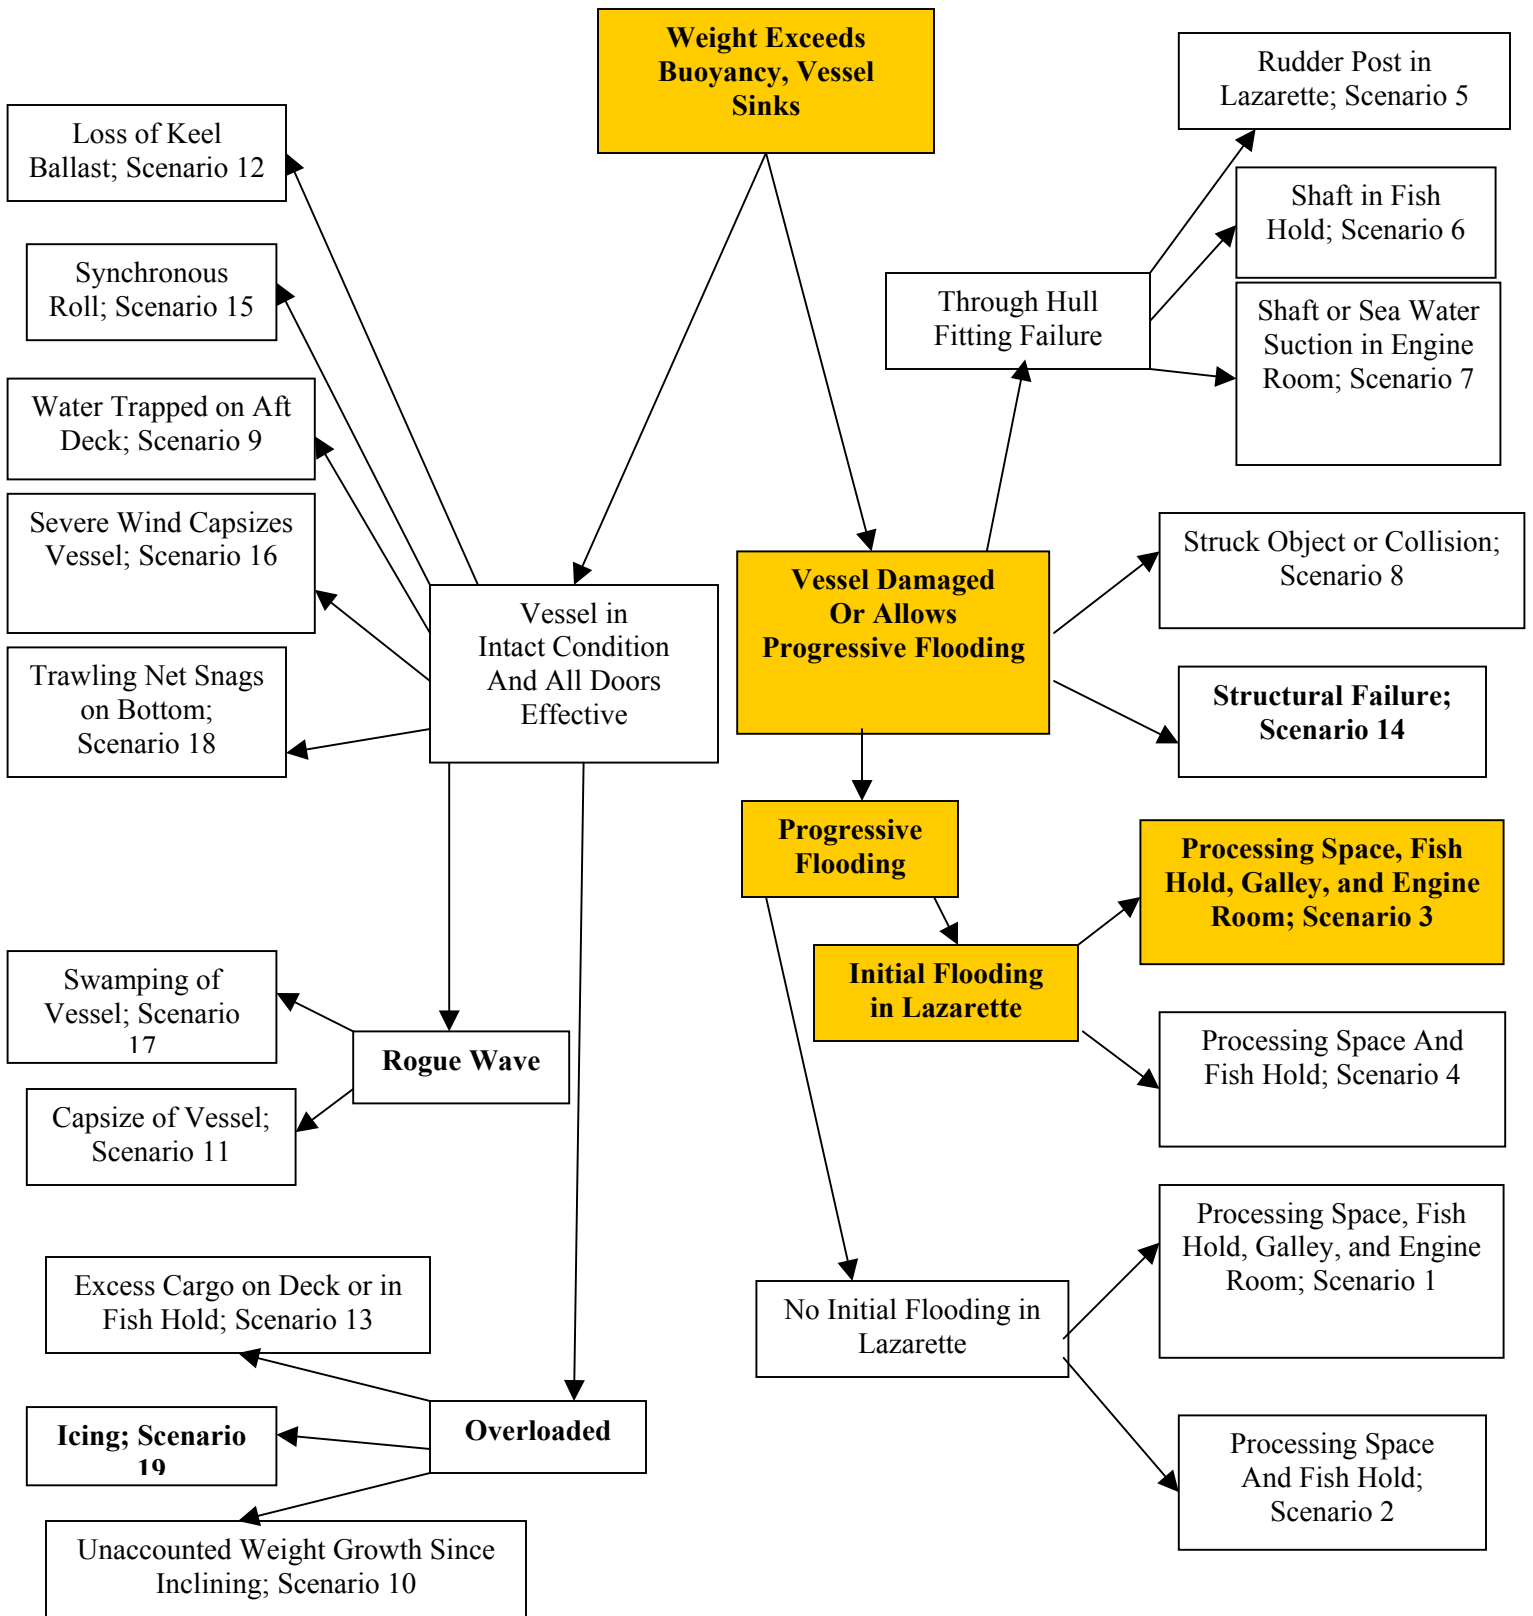
## SCENARIO 3

### PROGRESSIVE FLOODING INTO PROCESSING SPACE, FISH HOLD, GALLEY, AND ENGINE ROOM WITH LAZARETTE FLOODED TO EQUILIBRIUM

8. Based on the ARCTIC ROSE's rapid loss of positive stability and reserve buoyancy, the ROV video showing the aft door to the processing space open, testimony on the lack of watertight integrity above the main deck, and the arrangement of the vessel, it is possible that progressive flooding of the processing space, fish hold, engine room, and galley after the lazarette flooded to equilibrium was the cause of the loss of the ARCTIC ROSE. However, based on the lack of evidence the lazarette was flooded at the time of the casualty, it is not the most likely scenario analyzed.

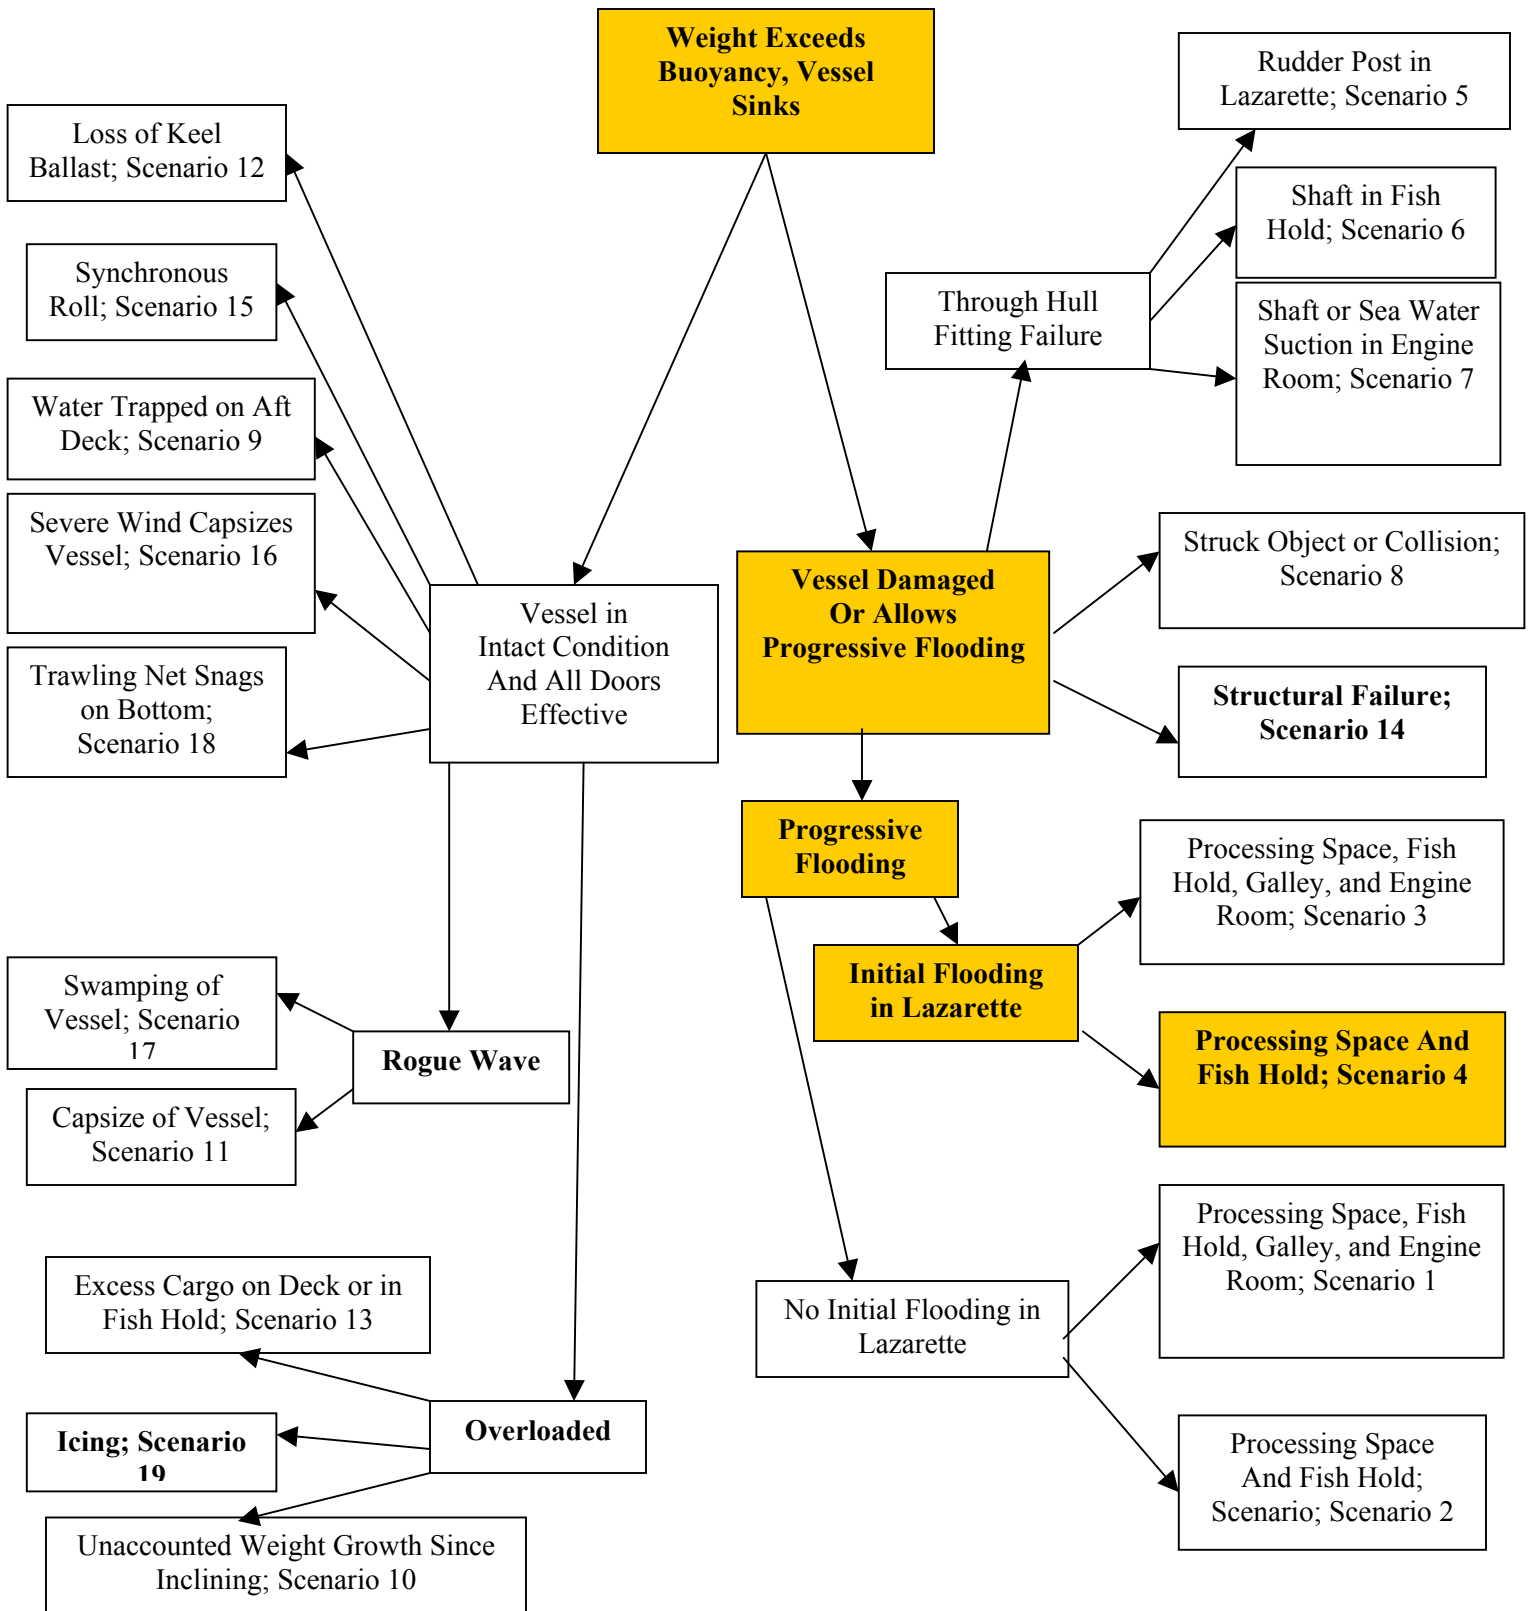
## SCENARIO 4

### PROGRESSIVE FLOODING INTO PROCESSING SPACE AND FISH HOLD WITH LAZARETTE FLOODED TO EQUILIBRIUM

8. Based on the ARCTIC ROSE's rapid loss of positive stability and reserve buoyancy, the ROV video showing the aft door to the processing space open, testimony on the lack of watertight integrity above the main deck, and the arrangement of the vessel, it is possible that progressive flooding of the processing space and fish hold after the lazarette flooded to equilibrium was the cause of the loss of the ARCTIC ROSE. However, based on the lack of evidence the lazarette was flooded at the time of the casualty, and the necessity for other spaces to eventually flood, it is not the most likely scenario analyzed.

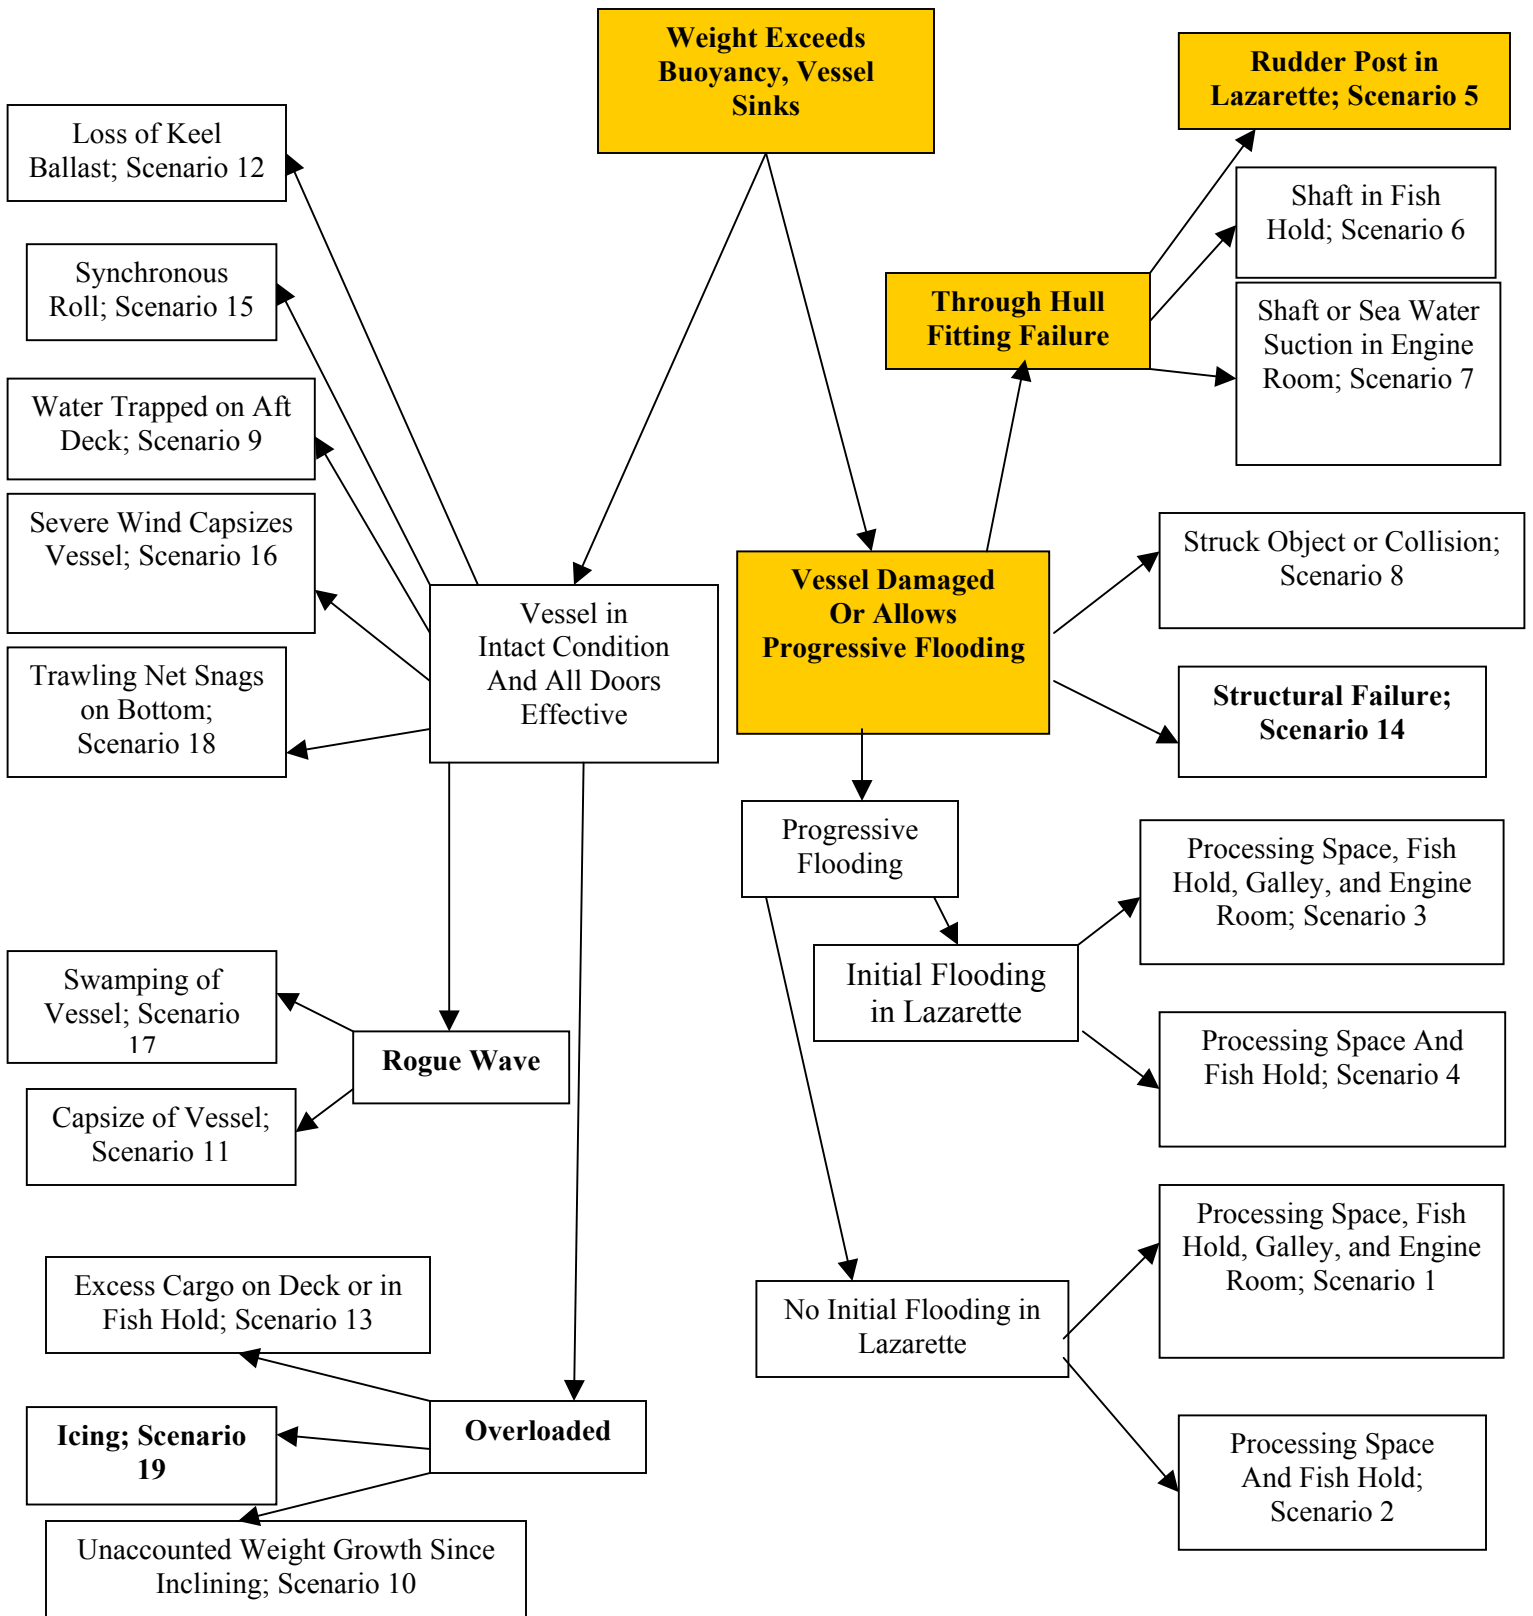
## SCENARIO 5

### THROUGH HULL FITTING FAILURE: RUDDER POST IN LAZARETTE AND DRY HOLD

5. Based on the ARCTIC ROSE's stability characteristics with the lazarette and dry stores spaces flooded and the lack of evidence of structural damage around the rudder post, it is unlikely that the loss of the ARCTIC ROSE was due to failure of a through hull fitting in the lazarette and dry store spaces.

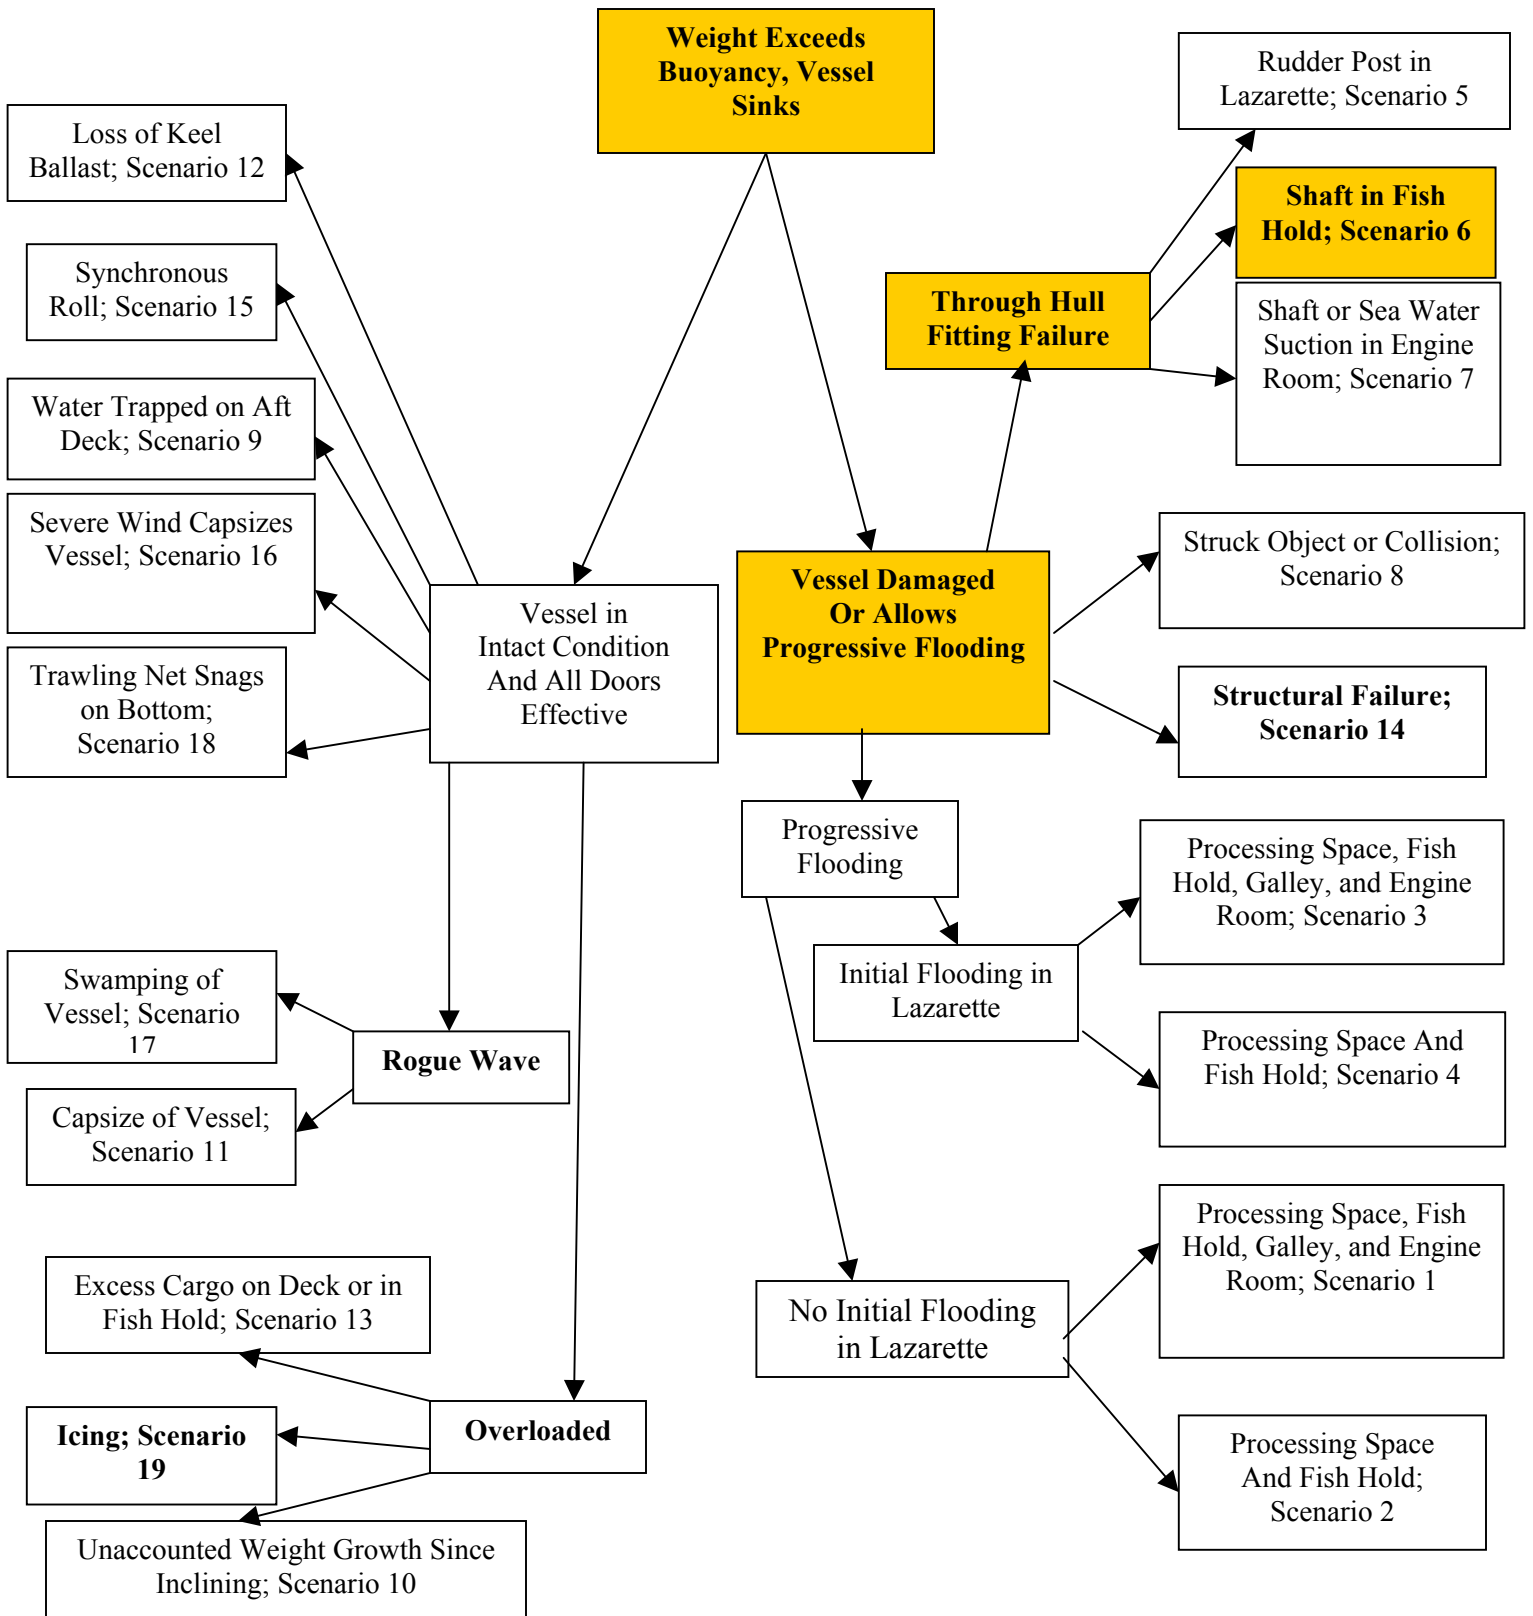
## SCENARIO 6

### THROUGH HULL FITTING FAILURE: SHAFT IN FISH HOLD

4. Based on the ARCTIC ROSE's stability characteristics with the fish hold space flooded and the lack of evidence of structural damage at a through hull fitting, it is unlikely that the loss of the ARCTIC ROSE was due to failure of a through hull fitting in the fish hold.

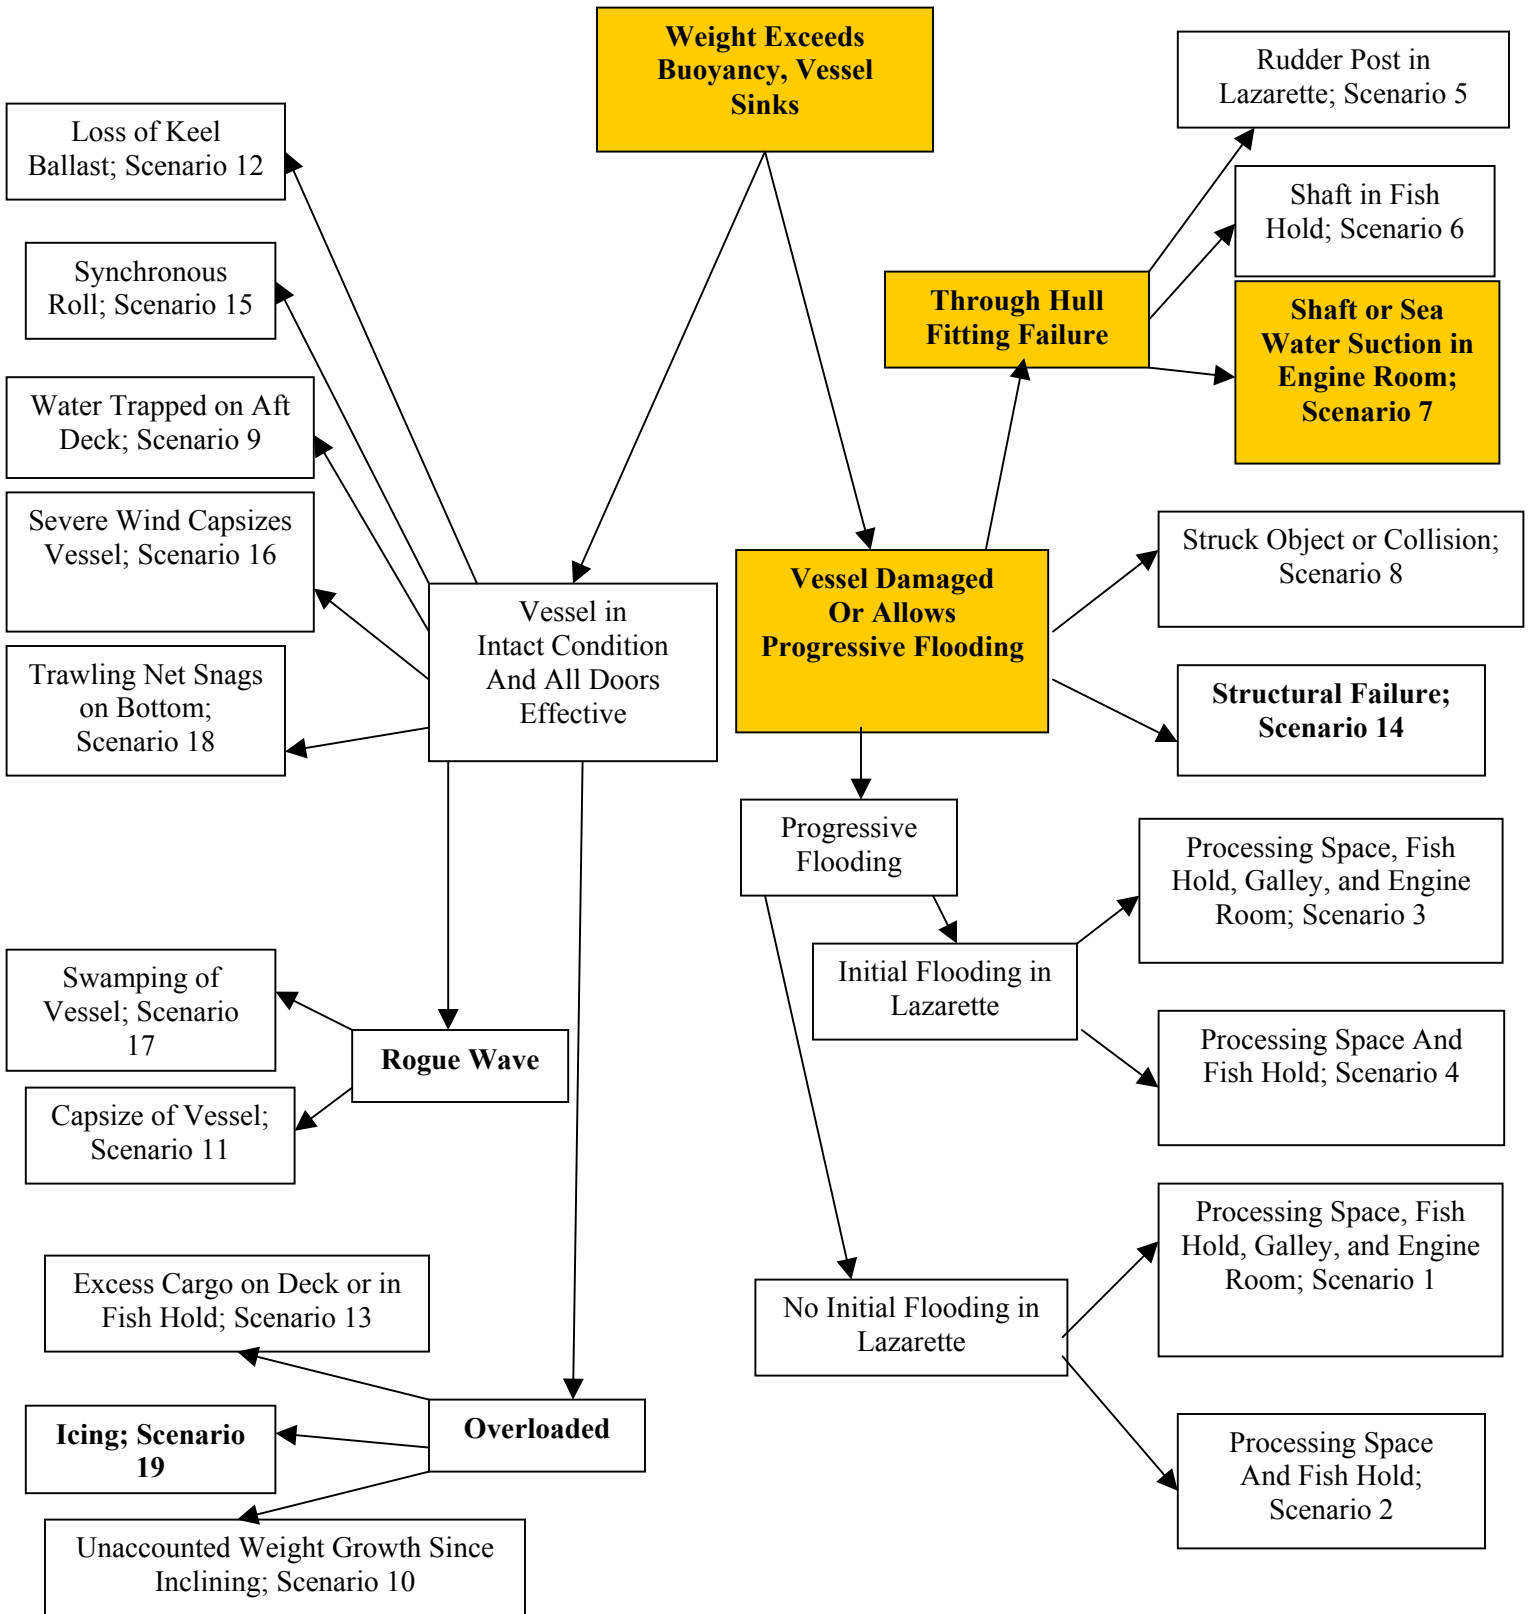
## SCENARIO 7

### THROUGH HULL FITTING FAILURE: SHAFT OR SEA SUCTION IN ENGINE ROOM AND MACHINERY SPACE

5. Based on the ARCTIC ROSE's stability characteristics with the engine room and machinery space flooded and the lack of evidence of structural damage around the engine room, it is unlikely that the loss of the ARCTIC ROSE was due to failure of a through hull fitting in the engine room or machinery space.

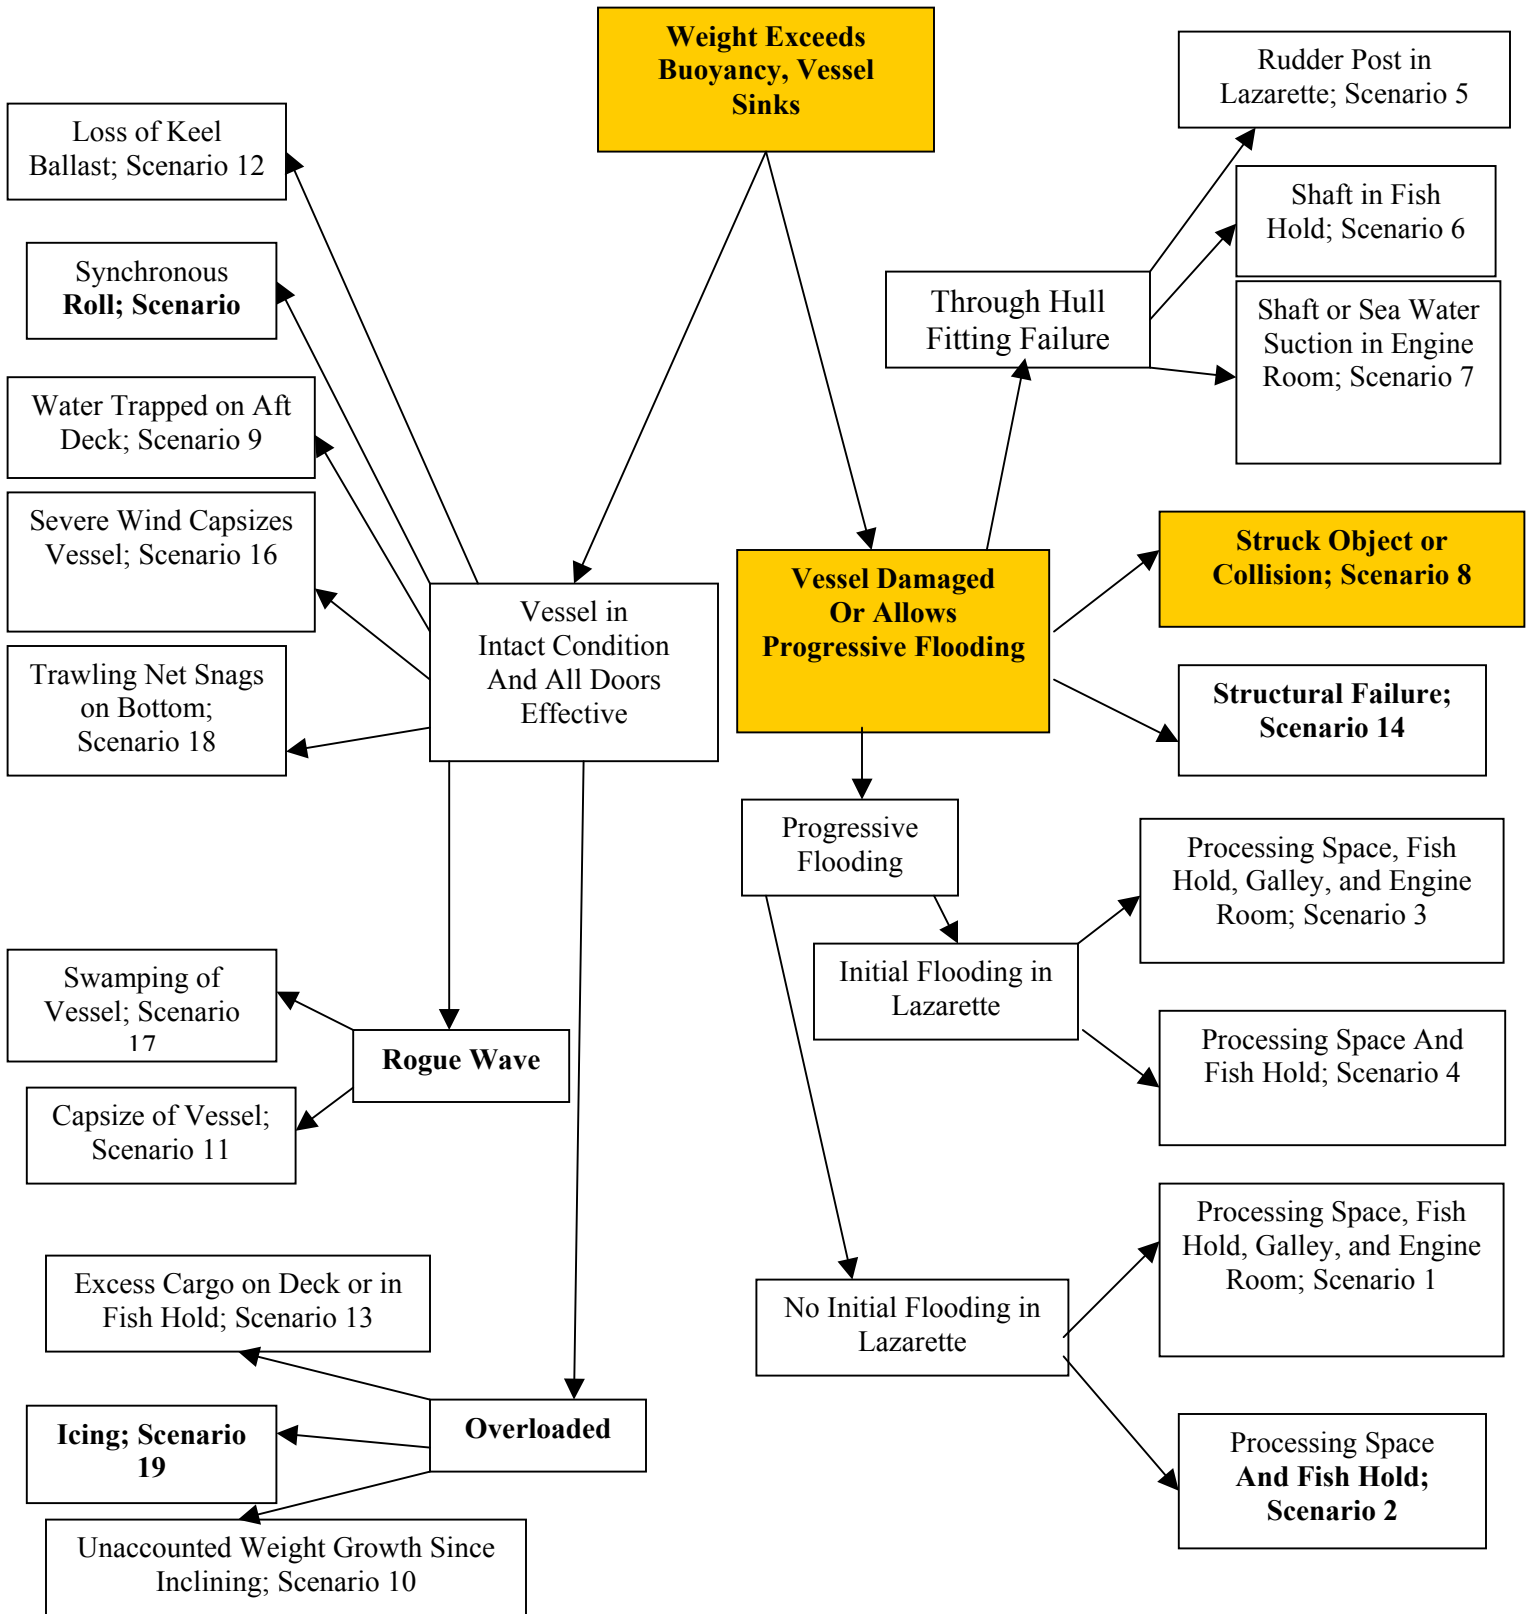
## SCENARIO 8

### STRUCK OBJECT OR COLLISION

6. Based on the ARCTIC ROSE's stability characteristics with either the fuel oil wing tanks or the forepeak compartment flooded, and the lack of evidence of structural damage on the outside of the vessel, it is unlikely that the loss of the ARCTIC ROSE was due to striking a submerged object or colliding with an object.

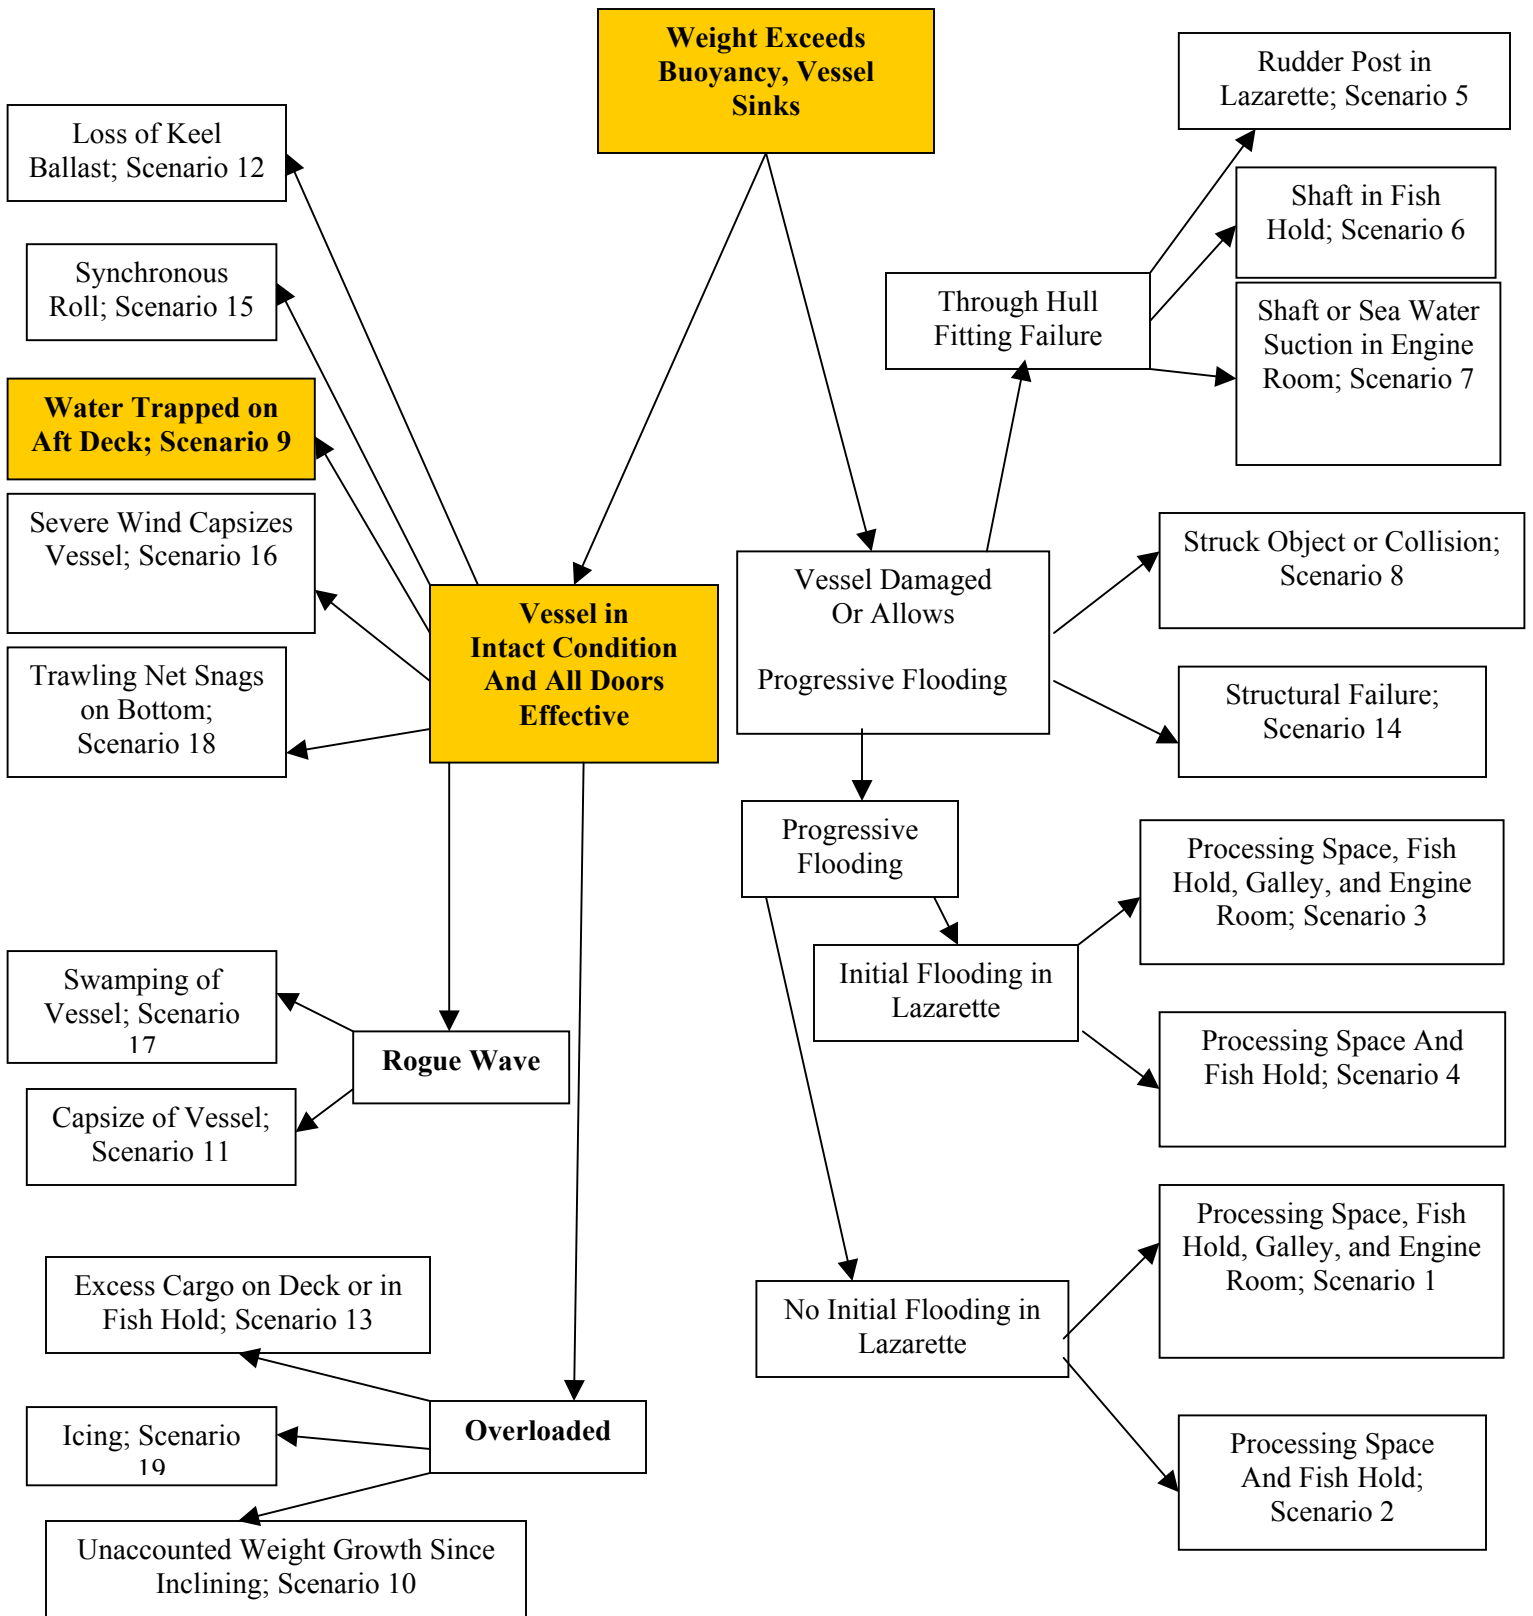
## SCENARIO 9

### WATER TRAPPED ON AFT DECK

4. Although the ARCTIC ROSE's stability would be reduced by water trapped on the after deck, the large range of stability, large reserve buoyancy of the vessel, and lack of evidence that water could gather and remain trapped on deck make it unlikely that the loss of the ARCTIC ROSE was due solely to water trapped on the after deck.

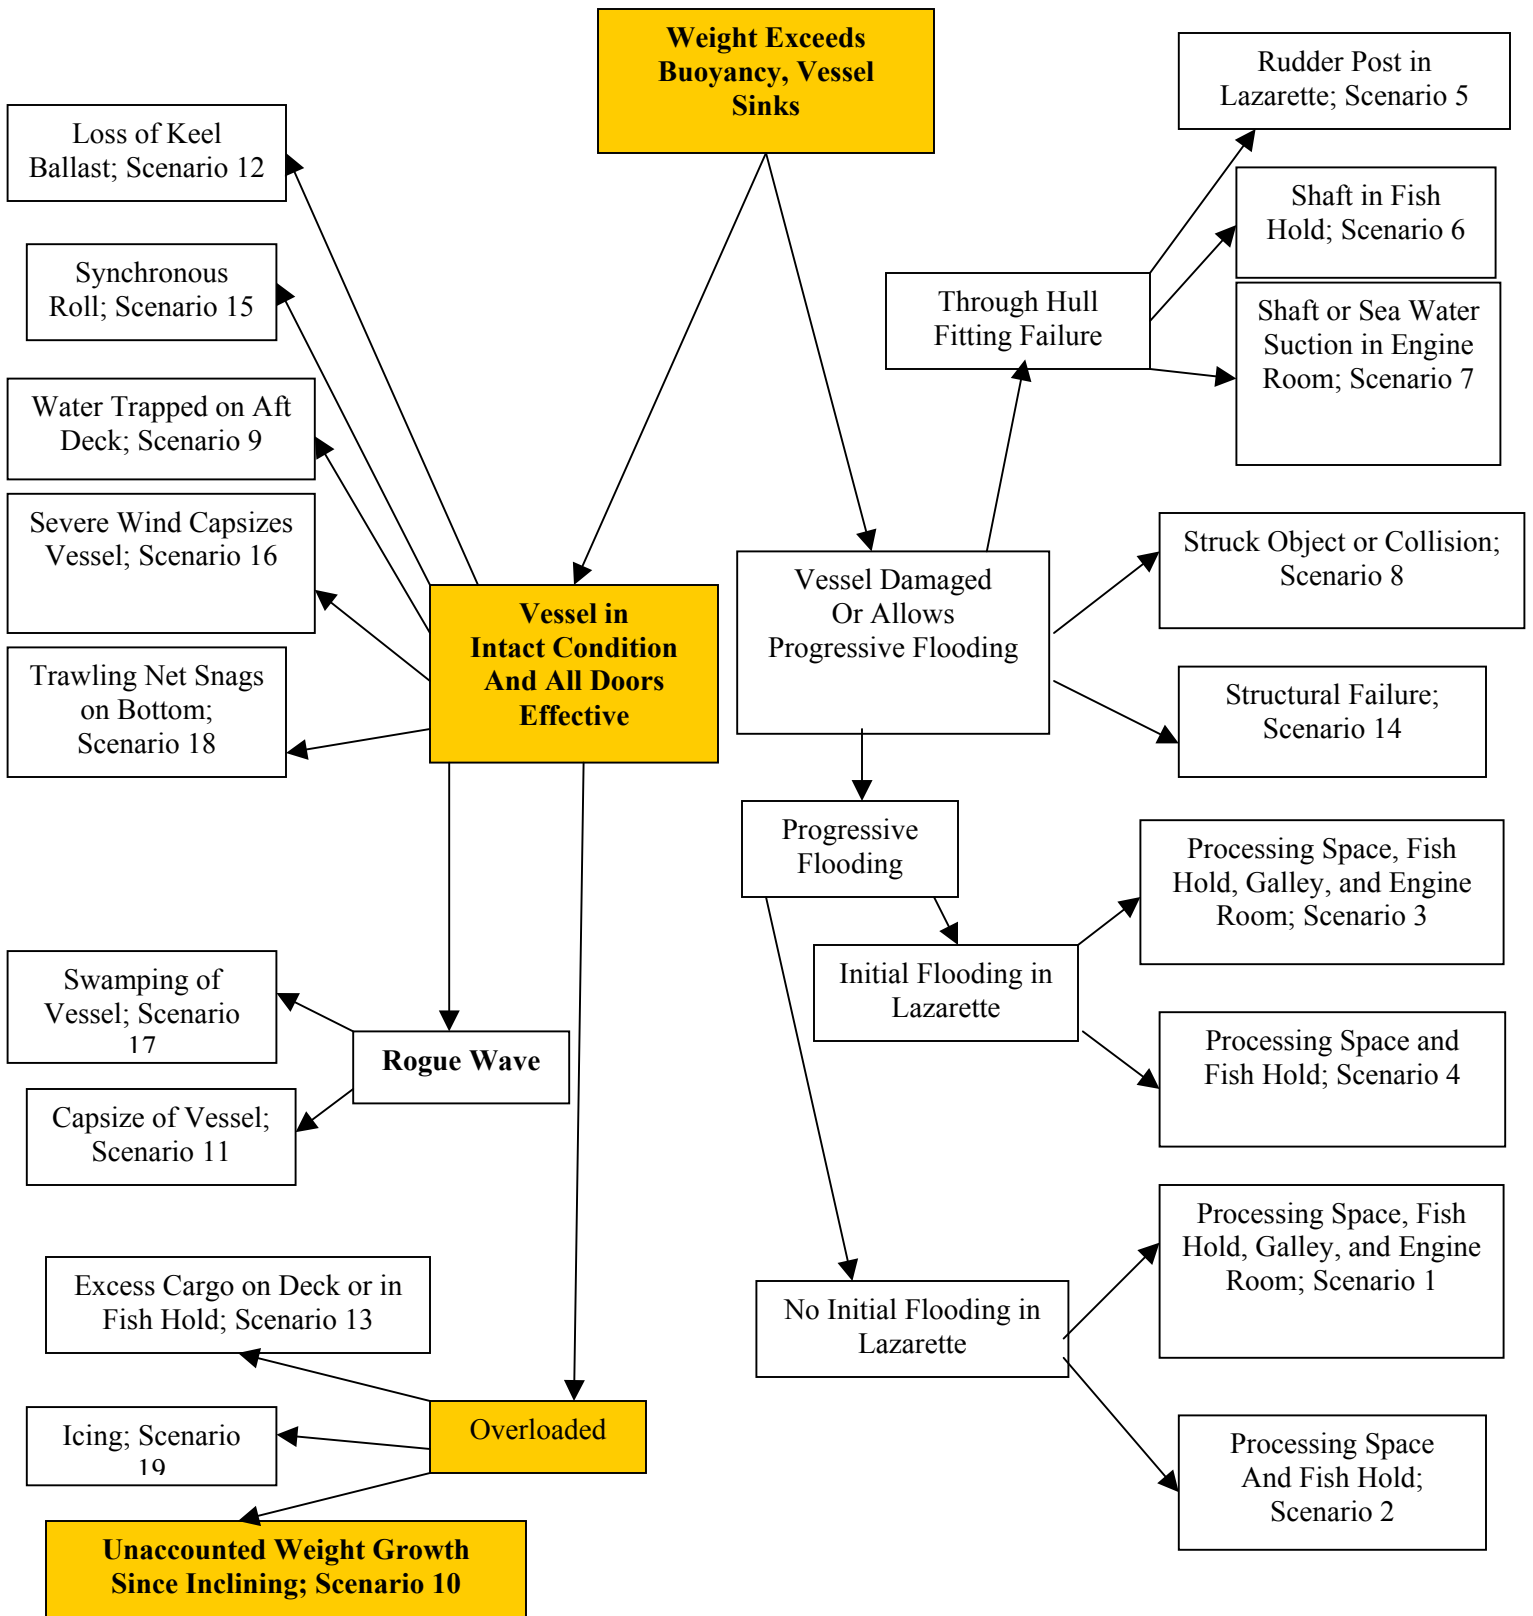
## **SCENARIO 10**

### **UNACCOUNTED FOR WEIGHT GROWTH SINCE INCLINING**

3. Based on the accurate correlation between the list of weights added, removed, or moved provided by Jensen Maritime Consultants and the testimony collected by the Marine Board, the ARCTIC ROSE' stability was very likely not severely affected by unaccounted for weight growth.
