# UNITED STATES COAST GUARD

INVESTIGATION INTO THE CIRCUMSTANCES  
SURROUNDING THE SINKING OF THE  
UNINSPECTED FISHING VESSEL

## ARCTIC ROSE

OFFICIAL NUMBER 931446, IN THE BERING SEA ON  
APRIL 2, 2001, WITH ONE PERSON DECEASED AND  
FOURTEEN PERSONS MISSING AND PRESUMED DEAD

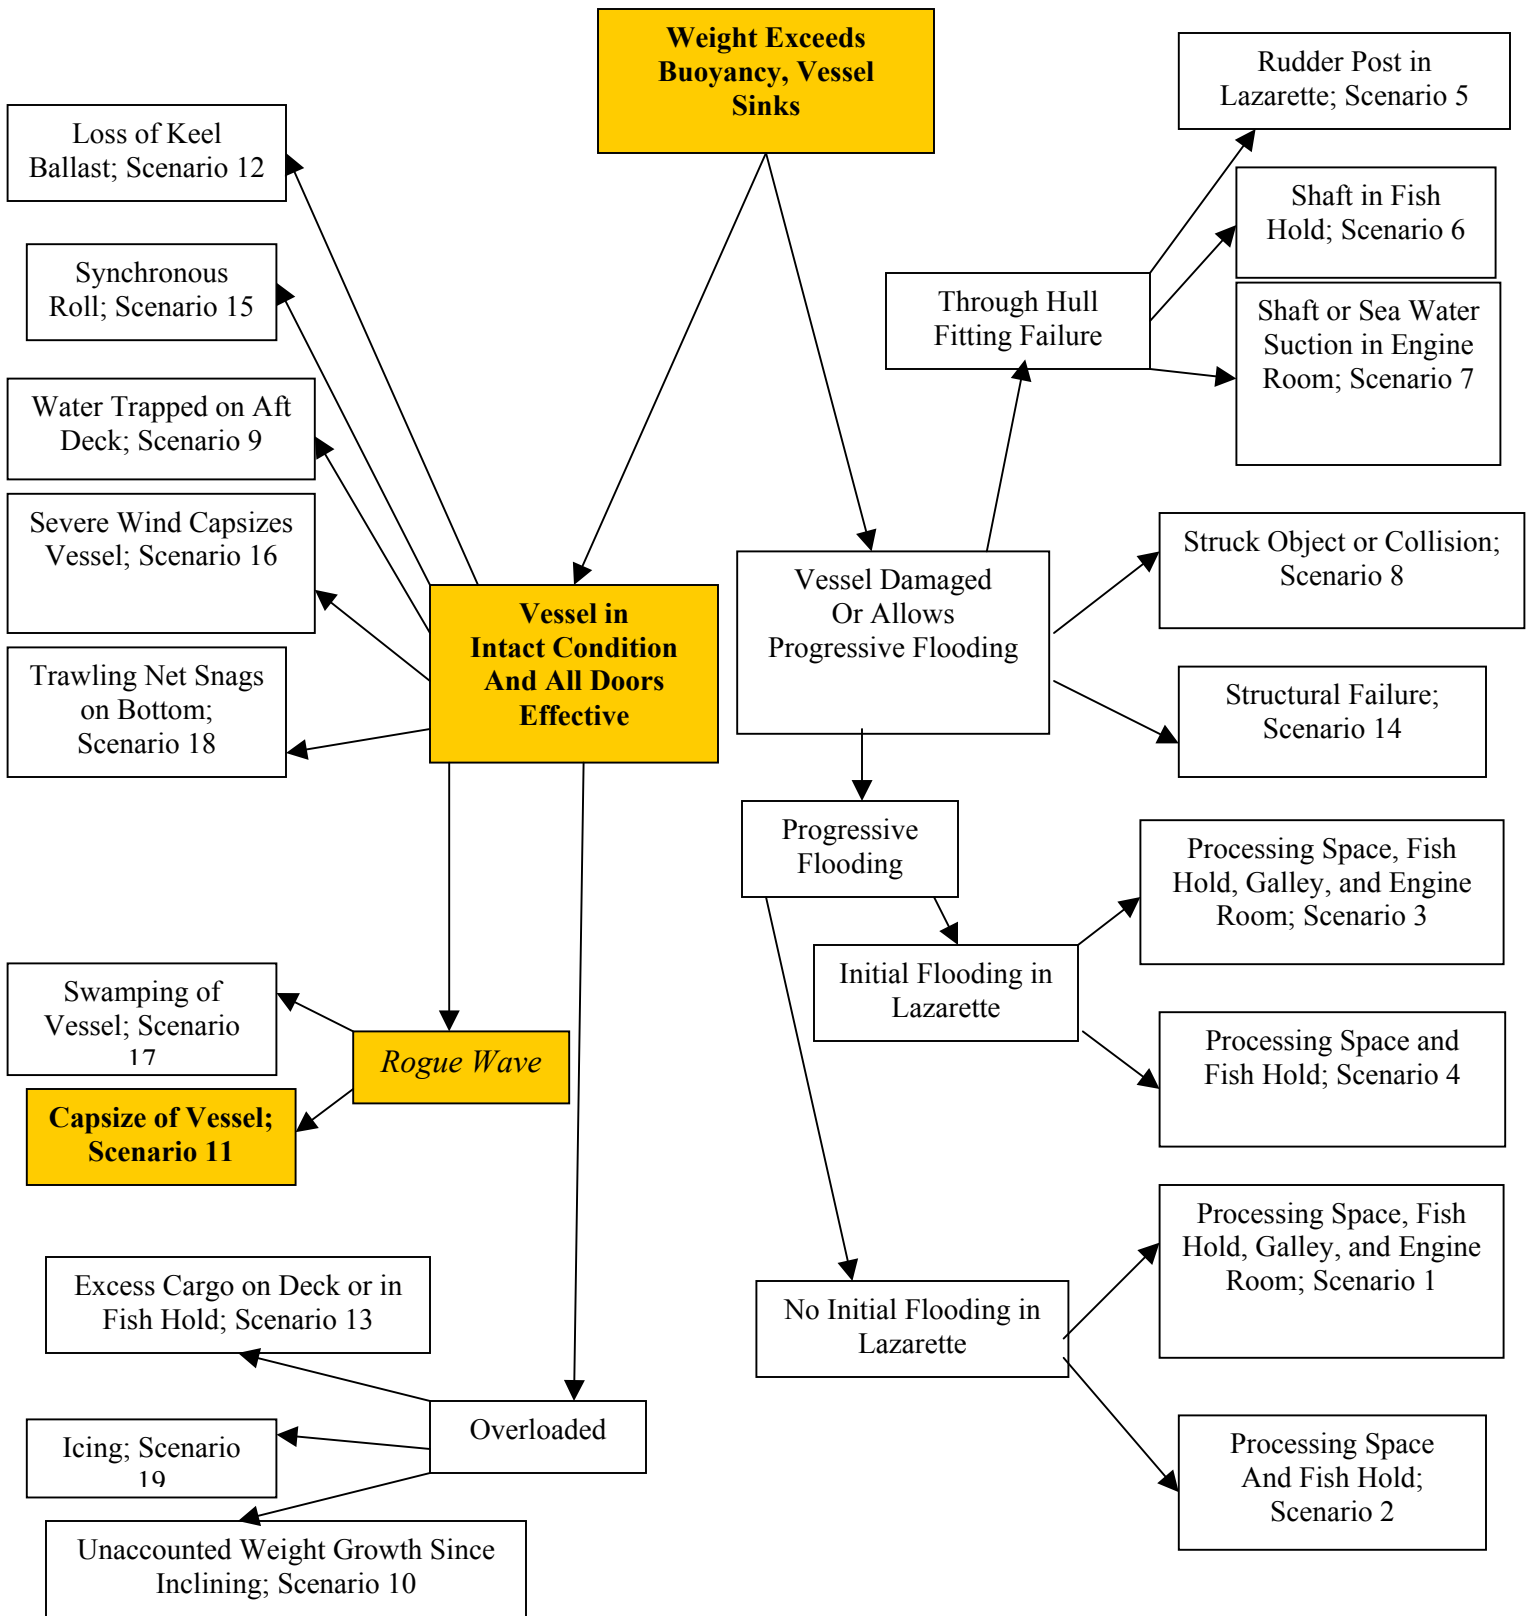
## SCENARIO 11

### CAPSIZING OF VESSEL DUE TO ROGUE WAVE

5. Based on the extremely large wave height calculated as necessary to cause the capsize of the ARCTIC ROSE, and the size of the seas on the night of the casualty, it is very unlikely that the loss of the vessel was due to a rogue wave.

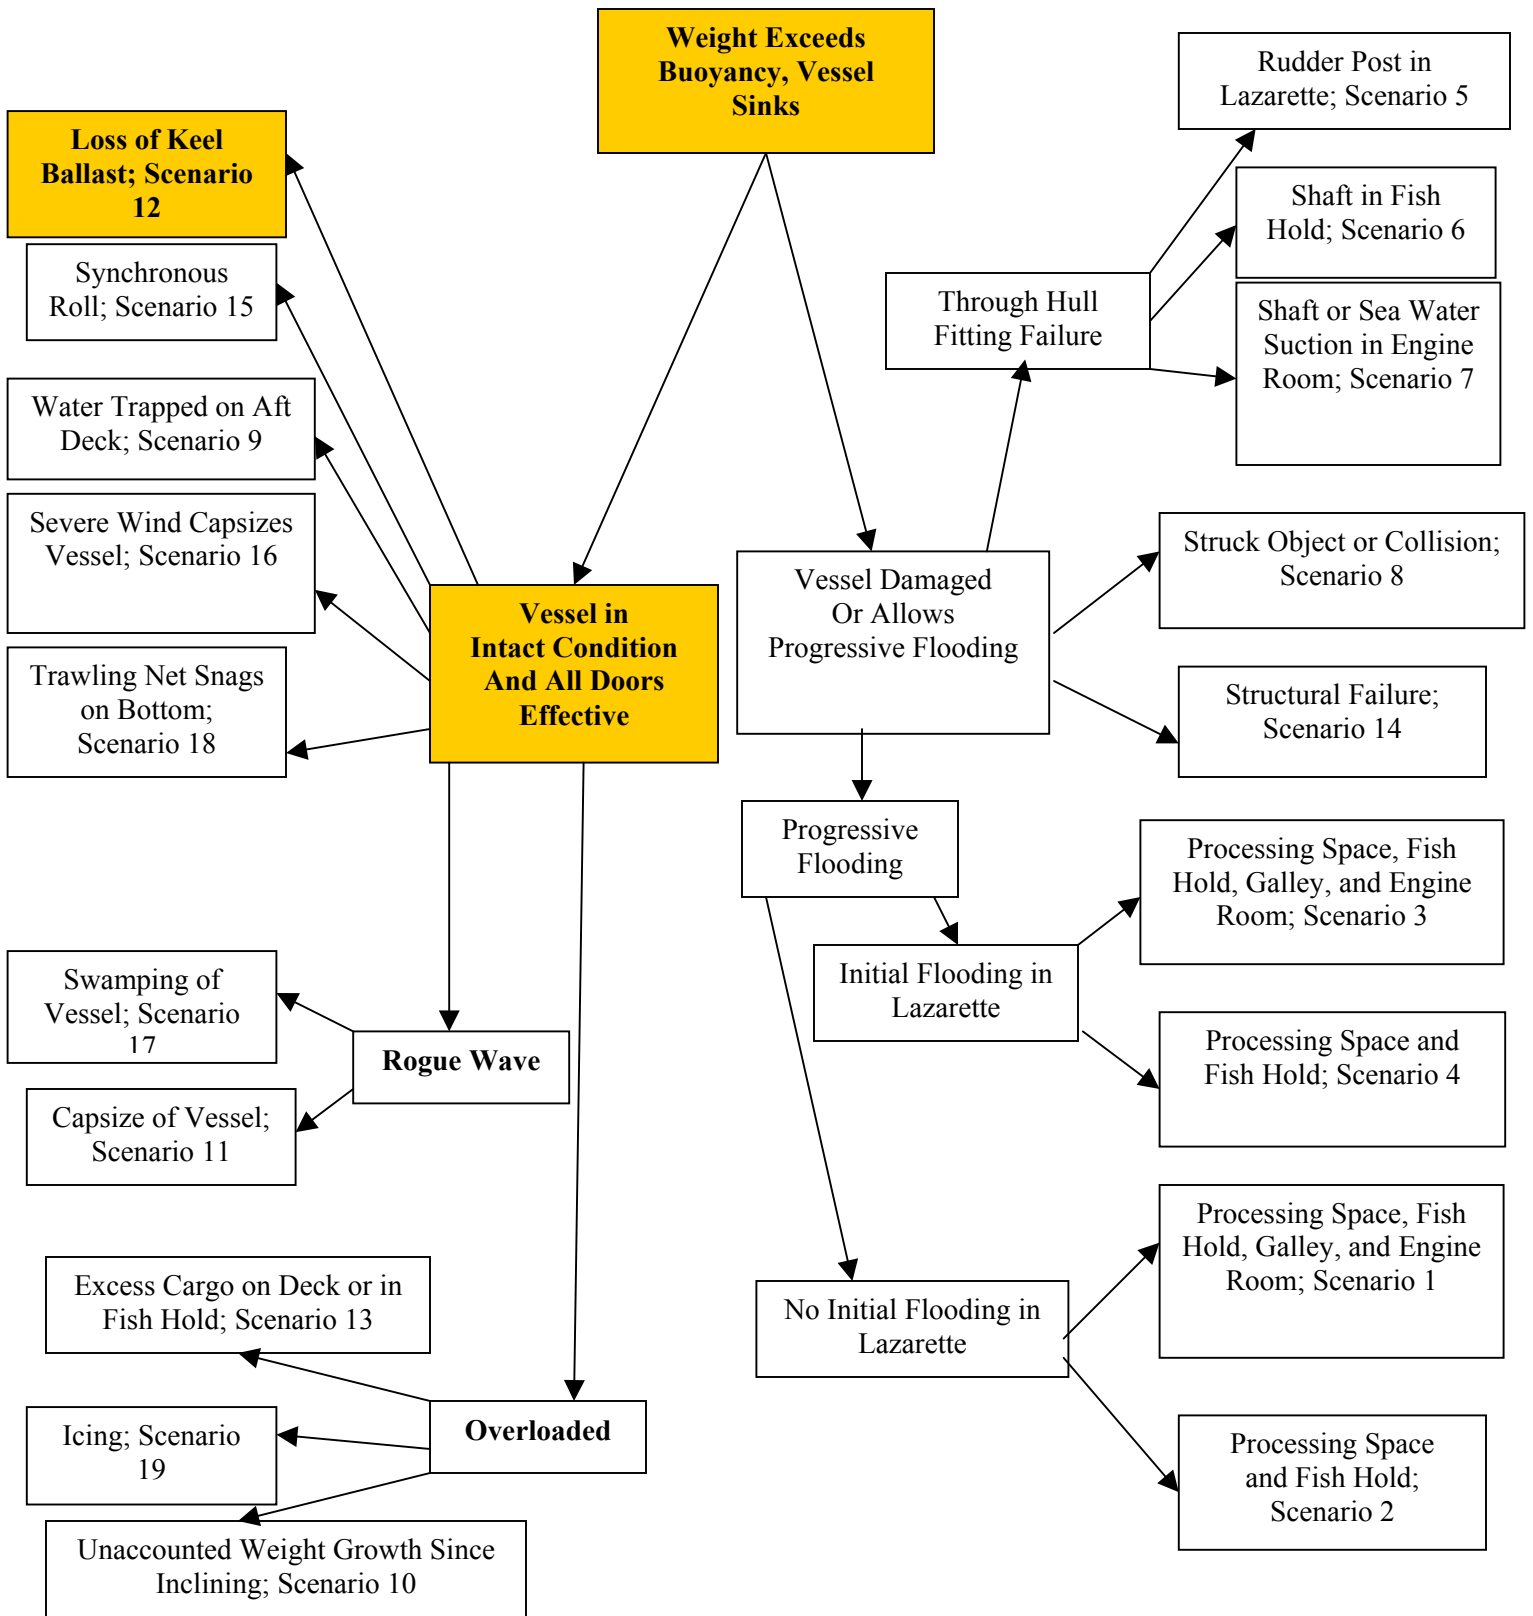
## SCENARIO 12

### LOSS OF KEEL BALLAST

4. Based on the ARCTIC ROSE's stability characteristics without the keel ballast and the fact there was no evidence of structural damage around the keel area, it is unlikely that the loss of the ARCTIC ROSE was due to the loss of the keel ballast.

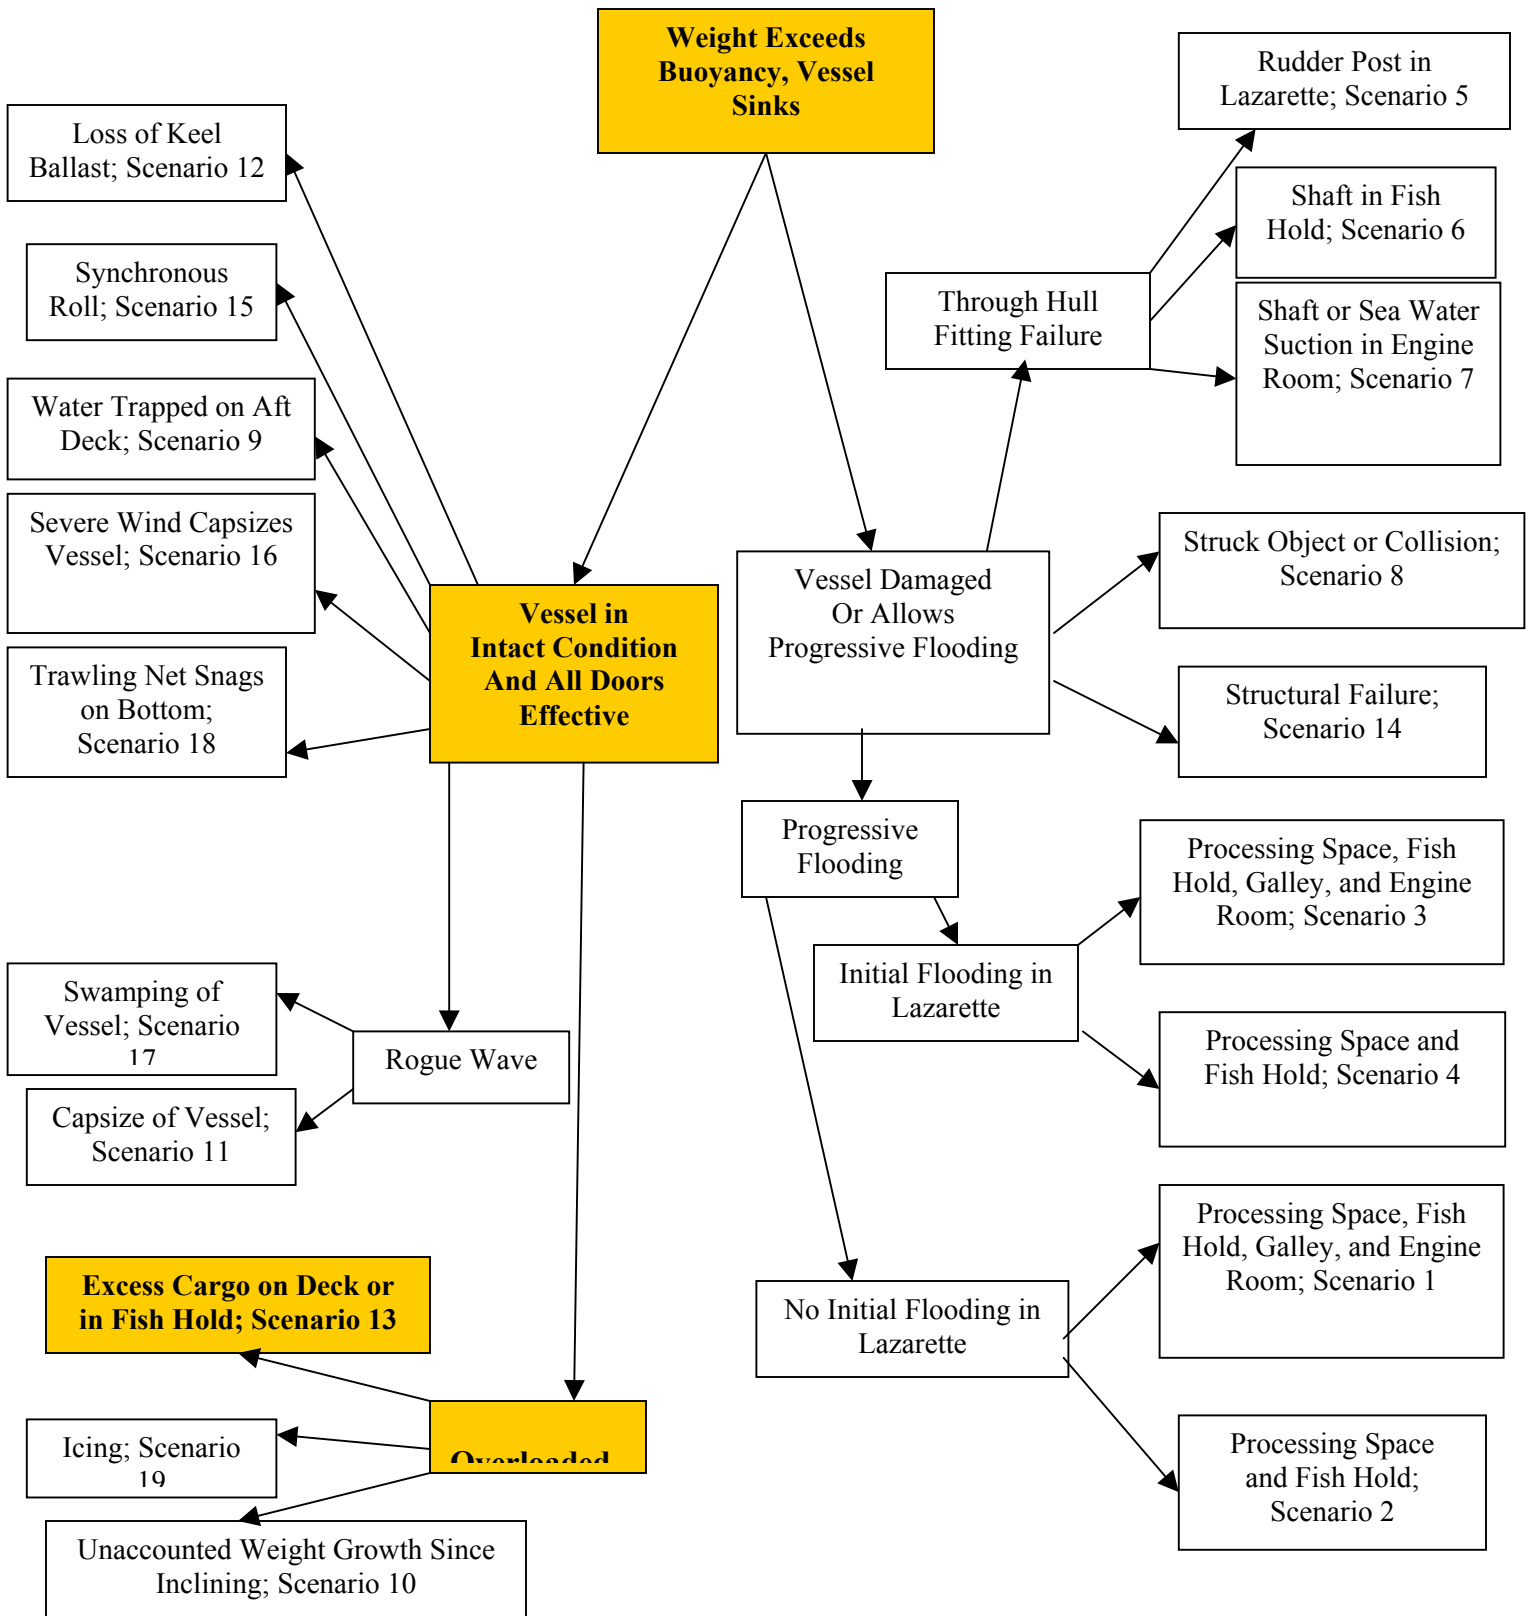
## SCENARIO 13

### OVERLOADED WITH EXCESS CARGO ON DECK OR IN FISH HOLD

3. Based on the cargo loads provided to the Coast Guard by the Marine Board of Investigation and the ROV video, it is very unlikely the loss of the ARCTIC ROSE was due to the vessel being overloaded with excess cargo on deck or in the fish hold.

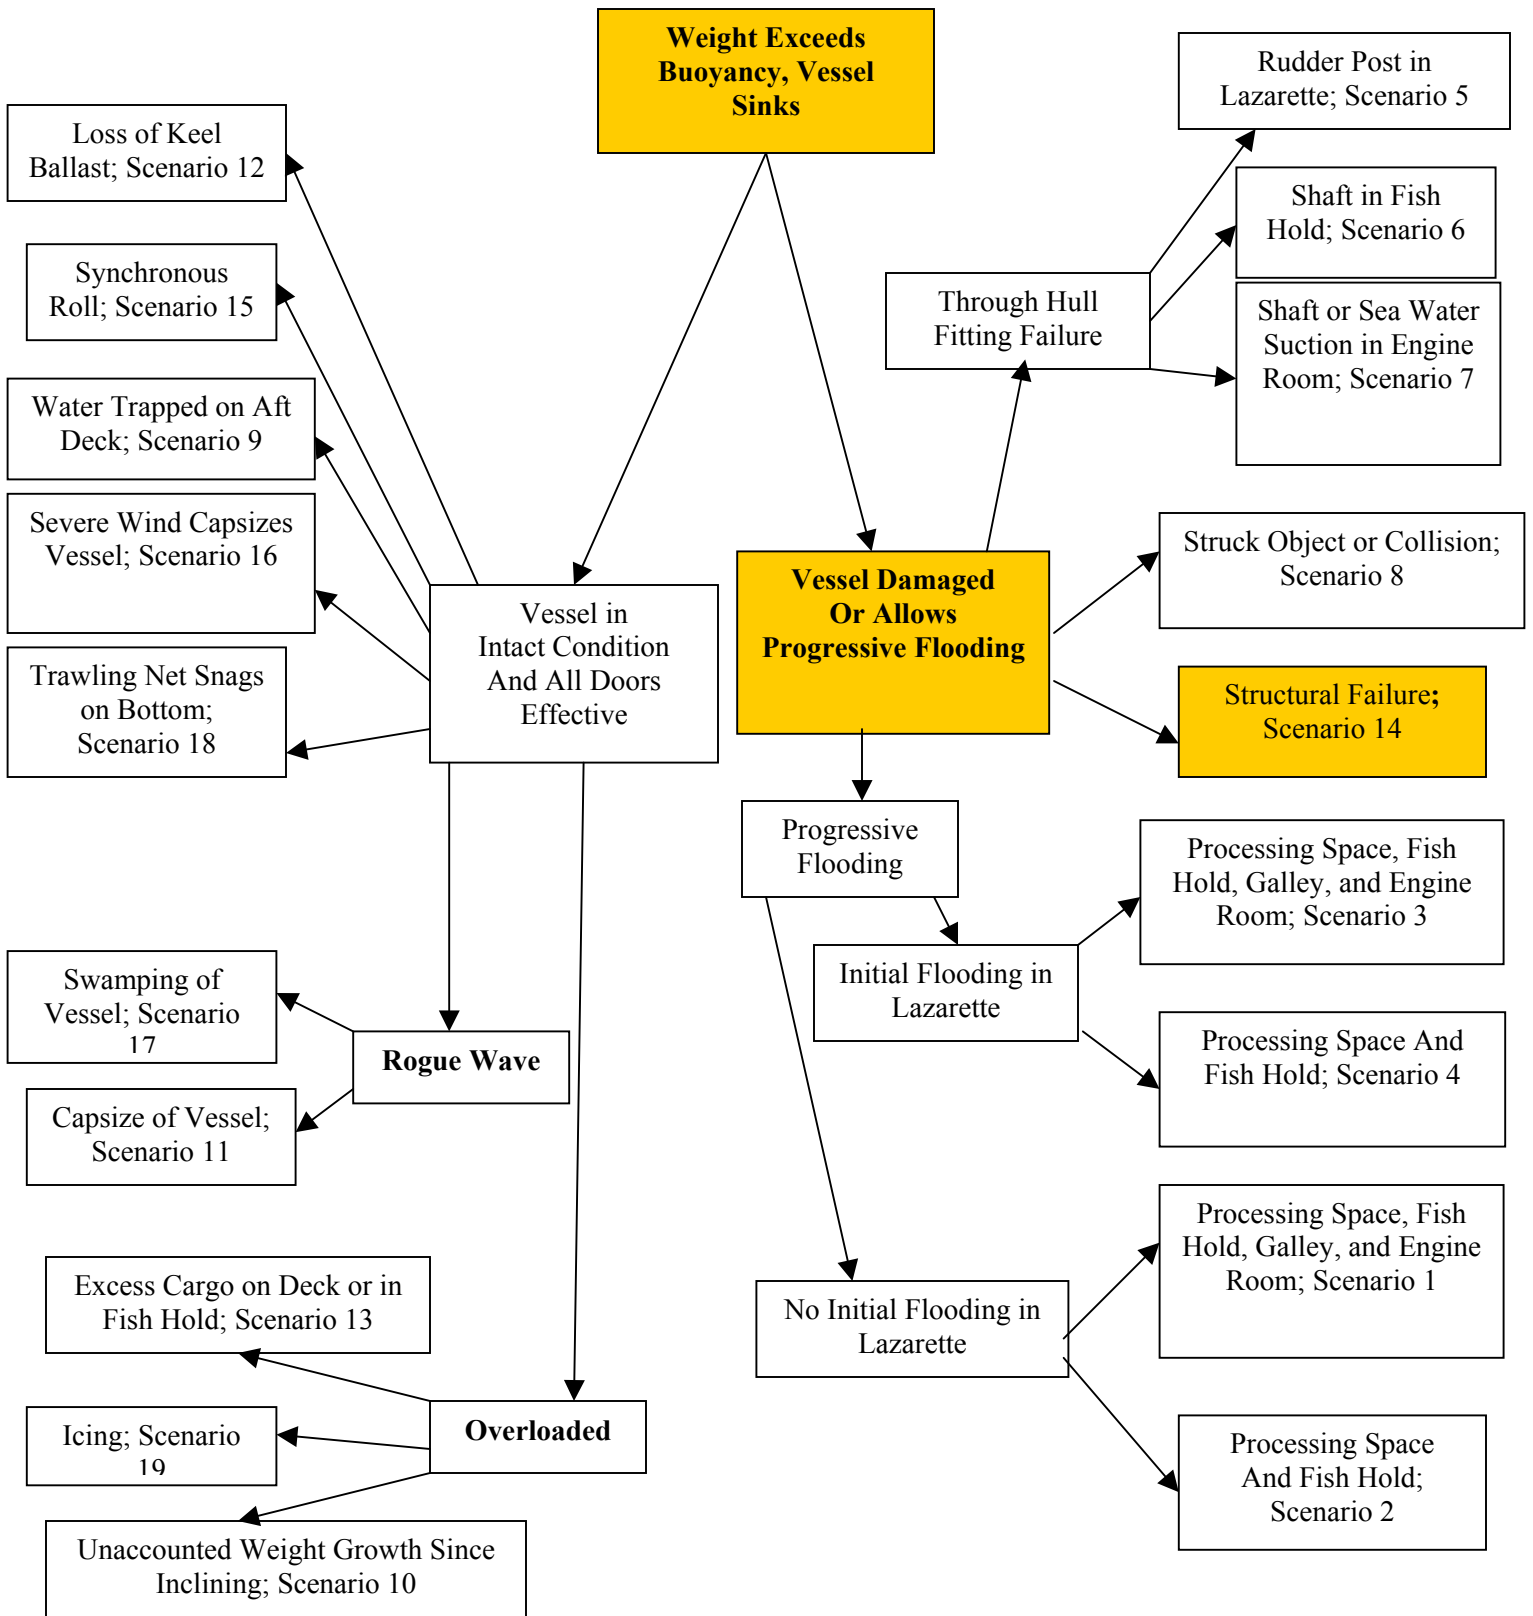
## SCENARIO 14

### STRUCTURAL FAILURE

4. Based on the ROV video of the ARCTIC ROSE side shell, deck plating, and bottom plating, it is very unlikely that the vessel sank due to a global structural failure.

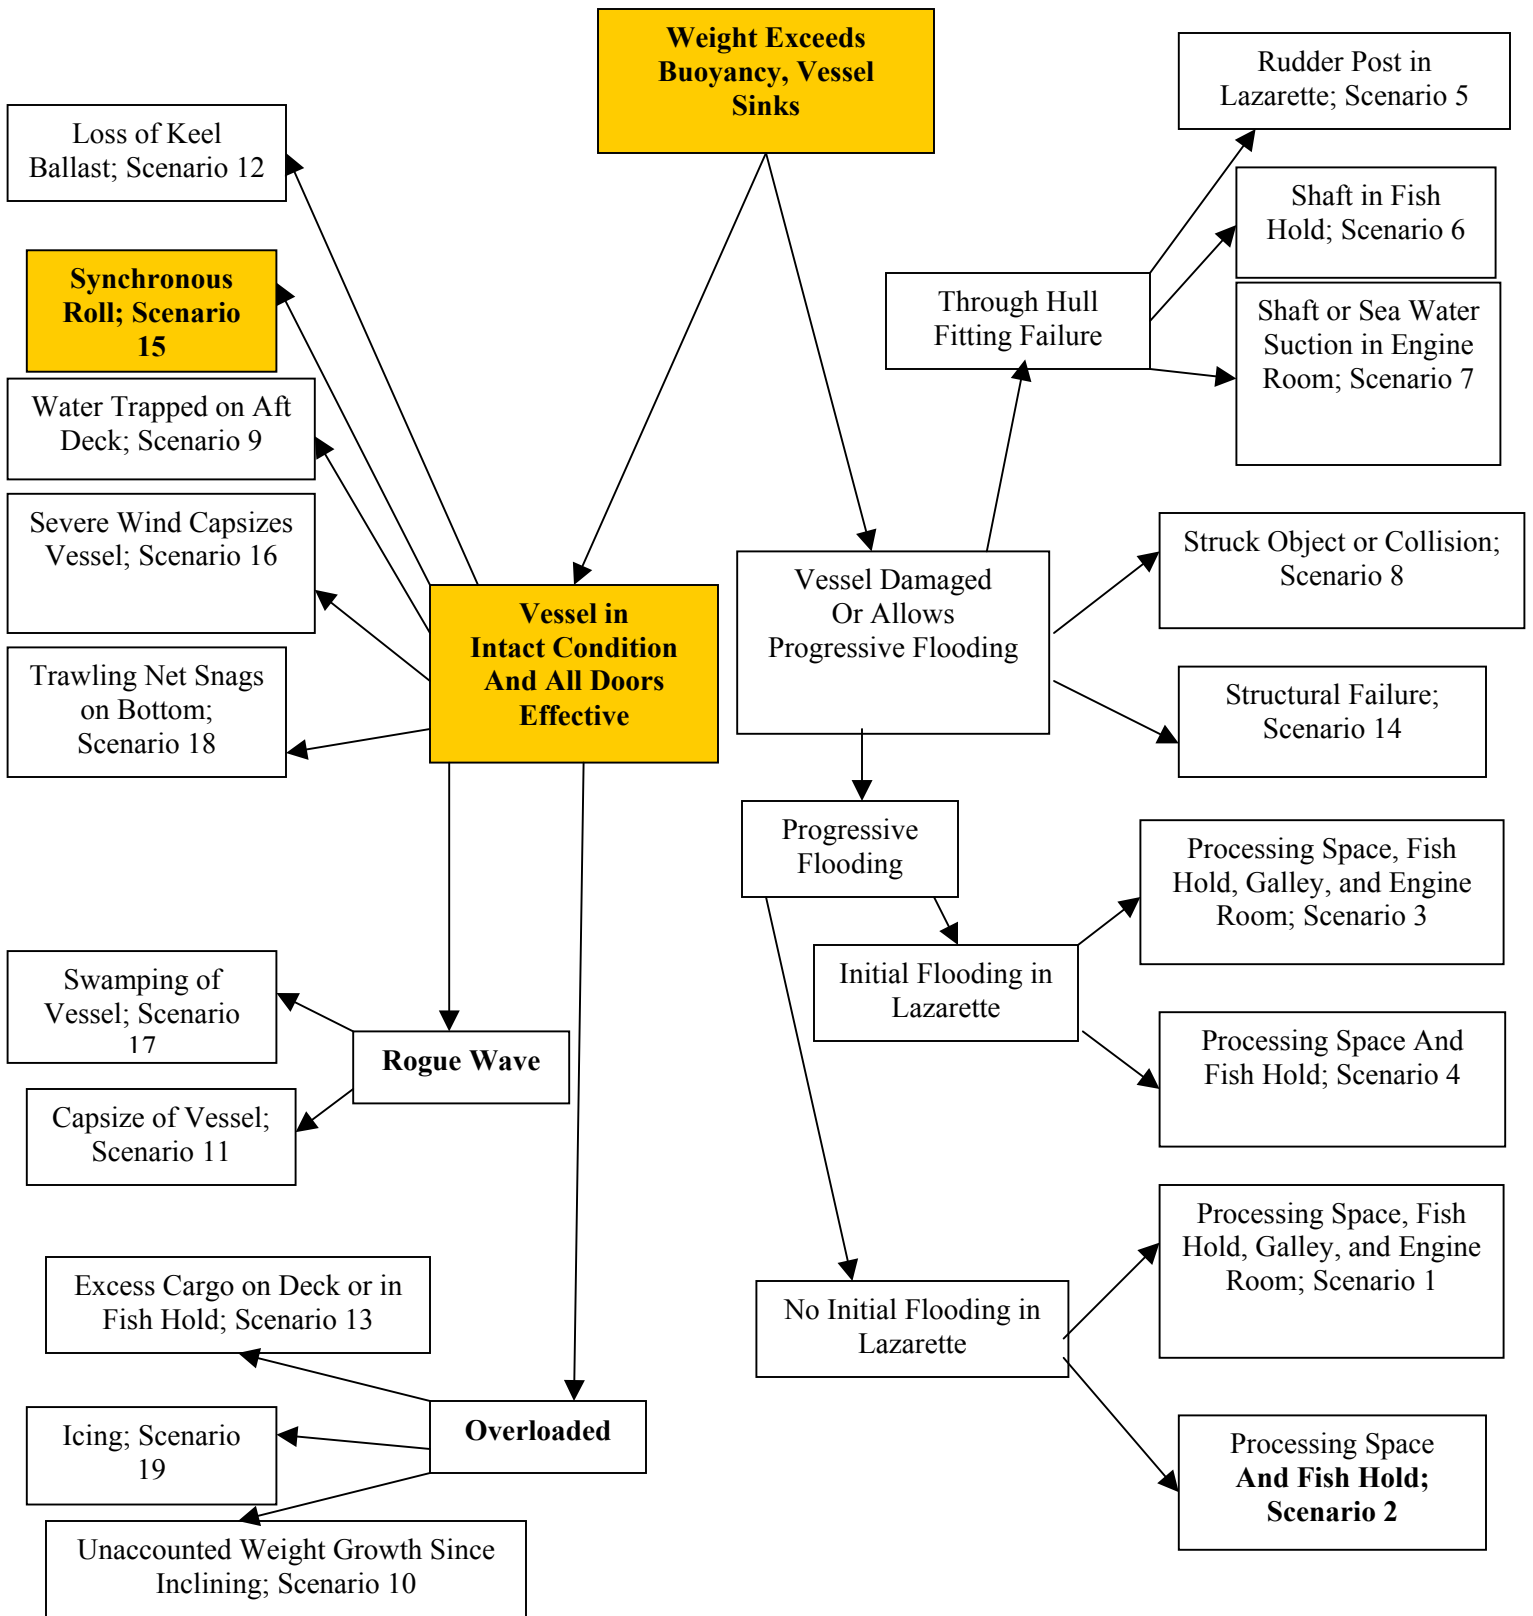
## SCENARIO 15

### SYNCHRONOUS ROLL

4. Based on the roll characteristics of the ARCTIC ROSE, the weather conditions the night of the vessel's loss, and the probable speed of the vessel, it is very unlikely that the loss of the ARCTIC ROSE was due to synchronous roll.

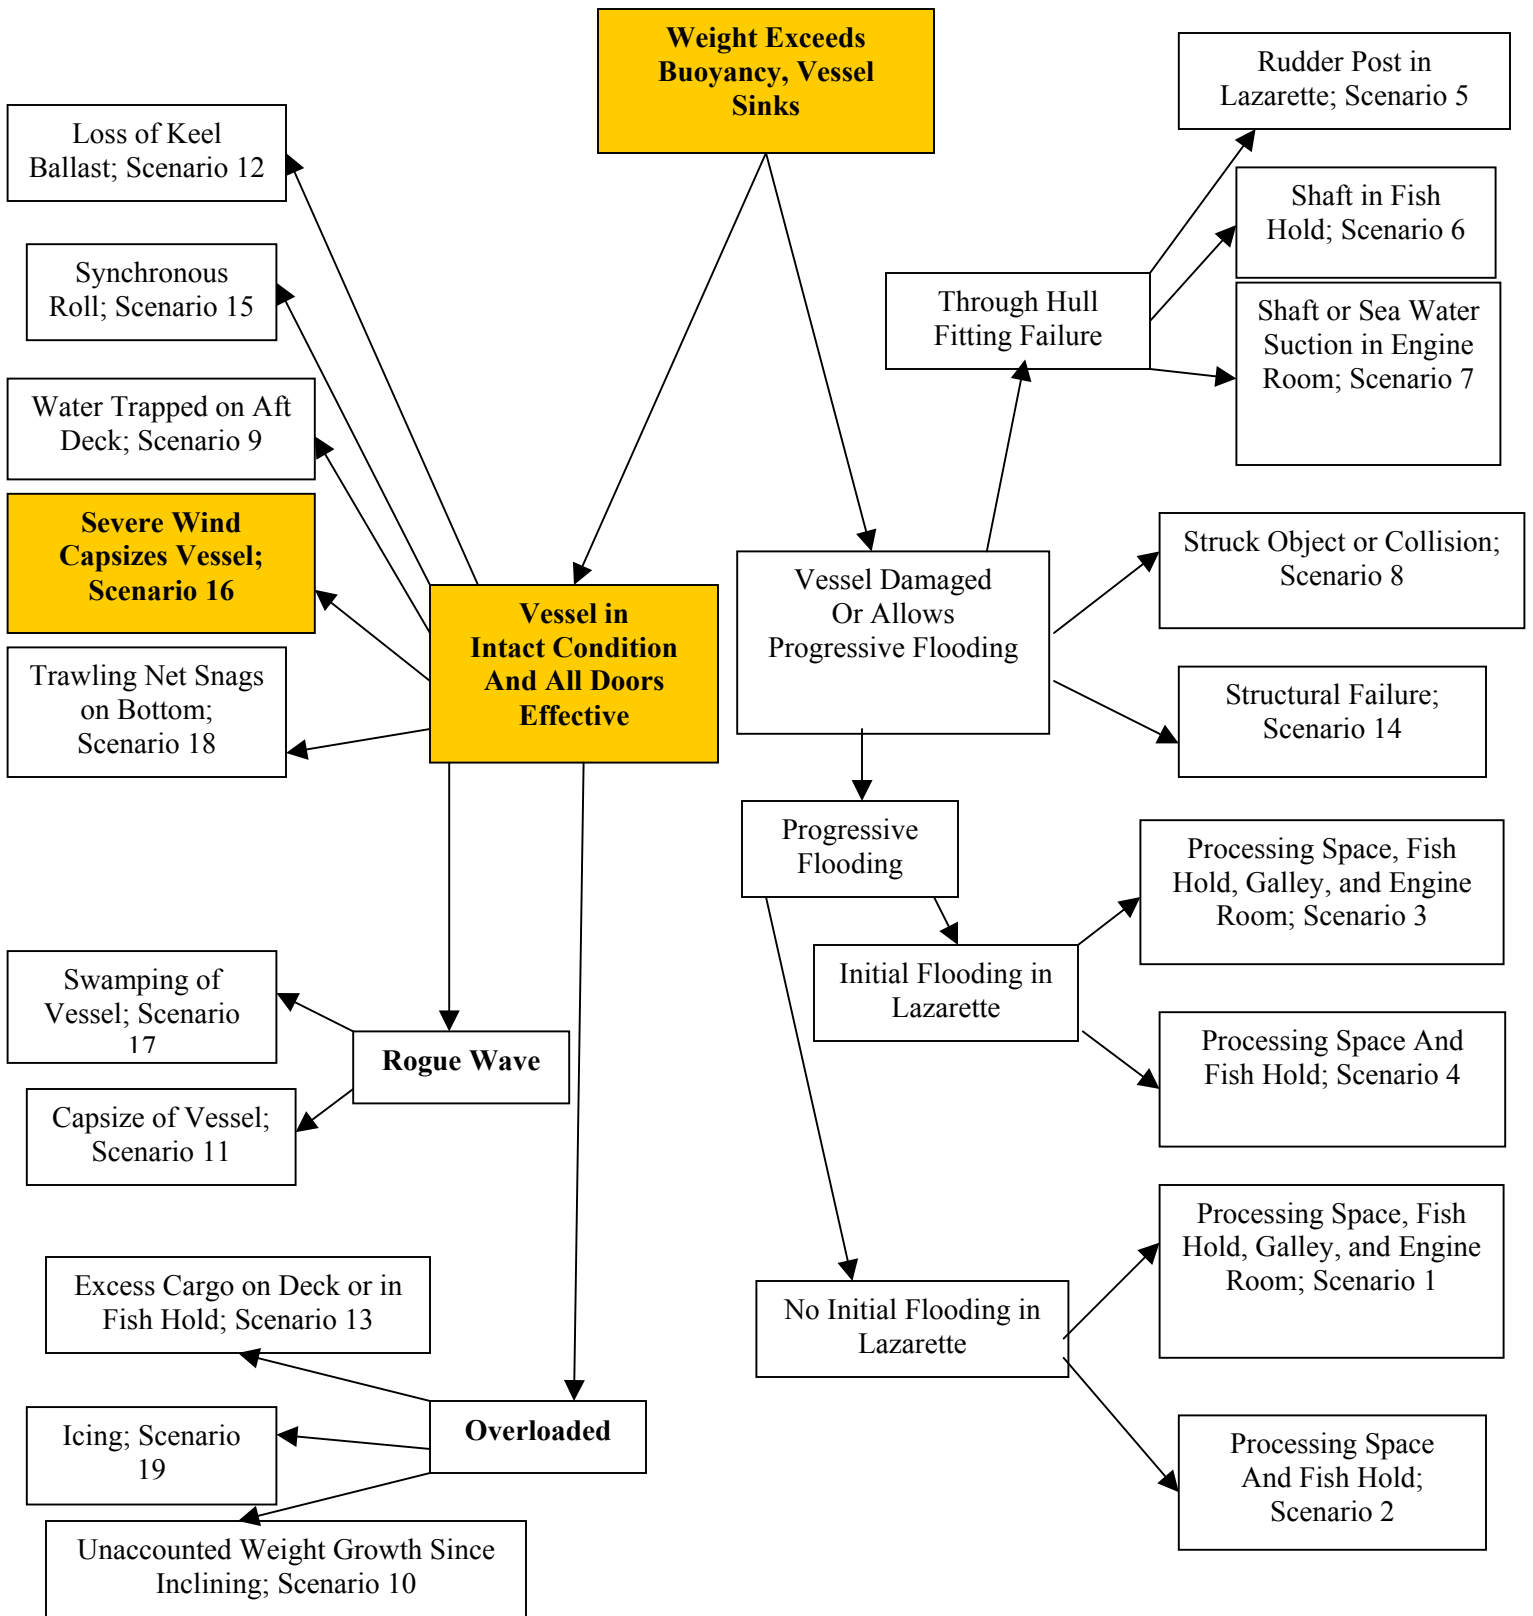
## SCENARIO 16

### SEVERE WIND CAPSIZES VESSEL

4. Based on the ARCTIC ROSE's stability characteristics when a 100 knot wind was applied, it is very unlikely that a severe wind would heel the vessel past its angle of vanishing stability and capsize the vessel.

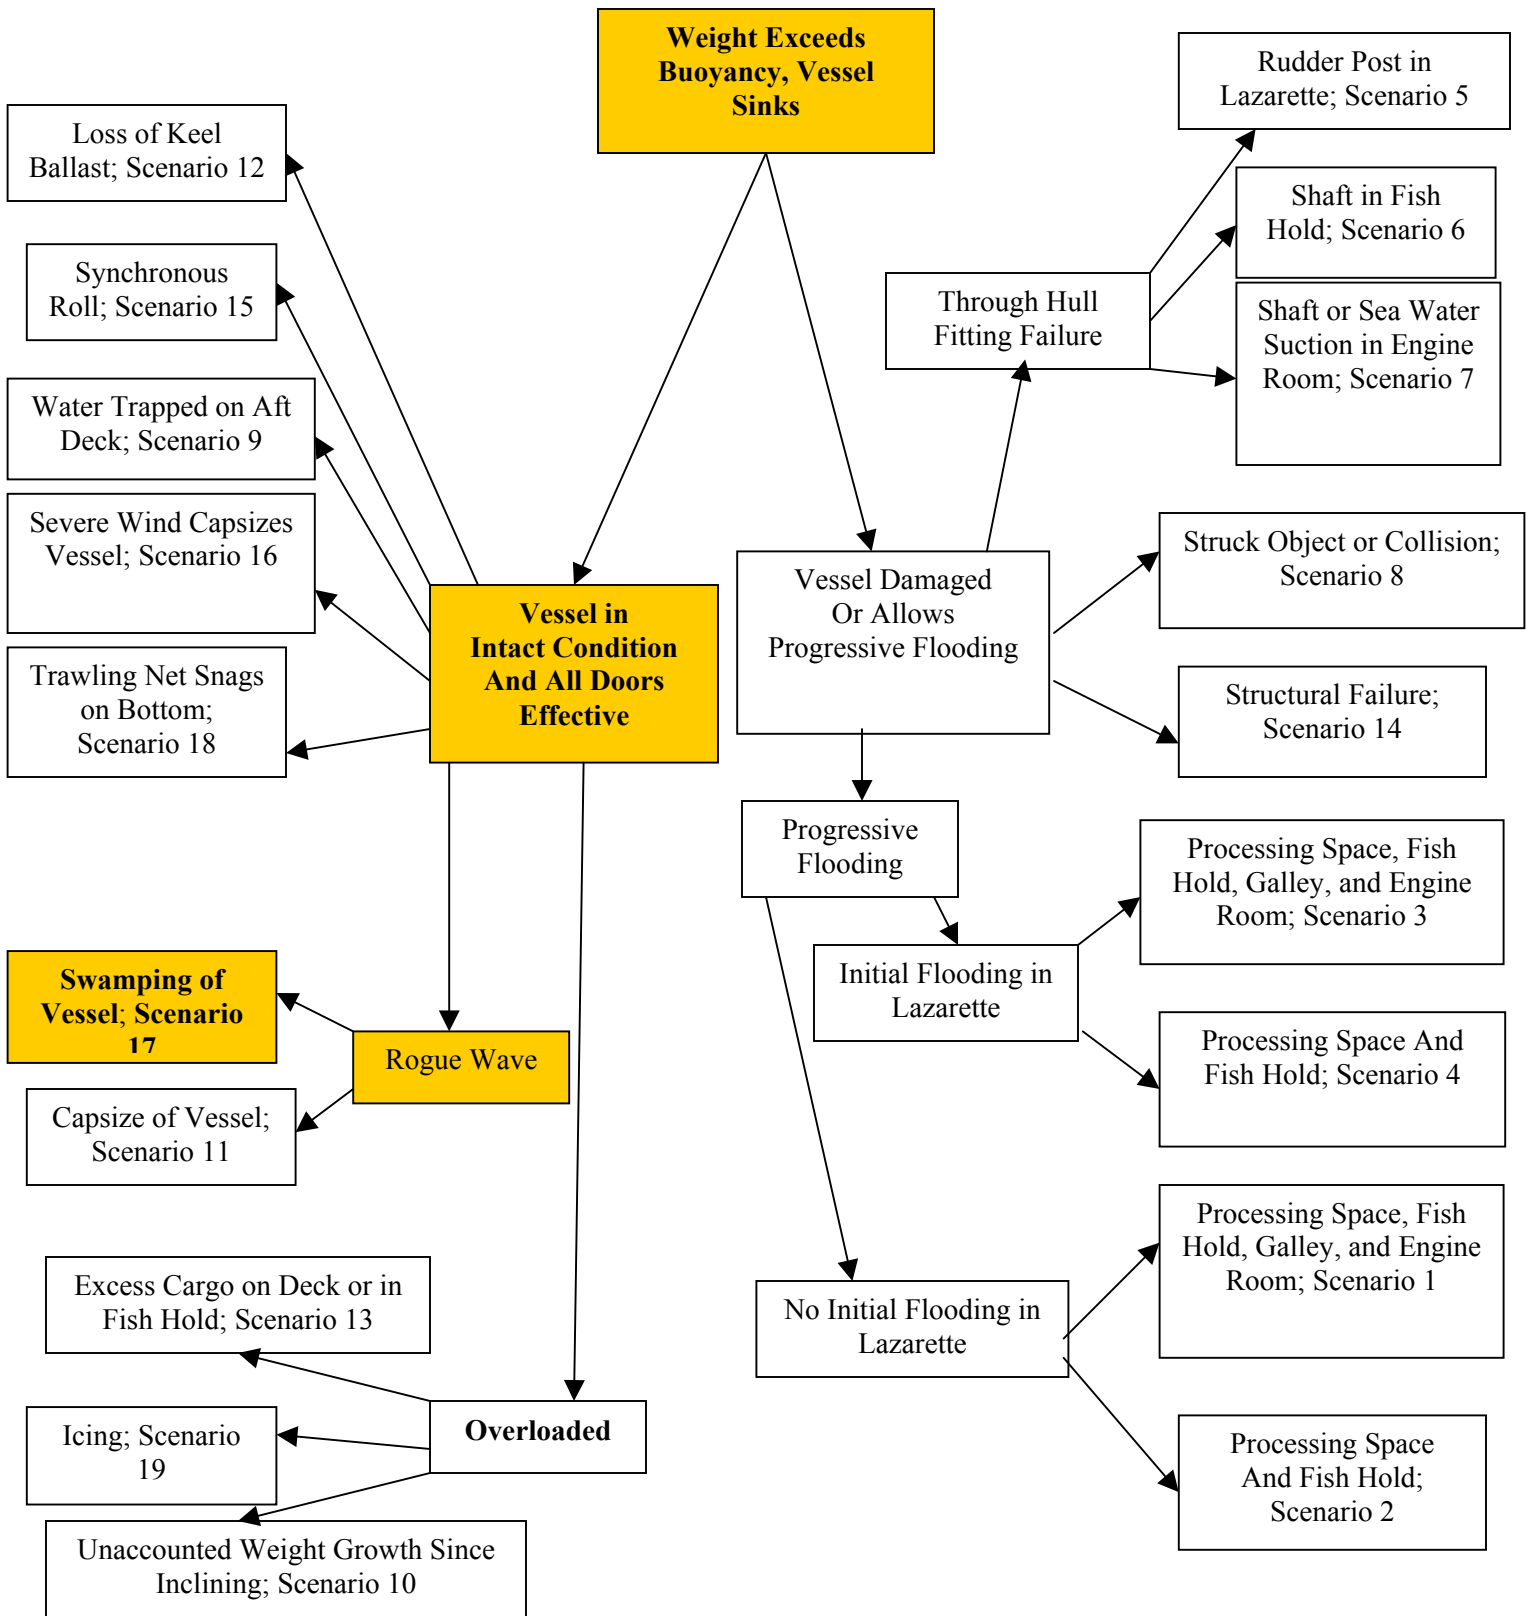
## SCENARIO 17

### SWAMPING OF VESSEL DUE TO ROGUE WAVE

3. Based on the extremely large volume of water that would be needed to swamp the ARCTIC ROSE, the small aft deck area, and the relatively small door opening through which water could enter the processing space, it is very unlikely that a rogue wave swamped the vessel and caused it to sink.

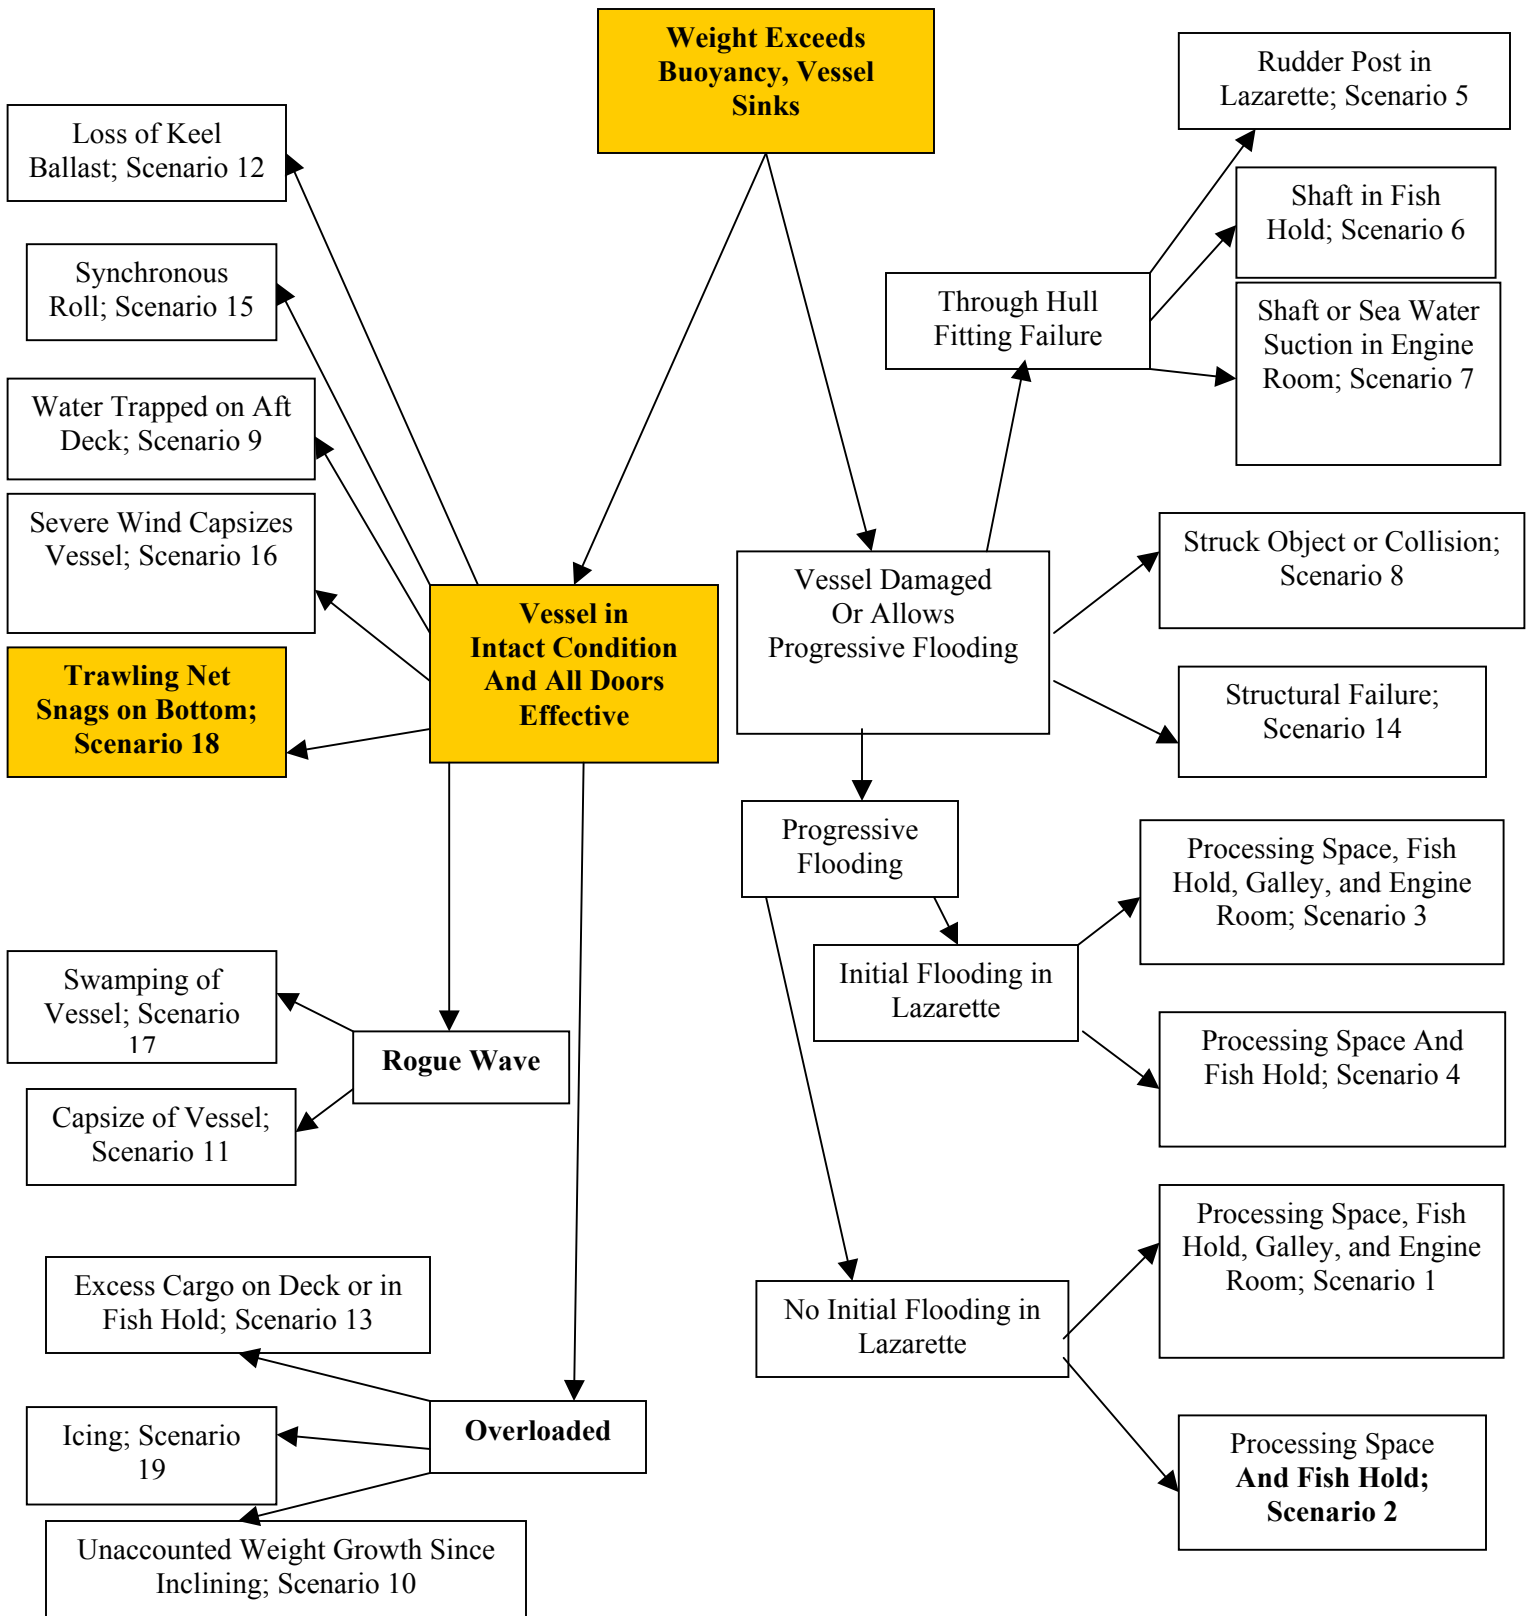
## SCENARIO 18

### TRAWLING NET SNAGS ON BOTTOM

3. Based on the ROV video which shows the trawling net stowed on the aft reel, it is very unlikely that the ARCTIC ROSE sank due to the trawling net snagging the bottom and dragging the aft end of the vessel down.

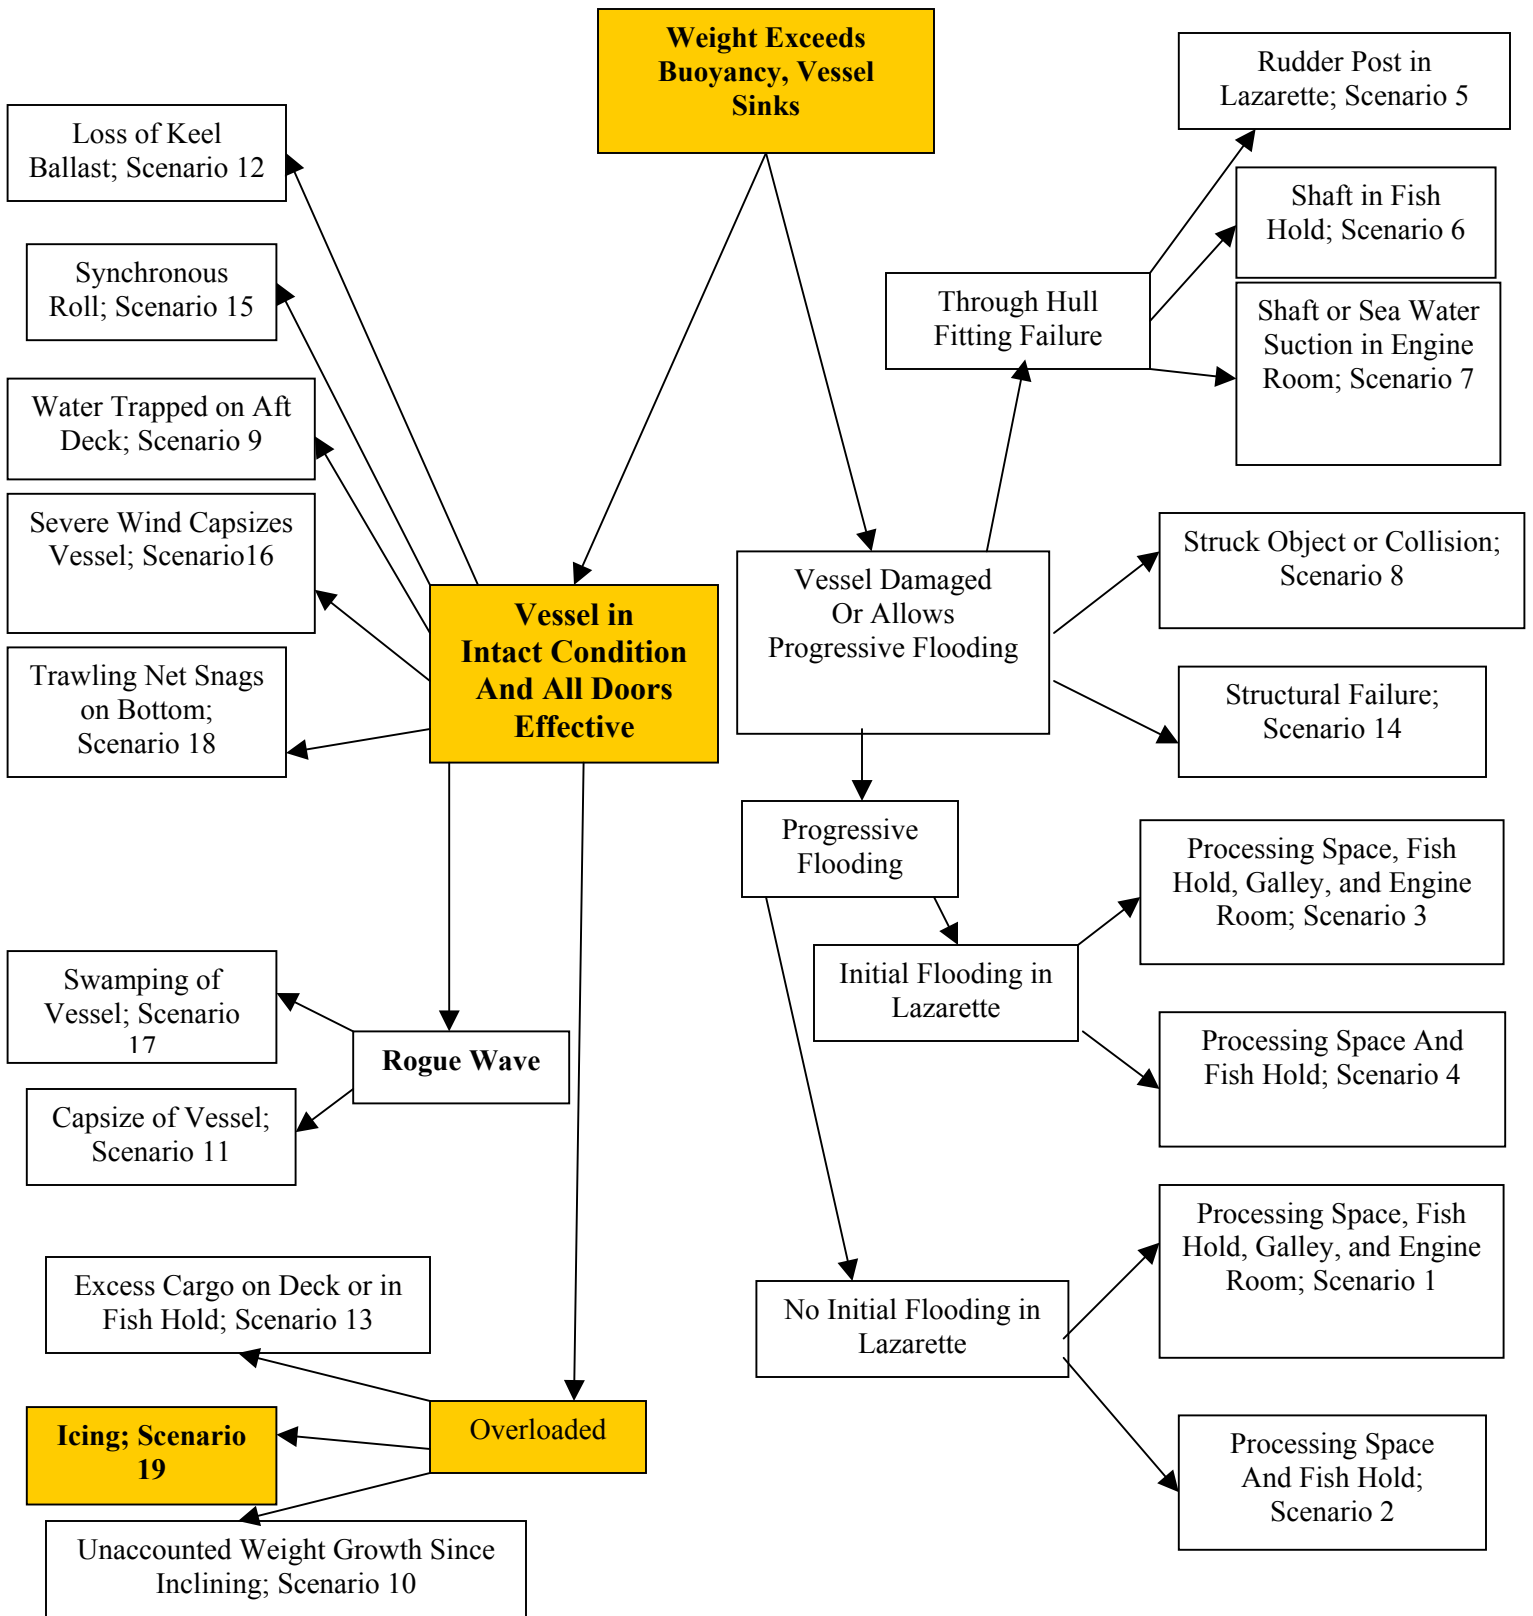
## SCENARIO 19

### OVERLOADED DUE TO ICING
