# UNITED STATES COAST GUARD

INVESTIGATION INTO THE CIRCUMSTANCES  
SURROUNDING THE SINKING OF THE  
UNINSPECTED FISHING VESSEL

## ARCTIC ROSE

OFFICIAL NUMBER 931446, IN THE BERING SEA ON  
APRIL 2, 2001, WITH ONE PERSON DECEASED AND  
FOURTEEN PERSONS MISSING AND PRESUMED DEAD

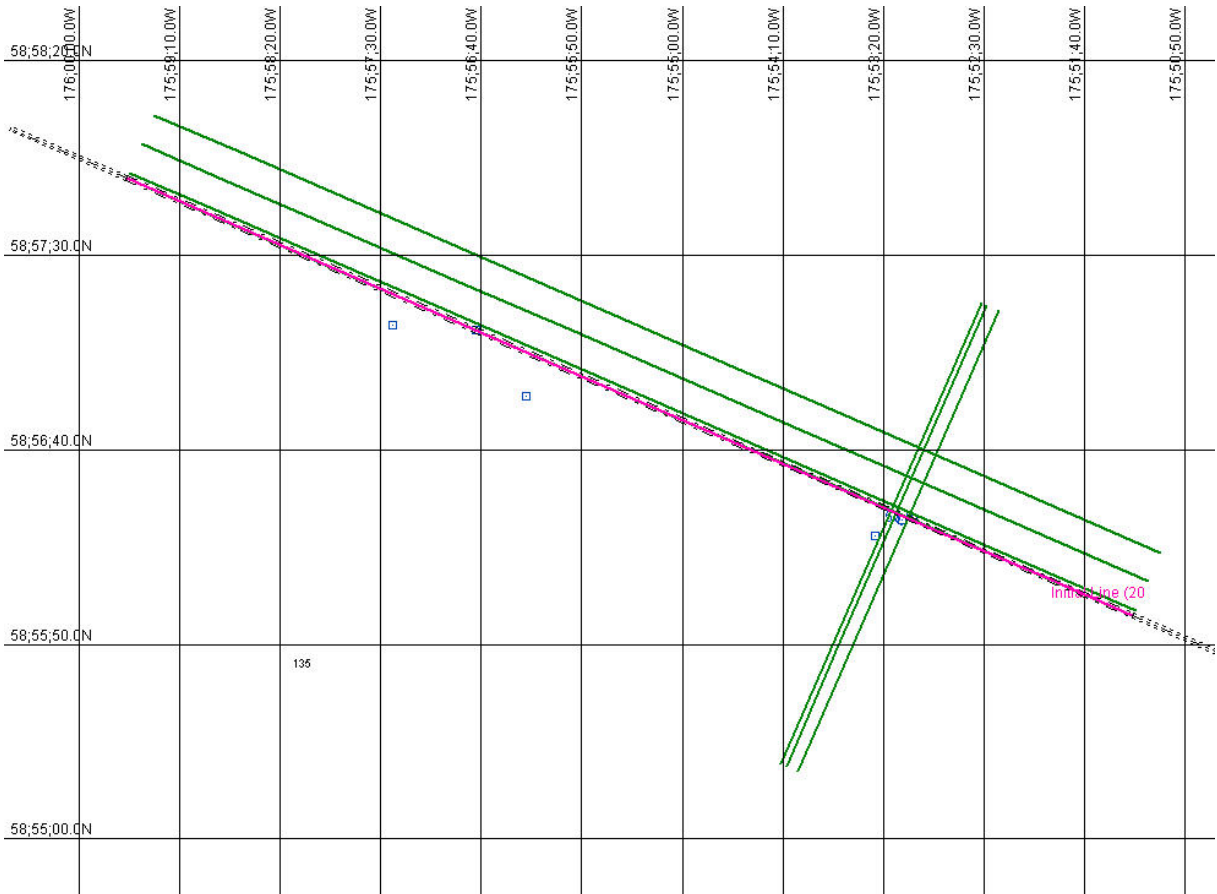
Once on-scene the M/V OCEAN EXPLORER conducted a pass on the initial trackline using its bottom scanning sonar to check for any possible snags so as not to entangle or damage the Klein 5000. At 0330, during the third sonar pass, a large target was found. Subsequent passes revealed a silhouette that matched the profile of the ARCTIC ROSE.

Using these techniques, the team located the wreckage and identified the ARCTIC ROSE soon after the start of the search. The ARCTIC ROSE lies at a 428 feet depth, 200 miles northwest of St. Paul Island in the Bearing Sea. It took the team only two hours from putting the towfish in the water to locate the vessel. The team made several passes to resolve the image at the bottom and look for any debris that may entrap the ROV.

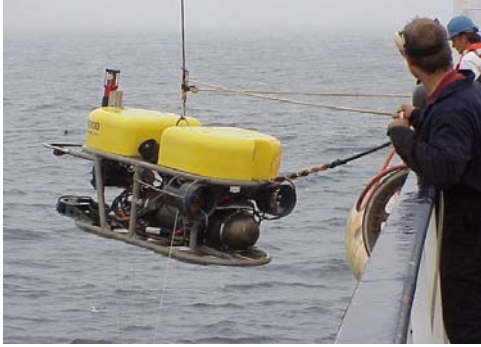
The team arrived on-scene on August, 22, 2001, but rough sea conditions forced the team to wait for better operating conditions. After loitering for several days, the weather calmed falling within the minimum weather window for safe ROV operations. The ROV was lowered over the side and operationally tested. The MAXRover descended to the wreck. The video camera was activated and filmed the wreckage for clues. The MAXRover completed five dives and surveys of the wreckage. The Marine Board was able to examine the entire stbd hull, stern/transom area, the trawl deck along with all associated equipment, and the exterior of the processing space. The Marine Board was also able to view the aft port section of the hull, keel cooler, shaft, kort nozzle and rudder. The Marine Board was able to learn a great deal about the vessel and its condition.

The Marine Board discovered the following details concerning the vessel:

1. No hull failure or excessive corrosion,
2. No damage or indication that the vessel was rammed or struck an object prior to the sinking,
3. No buckled decking or side shell insets,
4. The vessel's rudder was hard over to port,
5. The vessel appeared to strike the bottom stern first,
6. The aft weathertight door to the processing space was open,
7. A starboard guillotine closure for the by-catch overboard discharge chute was open,
8. Heavy gear was strewn across the deck and resting over the starboard bulwarks of the vessel,
9. The vessel's trawl doors are missing,
10. The vessel's trawl net was on the net reels, and;
11. The vessel's propeller and shaft were in place.
