MARINE CASUALTY REPORT

SS AMERICAN EAGLE, O.N. 278327

EXPLOSION IN THE GULF OF MEXICO

**Marine Board of Investigation Report
and
Commandant's Action**

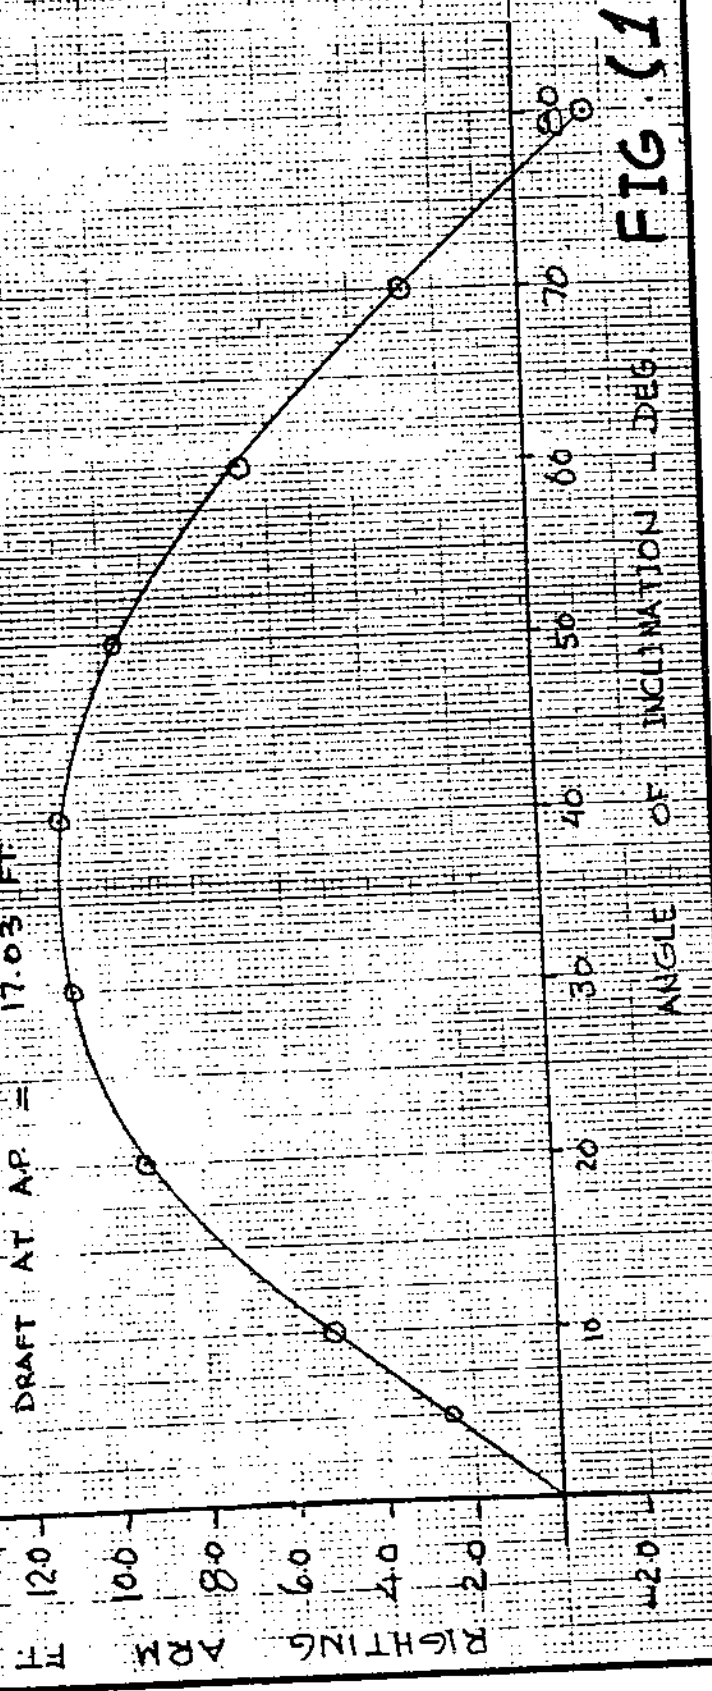
FIG. (1)

The intact statical stability righting arm curve is shown in Figure 1. The analysis indicates that the ship as loaded just before the explosion met U.S. Coast Guard and Marpol 73/78 stability requirements.

MEAN DRAFT \bar{x} = 12.42 FT
 Δ LT. S.W. = 14,124.7
 KG' = 28,113 FT
 GM_T = 28.42 FT
 TRIM BY STERN = 8.78 FT
 DRAFT AT F.P. = 8.24 FT
 DRAFT AT A.P. = 17.03 FT

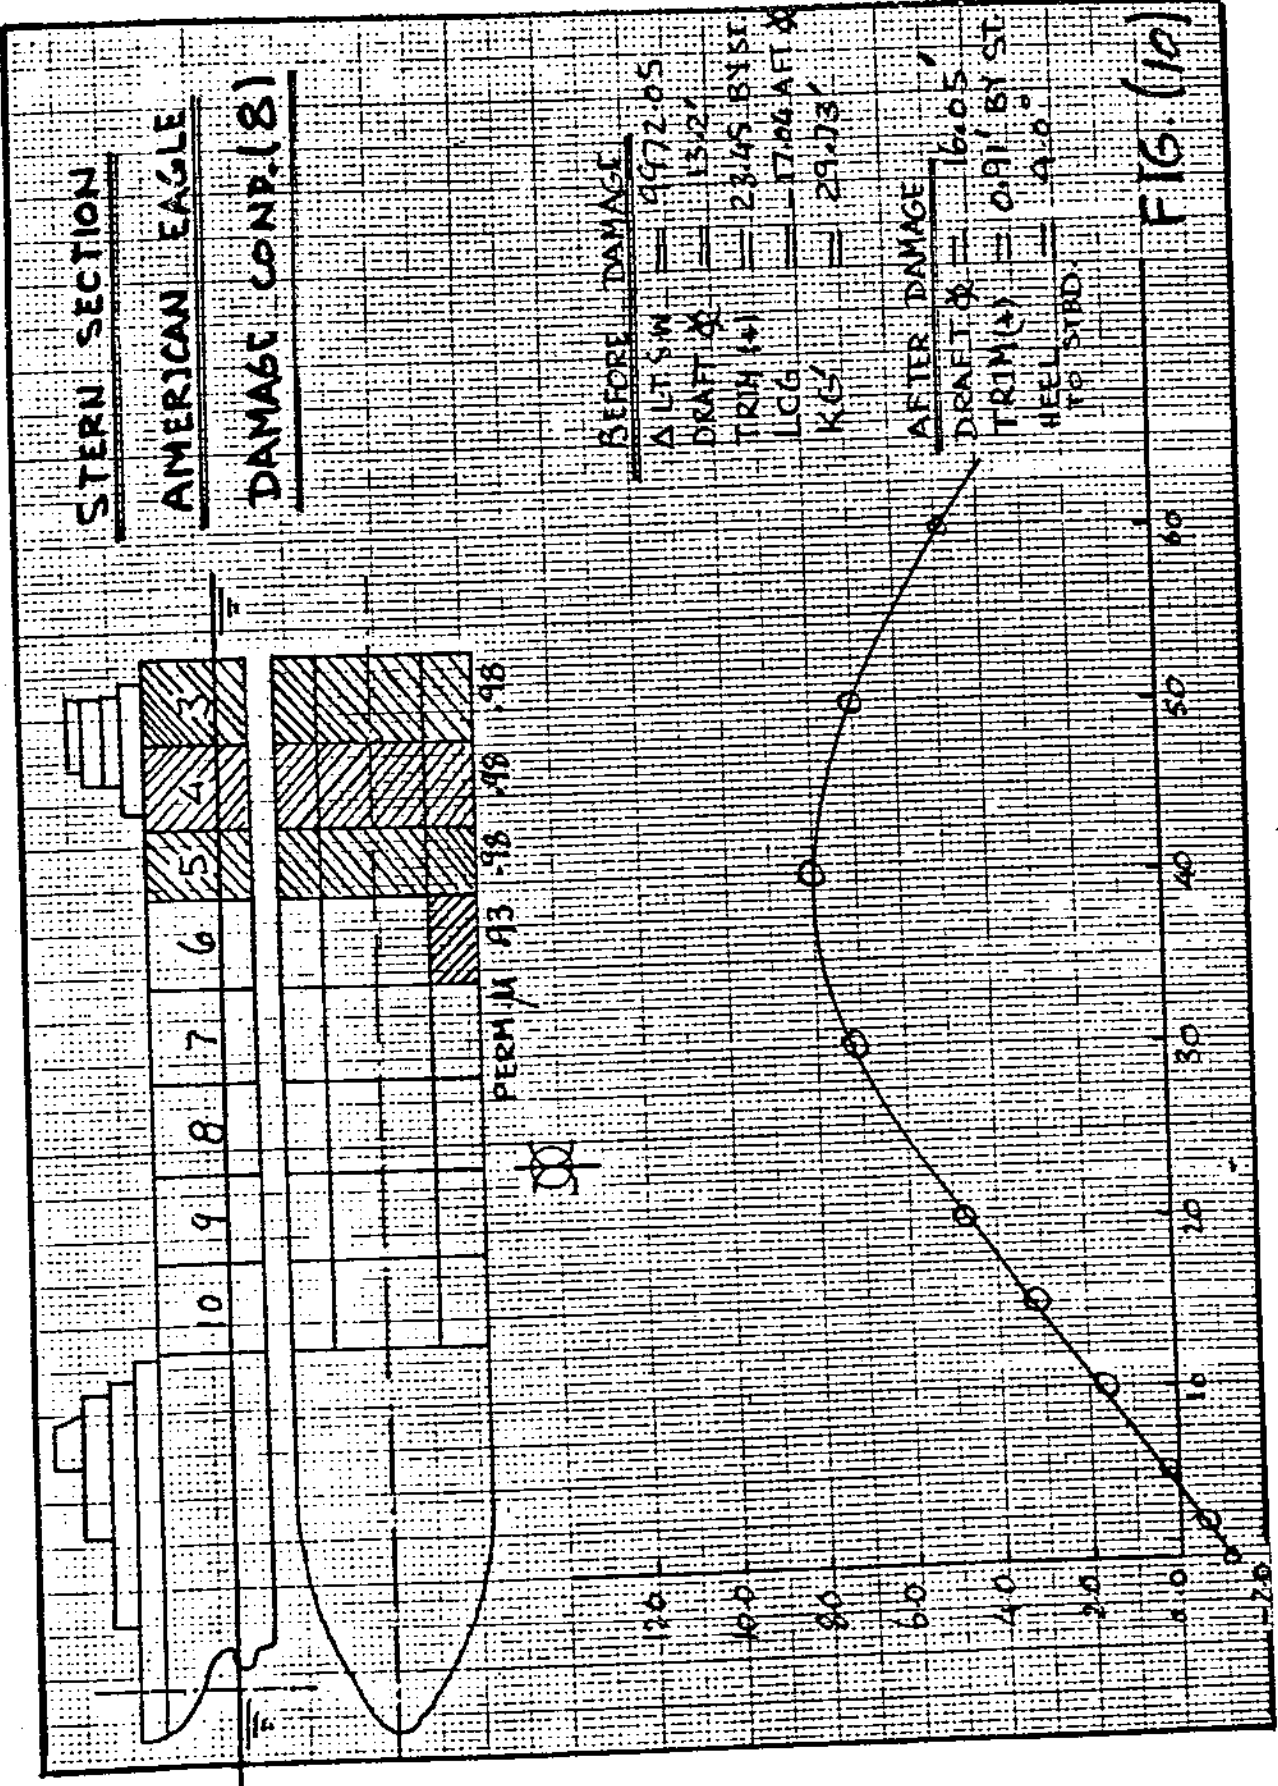
FIG. (10)

After separation from the bow section, the stern section has a trim by the stern of 23.5 ft. As progressive flooding continues, the trim by the stern decreases gradually until the stern section becomes nearly on an even keel. Heel during this stage of flooding is 4 degrees. These conditions are shown in Figure 10.

Up to this point, tanks No. 3 P/S/C, 4 P/S/C, 5 P/S/C and 6 S are flooded (Figure 10). Additional flooding causes trim by the bow. Figure 11 shows trim by the bow of 12.0 ft. Trim by the bow increases gradually as progressive flooding continues, until it reaches 81.1 ft. At this point, the deck house is submerged to the first level and the stern is out of the water. Starboard heel during this stage reaches a maximum value of 13 degrees (Figure 14).

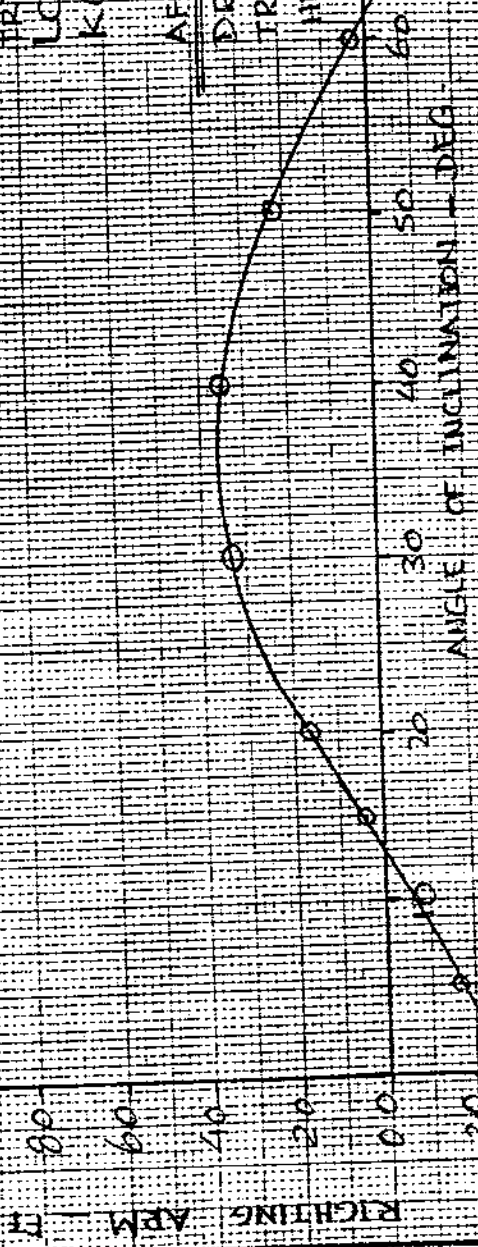
FIG (14)

DRAFT (X)	26.6
TRIM (M)	60.51 BOW
HEEL TO STUD	13.0°

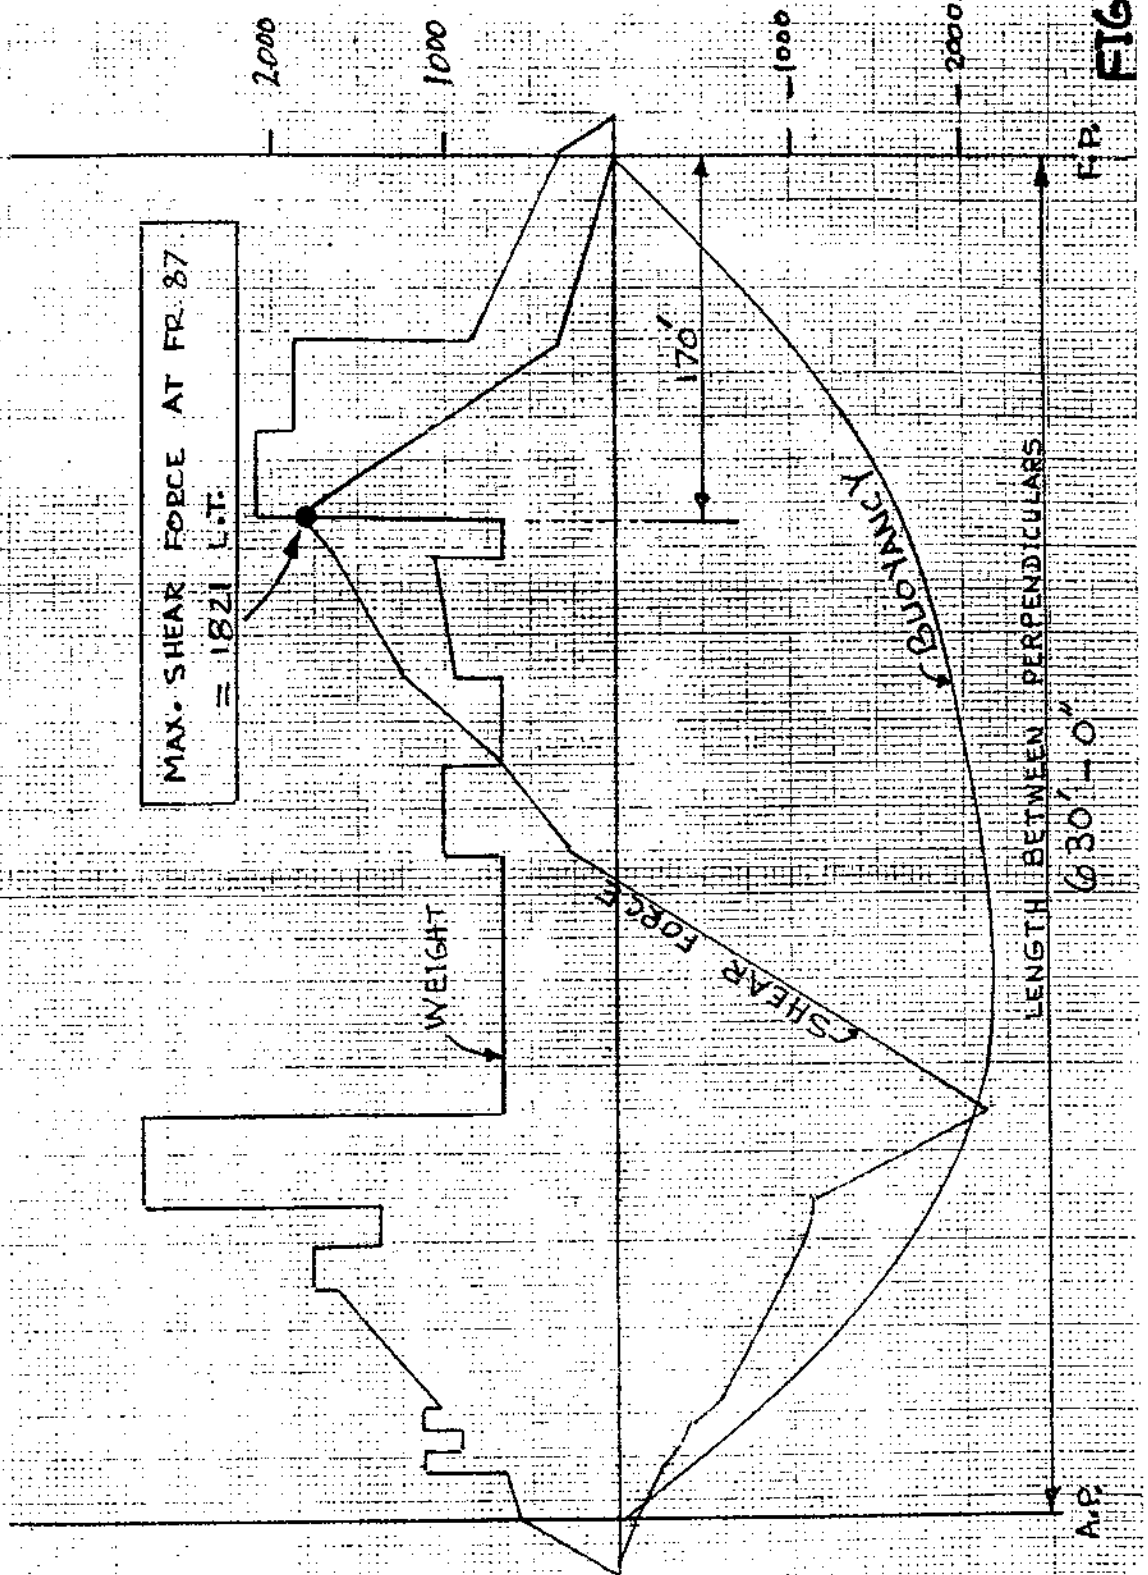
FIG. 17

The light ship weight distribution curve was supplied by the Marine Board of Investigation. Using this curve and the loading condition of the ship before the explosion, the weight distribution curve was constructed. The longitudinal strength analysis was performed using the SHCP computer program. Weight, buoyancy and shear force diagrams are shown in Figure 17. The maximum shear force occurs at 170 ft aft of the forward perpendicular (FP). The shear force at this location is 1821 long tons.
