**USCGC BLACKTHORN, SS CAPRICORN;  
COLLISION IN TAMPA BAY  
ON 28 JANUARY 1980 WITH LOSS OF LIFE**

**U.S. COAST GUARD  
MARINE BOARD OF INVESTIGATION REPORT**

**REPORT NO. USCG 16732/01279**

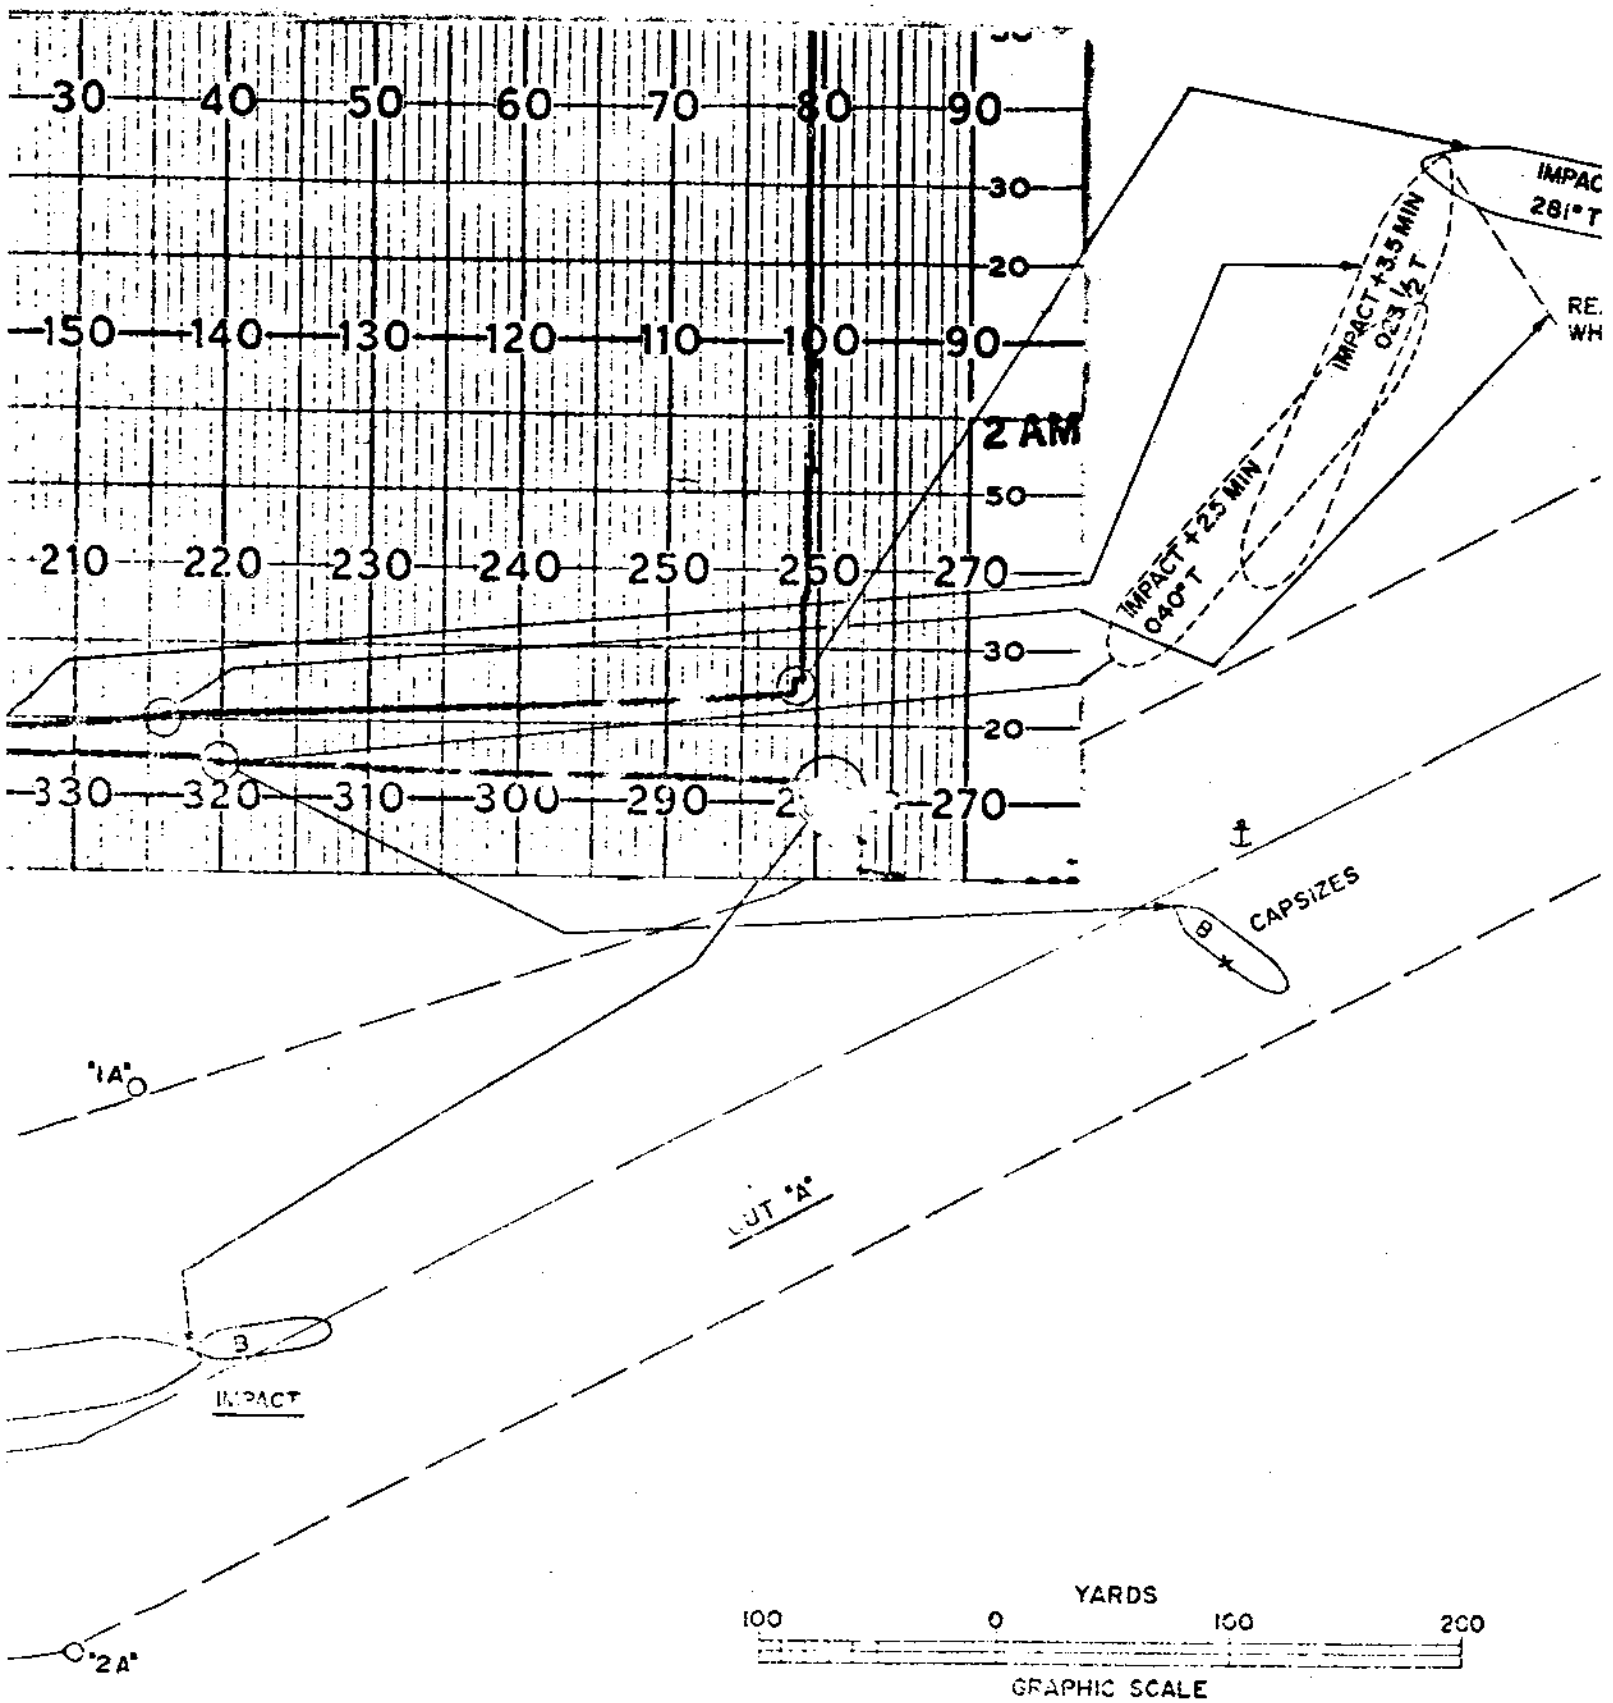
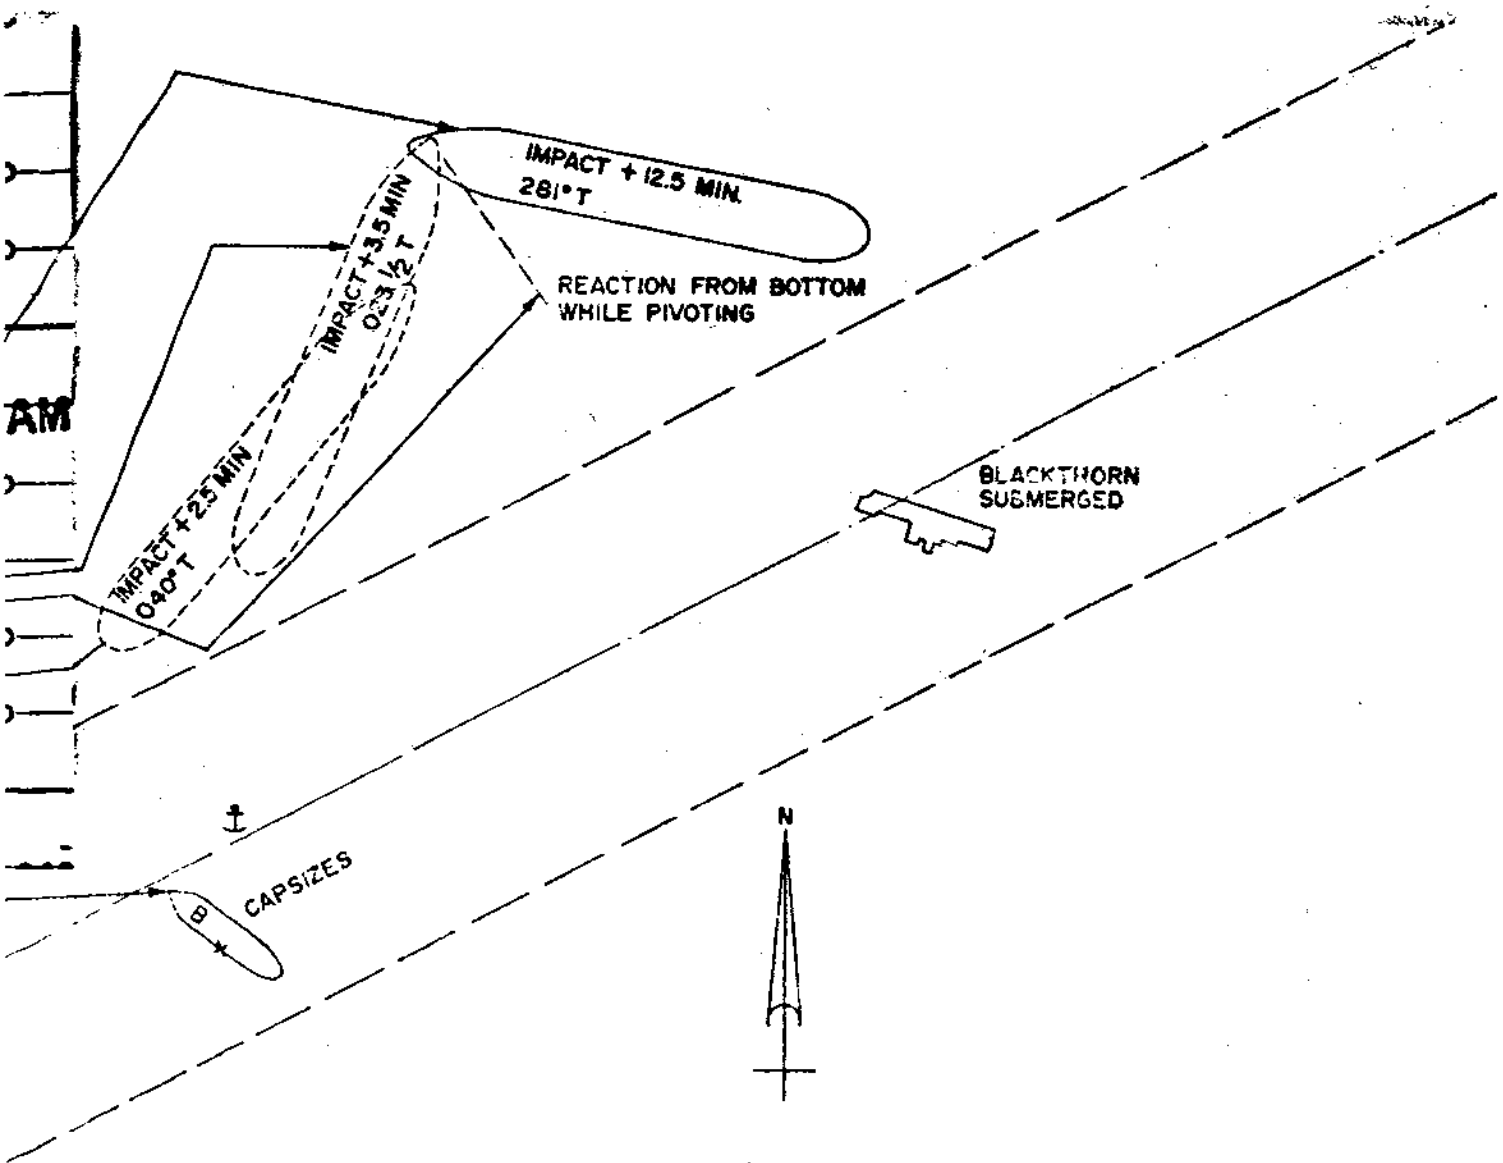
CHART C

ALL POSITIONS ARE ESTIMATES  
BASED ON EVIDENCE

TAKEN FROM CHART 11414.  
OUTER BOUNDARY LINES OF  
THE CHANNELS ARE APPROXI-  
MATE DUE TO THE DISTORTION  
OF CHART 11414 IN THIS AREA.

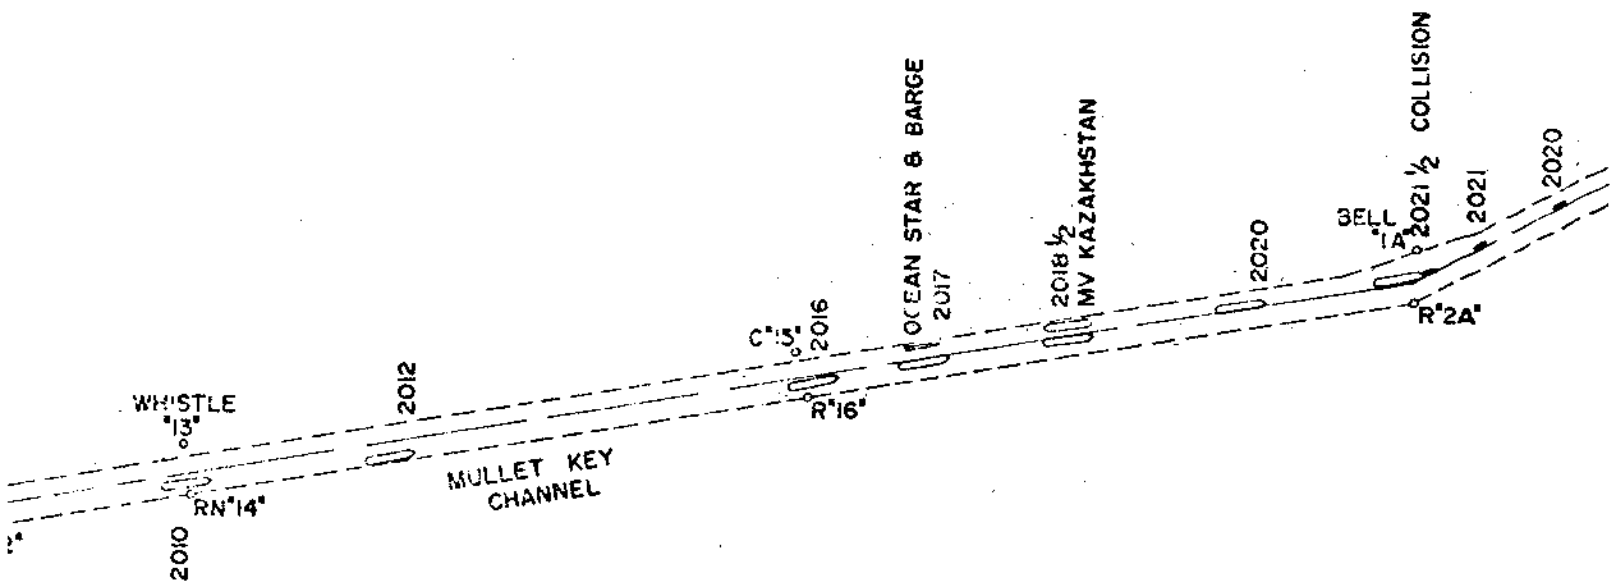
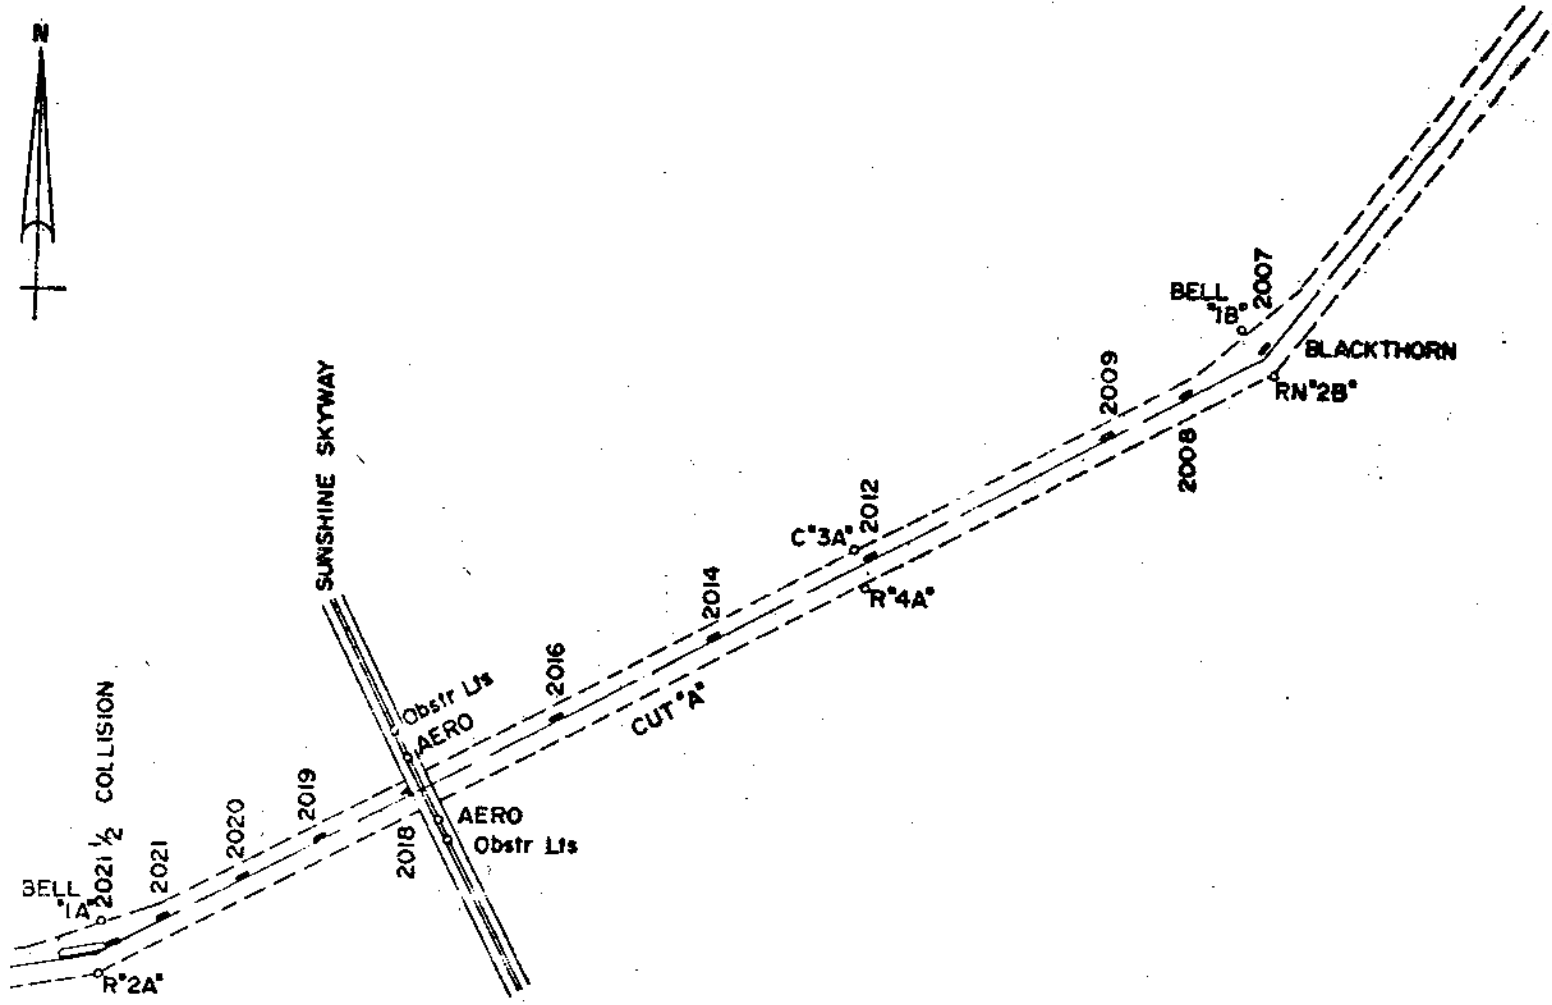
CHART A

TAKEN FROM CHART 11414  
 OUTER BOUNDARY LINES OF  
 THE CHANNELS ARE APPROX-  
 IIMATE DUE TO THE DISTORTION  
 OF CHART 11414 IN THIS AREA
