# **MARINE CASUALTY REPORT**

## **SS POET: DISAPPEARANCE IN THE ATLANTIC OCEAN AFTER DEPARTURE FROM CAPE HENLOPEN, DELAWARE ON 24 OCTOBER 1980 WITH LOSS OF LIFE**

MARINE BOARD OF INVESTIGATION REPORT

REPORT NO. USCG 16732/11486

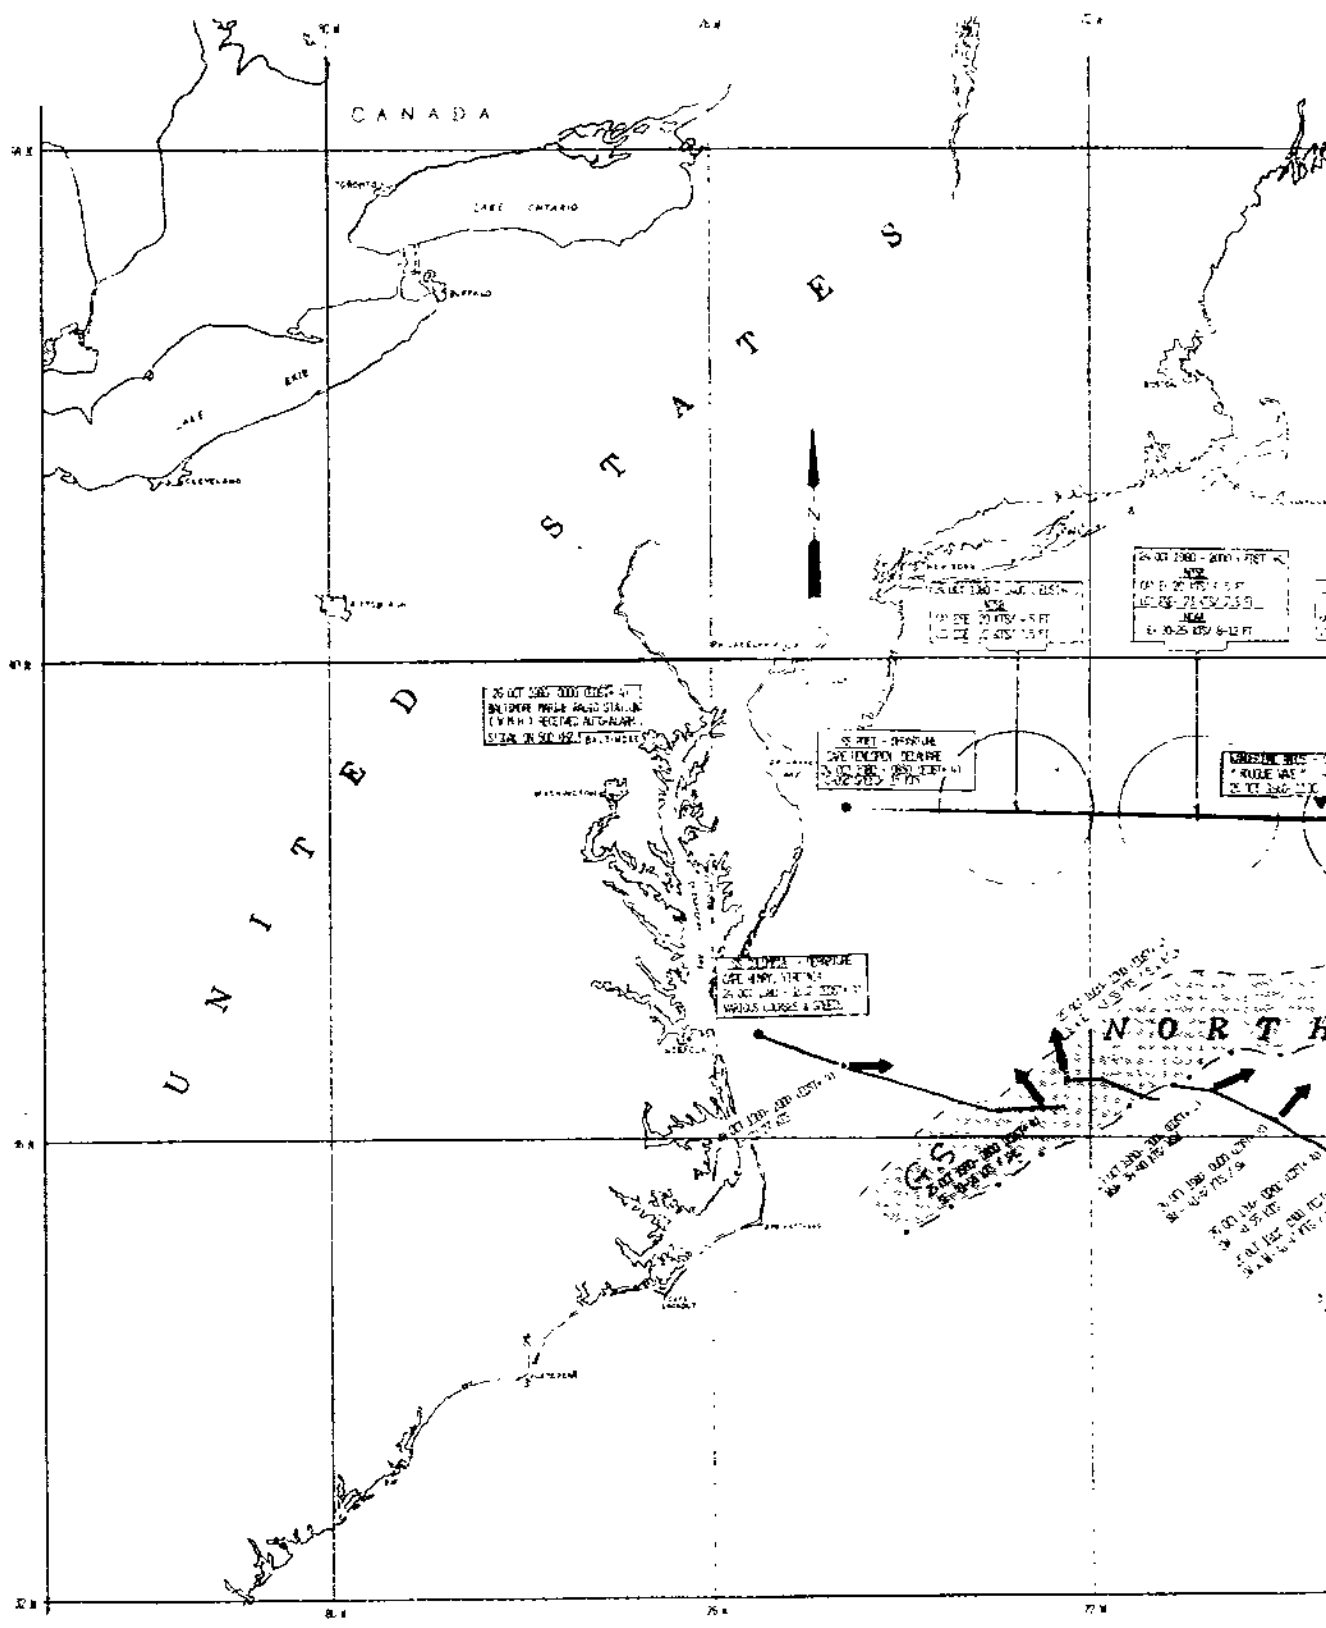
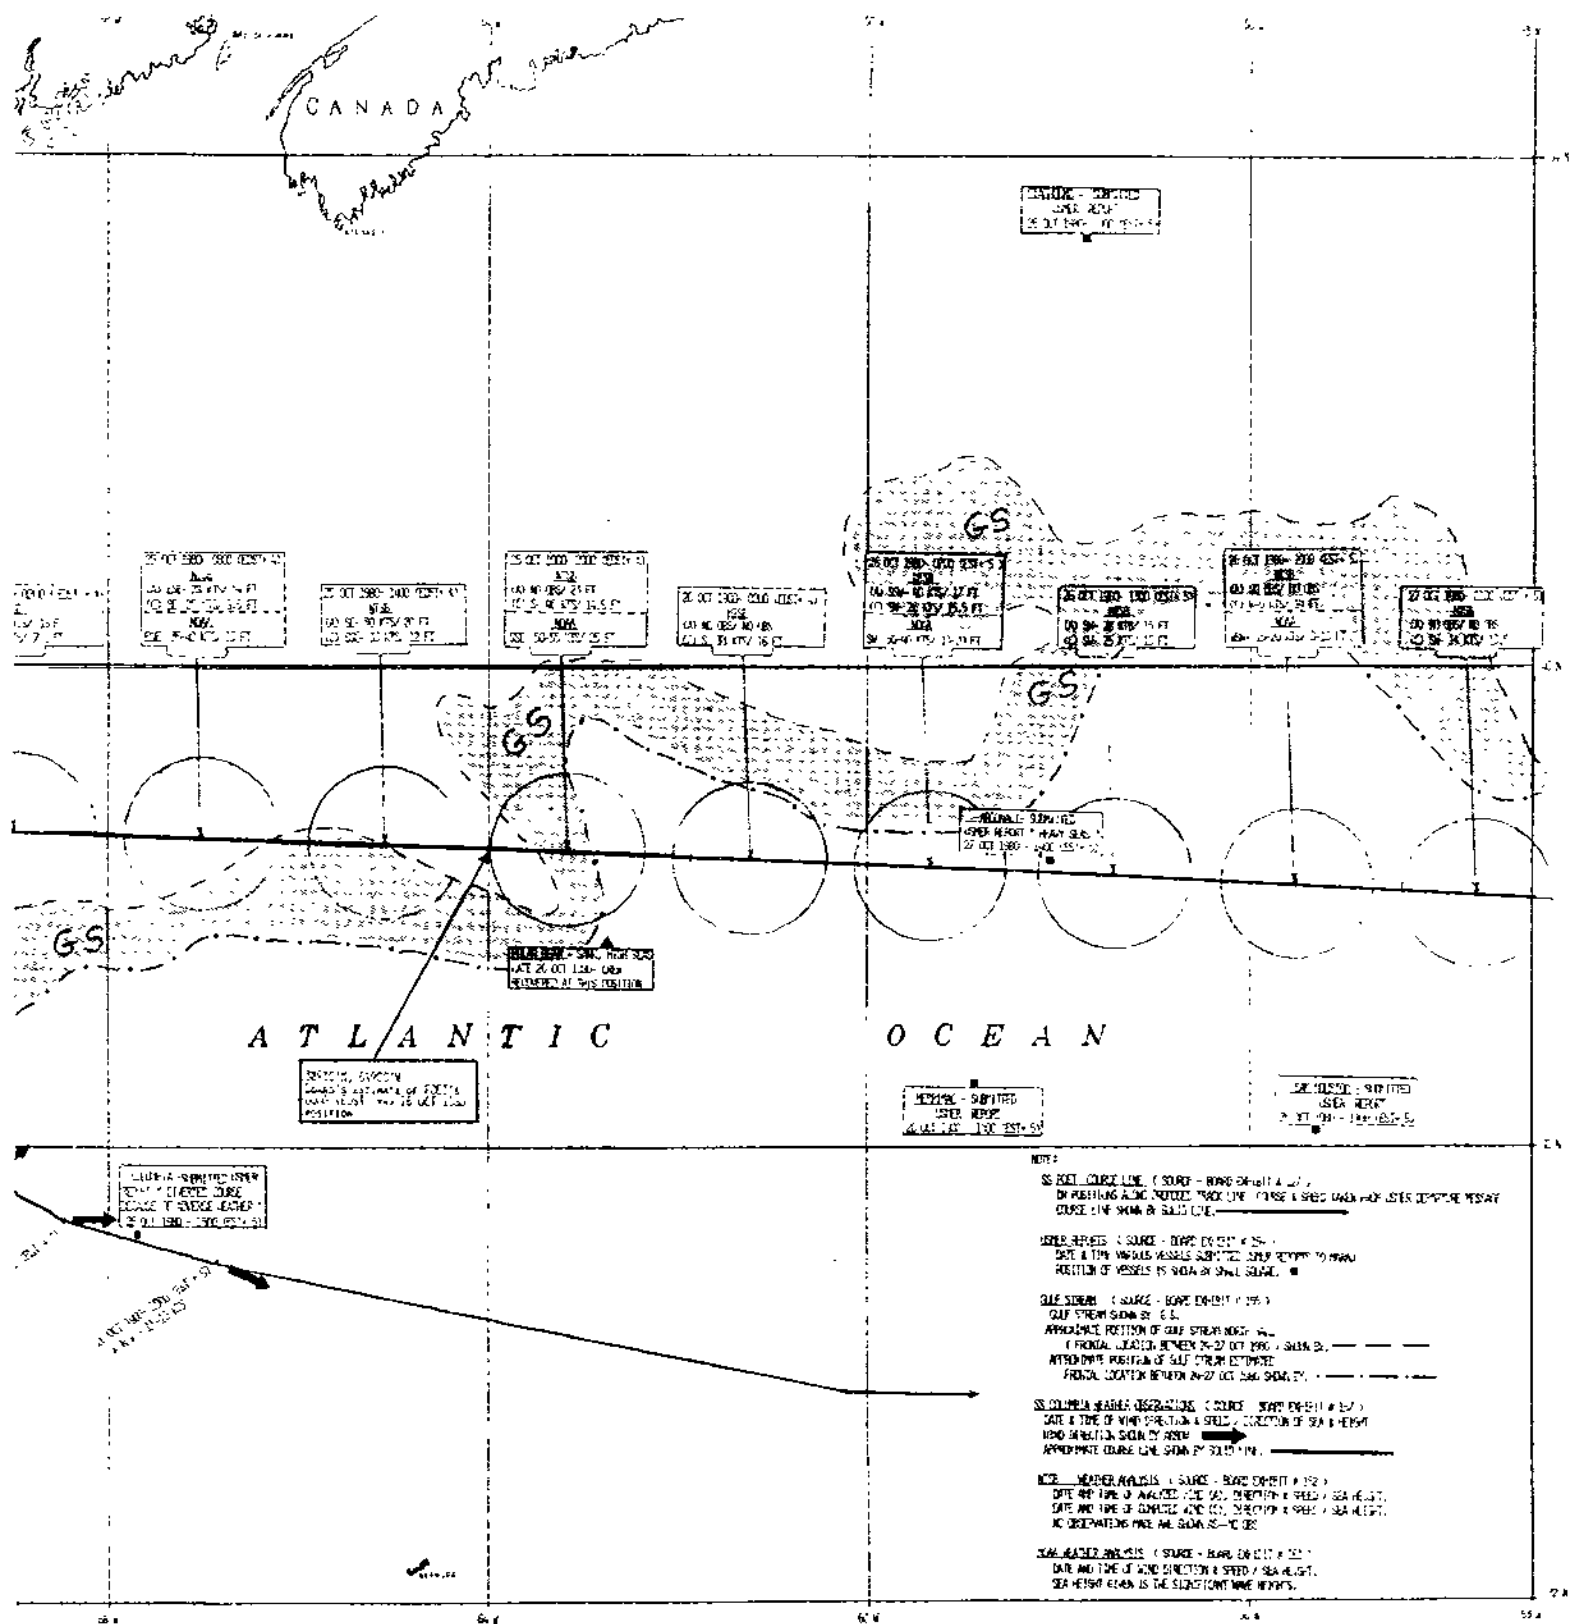
Figure 4 POET--Projected Track  
24-26 October 1980

Using information in POET's USMER departure message indicating the vessel intended to follow a rhumb line track from Cape Henlopen to Gibraltar at a speed of 15 knots, the Board constructed the projected track of Figure 4. Also shown in Figure 4 is information on estimated wind and sea conditions along the track from NTSB and NOAA analyses, estimated location of Gulf Stream North Wall, and weather and weather-related problems experienced by other craft in the area. After departure on the 24th, POET would have initially encountered winds of 20-25 knots and seas of 10 feet from directly ahead. These would have gradually increased and shifted to the southeast during the day on the 25th as the low pressure area moved up the coast. The vessel would have approached within 50-100 nautical miles of the northern edge of the Gulf Stream late on the 24th or early on the 25th, a region where the Navy North Wall advisories indicate wind and seas may be more severe than generally forecast. It appears likely that the vessel's speed would have been reduced from 15 knots to 5-8 knots in order to moderate increasing ship motions, but this speed reduction would not have changed the vessel's estimated time of arrival at its destination enough to require an update message to USMER.

Other vessels in the area at the time reported speed reductions due to heavy weather in regular USMER messages they submitted. The POET would have encountered the most severe weather conditions late on the 25th and early on the 26th as wind and seas shifted from south-southeast (broad on the starboard bow) around to the south and southwest (on the starboard quarter). With the effect of the North Wall, POET may have encountered winds of up to 60 knots and seas up to 30 feet somewhere in the vicinity of 38 degrees 30 minutes north latitude, 64 degrees west longitude (indicated on Figure 4) around midnight on 25 October 1980. It was at this time that an unidentifiable and incomplete auto alarm signal was received by radio station WMH in Baltimore. In addition, the next regular USMER message scheduled to be sent around 1200-1400 on 26 October 1980 was not received.
