# **MARINE CASUALTY REPORT**

**Capsizing and Sinking  
Of The  
MOBILE OFFSHORE DRILLING UNIT  
ROWAN GORILLA I  
In The North Atlantic Ocean  
On  
15 December 1988**

**U.S COAST GUARD  
MARINE BOARD OF INVESTIGATION REPORT  
AND  
COMMANDANT'S ACTION**

**REPORT NO. USCG 16732/02 HQS 92**

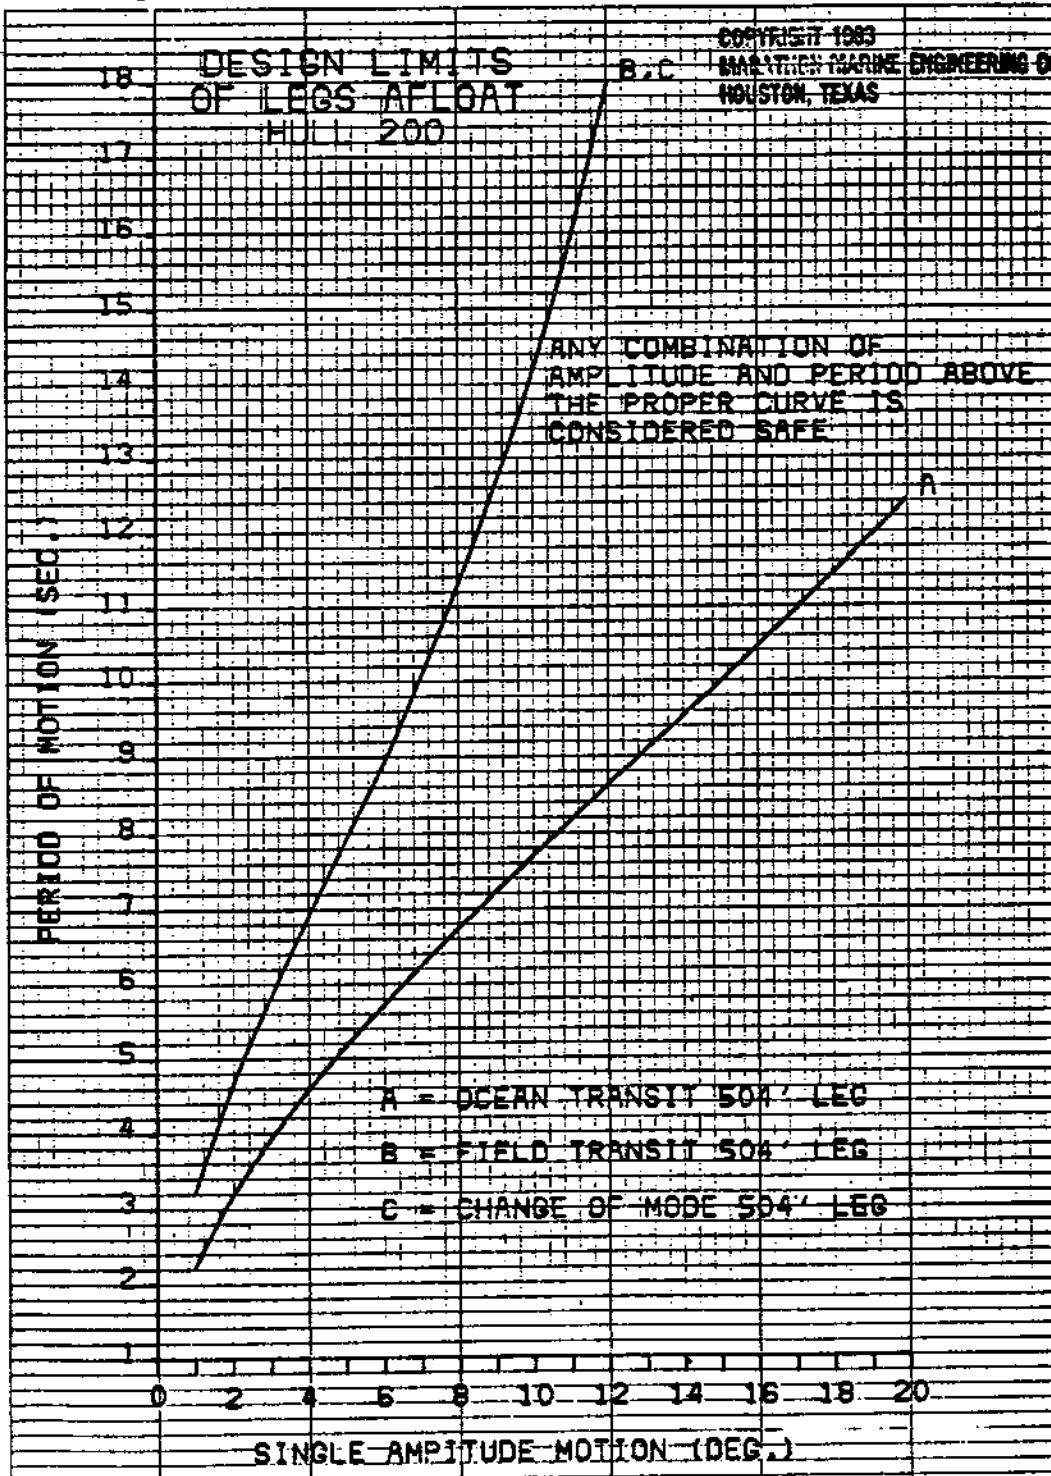
Figure 6

Page 13 of the ROWAN GORILLA I's operations manual is a graph (see figure 6) of the design limits of legs afloat. The curve marked A represents the maximum motions and period permitted for the legs during ocean transit. The combination of motions and period to the right of the line represent conditions that exceed design limits and will likely damage the legs and their supporting structure. The recorded rig motions from the evening of 14 December, to the time of the sinking, generally exceed the design limitations. As noted earlier, the legs were in the approved storm position during this time to limit (dampen) motions.
