M/V SANTA CLARA I

BOARD OF INQUIRY REPORT

CONCERNING THE LOSS OF HAZARDOUS MATERIALS

ON 3 JANUARY 1992

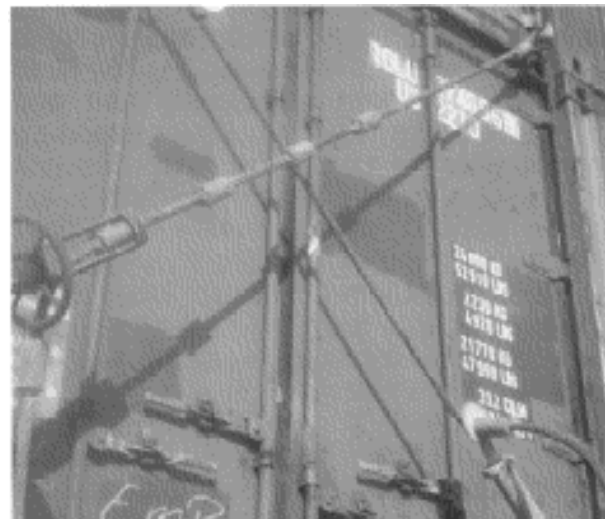
Two types of turnbuckles onboard SANTA CLARA I
(cylindrical claw on left; rigid hook on right)

Both types in use

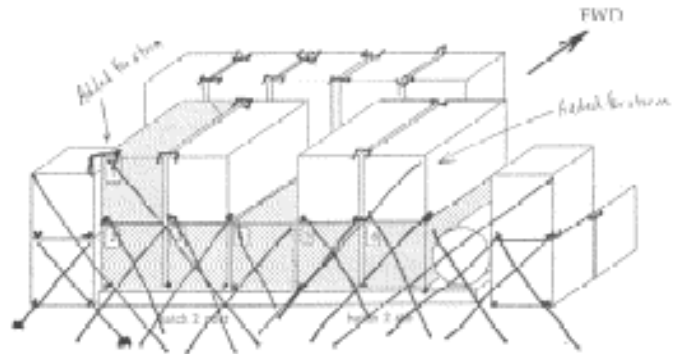
Lashing sketch by Bosun
(Arsenic trioxide containers are shaded)

During questioning, several of the crew sketched the lashing arrangements on #2 from memory. The sketches were remarkably consistent even in most minor details, showing a fairly standard "inside diagonal" lashing configuration, with four extra long lashings reportedly fitted for Heavy weather

An inherent weakness in this configuration is the stowage of 20-foot containers in the 40-foot spaces on both outboard sides. It leaves no room for lashing the abutting ends of the containers, which are separated by only about 3 inches. At the base they're resting on cones only. Essentially these containers are secured at one end only.

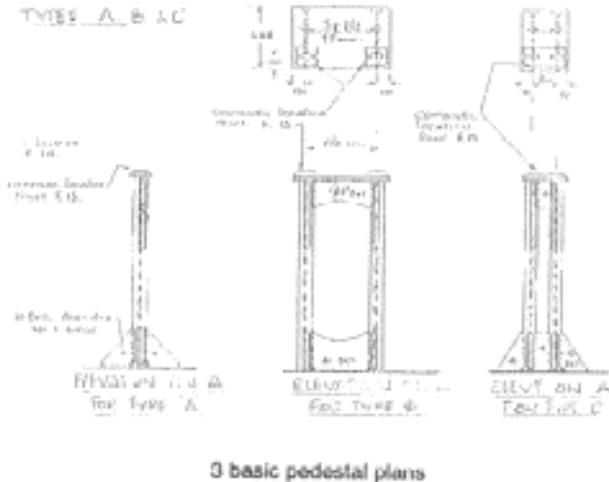
2) Only the middle two pedestals on the starboard side failed, with only a single

20-foot container spanning these. Both were double-width pedestals with double web frames. The weakest pedestal, with only a single web frame, didn't fail, yet supported a two-high stack and about twice the weight

3) Normal-to-deck forces were not enough to cause such failure in compression. In fact, the total downward forces on these two pedestals were substantially less with one container than under the simple static weight of two containers for which they were designed and often carried.

4) Transverse forces on these two pedestals in particular were also substantially less (over 50%) than the design condition of a two-high stack, and far less than with a three-high stack. The single 20-foot container was not tied to any inboard stack (a piece of machinery was stowed in that position, separately lashed), and therefore no additive loads were imposed.

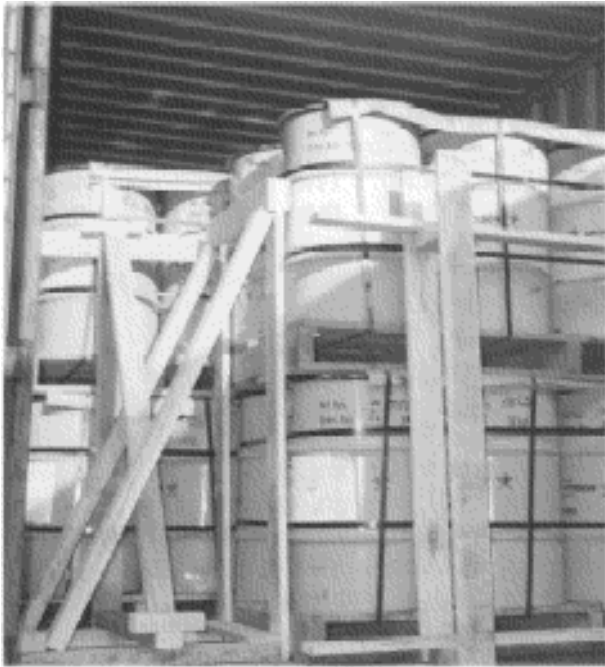
Review of the container packing certificates (which are recommended by the IMDG Code as prerequisite for accepting the containers for shipment, and which were available in this case), revealed no specific procedural problems in packing; the end-result, however, plainly argues the weakness of the overall blocking and bracing scheme used.

inside and belowdeck stowed arsenic container.

A few possible shortcomings were identified. First, palletizing the drums often results in too much void space across the container floor, making a tight stow more difficult. While palletizing cargo is generally more economical in terms of handling costs, drums in particular are more easily stowed in a tight, balanced arrangement individually.

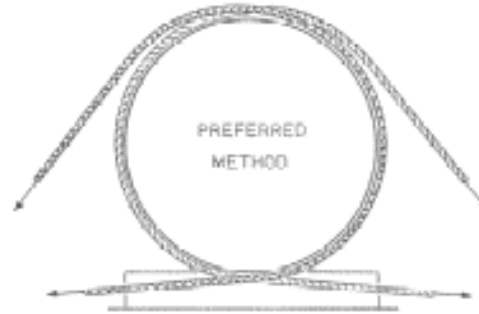
IMO guideline for securing heavy items

The weakness of this configuration is fairly evident. IMO guidelines for lashing this type of cargo unit (MSC Circular 530) specify that effective lashings are to be brought around the unit and both ends secured *at the same side*, to prevent transverse movement. The lashings depicted in the Chief Mate's drawing, in contrast, develop a sort of "rolling eye" in the wire as the cargo is permitted to shift short distances easily.

7.2 Lashings attached to lines without securing points should pass around the item, or a rigid part thereof, and both ends of the lashing should be secured to the same side of the unit (figure 2).
