# The Submarine Division of the Naval Safety Center Presents:

# FLASH

## Factual Lines About Submarine Hazards

December 2001 – January 2002

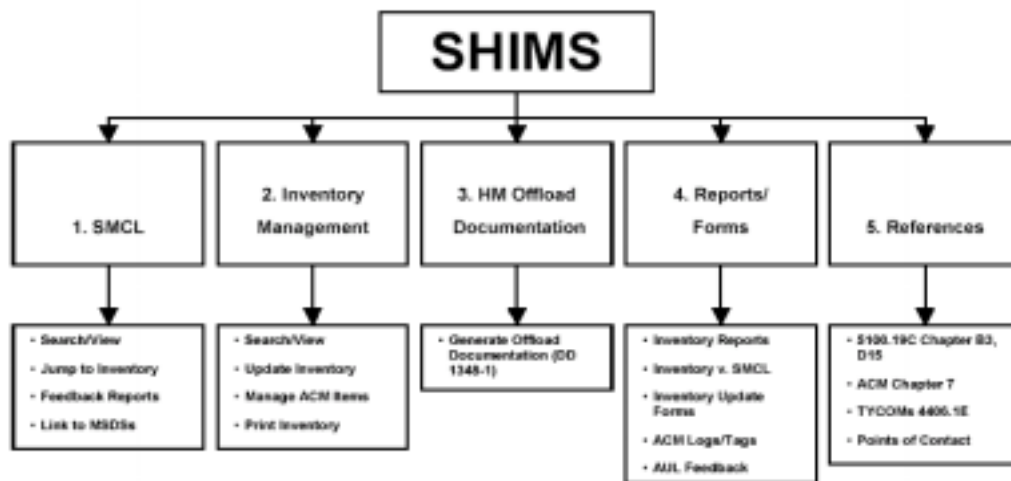
Figure 1: Submarine Hazardous Material Inventory & Management System Overview

COMSUBLANT and COMSUBPAC requested a standardized HMC&M tool be developed to help submarines meet the CNO/NAVSEA/TYCOM requirements. The submarine hazardous material inventory and management system (SHIMS) is the software tool designed by NAVSEA to fulfill those requirements. SHIMS is a Windows®-based application (meets IT-21 requirements) with standard look-and-feel familiar to most users. The database application provides five primary functions: submarine material control list (SMCL), inventory management, HM offload documentation, reports/forms, and references (see Figure 1).

- 1) **SMCL** - Allows screening of HM against the SMCL prior to procurement, and generates SMCL feedback reports (SFRs), if required.
- 2) **Inventory Management** - Tracks the types, quantities and stowage locations of HM on board submarines.
- 3) **HM Off-Load Documentation** - Assists user in completing DD Form 1348-1, DoD single line item release/receipt document.
- 4) **Reports/Forms** - Generates a variety of standard inventory reports, forms, and checklists.
- 5) **References** - Provides a ready online source of relevant HM guidance.

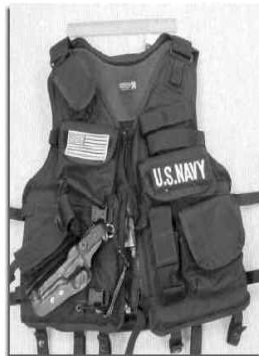
The tactical vest was never certified to be used for ballistic protection. In other words, *the tactical vest provides no ballistic protection! None!* COMSUBLANT 141709 JAN 02 (NOTAL) cancels COMSUBLANT 061709Z DEC 01 (NOTAL).

ALSAFE 003/02 (COMNAVSAFECEN 102000Z JAN 02) reports that NAVSEA has completed testing on the tactical vest's holster

and buoyancy fixes. Tactical vest modification kits will be delivered to the fleet by the fleet ILOs (Fleet CINCs will determine delivery priority). NAVSEA will be providing delivery information under separate correspondence.
