SAGAMORE HILL HOME OF THEODORE ROOSEVELT

Sagamore Hill National Historic Site
Oyster Bay, New York

Historic Structure Report

Building Conservation Branch, Cultural Resources Center
North Atlantic Region, National Park Service
U.S. Department of the Interior
Boston, Massachusetts

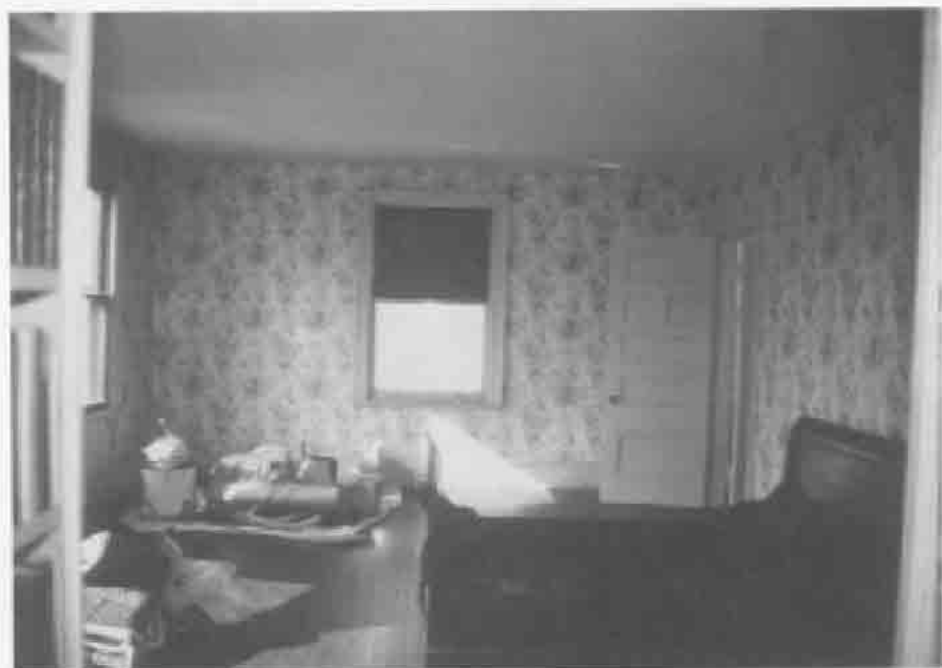
Gate Room: Before Restoration

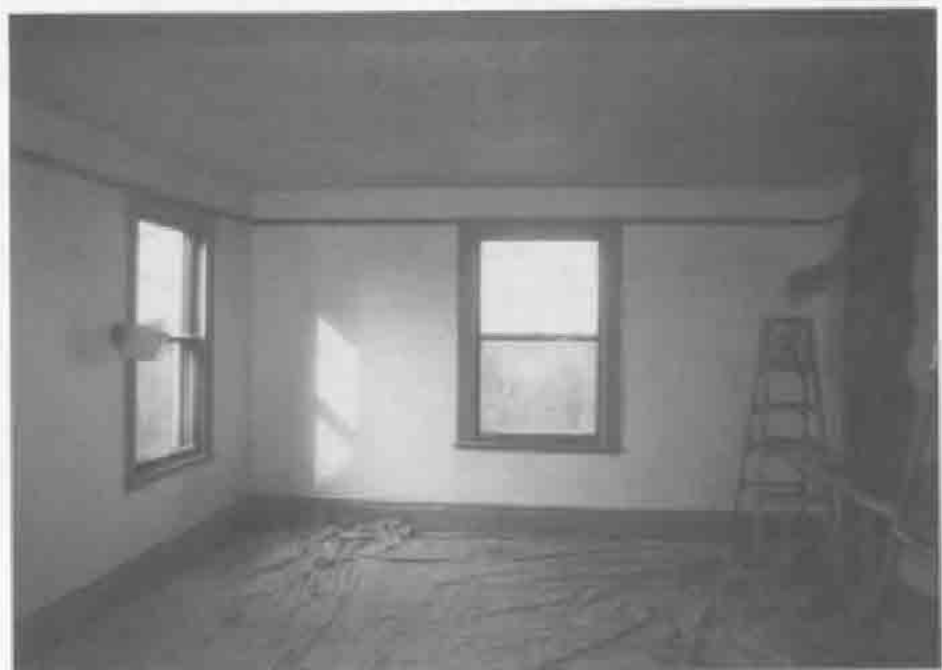
Gate Room: During Restoration (picture molding lowered, wallpaper removed).

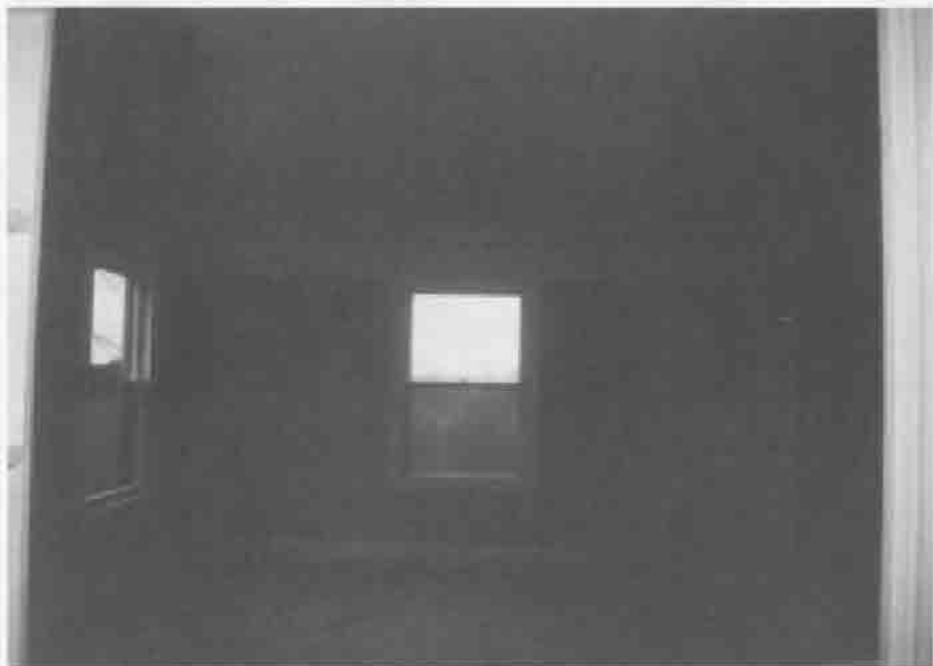
Gate Room: After Restoration

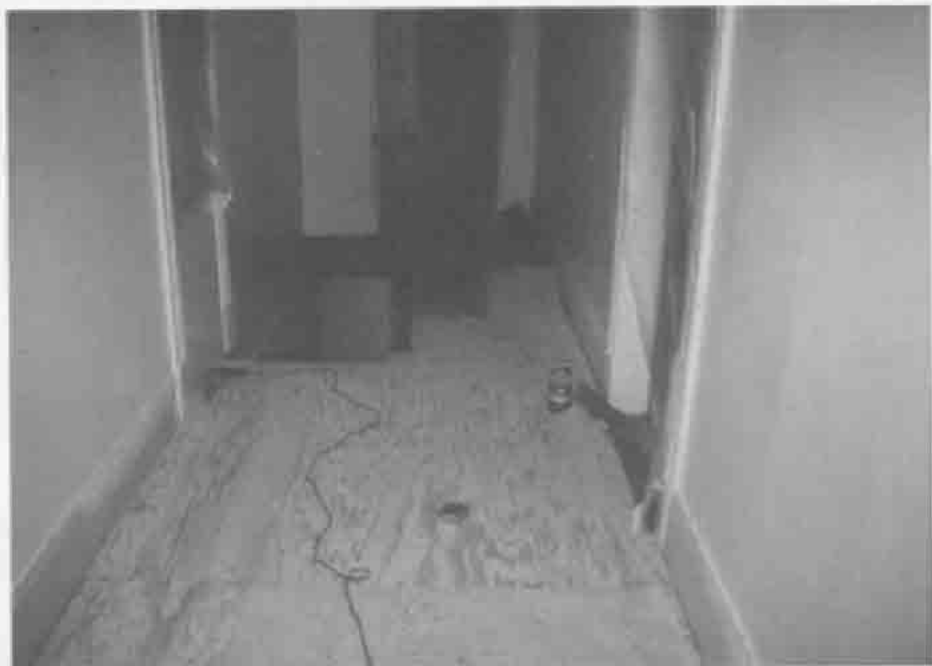
Third Floor Hall: Plywood Installed On Floor

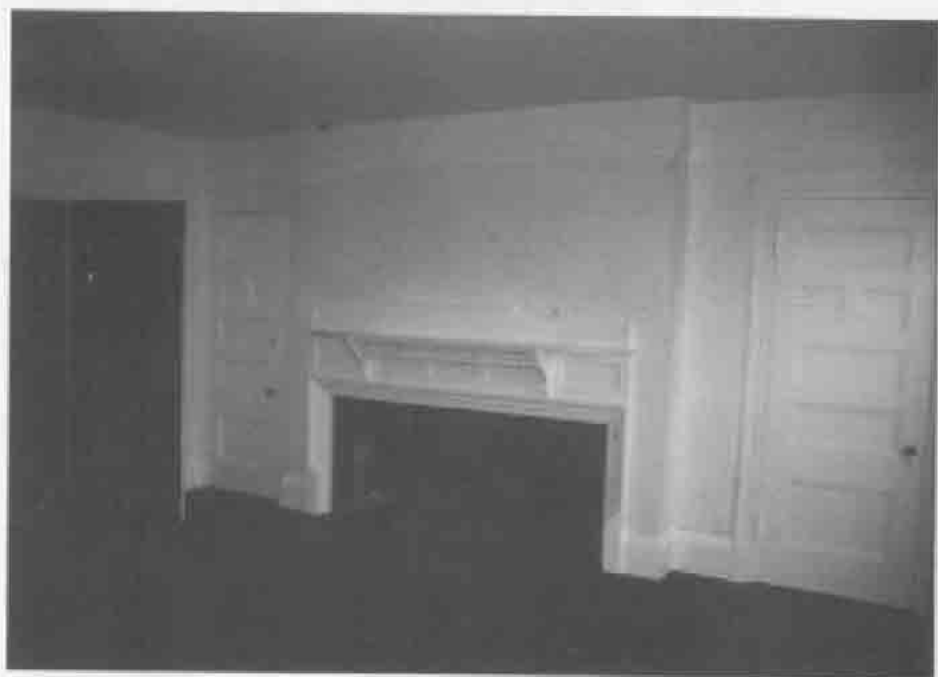
South Bedroom: After Restoration (ready for wallpapering).

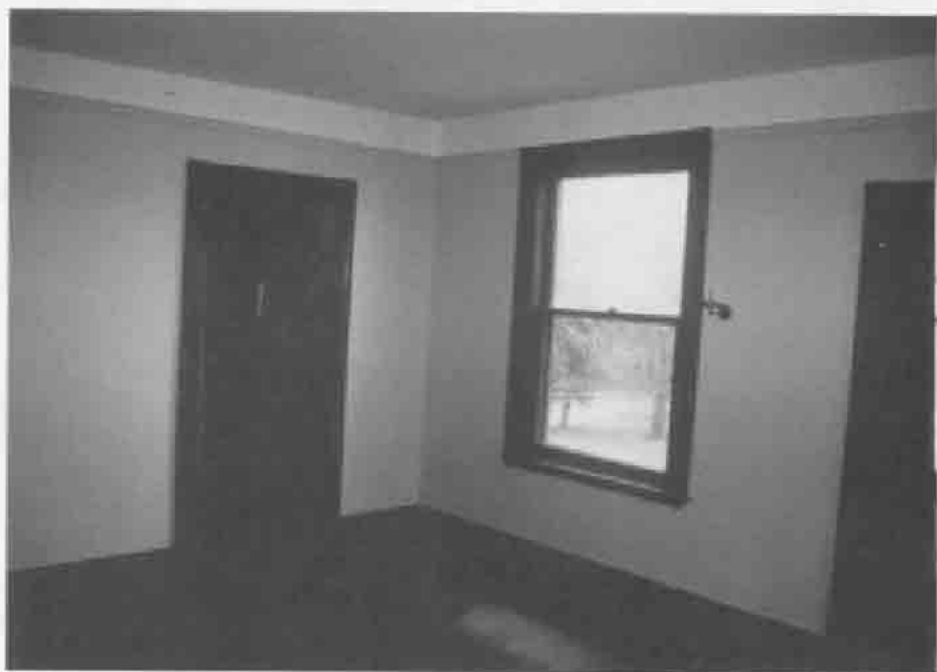
Nursery: After Restoration

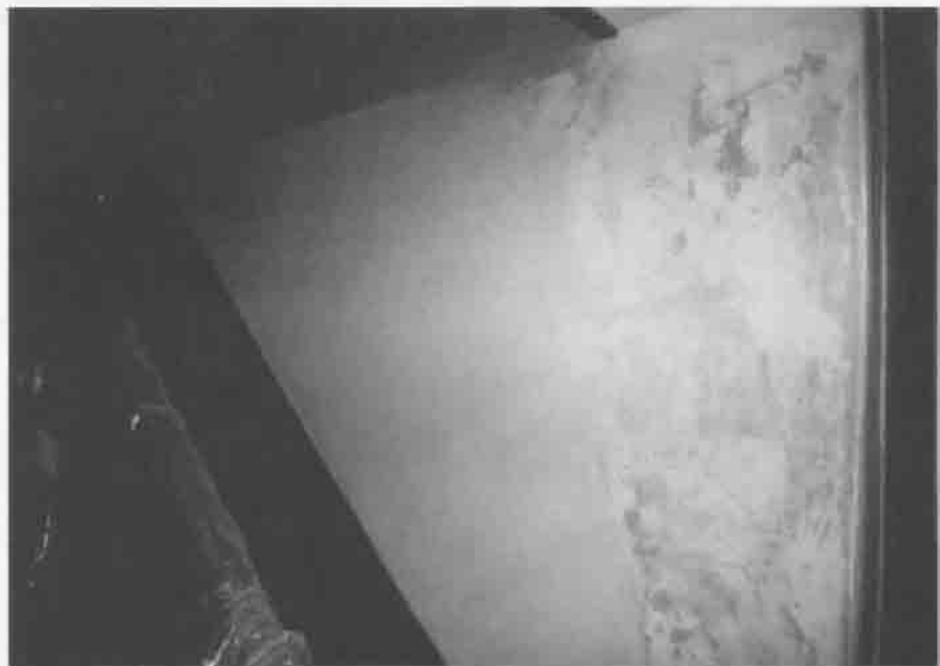
Second Floor Rear Hall Stairway: After Replastering

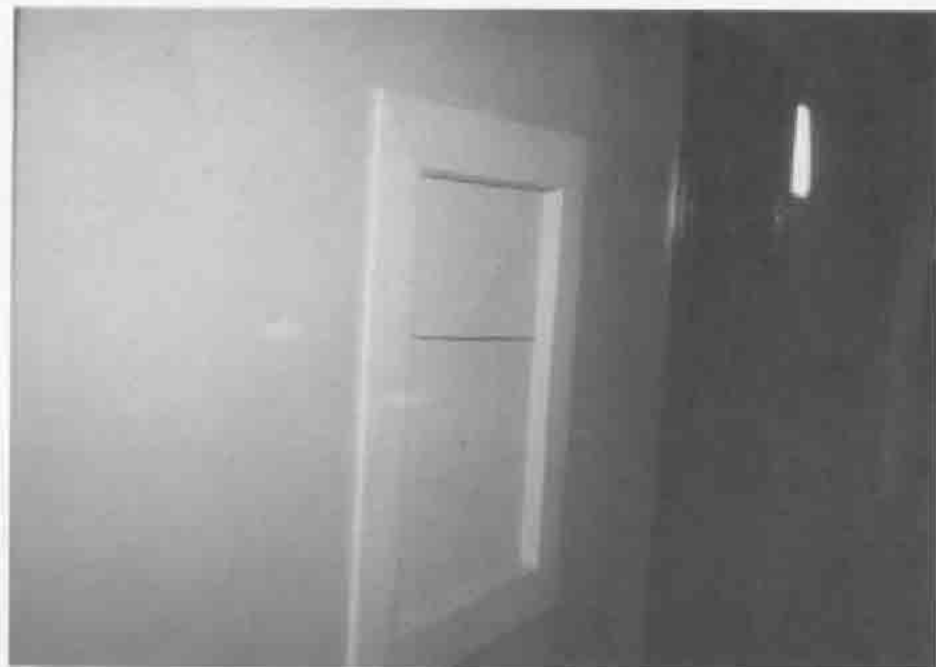
Typical Firebox Location in Hallway: Before Restoration

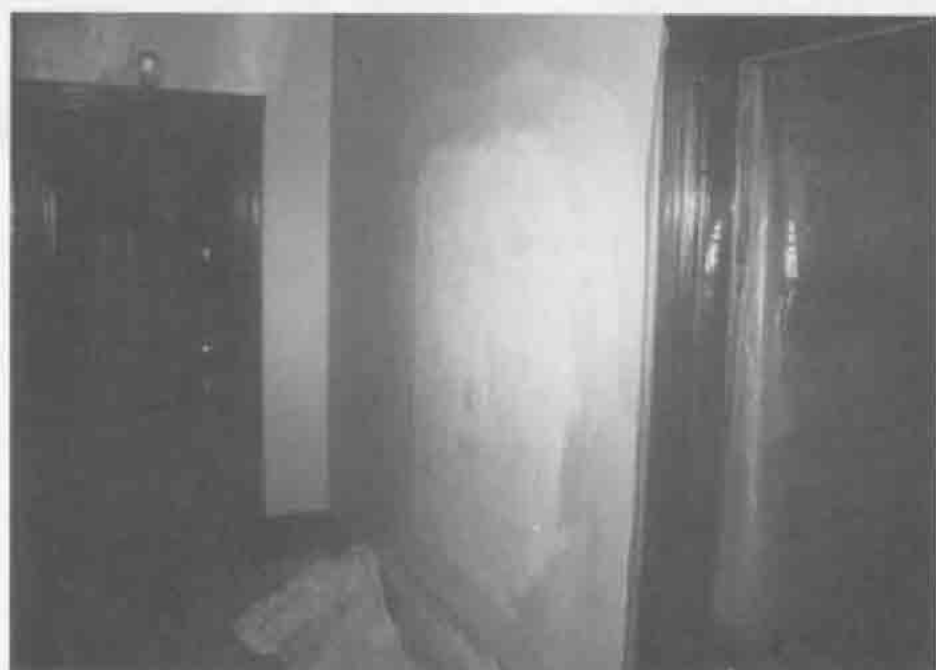
Typical Firebox Location After Removal and Replastering
