AIRCRAFT ACCIDENT REPORT

IN-FLIGHT ICING ENCOUNTER AND LOSS OF CONTROL
SIMMONS AIRLINES, d.b.a. AMERICAN EAGLE FLIGHT 4184
AVIONS de TRANSPORT REGIONAL (ATR)
MODEL 72-212, N401AM
ROSELAWN, INDIANA
OCTOBER 31, 1994

VOLUME II: RESPONSE OF BUREAU ENQUETES-ACCIDENTS
TO SAFETY BOARD'S DRAFT REPORT

COMMENTS OF THE BUREAU ENQUETES ACCIDENTS (FRANCE)

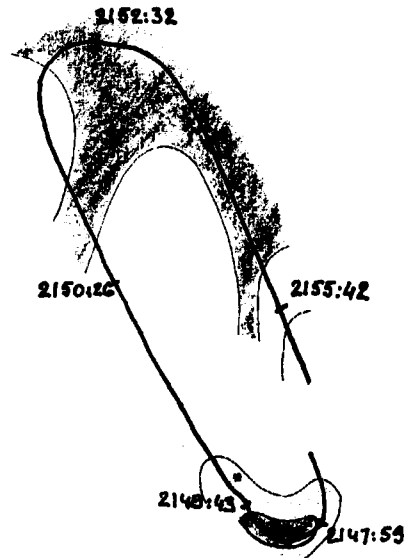
APPENDIX 14

Calculation of the time spent by the ATR 72 in precipitation leads to a cumulative time of almost 24 minutes, out of a total time of more than 30 minutes in such conditions in the holding pattern, with Static Air Temperature varying between -2 and -4 °C (Total Air Temperature between +1.5 and +3.5 °C). This duration is based on precipitation echoes detected on the weather radar in the area of the holding pattern of the aircraft, which means, by deduction, drop size diameters detected of about 100µm or more (see appendices 11 to 14).

PRECIPITATION ECHOES IN THE HOLDING PATTERN (WEATHER RADAR REFLECTIVITIES)
