**Loss of Pitch Control on Takeoff
Emery Worldwide Airlines, Flight 17
McDonnell Douglas DC-8-71F, N8079U
Rancho Cordova, California
February 16, 2000**

Aircraft Accident Report
NTSB/AAR-03/02

**National
Transportation
Safety Board**
Washington, D.C.

**NTSB/AAR-03/02
PB2003-910402
Notation 7299A
Adopted August 5, 2003**

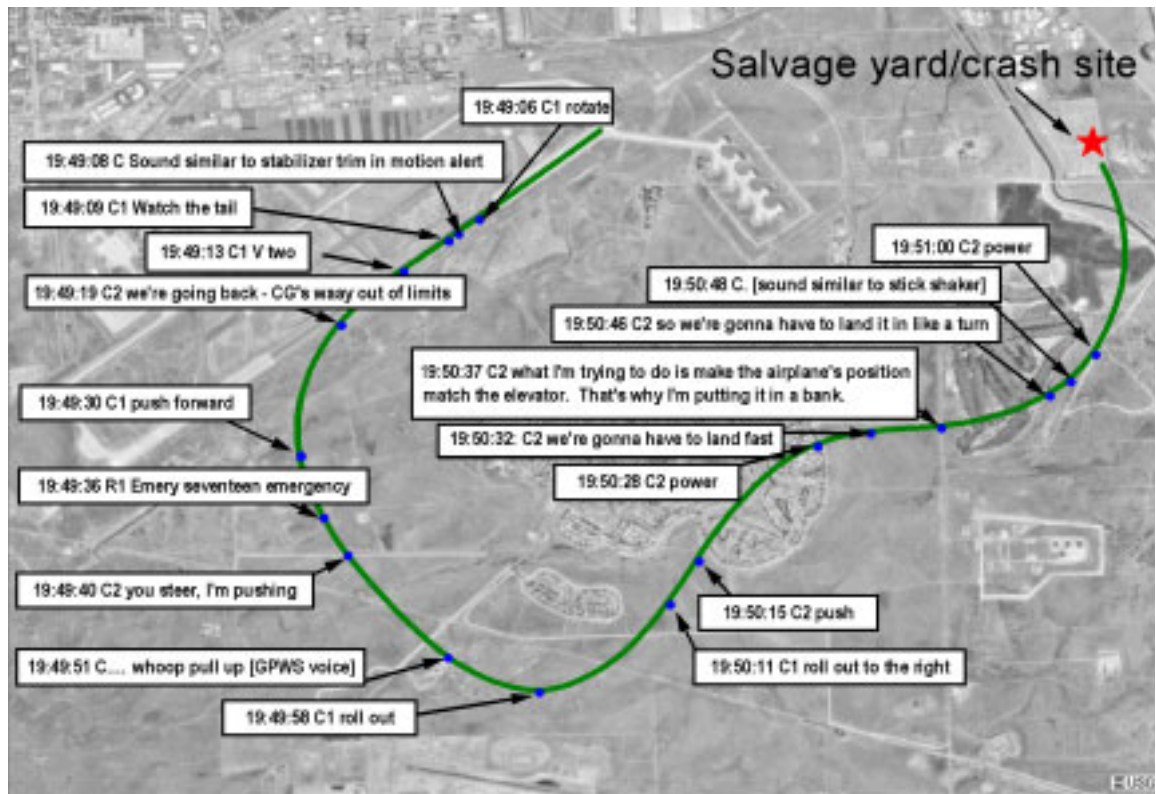
The airplane impacted the ground in a left-wing-low, slightly nose-up attitude in an automobile salvage yard, about 1 mile east of the departure runway. Figure 1 shows the airplane’s ground track, with selected CVR comments, during the accident flight. (For additional information regarding CVR comments, see the CVR transcript in appendix B).

Figure 1. The airplane’s ground track, with selected CVR comments, during the accident flight.

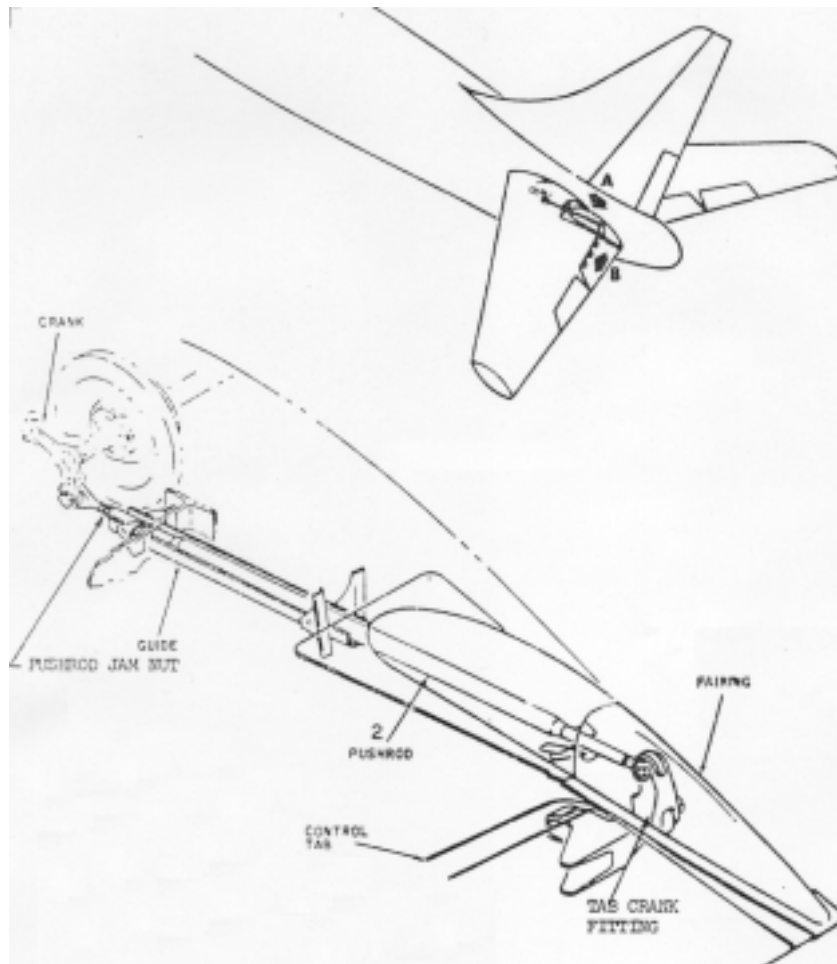
Each elevator control tab is hinged to the inboard trailing edge of the associated elevator surface, then connected by a mechanical linkage (including a crank fitting, pushrod, and bellcrank assembly) at the inboard edge of the tab to the flight control system on that side of the airplane. Figure 2 is a diagram of the elevator control tab installation. The elevator control tabs are in their neutral position when they are in line with the elevator surfaces and should have a maximum TEU deflection of $8.5^\circ \pm 0.5^\circ$ and a maximum TED deflection of $26.5^\circ \pm 0.5^\circ$ from that neutral position.

Figure 2. A diagram of the elevator control tab installation.

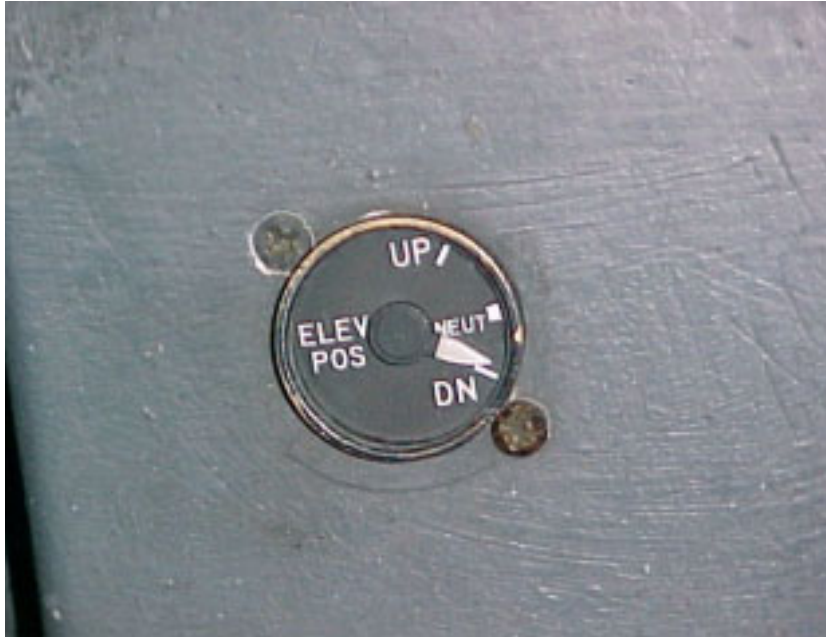
The DC-8 EPI is a 1-inch diameter circular cockpit gauge with a pointer needle and index markings for UP, DN (down), and NEUT (neutral) positions to indicate the position of the elevators. When the EPI is properly calibrated, the up index mark should correspond to the maximum TEU elevator surface position of 27° and the down index mark should correspond to the maximum TED elevator surface position of 16.5° TED. A narrow white band adjacent to the NEUT index mark indicates an elevator surface position between 0° and 5° TEU. Figure 3 is a photograph of an EPI gauge similar to that on the accident airplane.

Figure 3. A photograph of an EPI gauge similar to the gauge installed on the accident airplane.

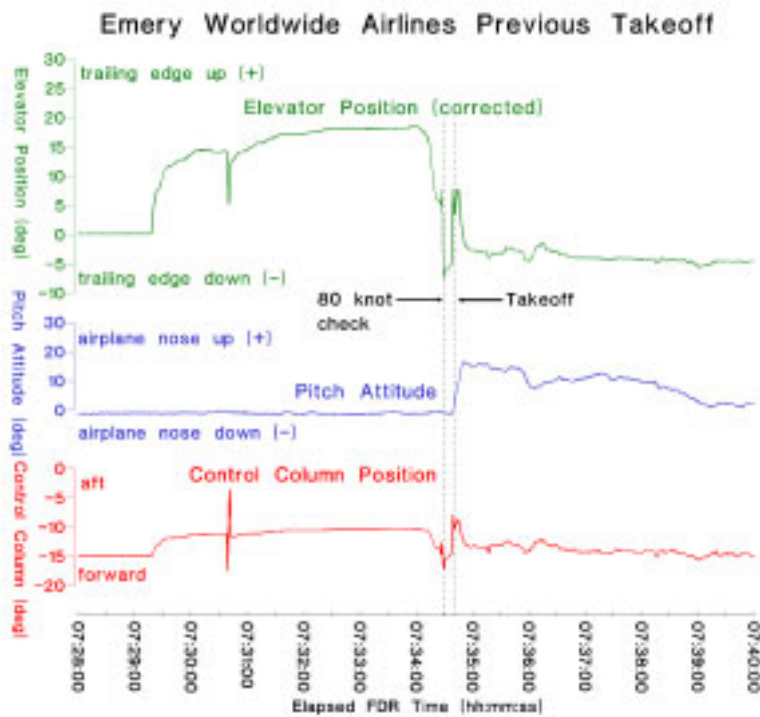
Figure 8. Pitch attitude, control column position, and (corrected) elevator position FDR data for the previous takeoff from RNO. About the first 1 minute 20 seconds of data were recorded while the gust lock was engaged.
