**Hazardous Materials Accident
Failure of an Anhydrous Ammonia
Nurse Tank**

Calamus, Iowa, April 15, 2003

DCA-03-MZ-001

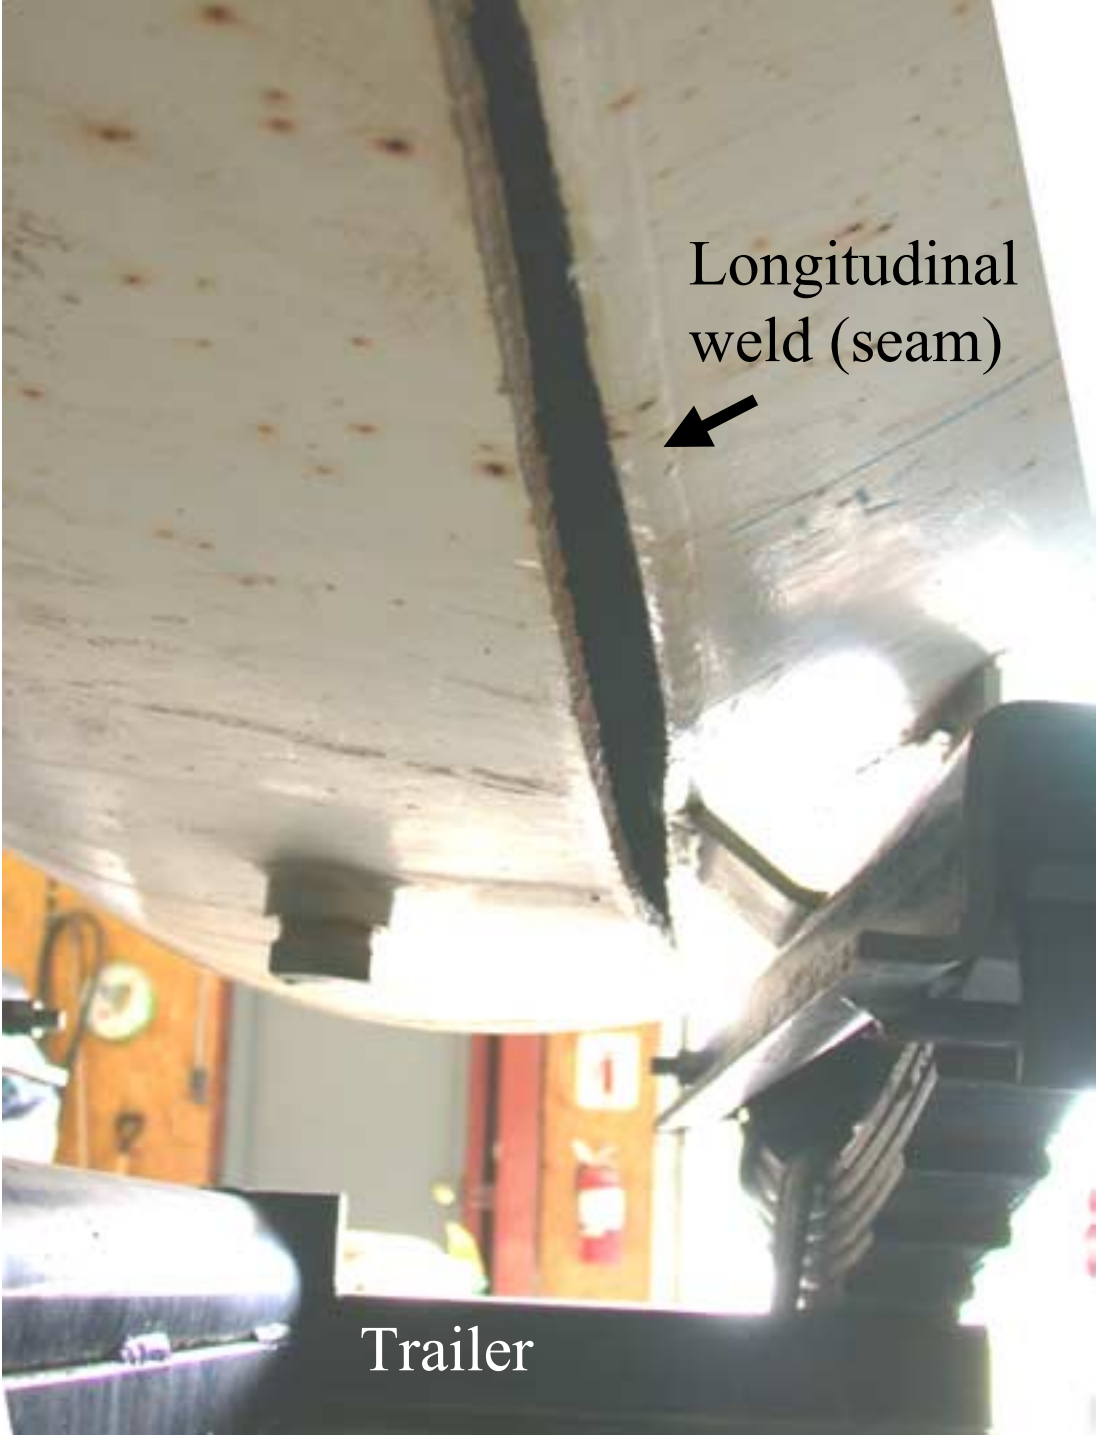
Longitudinal
weld (seam)

Underside of
the nurse tank

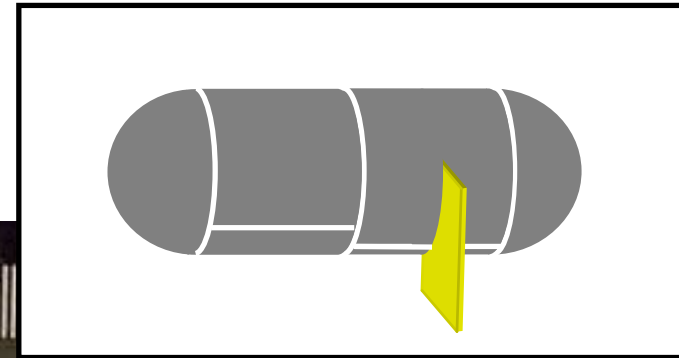
Fracture Cross-Section

Fractured region

Uncracked region

- The unfused area and offset weld bead weakened the tank wall.
- Misalignment of the shell surfaces and the large angle weld bead increased the stresses in this area.

- A crack extended from the unfused area of the weld, probably during the manufacturing proof pressure test.
- The crack grew by fatigue under normal operating loads until the tank failed.
