Lessons Learned From the Construction of Upgrades to the NASA Glenn Icing Research Tunnel and Re-Activation Testing

David W. Sheldon, Charles R. Andracchio, and Thomas M. Krivanek
Glenn Research Center, Cleveland, Ohio

Major upgrades were made in 1999 to the 6-ft by 9-ft (1.8 m by 2.7 m) Icing Research Tunnel (IRT) at the NASA Glenn Research Center. These included replacement of the electronic controls for the variable-speed drive motor, replacement of the heat exchanger, complete replacement and enlargement of the leg of the tunnel containing the new heat-exchanger, the addition of flow-expanding and flow-contracting turning vanes upstream and downstream of the heat exchanger, respectively, and the addition of fan outlet guide vanes (OGV's).

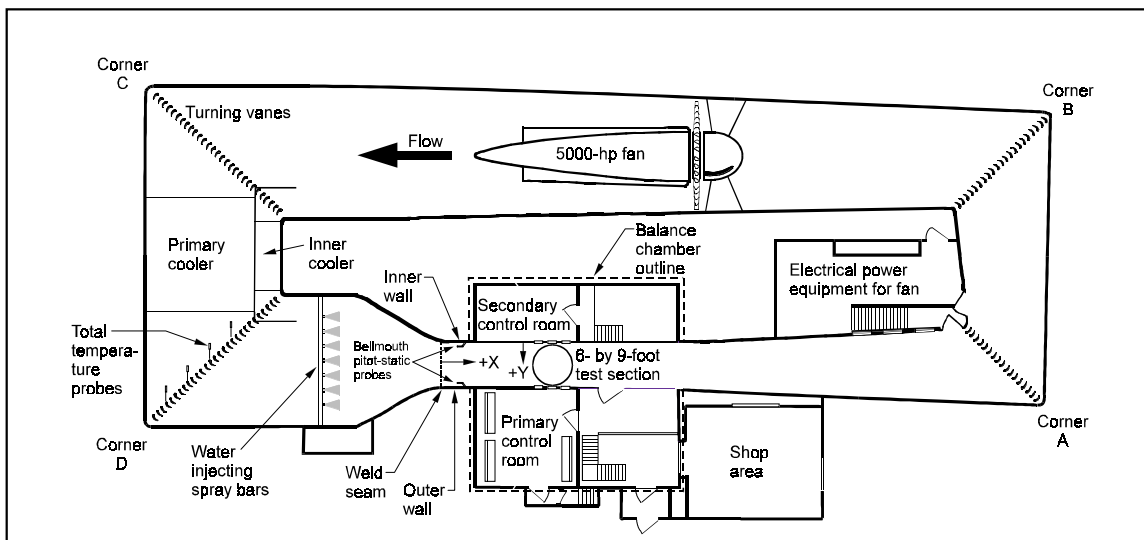
Figure 1.—Loop configuration of the IRT before the 1999 modifications.

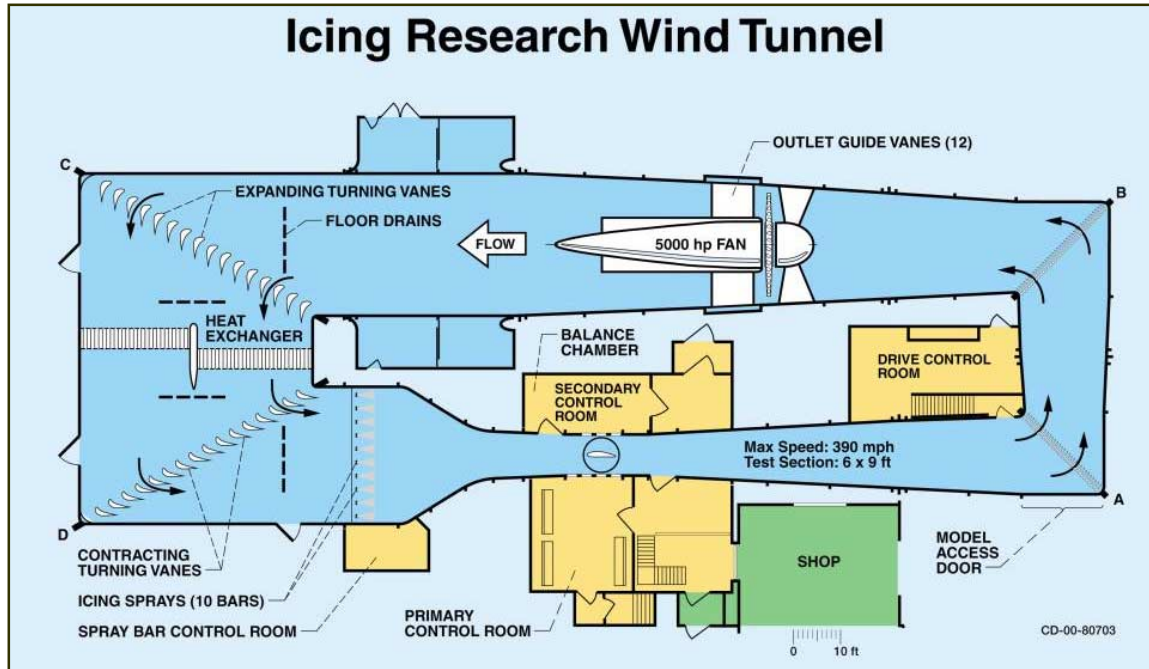
Figure 4.—Loop configuration of the IRT after the 1999 modifications. The width of the new C-D leg has been increased 69 percent to accommodate a flat heat exchanger, new turning vanes have been installed in Corners C and D, and new outlet guide vanes have been installed around the fan motor housing. The electronic controls in the drive control room have also been replaced.

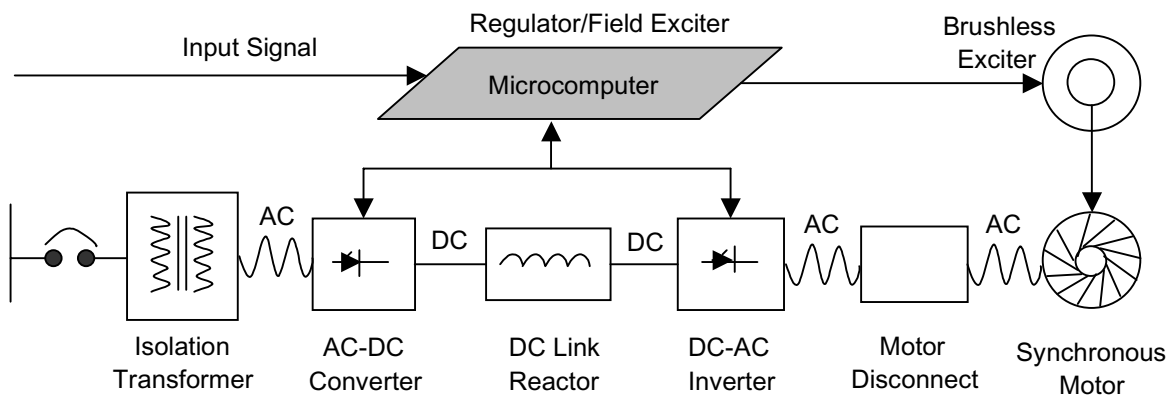
Figure 5.—Block diagram representing the various components and functions of the IRT Varichron drive system. Only the obsolete microcomputer was upgraded during this program.

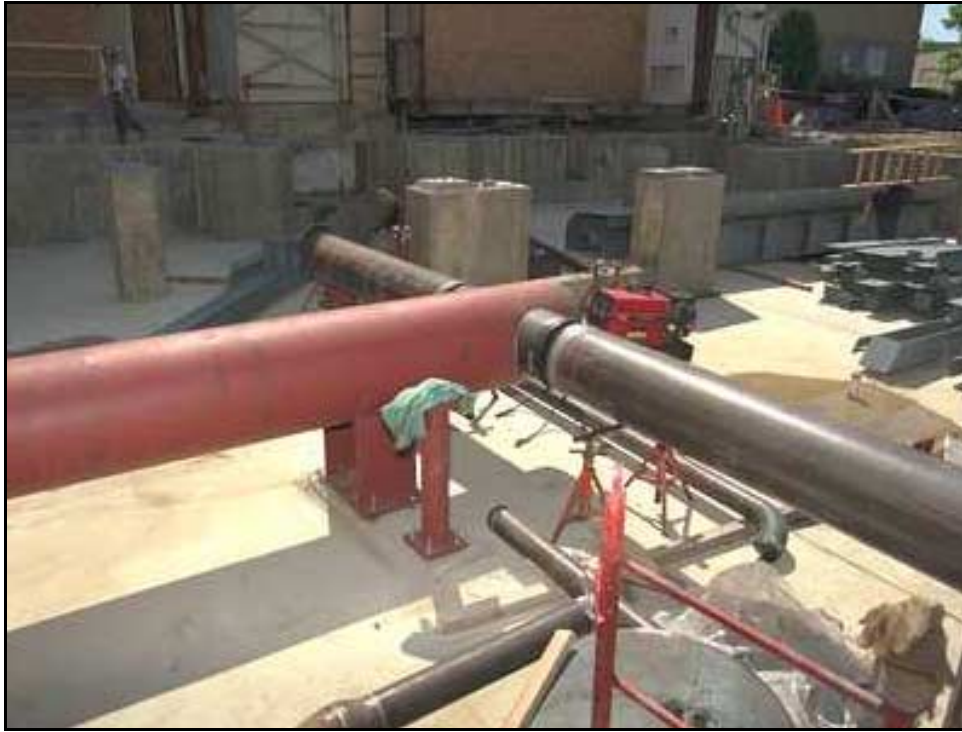
Figure 8.—Foundations for the new basement under the C-D leg. Main coolant supply and return pipes are in the foreground. (C-99-1599)

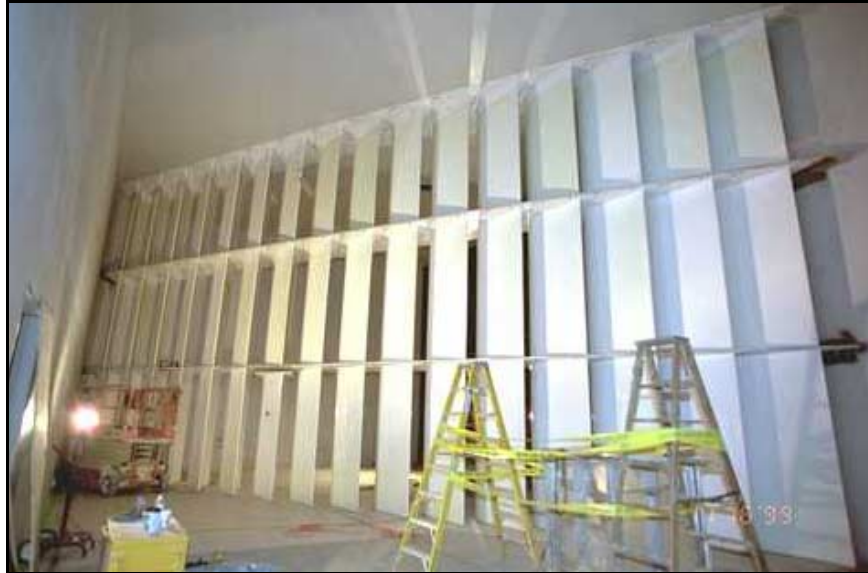
New cascades of turning vanes were installed in Corners C and D, each consisting of 16 hollow fiberglass airfoils 26.2 feet (7.98 m) in span and oriented vertically. As shown in **Figures 9, 10, and 11**, these vanes were fabricated in three sections and tied together by horizontal fiberglass plates. The tie plates were anchored to the tunnel's inner wall to help carry the lateral airloads on the turning vanes. These custom-designed turning vanes expand the flow in Corner C and contract the flow in Corner D, and their unique aerodynamic shapes make them relatively insensitive to incoming flow angles.⁵ The large size of the flow paths between vanes permits personnel access to either face of the HX, for inspection and repair work.

Figure 10.—View from the Stilling Chamber, looking upstream at the Corner D turning vanes. The lower segment of the seventh vane from the corner is removable, to provide access to the heat exchanger for a maintenance lift vehicle. (C-99-2285)

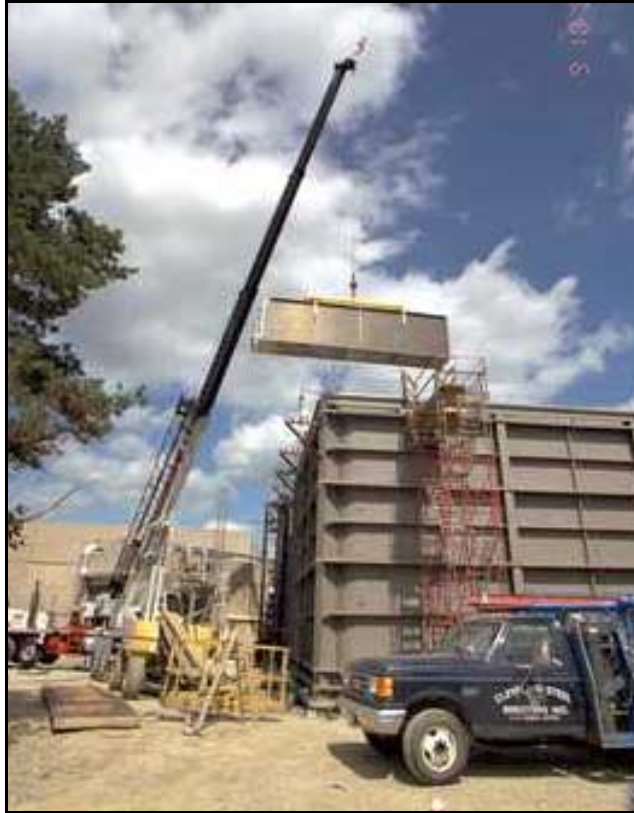
The replacement heat exchanger, located in the new C-D leg, presents a flat surface to the airflow, in order to eliminate the flow distortions caused by the "W" shape of the original HX. The new HX consists of eight identical modules stacked in two sets of four, to form two separate units. **Figures 12 to 15** show the installation of the new HX modules. Each module is divided into three zones in the flow direction, and each zone has its own supply and return headers for the coolant, R-134a. Coolant tubes run horizontally from a secondary supply header at the tunnel wall to mid-tunnel and then turn 180 degrees and back to a secondary return header. The units are offset from one another as shown in **Figures 5 and 14**, to permit inspection and maintenance of the U-fittings welded onto the ends of the coolant tubes at mid-tunnel.

Figure 12.—Construction of the new Corner D and placing of one of the eight heat exchanger modules.
(C-99-1997)

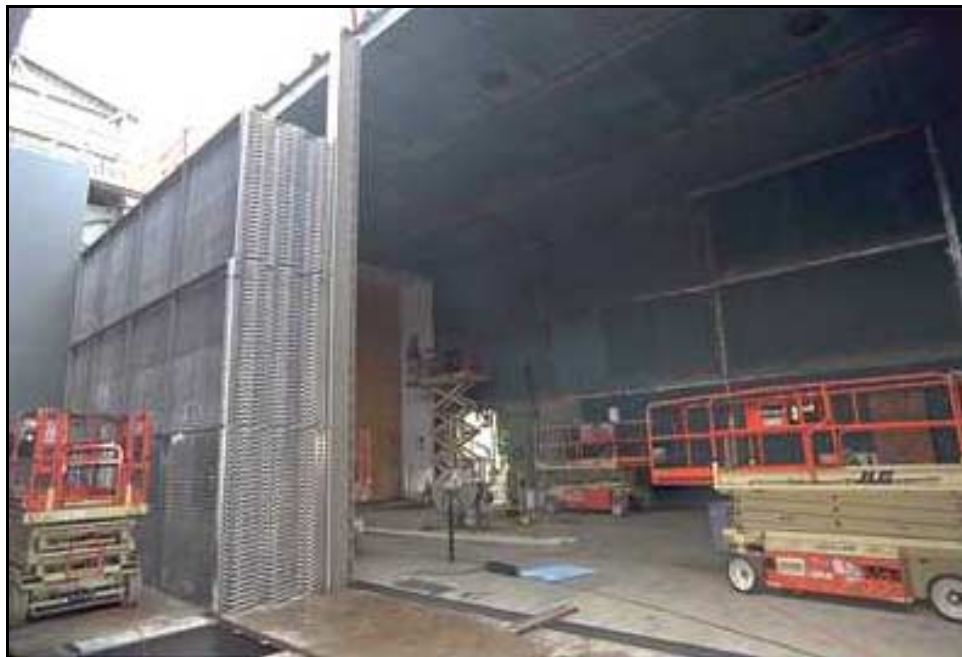
Figure 13.—Interior view of the new Corner C during construction, with three heat exchanger modules in place. The end turns in the aluminum coolant tubes indicate the locations of the three streamwise zones in each module. The coolant flow in each zone can be controlled independently, to minimize temperature variations in the outflow. (C-99-2005)

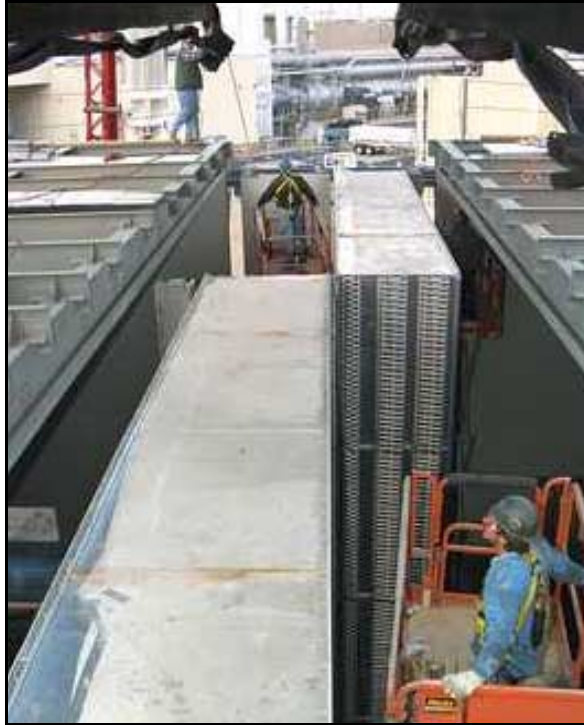
Figure 14.—View through the roof of the new C-D leg, showing the offset positions of the two heat exchanger units. The end turns in the coolant tubes are readily accessible for inspection and repair, without loss of active flow area for a corridor between units. (C-99-2178)

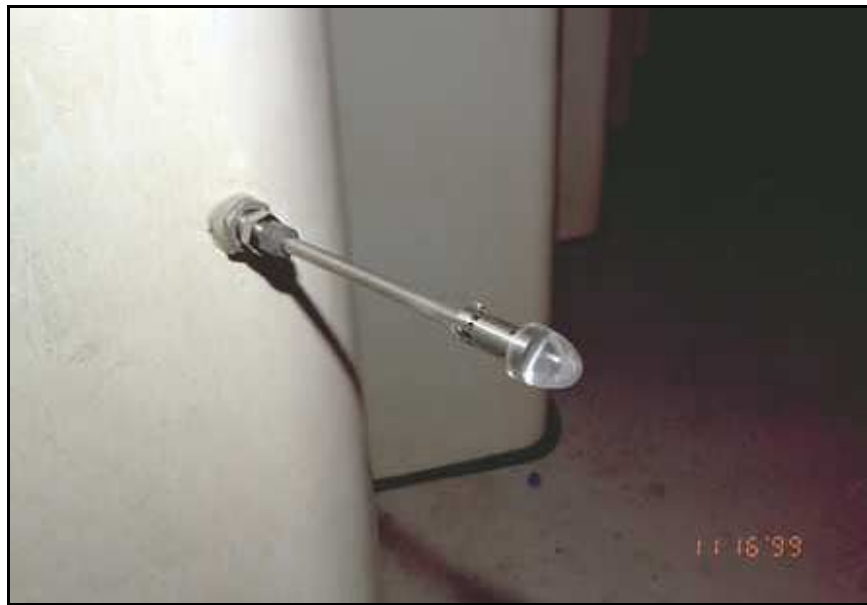
the leading edges of the fiberglass turning vanes, as shown in **Figure 16**. Sixteen probes were installed on the Corner C turning vanes, with two probes at the mid-elevation of each HX module. Twenty-four thermocouple probes were installed on the Corner D turning vanes, with three at the mid-elevation of each HX module. Each probe contains two Type T thermocouples for redundancy. One signal goes to the WDPF tunnel control system computer and the other goes to the Glenn ESCORT data acquisition system.

Figure 16.—Typical thermocouple probe mounted on the turning vanes in Corners C and D. Probes point directly upwind and contain two Type T thermocouples. The nosepiece protects the thermocouple from ice and water, and the tubular sheath has holes that admit air at near-zero speed for accurate measurement of total temperature. (C-99-2438)

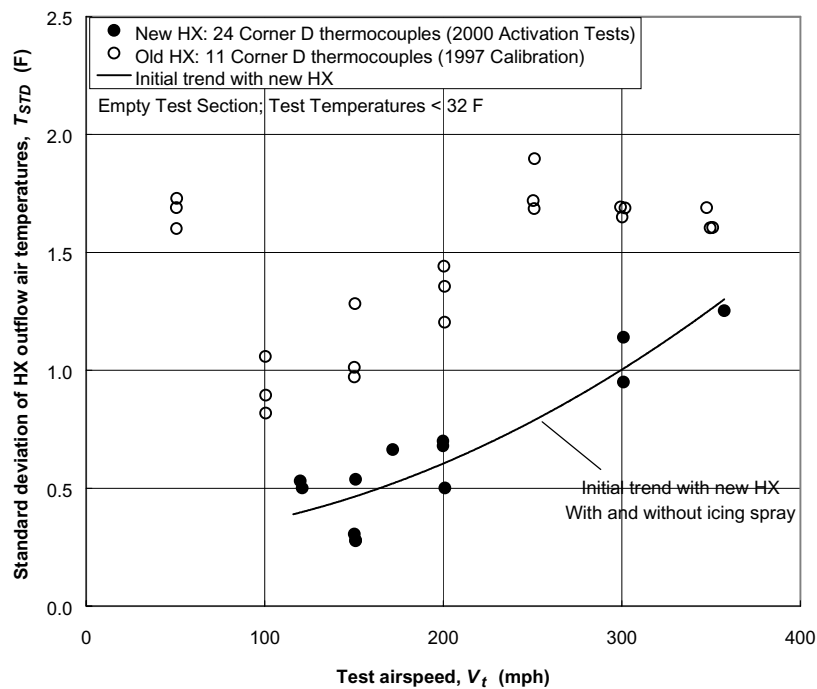
Figure 19 illustrates the improvements obtained in air temperature uniformity with the replacement HX. In this chart, the standard deviation of air temperature measured downstream of the HX, at the entrance to Corner D, is plotted versus the test airspeed. Deviations are approximately 0.6 F (0.3 C) less with the new HX than with the old, which is a reduction of approximately 50 percent at a test airspeed of 200 mph (89 m/s). Therefore, all PRVs were placed in a full-open condition pending their removal during a future

Figure 19.—Improvement in the uniformity of temperature in the outflow of the replacement heat exchanger, compared with the original heat exchanger. The standard deviation of the temperatures measured with the array of thermocouples in Corner D is used as the measure of uniformity.

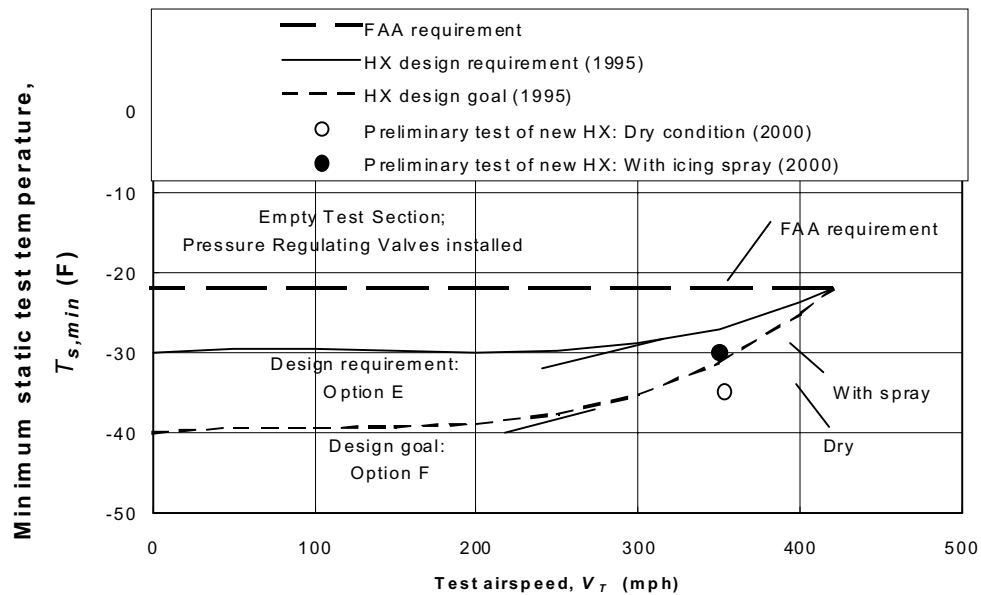
Testing of the current low-temperature capability of the IRT was begun, but has now been postponed until the remotely controlled coolant valves have been removed, because this should improve the results of the tests. **Figure 20** shows the preliminary low-temperature data obtained with the PRVs in place and fully open. In this chart the minimum static temperature attainable is plotted versus the test airspeed. The FAA requirement of -22°F (-30°C) is shown, together with the design requirement for the new HX (Option E) and a more ambitious design goal (Option F). These options represent upper and lower bounds on low-temperature test data measured in 1995 with the original W-shaped HX in operation. The test data shown in the figure are at an airspeed of 350 mph (156 meter/s) with all pressure regulating valves in place, with and without an icing spray.

Figure 20.—Preliminary lowest-temperature data obtained with the pressure regulating valves in place and fully open.

4. Remote control of individual cooling zones in the replacement heat exchanger is not required for temperature uniformity downstream. Remote control pressure regulating valves can be removed from the system, reducing the coolant pressure drop through the heat exchanger and increasing maximum coolant flow rates.

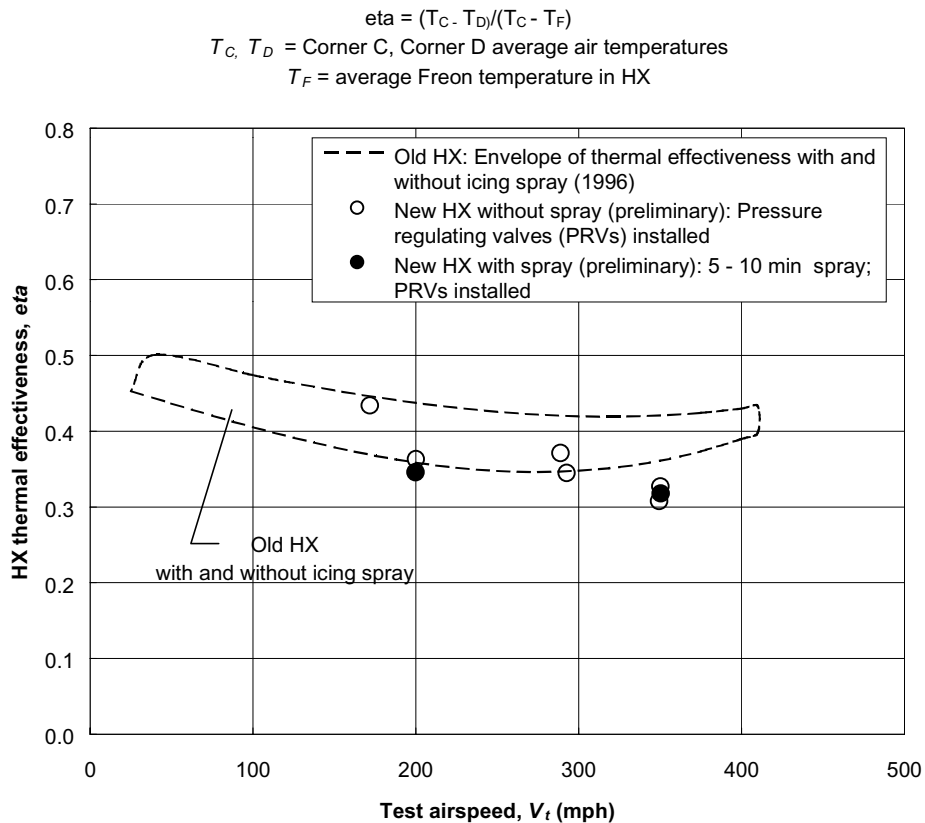
A quantitative measure of the cooling performance of a heat exchanger is its *thermal effectiveness*, defined as the ratio of the drop in air temperature across the HX to the difference between the inlet air temperature and the internal coolant temperature. In **Figure 21** some preliminary data on the thermal effectiveness of the new HX are compared with performance data for the original HX. As expected, the higher face (inlet) airspeeds into the new HX reduce its thermal effectiveness somewhat, compared to the W-shaped HX with its much lower face speeds for the same test airspeed. However, these preliminary data still indicate that the performance of the new HX under icing test conditions will meet design requirements and may be close to the design goal shown in **Figure 20** after the 24 PRVs are removed.

Figure 21.—Preliminary comparison of the measured thermal effectiveness of the new HX with that of the original HX.

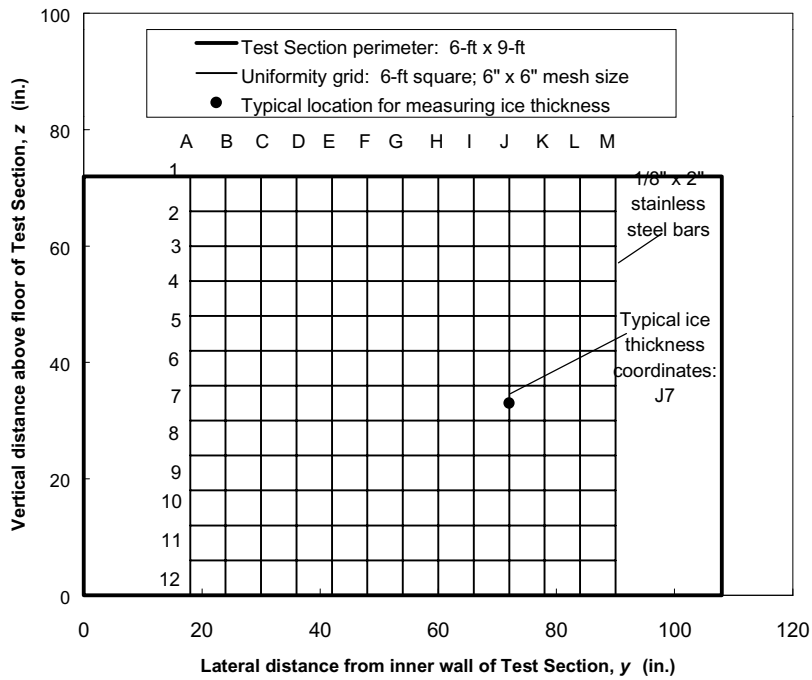
Calibration of the uniformity, droplet size, and liquid water content of the icing cloud was a major element of the activation program, consuming almost 60 percent of the activation operating time. Because of the major changes made to the quality of the airflow entering the spraybar section of the tunnel, hundreds of spray nozzles were repositioned to obtain the maximum uniformity of ice accretion in the Test Section.⁸ Icing uniformity was assessed by measuring the thickness of ice deposited on a grid of steel bars with a spacing size of 6 in. by 6 in. (152 mm x 152 mm). **Figure 22** is a layout of this uniformity grid and the nomenclature

Figure 22.—Layout of the grid of steel bars used to measure the uniformity of ice accretion in the IRT Test Section.

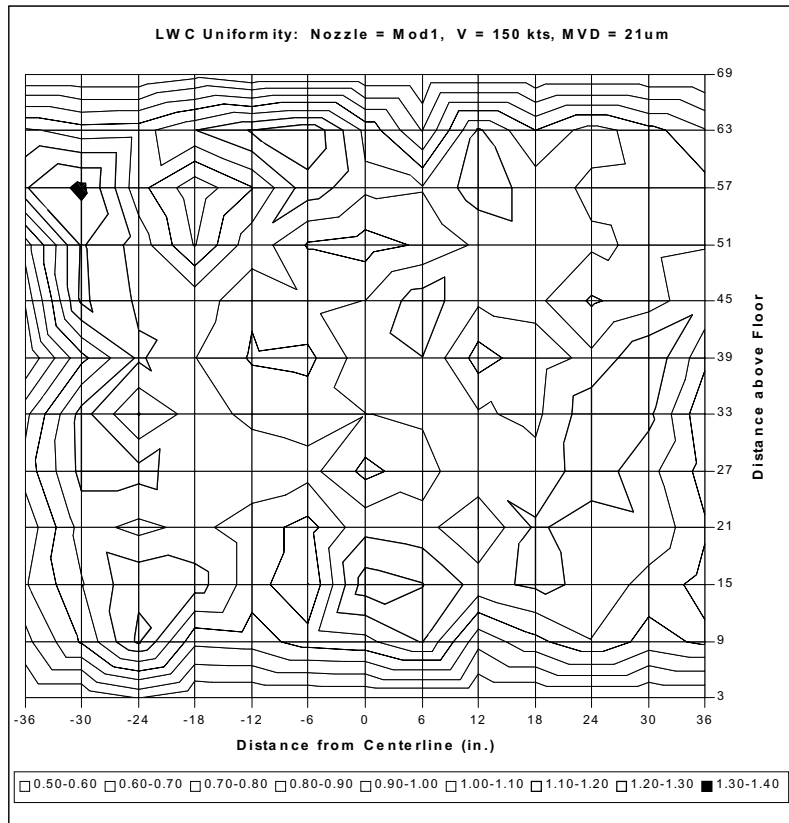
used to record ice thickness data. **Figure 23** is a typical contour plot of the variability of ice accretion across the Test Section, expressed as deviations of local thickness from the average thickness.

Figure 23.—Typical contour plot of the variability of ice accretion across a 6-ft by 6-ft (1.8-m by 1.8-m) zone in the middle of the Test Section.

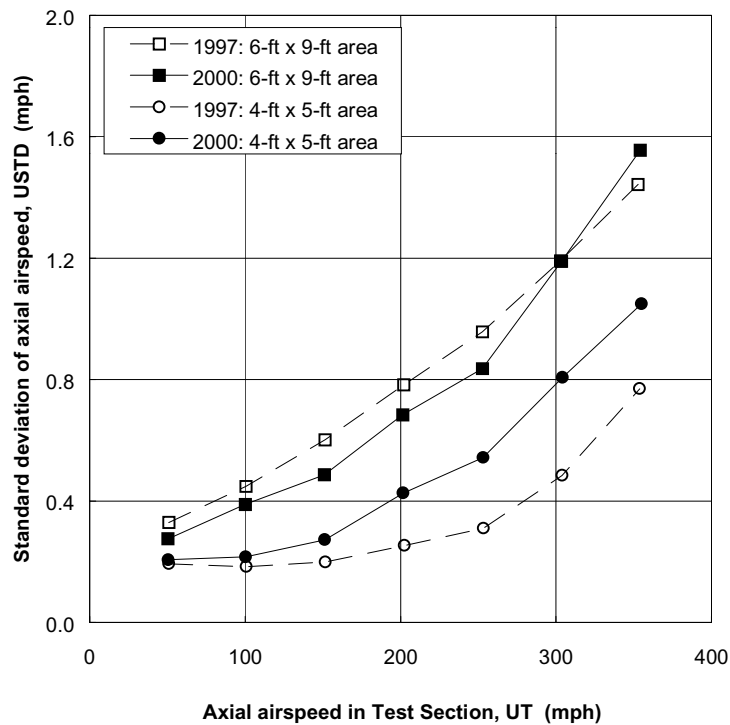
Figure 24.—Standard deviation of axial airspeed in the middle of the Test Section, as a function of the test airspeed. Airspeed deviations in the modified IRT are compared with measurements made in 1997.

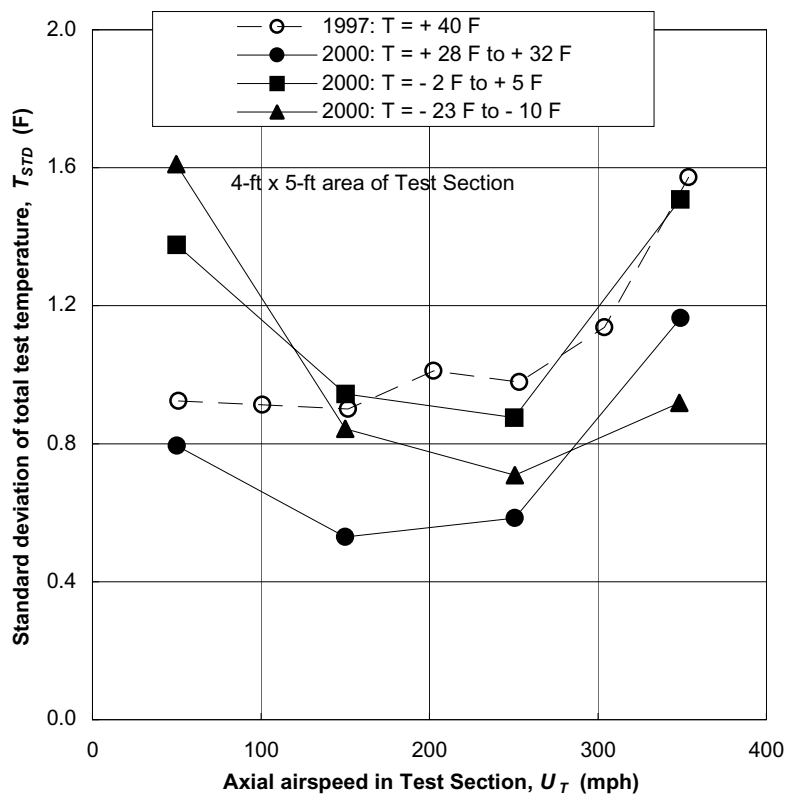
Figure 25.—Standard deviation of total test temperature in the middle of the Test Section, as a function of the test airspeed and temperature. Temperature deviations in the modified IRT are compared with measurements made in 1997.
