OPERATING EXPERIENCE SUMMARY

U.S. Department of Energy
Office of Environment, Safety and Health
OE Summary 2004-19
October 4, 2004

1. INADEQUATE EQUIPMENT ISOLATION RESULTS IN ELECTRICAL SHOCK

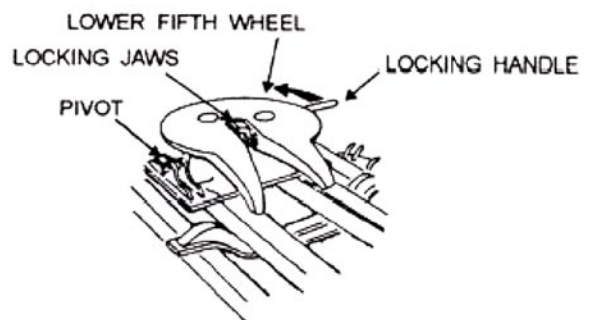
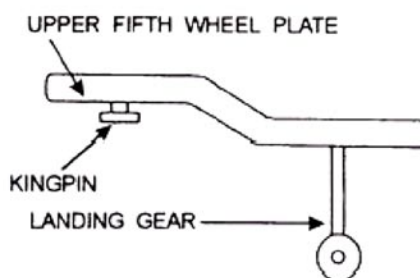
Figure 2-1. Diagrams of lower and upper fifth wheels

A tractor and trailer are joined together by a fifth-wheel coupling, which consists of two metal plates: the lower fifth wheel, which is mounted on the tractor; and the upper fifth wheel, which is mounted on the trailer (Figure 2-1). The upper fifth wheel consists of a flat plate and a kingpin. The lower fifth wheel has locking jaws that lock around the kingpin to connect the tractor and trailer. The two parts, locked together, allow rotational and vertical movement between the tractor and trailer.

trailer came to rest on the right-side wheels of the tractor and the trailer's right landing gear. The LLW packages remained on the trailer, and there was no release of material and no personnel injury. An investigation disclosed that the driver failed to ensure that the fifth-wheel coupling was fully engaged. (ORPS Report RFO--KHLL-TRANSOPS-2004-0003)

Investigators determined that the kingpin (shown in Figure 2-2) was probably not fully engaged and locked during the coupling procedure. They believed that the trailer was likely too high when the coupling procedure was initiated. This allowed the fifth wheel latch to engage but not completely grasp the kingpin. In effect, the kingpin was resting on a lip within the fifth-wheel latch and was not completely secured. This condition allowed the operator to think that the coupling was completed. When the operator accelerated from a dead stop, the trailer kingpin lifted out of the fifth-wheel latch and the trailer slid off the tractor and fell to the pavement.
