FACE 88-06: Plumber Falls to His Death Through a Roof opening

On October 30, 1987, a 24-year-old plumber died when he fell 22 feet through a skylight opening to a concrete floor.

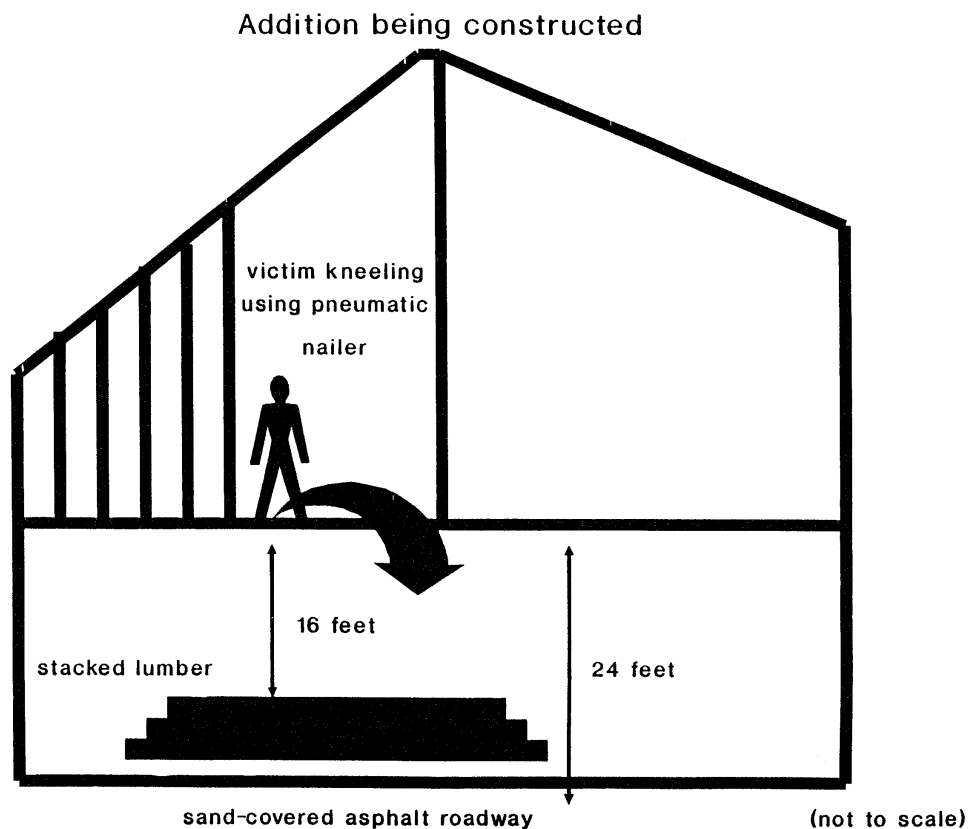
Figure.

Discussion: Although the pneumatic nailer was not directly responsible for the victim's death, it may have been a contributing factor. The pneumatic nailer weighs 9 pounds, 7 ounces, and has only a pistol-grip handle for the operator to hold. Also, the nailer is equipped with an automatic fastener feed, approximately 2 feet long, which makes it even more cumbersome to handle and work with, especially over a long period of time. (At the time of the incident, the nailer was being operated with 120 pounds per square inch of pressure.) Human factors engineers should evaluate this type of round head nailer to determine whether modifications can be made to improve its design. Even if this worker had not fallen, he still would have received a potentially serious injury from the nailer.

Recommendation #5: The pneumatic round head nailer should be evaluated to determine whether the human factors engineering design is adequate.

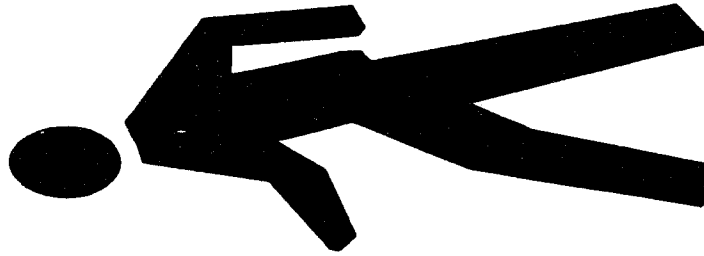
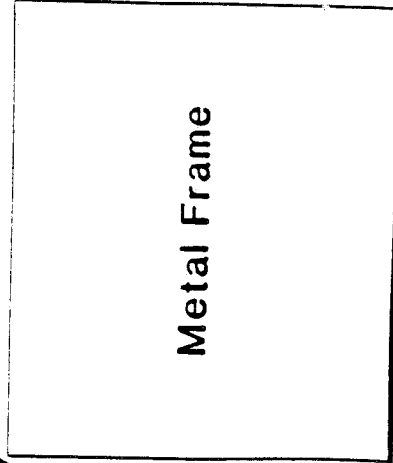
Victim Steeping Over

54" x 54" Galvanized Cap
approx. 75 lbs.

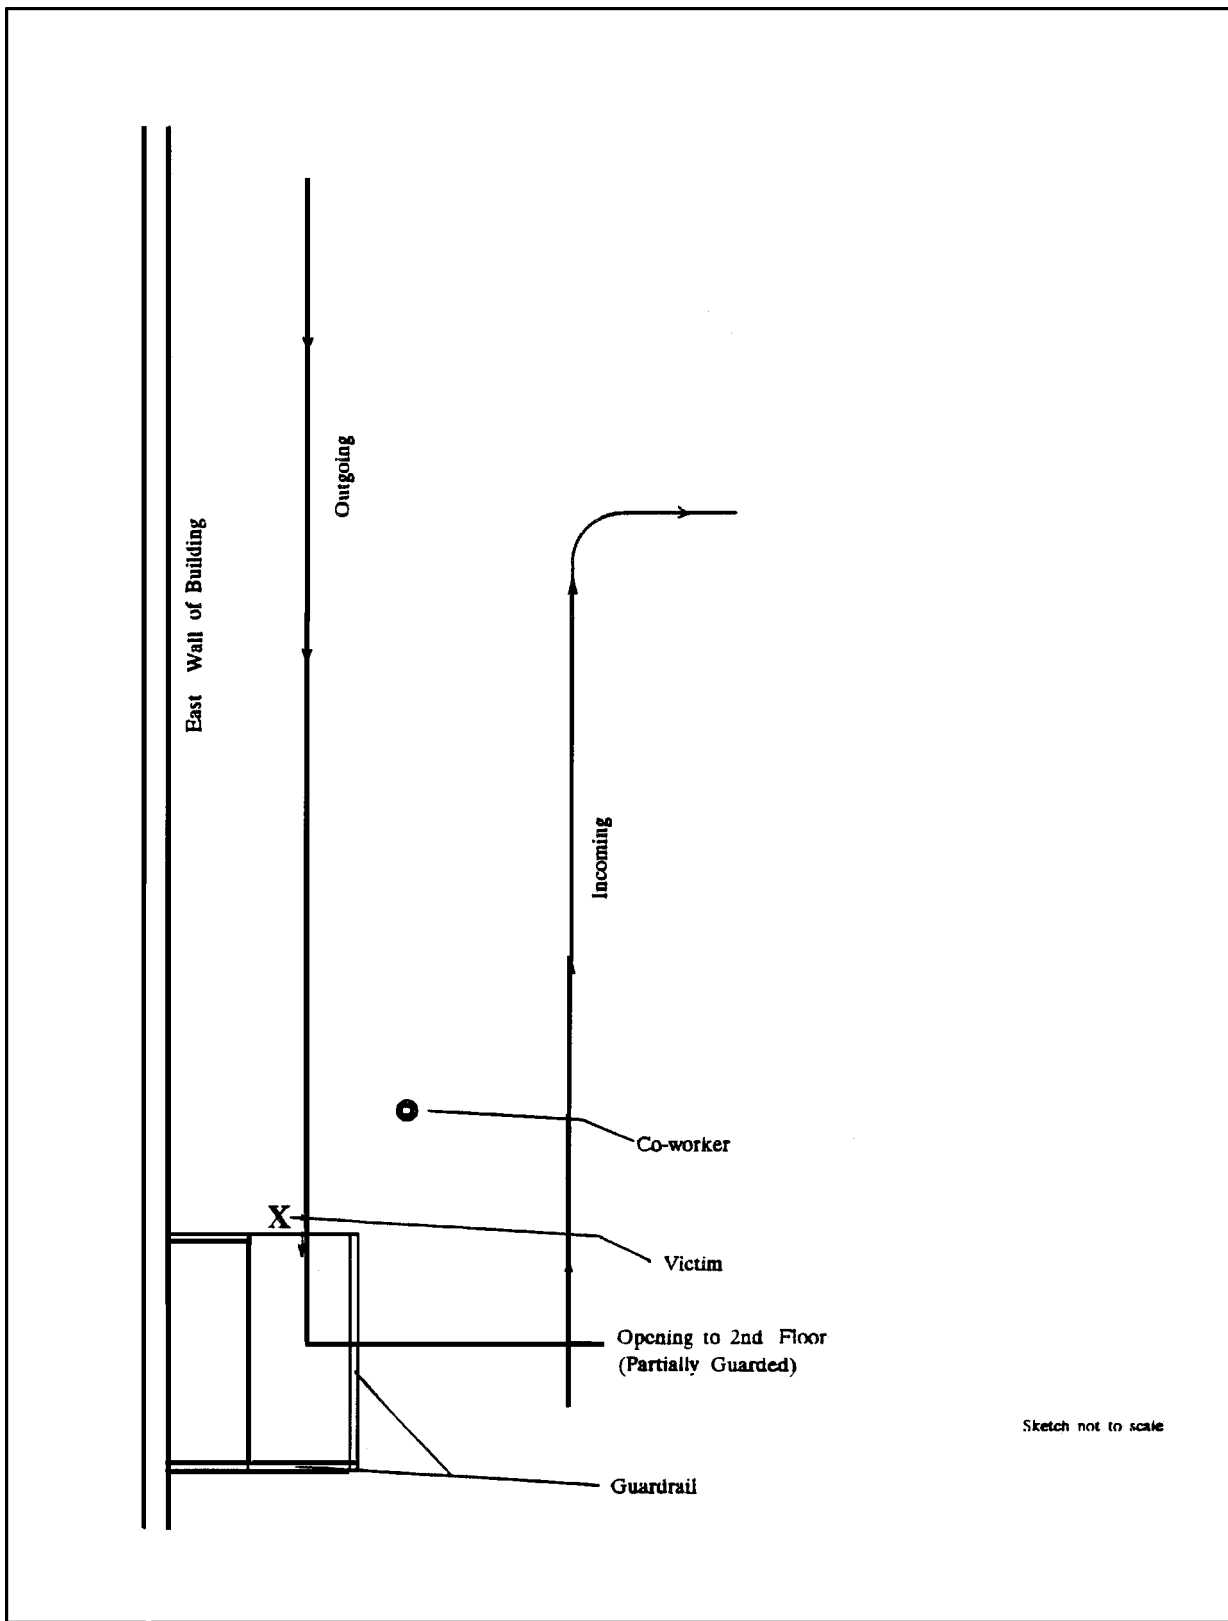
CAUSE OF DEATH

The incident occurred at a transfer location where furniture is transferred from the incoming line to the outgoing line before the outgoing line drops through a floor opening to the second floor. The outside edge of the 26 foot 7 inch by 6 foot 6 inch floor opening (the east side) was located 20 inches from the outside wall. A ledge (4 1/4 inches wide and 2 5/8 inches high) was located 1 foot from the opening, and extended the full width of the south side of the opening (Figure 2). A shutoff switch for the incoming conveyor was located about 12 feet from the southwest corner of the floor opening. The outgoing conveyor's shutoff switch was located on the outside building wall 5 feet 2 inches across from the conveyor line and 3 feet 6 inches up the line from the edge of the floor opening.

Discussion: At the time of the incident, the floor opening was partially guarded by standard railings (i.e., 42-inch high top rail, midrail, and toeboard). One railing extended along the full 26 foot 7 inch length of the west edge of the floor opening. Another extended across the 6 1/2-foot width of the north end of the floor opening and continued to the building wall. At the south end of the opening, the standard railing extended from the southwest corner of the floor opening 20 inches to the building wall. Since the incident, the employer has extended the west 26 foot 7 inch standard railing an additional 8 feet beyond the southwest corner of the floor opening, and has added a standard railing the full length of the east edge of the opening. At the time of the incident, the south edge of the floor opening providing conveyor access was not guarded. The employer has since covered the opening with an 800-pound-capacity cargo net which extends about 10 feet from the south edge (Figure 2). This method of covering offers fall protection yet still allows the conveyor to descend unimpeded through the opening. In response to reports that workers commonly sat on standard railings during break periods, the employer has also covered the north end with a second net secured to the top rail.
