NIST Response to the World Trade Center Disaster

World Trade Center Investigation Status

June 18, 2004

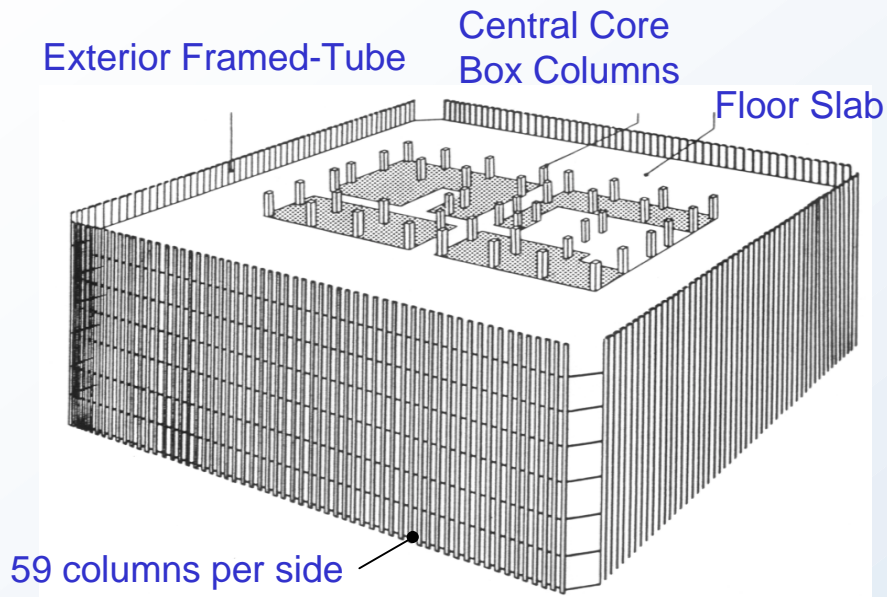
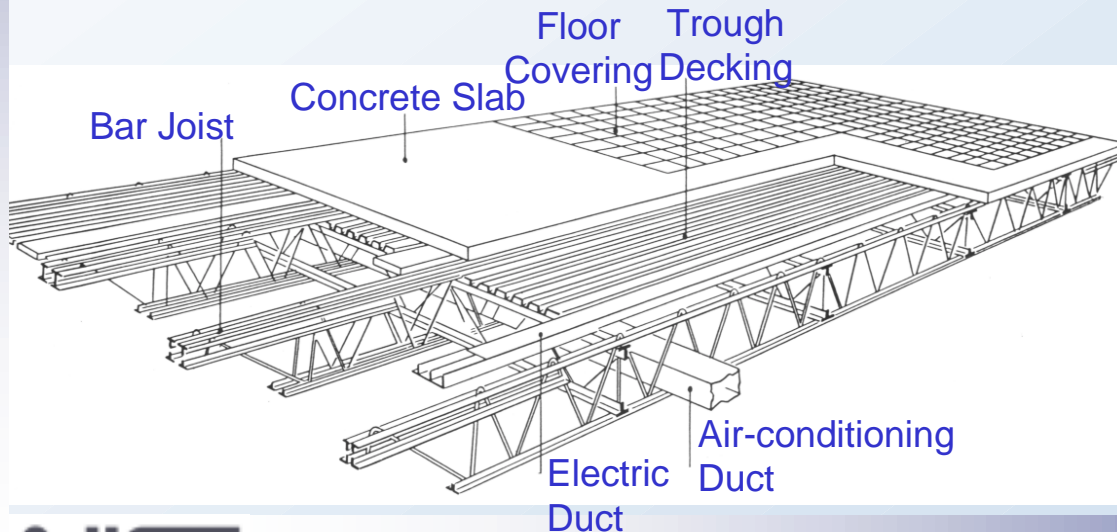
Innovative WTC Tower Structural System

- Innovative structural system when built; incorporated many new and unusual features
- Two features require additional consideration:
 - Composite floor truss system using long span open-web bar joists and spray-applied fireproofing
 - Design for wind loads and control of wind-induced vibrations

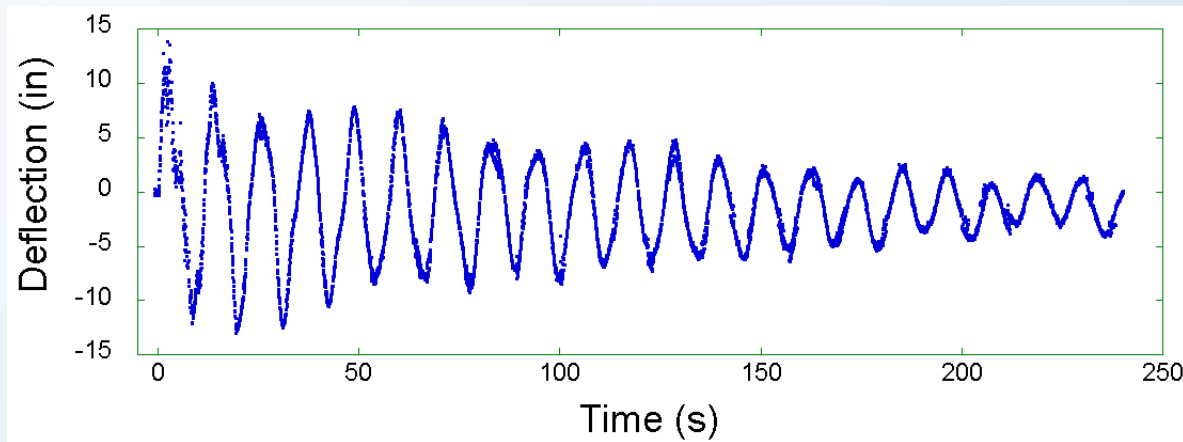
Relative Roles of Aircraft Impact and Fires

- The two WTC towers withstood the initial impact of virtually identical aircraft (Boeing 767- 200ER) during the terrorist attacks of September 11, 2001.
- The robustness of the perimeter frame- tube system and large dimensional size of the WTC towers helped the buildings withstand the aircraft impact.

- The WTC towers displayed significant reserve capacity, vibrating immediately following impact with amplitudes that were about half the amplitudes for design wind conditions expected by the building designers and an oscillation period nearly equal to that measured for the undamaged building.

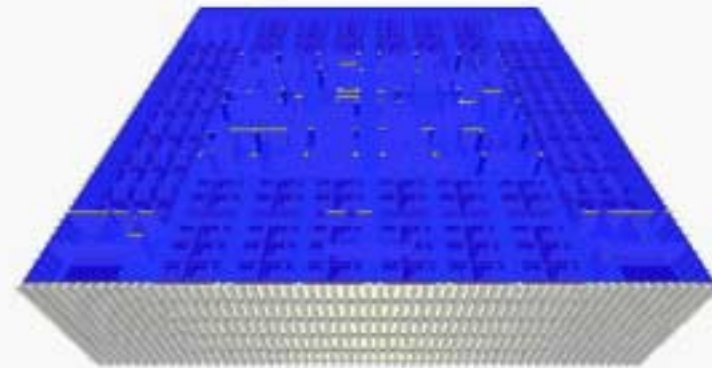
Reconstruction of the WTC Fires

- Consistent with available photographic and videographic evidence, NIST computer simulations capture the broad patterns of fire movement around the floors, with **flames in a given location lasting for about 20 min before spreading to adjacent, yet unburned combustibles**; some observed instances where fires persisted longer in regions with accumulated combustible debris; other instances of sudden or interrupted fire spread.

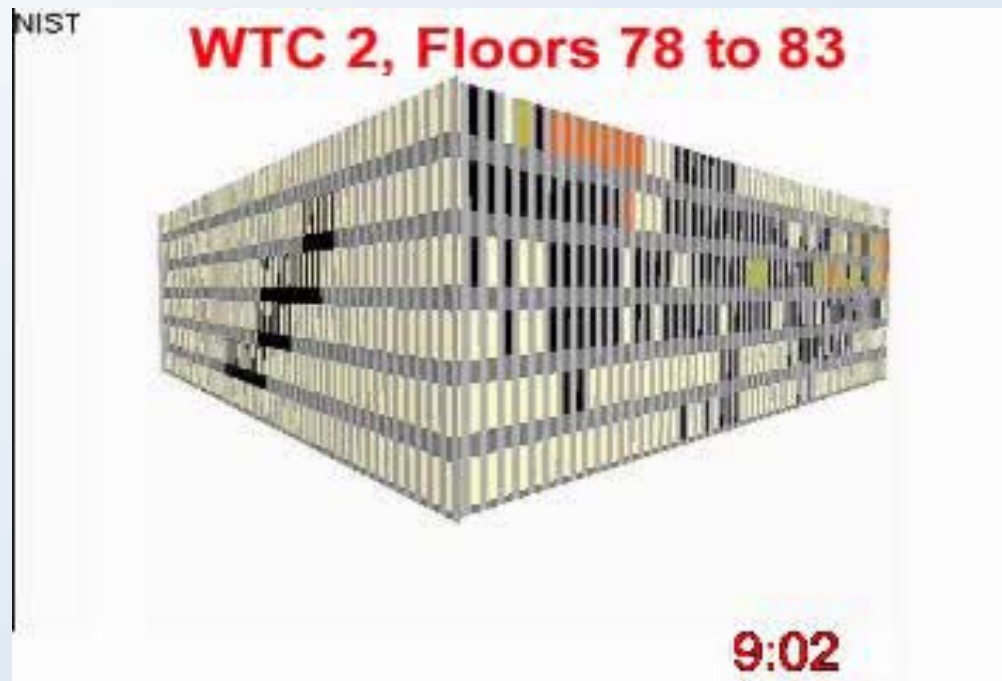
Collection and Analysis of Photographic and Video Images

- Visual database now contains:
 - Well in excess of 6,000 photographs taken by more than 185 photographers
 - 150 hours of videotape from major media outlets and more than 20 individuals
- From the analysis of the visual images to date, NIST has identified significant events for WTC 1 and 2 related to aircraft impact, fire development, and building damage
- **NIST has developed detailed mappings for the fire, smoke, and the condition of windows at several specific times for each WTC tower; work is nearing completion for WTC 7**

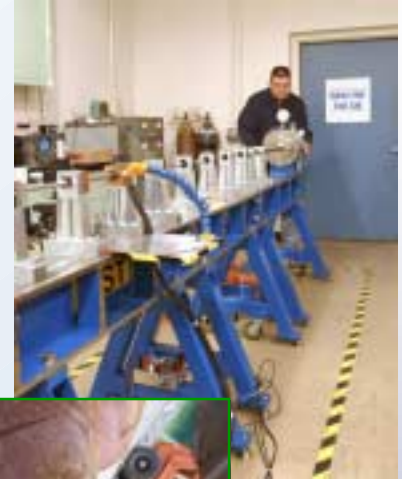
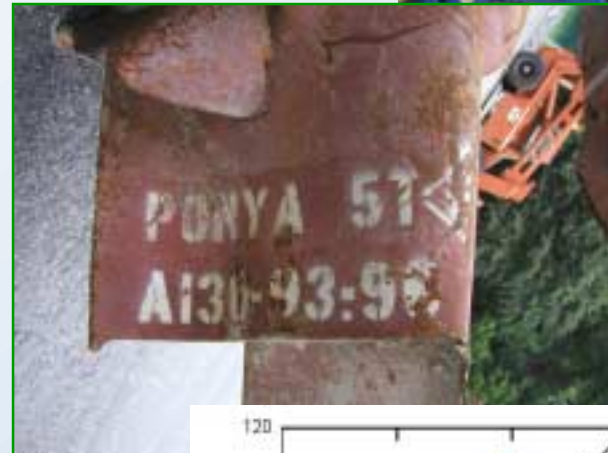
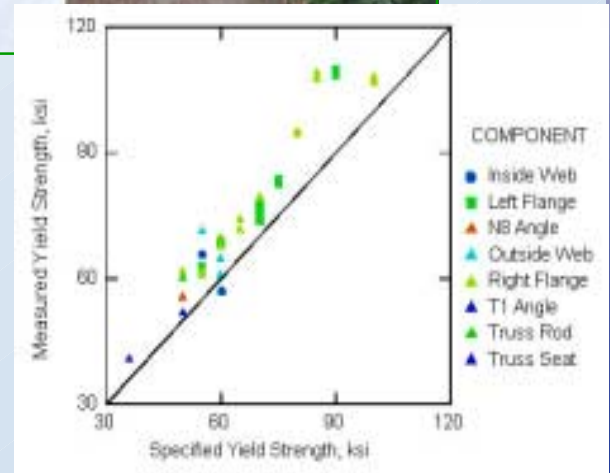
- ❑ Metallography and mechanical property tests indicate that the **strength and quality of the steel used in the towers was adequate, typical of the era, and likely met all qualifying test requirements.**

- ❑ **The room- temperature strength of steel used in the WTC towers met relevant standards** and, in many instances, exceeded requirements by 5 to 10 percent.
