Federal Building and Fire Safety Investigation of the World Trade Center Disaster

Project #3: Analysis of Structural Steel Update

October 20, 2004

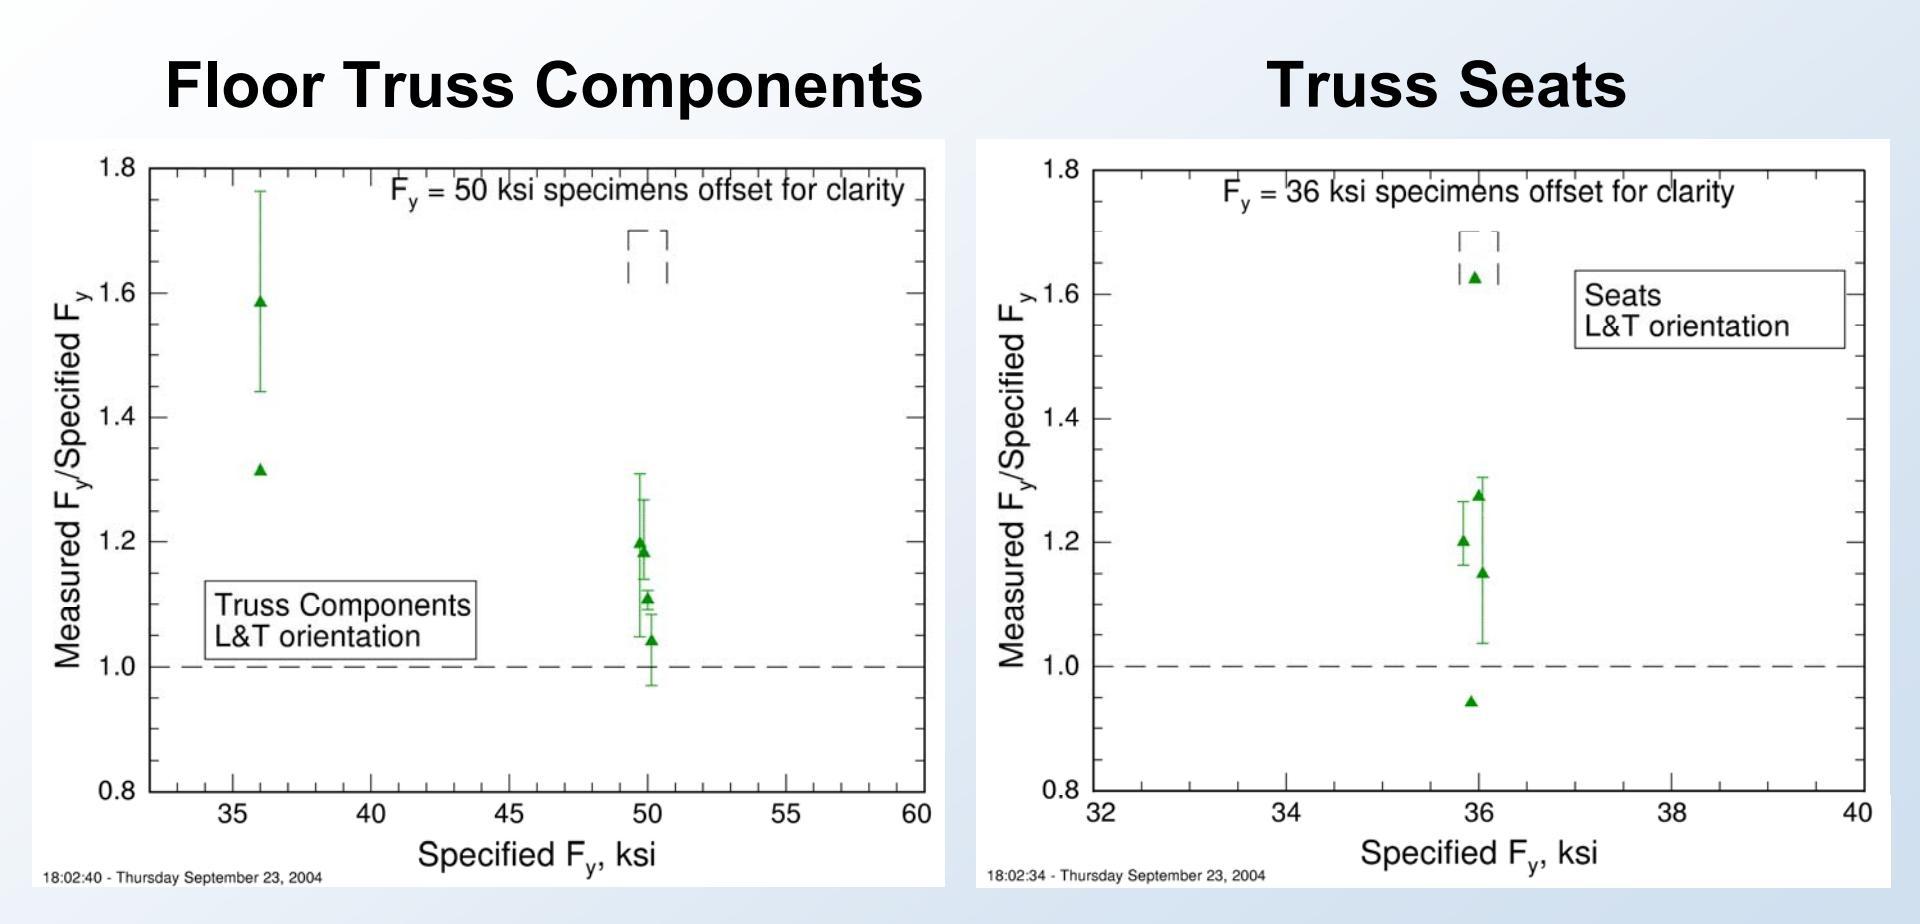
Task 4 - Correlate specified properties with measured properties

<u>Conclusions – Room Temperature Strength</u>

- ~87% of tests exceed required minimum yield strength ~13% of test results on the damaged steel did not meet the required minimum yield strength. This distribution not unexpected, considering:
 - Change in test procedure from mill tests could account for 2-3 ksi
 - Loss of yield point due to damage to steel accounts for 2-4 ksi in several cases
- Wide flange core column property distribution lower than expected from historical data; other component distributions consistent with historical data
- Observed distributions are accounted for in typical design factor of safety for allowable stress design.
