EFFECT OF DAMAGE ON THE GRADE YIELD OF RECYCLED LUMBER

ROBERT H. FALK[†]
DON DEVISSER[†]
STANDEN COOK
DALE STANSBURY

[†] Forest Products Society Member.
©Forest Products Society 1999.
Forest Prod. J. 49(7/8):71-79.

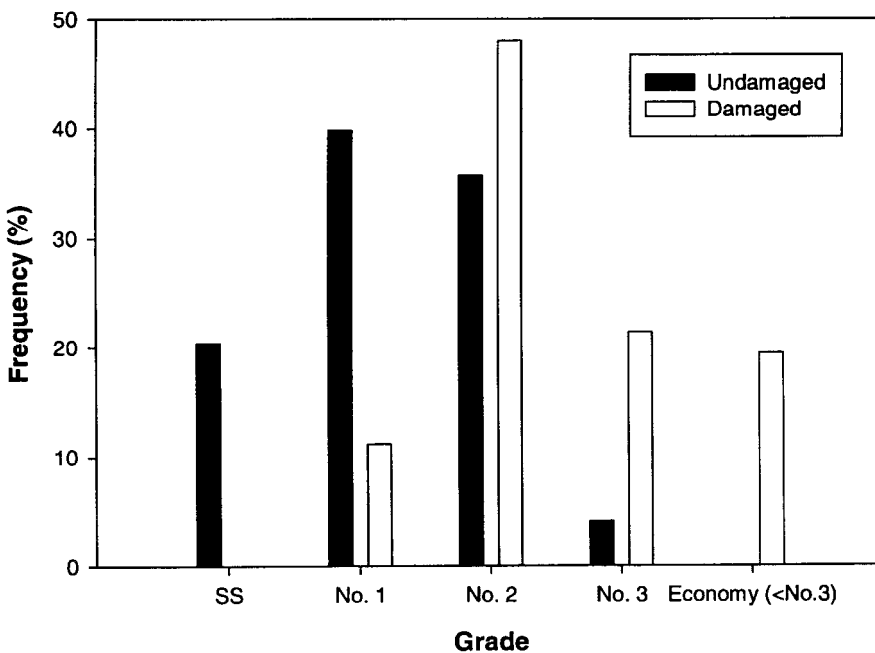
Figure 2. – Grade reduction as a result of damage, 2 by 6's, all forms of damage.

Figures 1 through **4** show the reduction in grade as a result of damage in 2 by 4's, 2 by 6's, 2 by 8's, and 2 by 10's, respectively. For all forms of damage (Types I, II, III), the figures indicate 1) the grades of lumber (as graded, including damage) and 2) the grades of lumber if no damage existed (undamaged). As expected, for all sizes of lumber, when damage exists, the grade was reduced.
