General Technical Report FPL-IMP-GTR-3

Quality Drying in a Hardwood Lumber Predryer Guidebook-Checklist

Eugene M. Wengert R. Sidney Boone

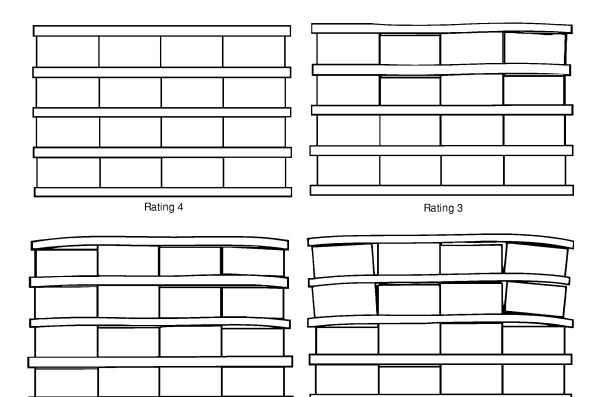
Figure 1. Evaluating lumber thickness variation (end view).

Look at the ends of 15 packages of green lumber. All the boards should appear the same thickness with the stickers straight and touching all boards. Figure 1 illustrates how to evaluate thickness variation.

- 4 All boards are uniform and touching stickers; stickers are not bent
- 3 Fewer than 10 boards per package do not touch stickers or stickers bend slightly over thick and thin lumber
- 2 Thickness variation is sufficient to bend stickers or show gaps more than 1/8 in. wide above boards
- 1 Thickness variation is great enough to make stacking visibly irregular

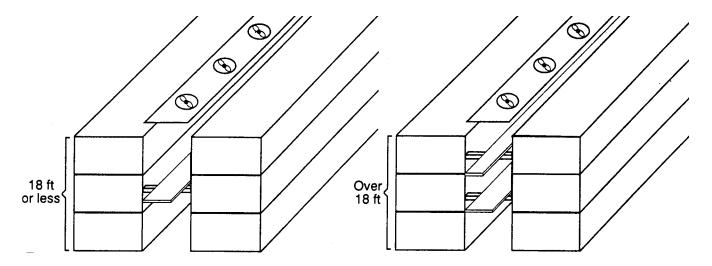
Figure 2. Placement of baffles in plenum space.

Flat baffles should be used in the plenum space of downdraft predryers to assist in obtaining uniform air flow. Two baffles may be required when stacks are more than 18 ft high. If baffles are not used, piles should be reloaded after 2 weeks, with packages reversed top to bottom and bottom to top (Fig. 2).

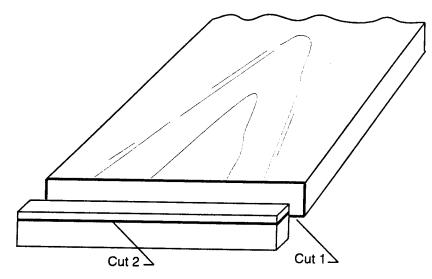
Figure 3. Inspect for surface checks by cutting a small section from end of board.

Incoming oak and beech lumber that is not green-from-the-saw should be checked for the presence of existing surface checks before or as it is being loaded in the predryer. This can be done by cutting a small section (at least 12 in.) from the end of the board (Fig. 3).
