Best Practices for Road Weather Management

Montana DOT Anti-Icing/Deicing Operations

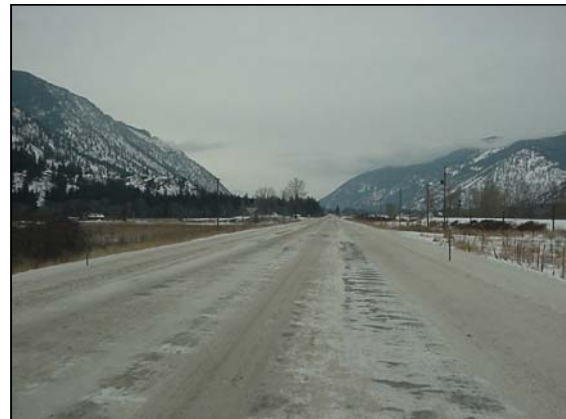
Thompson Falls Section

Montana Freeway with Snow-Covered and Dry Pavement Sections

Once the storm passed, numerous complaints were received from drivers due to striking differences in road surface conditions in the area separating the Plains and Thompson Falls road sections. The pavement was bare in Plains section, while the Thompson Falls section was compacted with snow and ice.
