IC 9466
INFORMATION CIRCULAR 2003

Geologic Hazards and Roof Stability in Coal Mines

By Gregory M. Molinda

October 2003

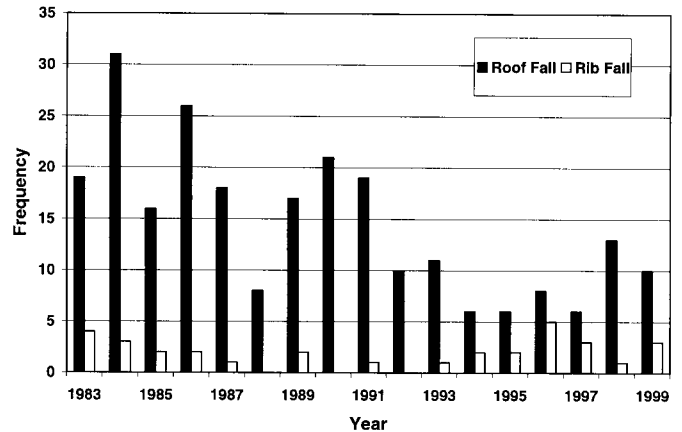
Figure 2.—Fatalities caused by the fall of roof and rib in U.S. coal mines, 1983-99.

Although roof and rib fall fatalities in U.S. coal mines have greatly decreased because of technological advances (e.g., roof bolting, canopies, automatic temporary roof supports (ATRS), longwall mining, rib support, and screening), fatalities (figure 1) and injuries (figure 2) continue to plague U.S. underground coal miners. In 1999, 745 injuries resulted from 2,087 reported roof falls [MSHA 1999]. Many of these fatalities and injuries are due to weak roof strata and unexpected discontinuities in the roof. Within the accident narratives filed by operators to the Mine Safety and Health Administration (MSHA) are numerous references to "slips," "horsebacks," "faults," "coal streaks," "clay veins," "joints," and "rolls".² These are all geologic defects or weaknesses in the roof that were not anticipated or adequately supported. The ground control program at the Pittsburgh Research Laboratory for more than 30 years has focused on numerous safety issues. These include roof bolt effectiveness, bump control, strata deformation, subsidence, retreat mining, and horizontal stress. Integral to each one of these topics and many more is geology. Indeed, the behavior of sedimentary sequences to the applied stresses of mining is central to both short- and long-term opening stability. Almost every aspect of the creation of underground excavations will require a description and analysis of the local strata to provide a framework for an engineering solution. This strata description is necessary to explain ground reactions and to attempt to capture the effect of a material variable that can change drastically on a micro and macro scale.

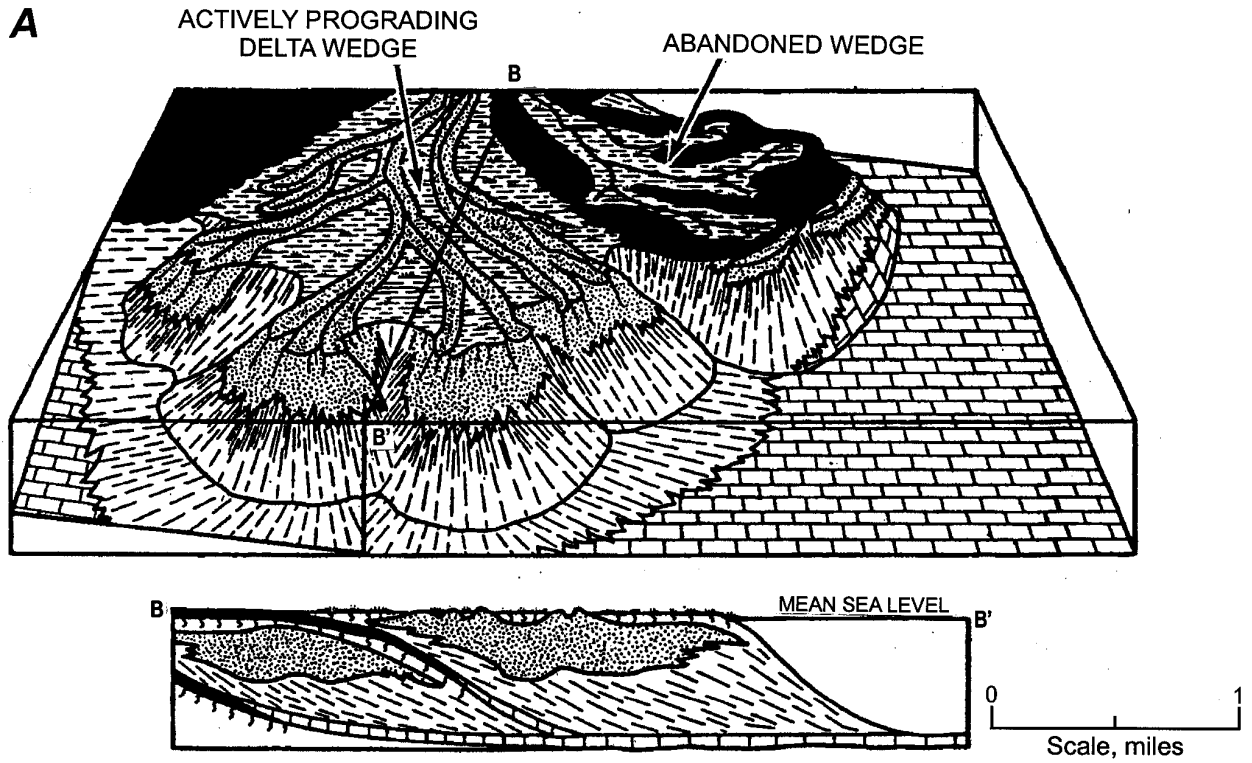
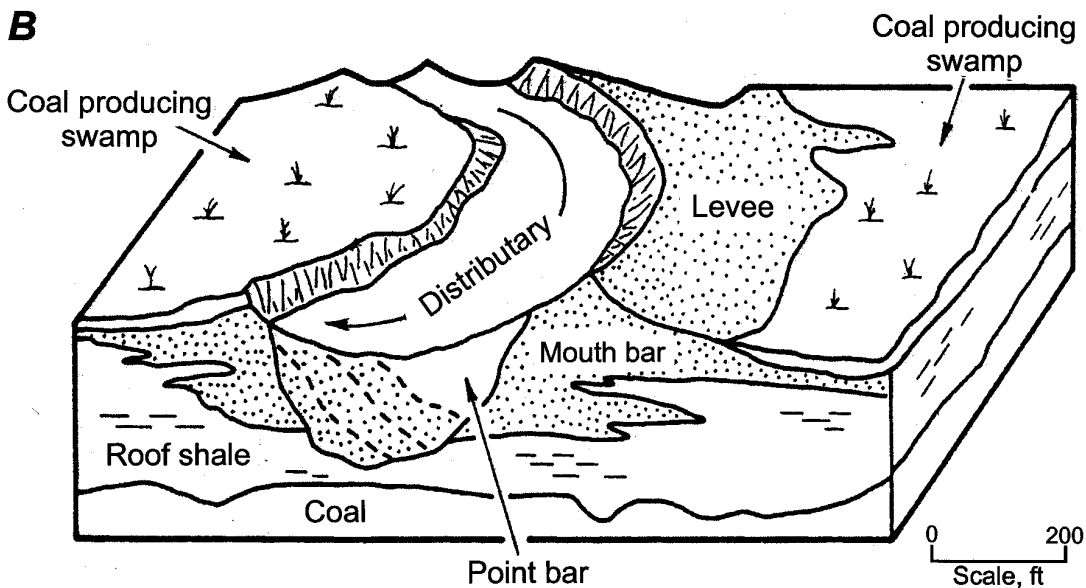
Vertical exaggeration on the order of 1000 X.

Figure 4.—Coal-forming environment of deposition. A, Advancing active delta wedge with an adjacent abandoned wedge (modified from Ferm [1974]). B, Detailed cross-section of a coal-forming wedge showing a stream channel dissecting a coal-forming sequence.

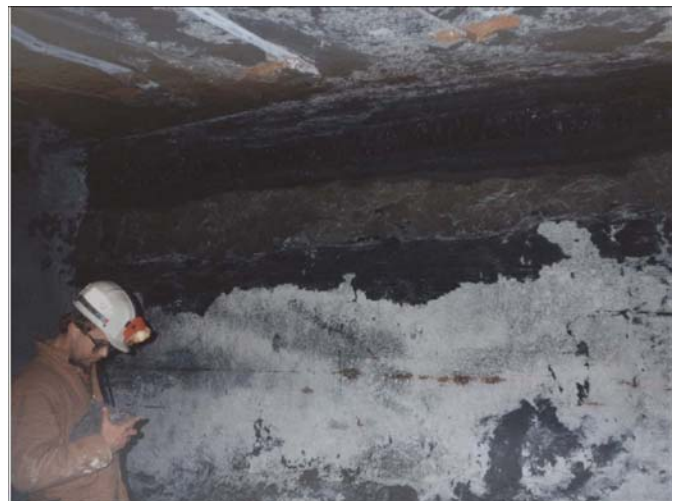
Figure 10.—As a weak seat earth thickens in a southern West Virginia mine roof, it causes roof bolts to miss anchorage in a strong sandstone.

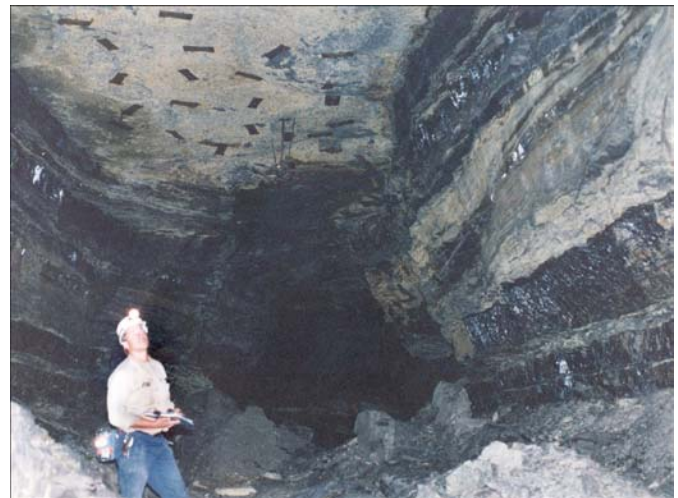
Figure 14.—Rider coalbeds above the main bench of the Pittsburgh Seam.

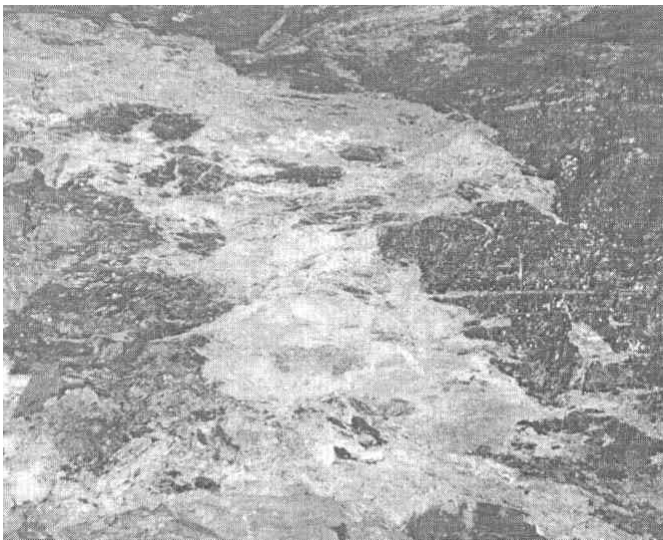
Figure 15.—Clay vein injected into the coalbed. Note inclusion of “floating” coal pieces.

Clay veins or clay dikes occur when soft, ductile roof or floor mudrocks are squeezed into tension fractures in the coalbed. They can also be injected parallel to bedding, or they may occur as a combination feature as in a stairstepping pattern (figure 15). Clay veins and their associated mining problems (water and gas barriers, roof damage) have been well documented [Chase and Ulery 1987; Hill 1986]. On a smaller scale, clay veins have squeezed into existing joint systems. The clay-filled tension features can then form the boundaries of roof falls. Clay veins can range in thickness from millimeters to tens of feet, and the dikes can occur from a single one to one every 10 ft or more often. Roof damage can be severe (figures 16-17). Roof rock dissected by clay veins is already failed upon exposure by mining and can fall out before bolting, covering the continuous miner and limiting cuts to only a few feet before cleanup and bolting. When a clay vein cuts through a pillar corner, large rib rolls can occur. When excess horizontal stress is added to a clay vein-broken roof, mining can be a nightmare. Conversely, there is some indication that clay veins can act as shock absorbers for horizontal stress. They can soften roof enough to prevent some massive roof falls that may have occurred in stiffer roof.

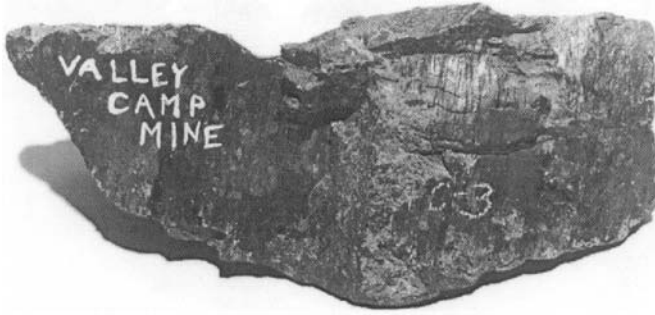
Figure 26.—Slickensides on a rock fallen from a coal mine roof.

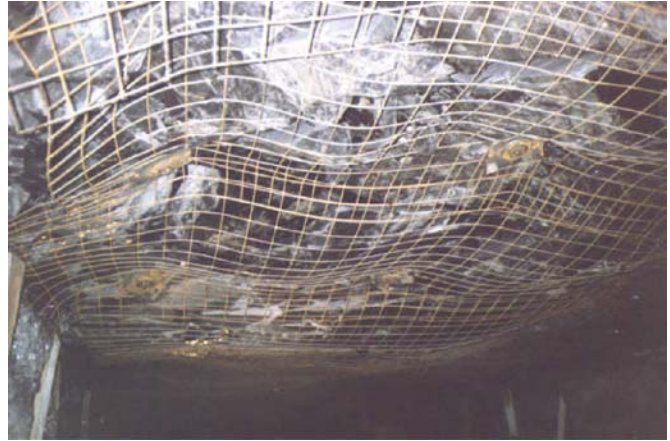
Figure 29.—Metal screen supporting roof scale formed in highly slickensided shale.

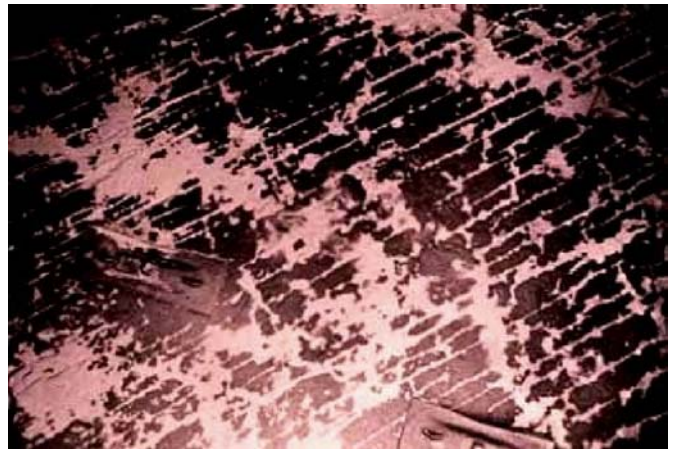
Figure 35.—Systematic jointing in the shale roof of a southwestern Pennsylvania mine continued only about 6 in vertically and terminated against a siltstone.

Rocks have different strengths and respond to tension in different ways. Joints are more closely spaced in mudrocks than in clastic rocks. In a roof sequence, joints may continue only for the thickness of the host strata and abut vertically in the upper or lower strata. This situation in a southwestern Pennsylvania mine resulted in small pieces (2-3 in thick) being isolated in the immediate roof shale, but only extending upward the thickness of the black shale (6 in) (figure 35). Conversely,

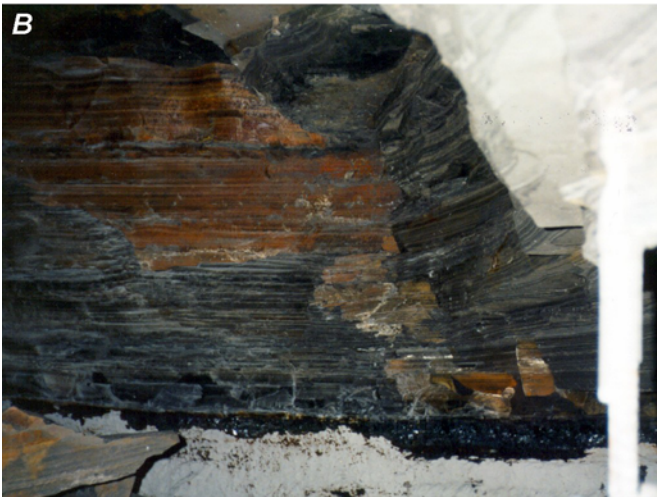
Figure 36.—Roof fall terminating against a large joint face. A, Diagram; B, photograph.

joints may be persistent, extending through numerous roof strata, effectively severing the roof beam. At one western Pennsylvania mine, joints formed the severed termination of a number of roof falls (figure 36). The fall pictured in the intersection had two turnouts, contributing to its oversized intersection span of 74 ft and likely triggering the fall (figure 37).

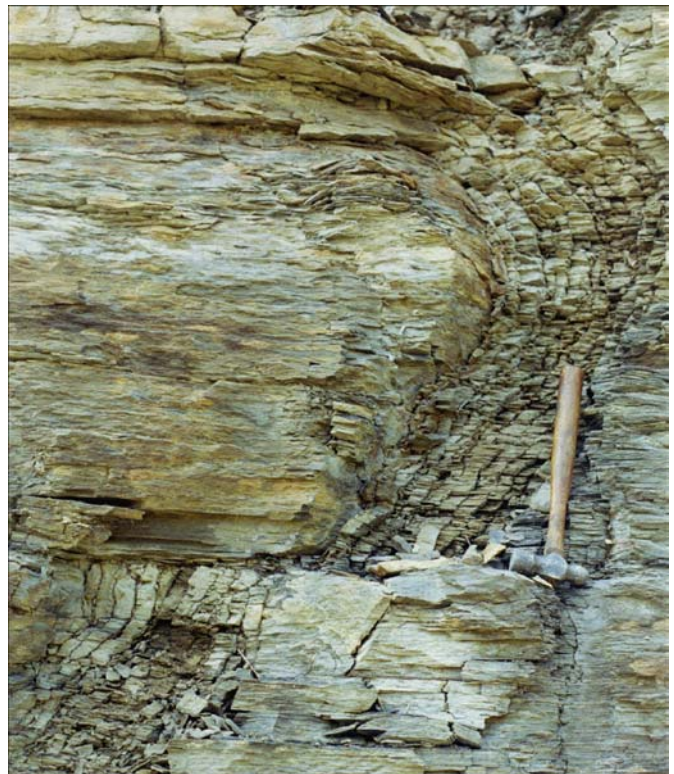
Figure 39.—A hillseam is a zone of numerous extensional fractures.

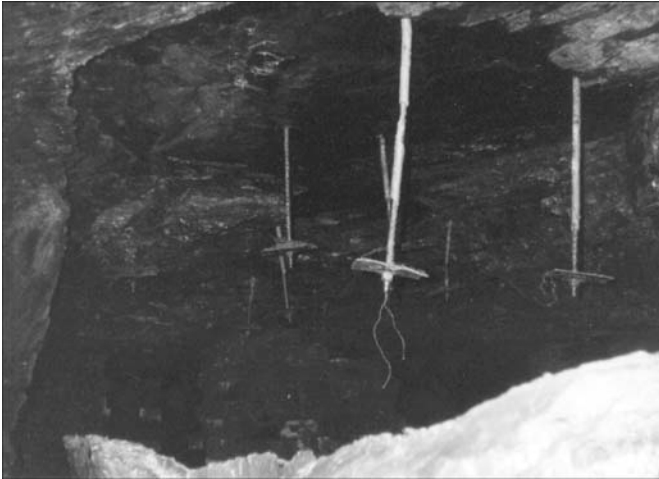
Figure 45.—Roof fall caused by broken rock falling between bolts.

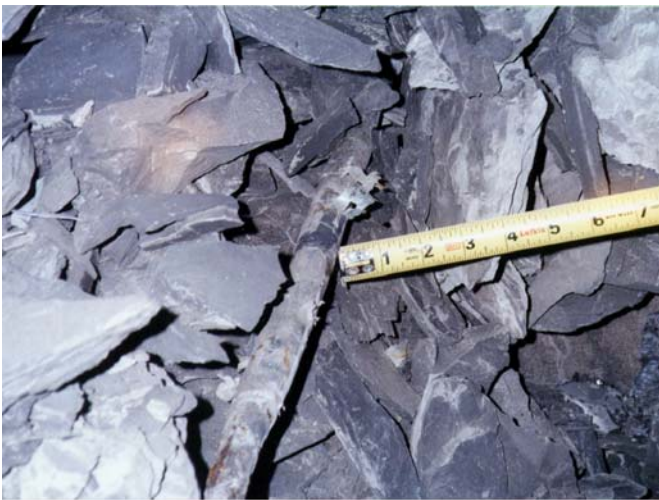
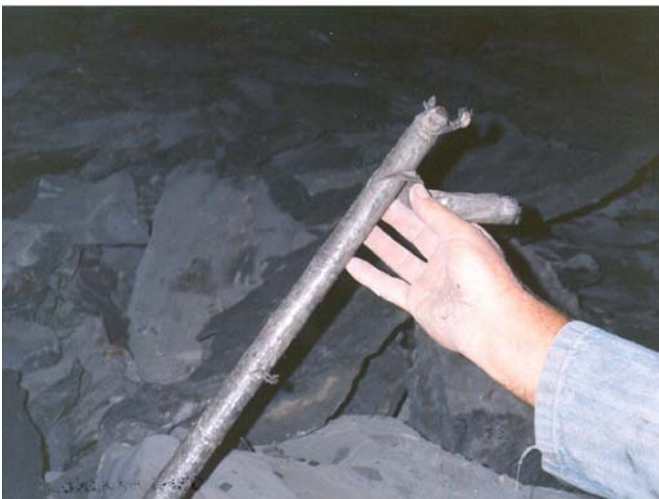
Figure 46.—Two views of "glove-fingered" bolts that provide little mechanical interlock to support strata.

Defective bolts may be the cause of more roof falls than is widely believed. Although sometimes hard to document, it is worth the effort to examine roof bolts in roof fall debris. Poor roof bolt installation can result from a number of practices [Mazzoni 1996]. "Glove-fingered" bolts occur when the bolt spins within the resin cartridge, failing to break the bag and preventing resin contact with the wall of the roof bolt hole (figure 46). At one mine in southern Illinois, nearly all of the bolts observed ($n = 10$) in several roof falls were "glove-fingered." "Glove-fingered" bolts can be eliminated by reducing the resin annulus and spinning the bolt as it is inserted. This can be done by drilling a smaller diameter hole or installing a larger bolt in the hole. One support manufacturer has developed a rebar that has a serrated surface, which ensures complete resin tube penetration during initial inserts of bolt in hole. If mechanically anchored bolts are undertensioned, roof failure can result. If the same bolts

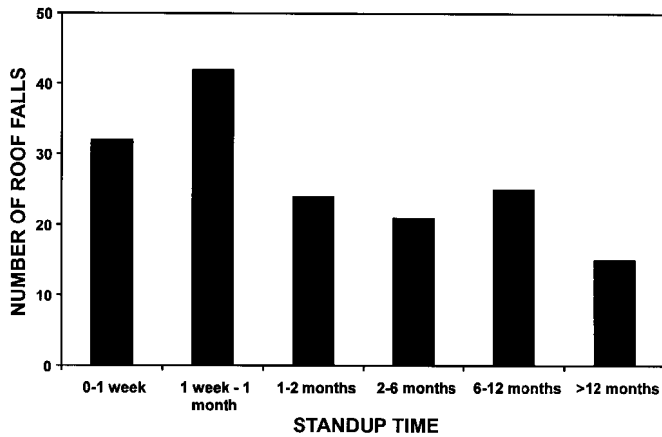
Figure 48.—Standup time for roof falls at a western Kentucky mine.

At one western Kentucky mine over a 3-year period, only 12% of 161 total falls occurred inby the feeder breaker, but 46% of the falls occurred within 1 month of development when mine workers are still frequently exposed (figure 48). This mine had more than 100 reported roof falls in 1996, the highest in the country. The roof lithology of this mine consists of a siltstone (UR = 32) 0-8 ft up in the roof with a 3-in-thick, highly reactive mudband 15-18 in up in the roof. In numerous falls, it seems that swelling of this member as well as the siltstone itself may be responsible. The siltstone "rats" out around the bolts because of pressure from the mudband, which causes "chandelier" bolts and much debris in the intakes. In addition, the use of wooden half headers as plates on some bolts has caused the loss of applied tension to the torque tension bolts used in the mine. Sixty-four percent of bolts tested, using wood headers, showed torque bleedoff (some of these bolts were as close as one to two breaks from the face). Only 28% of bolts with steel plates showed torque bleedoff. One possible solution to such conditions is the use of a fully grouted torque tension bolt with a steel plate to help prevent swelling and roof ratting. Another might be to leave 6-8 in of head coal. By doing this, the mine may be able to help seal the reactive zone in the roof.

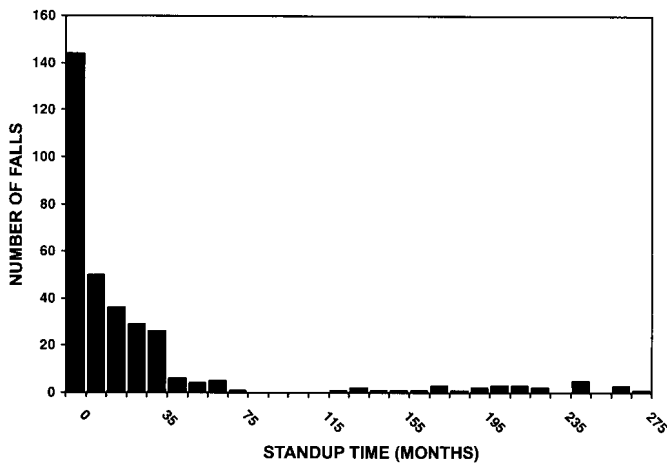
Figure 49.—Standup time for roof falls at an Illinois mine.

At one Illinois mine, most falls occur shortly after mining (figure 49), but a significant number occur many months or even years after development (average standup time is 34.8 months). In this mine the roof shale (Dykersburg Shale) is moisture-reactive. Although many falls occur within 1-2 months of development because of high horizontal stress, which is characteristic of the Illinois basin, moisture slaking continues, causing roof falls long after development.
