MARINE CASUALTY REPORT

DRILL SHIP

GLOMAR JAVA SEA

CAPSIZING AND SINKING

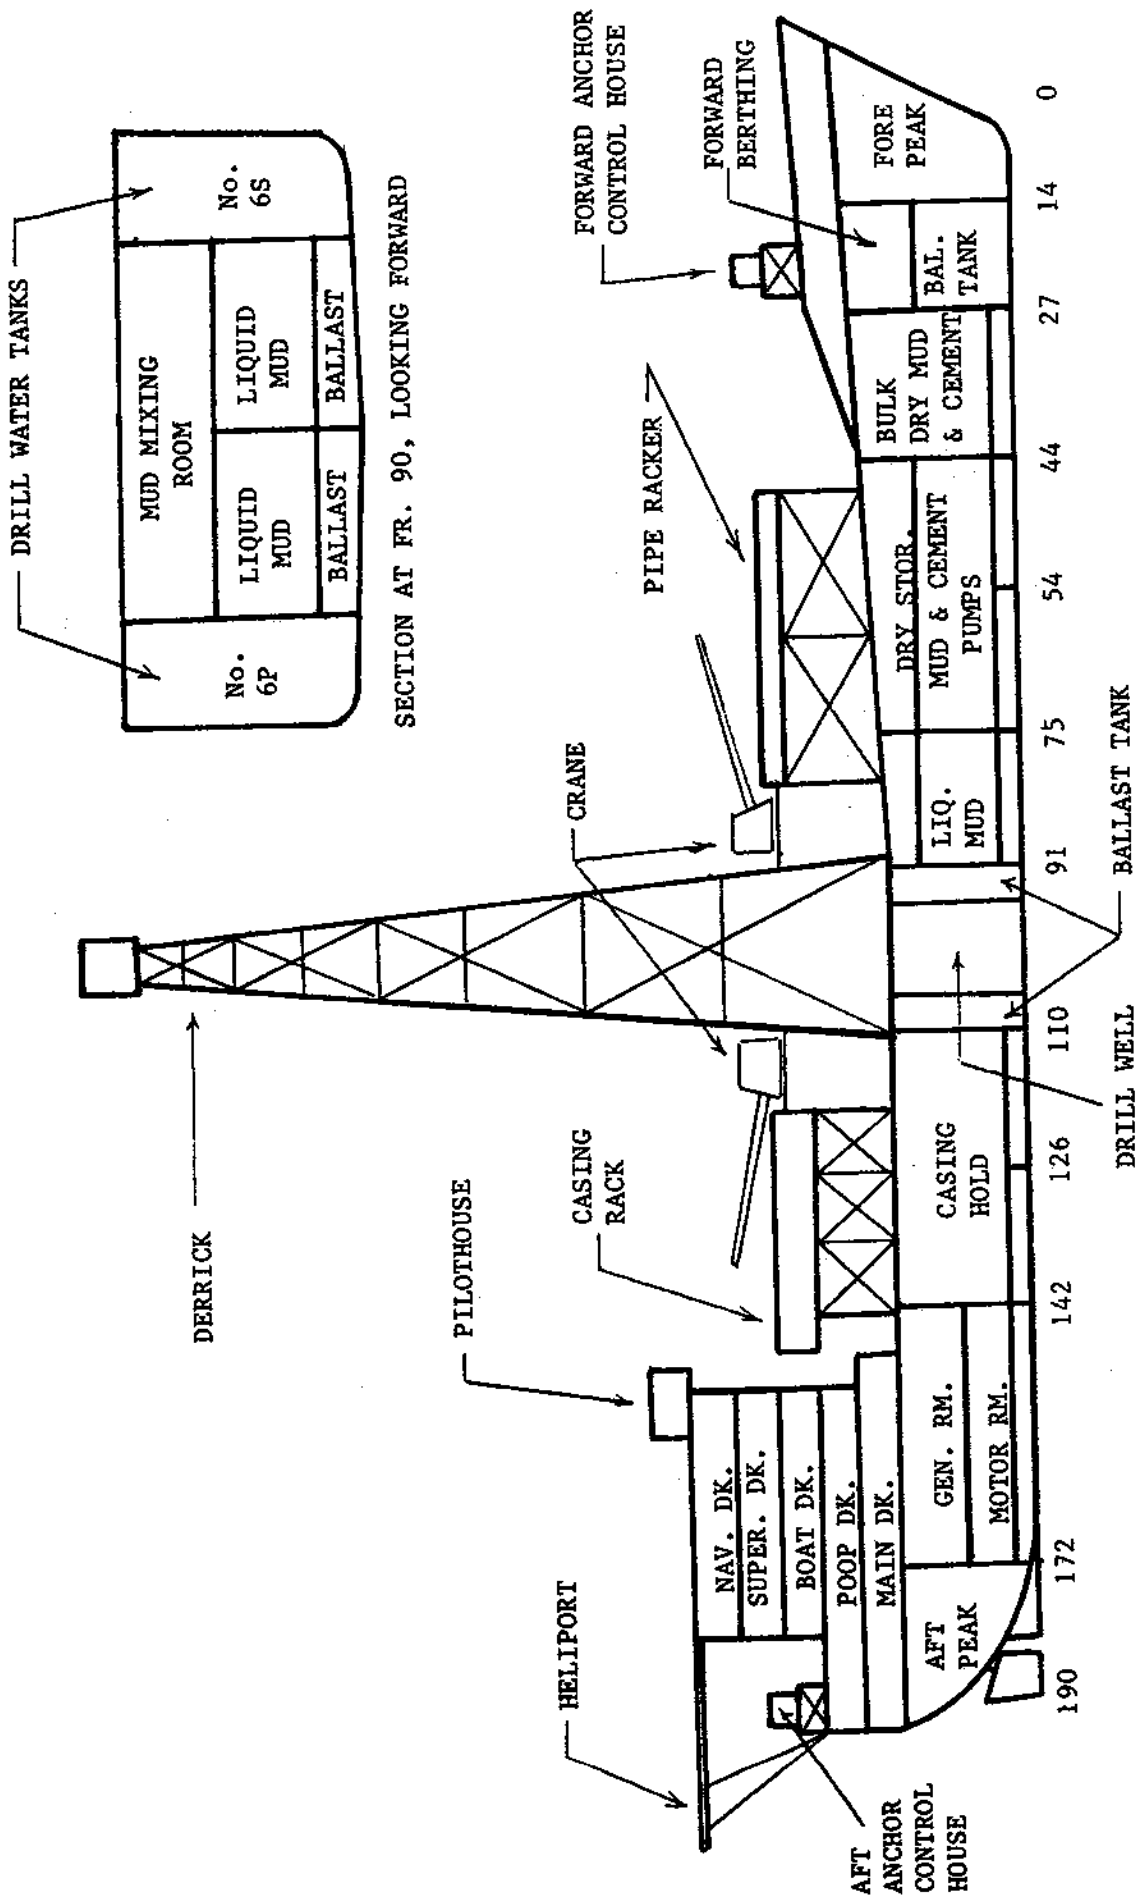
FIGURE 2: Drillship GLOMAR JAVA SEA, Inboard Profile

Above the main deck, aft, above the machinery spaces was a 5-level deckhouse topped by the pilothouse. Aft of the deckhouse cantilevered over the stern was the heliport. The main deck level of the house contained crew staterooms, change and shower rooms, the hospital, laundry, workshops, and the steward's storeroom. Aft of those spaces were the aft anchor chain lockers.

The poop deck (01) level contained the galley, messroom, freezer, and crew's lounge. Aft of those spaces were the aft anchor windlasses.

The boat deck (02) level contained crew staterooms including the Chief Engineer's room. The lifeboat davits and the aft anchor windlass control room were located on this deck.

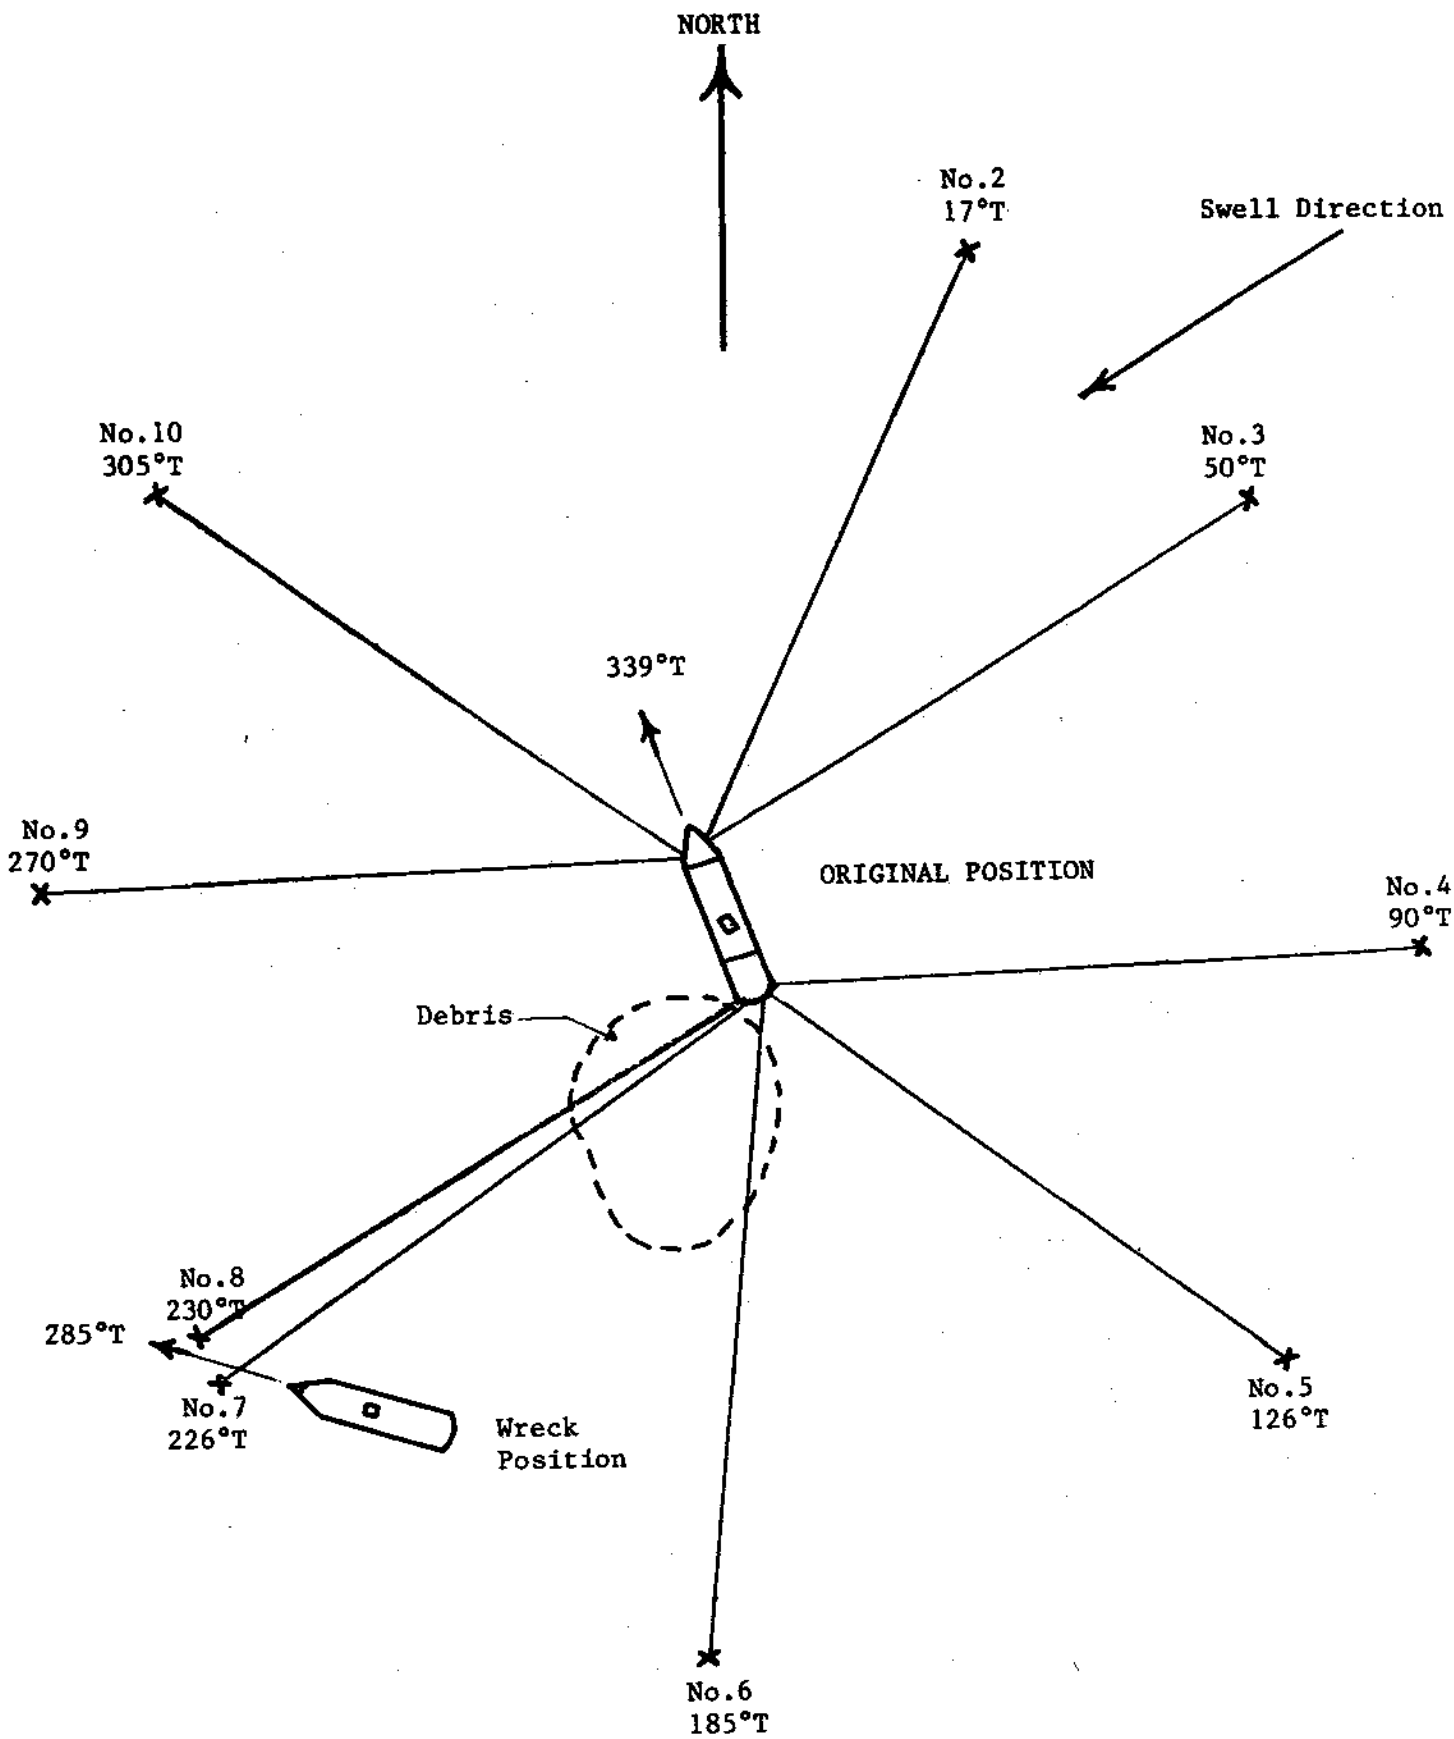
FIGURE 4: GLOMAR JAVA SEA's Anchor Pattern on 25 October 1983

The anchor pattern approximated pattern number 6 in the Marine Operations Manual and allowed for changes of approximately 30° to each side of the original heading to compensate, if necessary, for changes in weather or sea conditions, to limit vessel motions, or to reduce the strain on one or more chains. Such a change would be effected by slacking some chains and heaving in on others to pivot the vessel in place. This procedure was known to each of the Masters and the vessel's heading was changed from 335°T to 339°T sometime after it was anchored at the drill site.

The anchor system was designed to permit the retrieval or release of the anchors under controlled conditions as well as uncontrolled release under emergency conditions. Normal practice in retrieving the anchors entailed a supply vessel picking up the anchor and carrying it to the drillship while the drillship took in the chain or cable. However, the anchors could also be released rather than being retrieved. The chains had detachable links which could be opened to drop the anchor and part of the chain. Cutting the chains and wires was also an option. The anchors could also be released by disengaging the windlass clutches and brakes and allowing the chains or cable to run out. Under controlled conditions, a buoy known as a "breakaway buoy" or "baseball buoy" was attached to the loose end of chain by a wire pendant. When the chain was released, the buoy both marked the end and provided a means for retrieving it. However, connecting the buoys was a lengthy process which would not have been used in an emergency.

At the well site the drillship was anchored in 317 feet of water, heading 335°T. (The drillship's heading was subsequently changed to 339°T to compensate for prevailing environmental conditions.) Four bow anchors and five stern anchors were deployed in a spread pattern.
