# SOUTH-CENTRAL ARIZONA

Earth fissures and subsidence complicate development of desert water resources

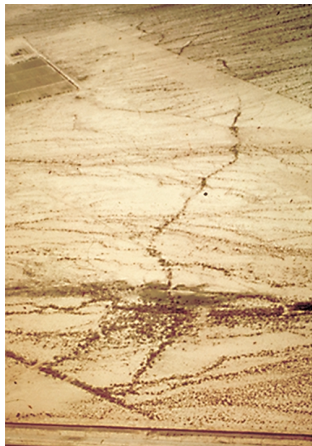
This aerial view taken in October 1967 shows the Picacho earth fissure as a single crack. A citrus grove is visible in the upper left.

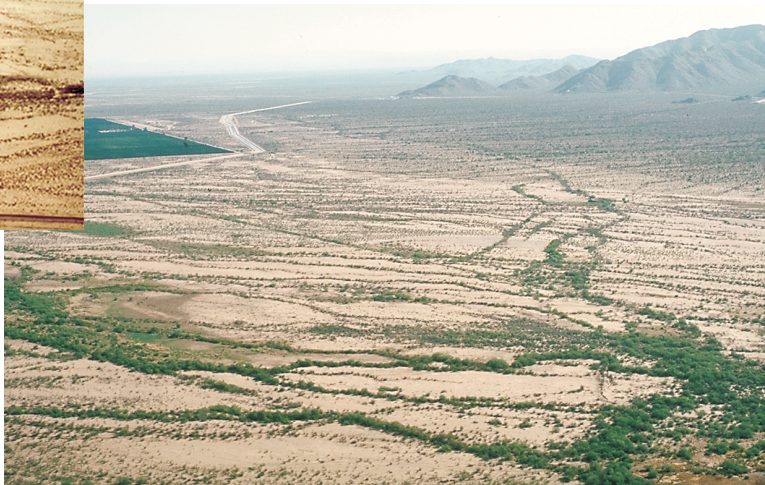
By June 1989 the fissure had developed into a system of multiple parallel cracks. A fissure scarp developed as much as 2 feet of vertical offset, with the west or left side of the fissure (as pictured) down-dropped.

A lateral canal in the upper left skirts a citrus grove. This canal originates from the Central Arizona Project Aqueduct (not visible) at the base of the mountains in the background and crosses the fissure north of the citrus grove.

The Picacho earth fissure, perhaps the most thoroughly investigated earth fissure (Holzer and others, 1979; Carpenter, 1993), began to creep vertically in 1961, forming a scarp. The scarp initially grew at a rate of more than 2 inches per year, before progressively slowing to about one-third inch per year by 1980 (Holzer, 1984). The observed opening and closing correlated with seasonal ground-water-level fluctuations from 1980 to 1984 (Carpenter, 1993). Surface deformation near the fissure indicated that formation of the vertical scarp was preceded by differential land subsidence and the formation of other earth fissures distributed over an approximately 1,000-foot-wide zone. Local geophysical and geologic surveys indicated that the Picacho earth fissure is associated with a preexisting high-angle, normal fault.

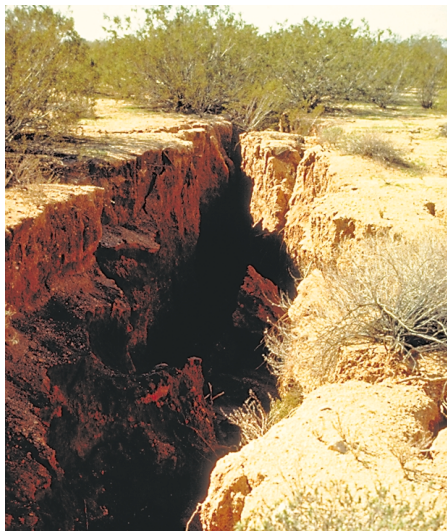
This fissure near the Picacho Mountains is undergoing erosional widening to become a fissure gully.

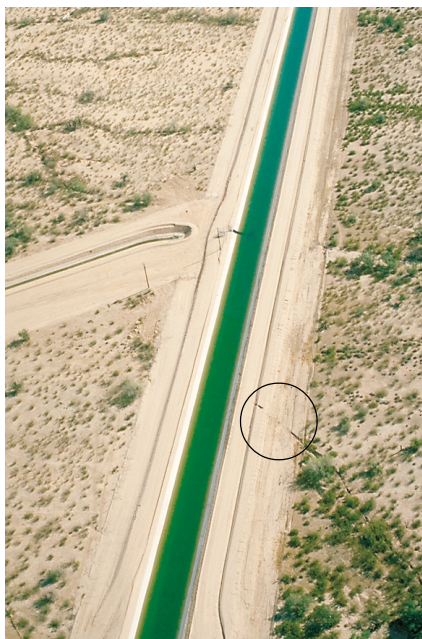
The Central Main Lateral Canal of the CAP was damaged where it crosses the Picacho earth fissure. Opening of the fissure is evident as a dark line in the lower middle of the photograph.

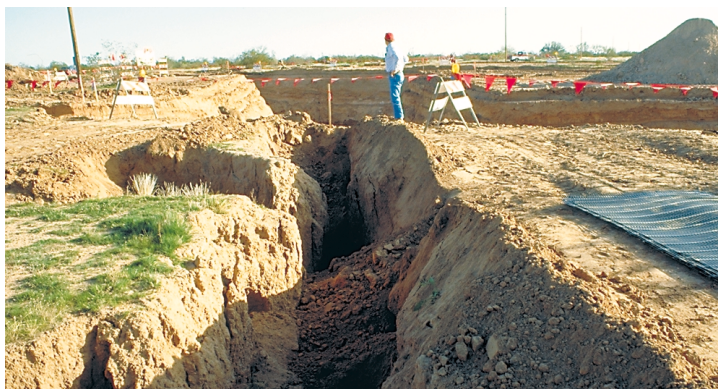
Part of this fissure south of Apache Junction has been trenched and backfilled for a land bridge.

Engineering measures can also mitigate damage where fissures undercut roads. At Apache Junction, a trench was dug to a depth of about 30 feet, backfilled by about 10 feet of compacted fill, and then draped by a reinforced plastic grid, geotextile felt, and an impermeable membrane. The membrane was buried by additional compacted fill. This treatment protects the road from subsurface erosion by enhancing its structural strength and by restricting the upward flow of water from the fissure into the land bridge during flooding.

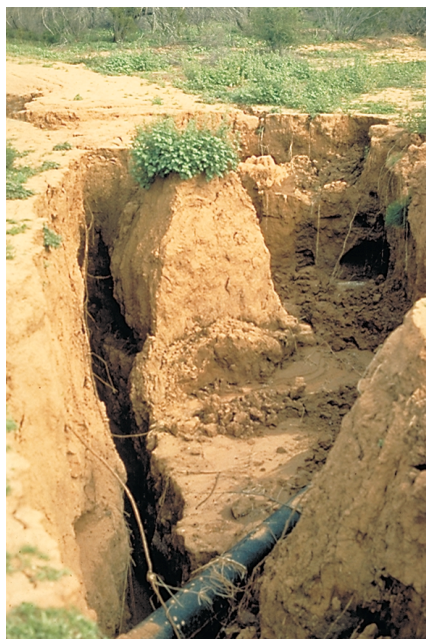
A natural-gas pipeline undercut by an earth fissure was exposed through erosional widening of the fissure. The pipeline was evacuated and cut to determine the stresses on it. Tension was evident, but no shear.

Where Interstate 10 crosses the Picacho earth fissure, more than 2 feet of vertical offset and several inches of horizontal opening have damaged the highway, requiring repeated pavement repairs. Where a natural gas pipeline crosses a fissure near the Picacho Mountains, erosional enlargement of the fissure left the pipeline exposed. The

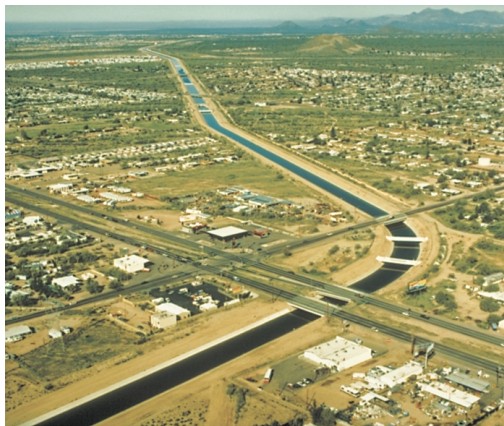
A section of the Central Arizona Project passes through Apache Junction.

The CAP aqueduct and associated canals have been affected by earth fissures at several localities. Near Apache Junction, the U.S. Bureau of Reclamation installed vertical sheet piles on both sides of the CAP aqueduct in a fissure that undercuts the aqueduct. Soil beneath the aqueduct was compacted to reduce erosion. Erosional damage at this site and at another similarly treated site south of the Casa Grande Mountains has been minimal (Cathy Wellendorf, U.S. Bureau of Reclamation, written communication, 1988).
