*Mitigation Case Studies*

# Clara Barton Hospital Shelter

Hoisington, Kansas

May 2004

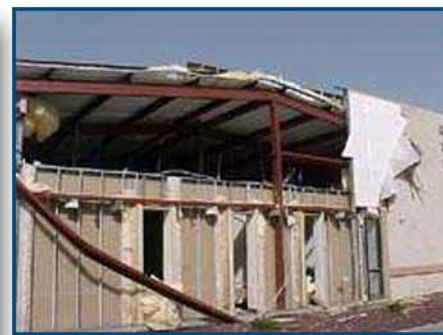
*Rear view of damaged clinic building (left) and main hospital building (right).*

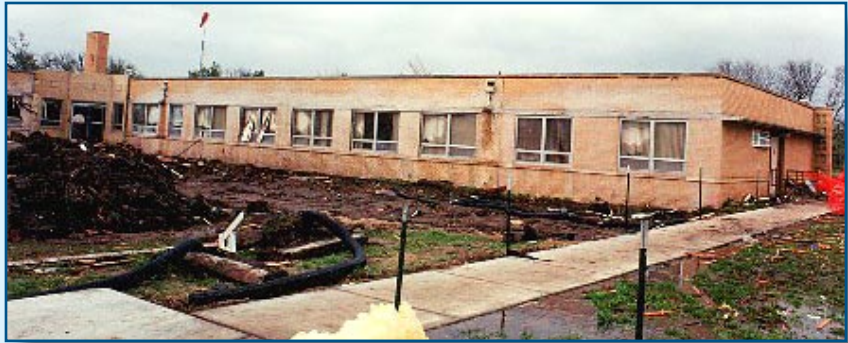
*Front view of damaged hospital building.*

The main hospital building survived the F4 tornado with broken windows and power loss. A new emergency generator, large enough to provide power for the entire building, was installed after the event because the existing generator served only some areas of the hospital. The protection and maintenance of these emergency generators is a critical issue. Emergency generators must be protected to the same level as the shelter occupants. The new generator for the hospital is located outside the building, mounted on a concrete slab that is adjacent to an exterior wall and provided with a lockable steel shell. To ensure its reliability during an emergency, the generator is tested every Monday by the hospital's maintenance staff.

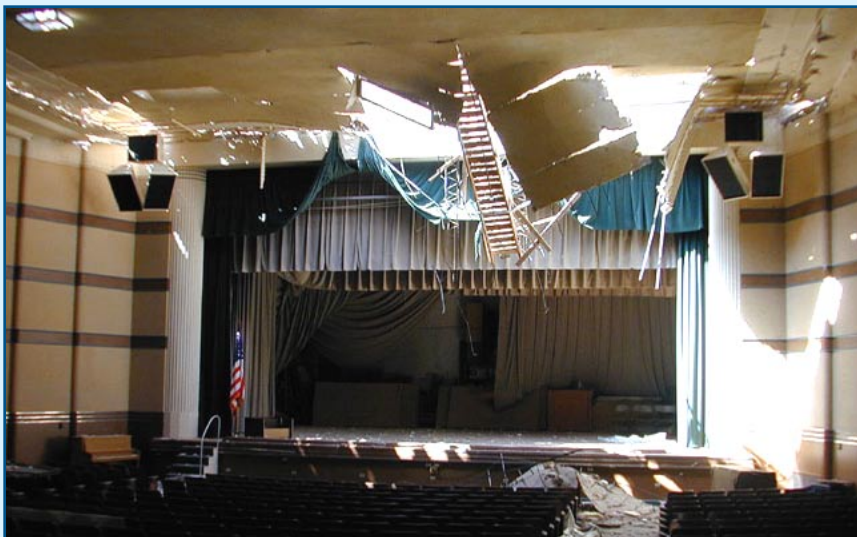
*The tornado caused serious damage to Hoisington High School. Part of the roof structure was removed by the high winds.*

Hoisington High School was another victim of the F4 tornado in April 2001. The building envelope was severely compromised in several places, rendering the building unfit for occupation for several weeks. The roof of the auditorium was torn away, the exterior wall of the art room was blown in, the technology building was damaged, and windows were smashed. Outside the school, parked buses were destroyed and the light poles for the football field were bent in half by the high winds. School had to be canceled until alternative arrangements for the students could be made.

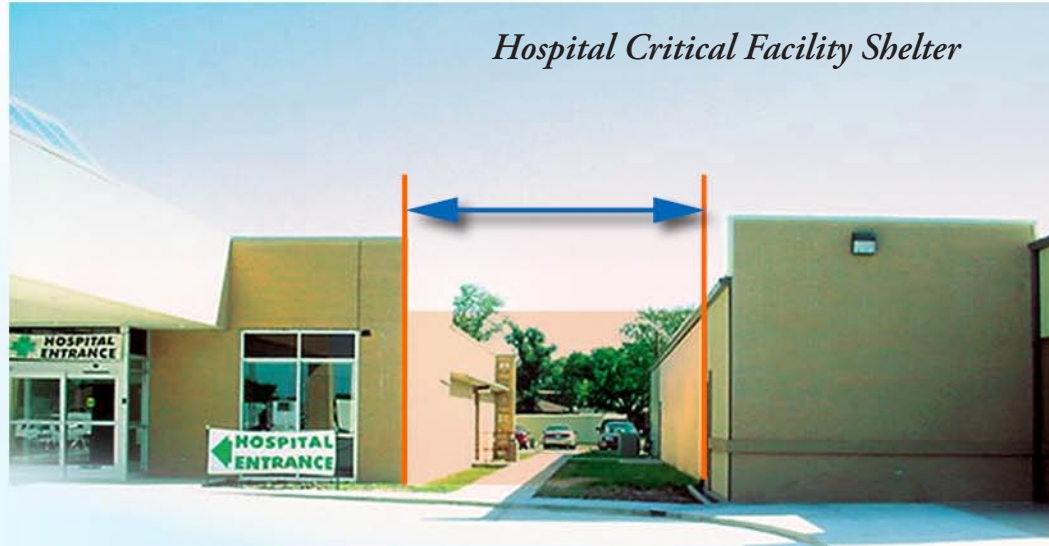
*This photograph, taken before construction of the shelter, shows the area between the hospital building (left) and clinic building (right) where the shelter is now located*

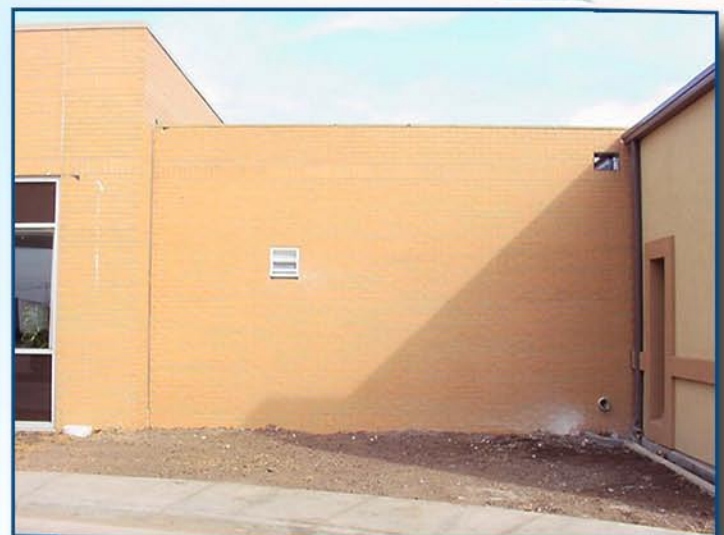
*Shelter, as seen from the front, between hospital building (left) and clinic building (right).*

The new shelter is located between the main hospital building and the clinic building to facilitate easy access from both areas. The shelter is connected to the two buildings with interior doors that meet the criteria presented in FEMA 361, *Design and Construction Guidance for Community Shelters*. The shelter has one exterior door (meets the FEMA 361 criteria) and no windows. The shelter has 1,026 square feet of finished area and is designed to accommodate 14 patients – assuming 6 are seated, 6 are in wheelchairs, and 2 are bedridden – and 30 standing staff members, with space for an additional 67 evacuees. The maximum number of occupants the shelter is designed to hold is 111. The shelter layout includes one large open area, two restrooms, a mechanical room, and a storage room. Typically, the open area is used for meetings and training classes.

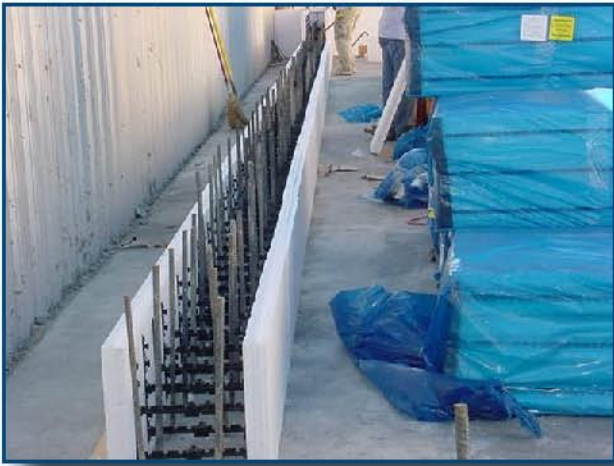
All perimeter walls were constructed with insulating concrete forms and reinforced with #5 bars spaced 8 inches on center to resist 250 mph wind speeds.

The wall system is Insulating Concrete Form (ICF) construction. This type of construction comprises 12-inch poured-in-place concrete, with polystyrene forms left in place, reinforced with #5 bars spaced at 8 inches on center (see cross-section of wall and roof on next page).

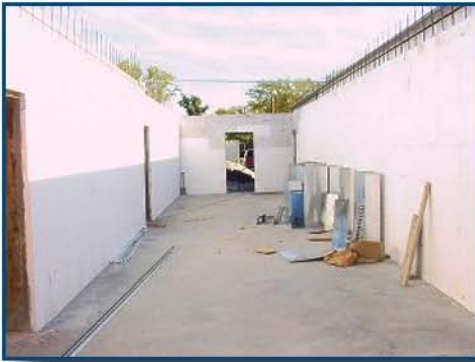
Interior of shelter, showing insulating concrete form perimeter walls.

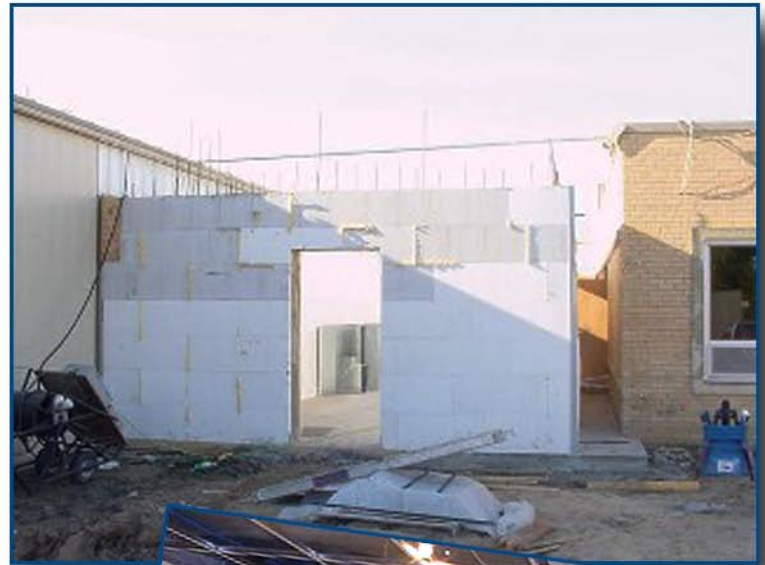
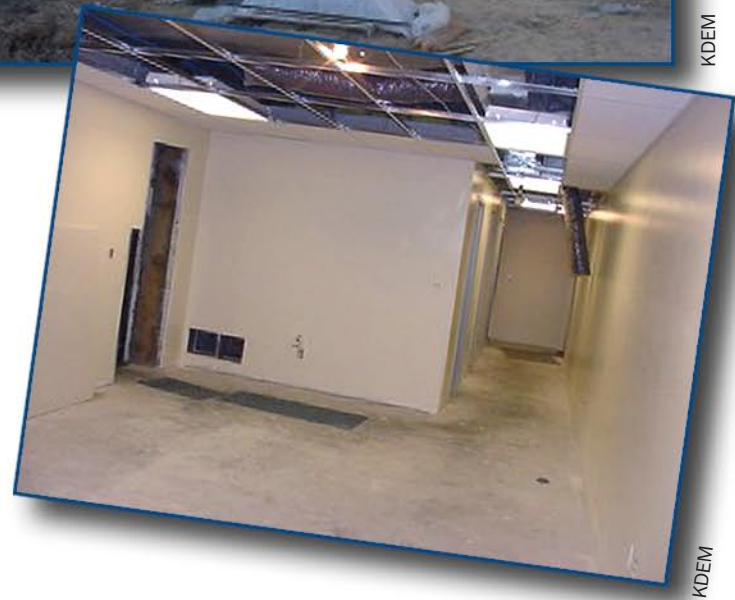
*Construction of the reinforced ICF exterior wall at the rear of the shelter (top). Interior walls of shelter with gypsum board finish (bottom).*

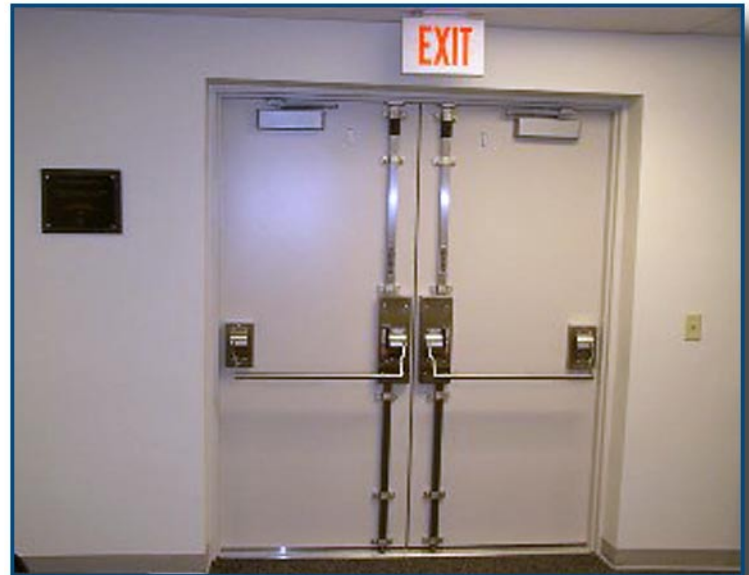
*View of the FEMA 361-compliant double door with 3-point latching hardware from inside shelter.*

Texas Tech University rates complete door assemblies – door, 6-point locking hardware (single-action activation), and steel frame – based on FEMA 361 criteria. These tested assemblies include both single and double doors. Door assemblies (door, frame, and hardware) that have successfully passed the pressure test (1.75 pounds per square inch) and three impact tests (15-pound wood 2x4 traveling at 100 mph) are summarized in the following table.

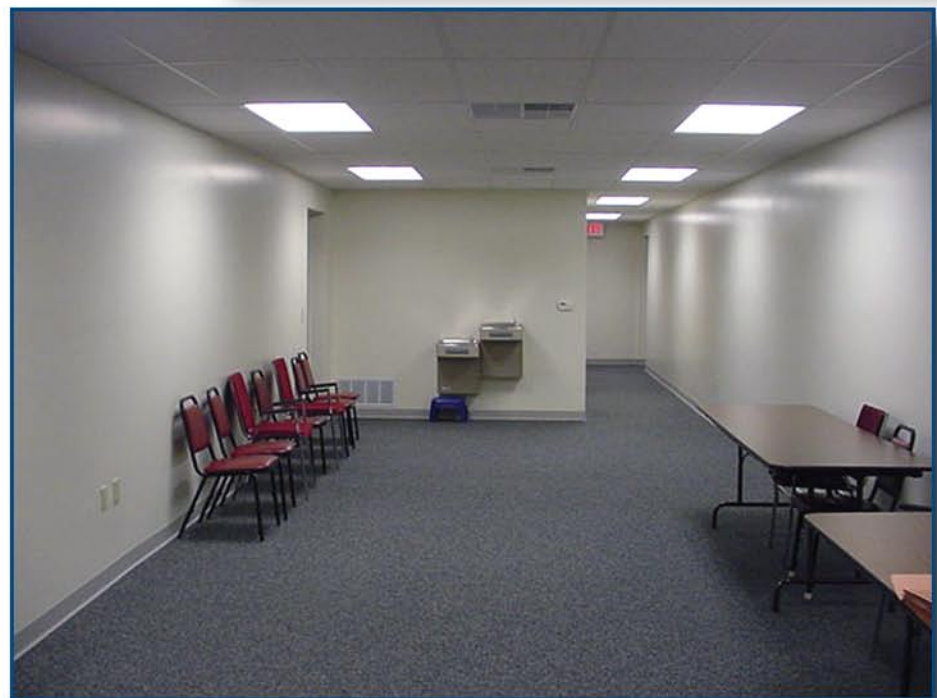
*Minimal furniture in the room is light and mobile for easy removal in order to clear the space for patients in an emergency (bottom).*
