# Design, Installation, and Retrofit of Doors, Windows, and Shutters

FEMA

HURRICANES IRMA AND MARIA IN THE U.S. VIRGIN ISLANDS *Recovery Advisory 4, March 2018*

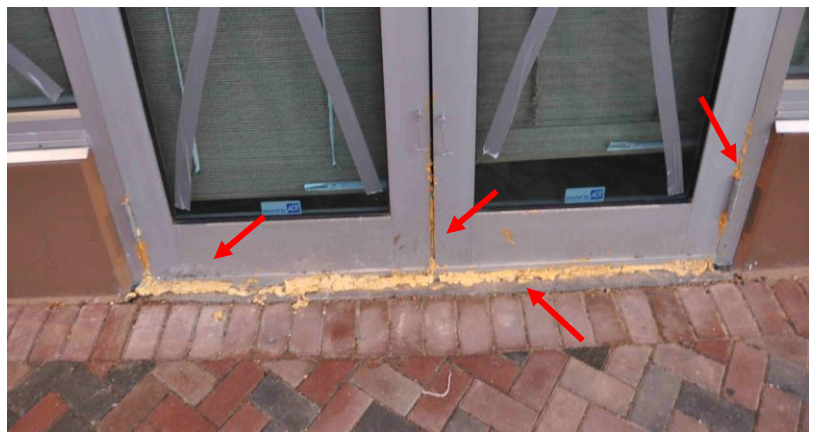
**Figure 1.** Expanding foam insulation was applied at gaps around and between these doors (red arrows).

- Adjust door weatherstripping to confirm a tight fit.
- Deploy shutters at doors and windows that are intended to be protected from wind-borne debris.
- Consider applying expanding foam insulation (available in aerosol cans) at door sill gaps and jambs (Figure 1) to avoid entrance of surface water and wind-driven rain. Removal of the foam may be difficult and time-consuming. Note that the window in Figure 1 was also taped. Tape is ineffective in increasing wind and wind-borne debris resistance.

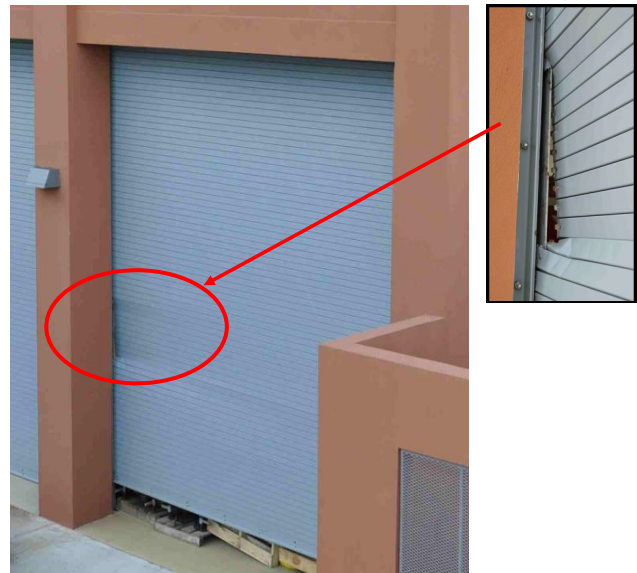
Figure 2. Rolling door damage at a new fire station.

Wind pressure failure of older sectional and rolling doors that were not manufactured to resist high wind loads is common. Surprisingly, several rolling door slats at a new fire station disengaged from their track (Figure 2). Also, two of the other five apparatus bay doors at this same fire station were not operational. The doors had a label that indicated pressure and impact resistance testing in accordance with Florida test standards, rather than DASMA test standard 115. DASMA 115 is more stringent than the applicable Florida test standards.

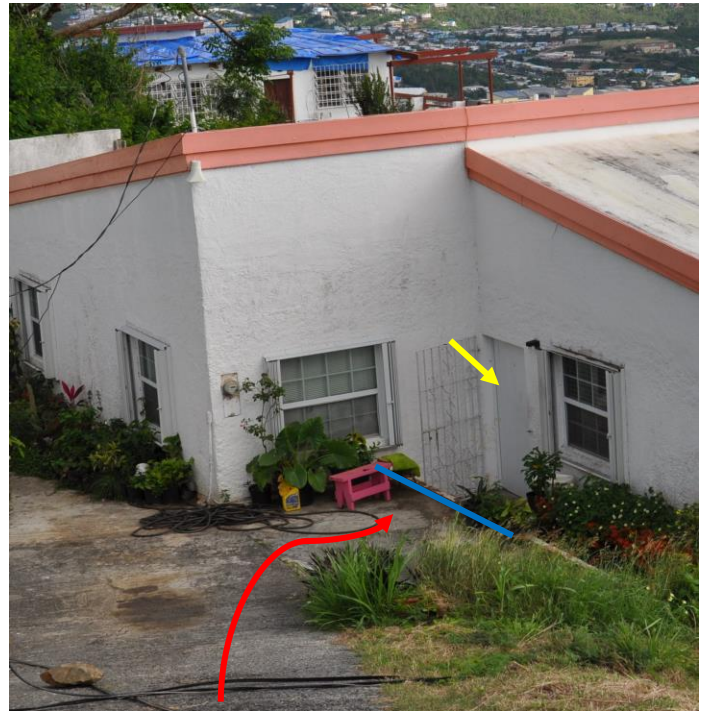
**Figure 3.** A substantial amount of water entered this house at the door (yellow arrow). The curb (blue line) was too short to divert the water running down the driveway.

Where the topography slopes towards doors, it is recommended that the grade be reconfigured with swales and/or berms to direct surface water flow away from doors. At the house shown in Figure 3, the driveway sloped down towards the entry door. A curb directed water away from the door, but it was too short to divert all the torrential rain.

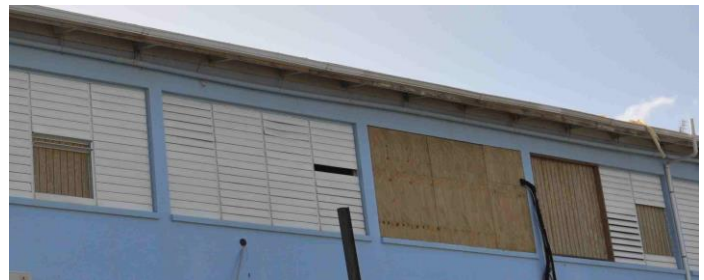
**Figure 4.** Several of the metal jalousie louvers at this school were blown away.

A jalousie opening has metal or glazed louvers that can be tilted to control airflow. Jalousies are common at schools, homes, and other types of buildings in the USVI. However, they are very susceptible to wind-driven rain, even when the louvers are undamaged (Figure 4). Depending upon the floor and wall construction, finishes, and location of furniture, entrance of wind-driven rain may cause limited or significant damage. If the magnitude and consequences of wind-driven rain infiltration associated with jalousies is unacceptable, fixed windows, or other types of operable windows, such as awning, casement, hopper, single-hung, or double-hung windows, can be specified.

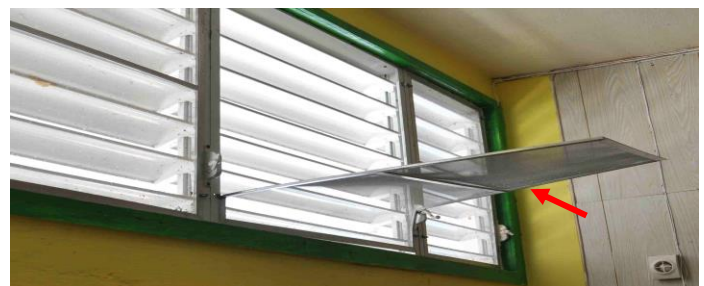
**Figure 5.** Glazed panels (red arrow) were mounted to the inside the jalousie. Such panels are typically ineffective in preventing entry of wind-driven rain.

At the school shown in Figure 5, panels glazed with plastic were mounted inside the jalousies for energy conservation. Most of the glazed panels were blown away. Even when the panels remain in place, interior water leakage can occur because the panels are not typically sealed to the jalousie frame.

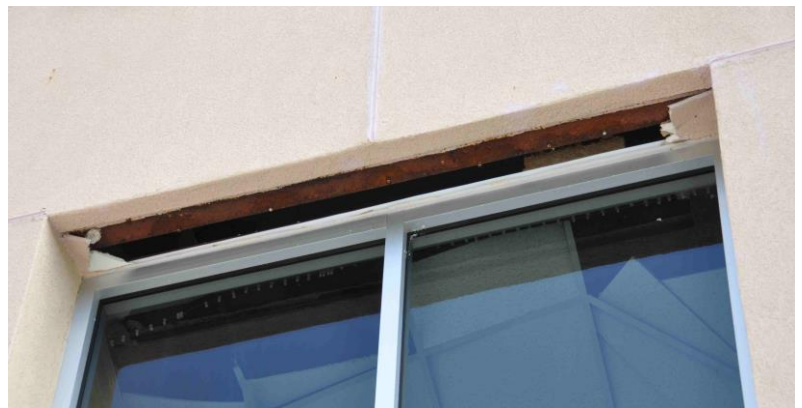
**Figure 6. Blow-off of the wall covering at the window head recess at a hospital allowed entrance of wind-driven rain.**

Fixed glazing assemblies are generally more resistant to wind-driven rain than operable assemblies, particularly as gaskets and seals at the operable interfaces age. Whether operable or fixed assemblies are specified, the assembly should be carefully integrated into the wall system. Figure 6 is an example where windows were replaced after Hurricane Marilyn (1995) with glazing systems that provided wind-borne debris and high wind pressure resistance. However, during Hurricane Irma, some of the wall covering blew away, and wind-driven rain entered the hospital. In addition, one window assembly blew into the facility, apparently due to inadequate attachment of the window frame to the wall framing.

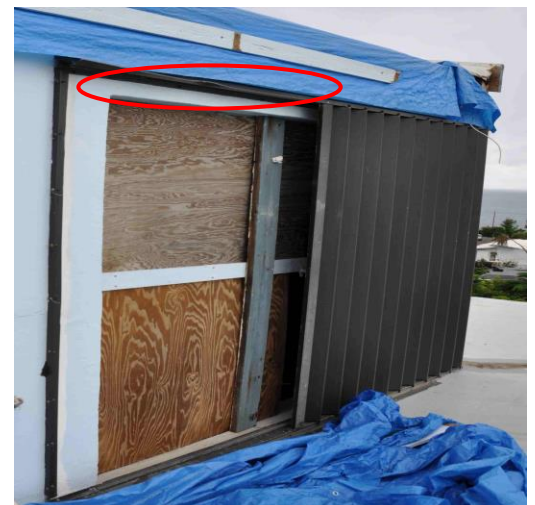
**Figure 7. The red oval indicates where the head track was deformed. Plywood was temporarily installed after the storm.**

It is recommended that only shutters bearing a label indicating that they have been tested and are building code compliant be installed. Figure 7 shows a damaged shutter without a label indicating whether it was a tested assembly. It is possible that the shutter experienced loads that exceeded those specified in the test standards, or it may not have been a tested assembly.

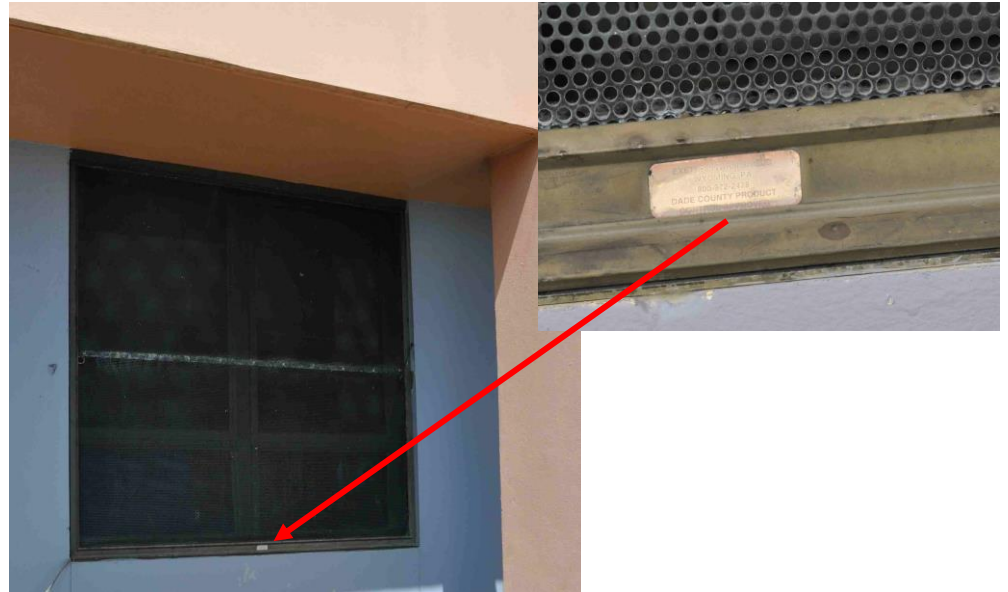
**Figure 8. Permanently mounted wind-borne debris-resistant screen at a medical clinic. The inset shows a close-up of the screen and a label indicating that the shutter was a tested assembly.**

Figure 8 illustrates a permanently mounted screen shutter. With this type of shutter, future deployment time and costs are eliminated.

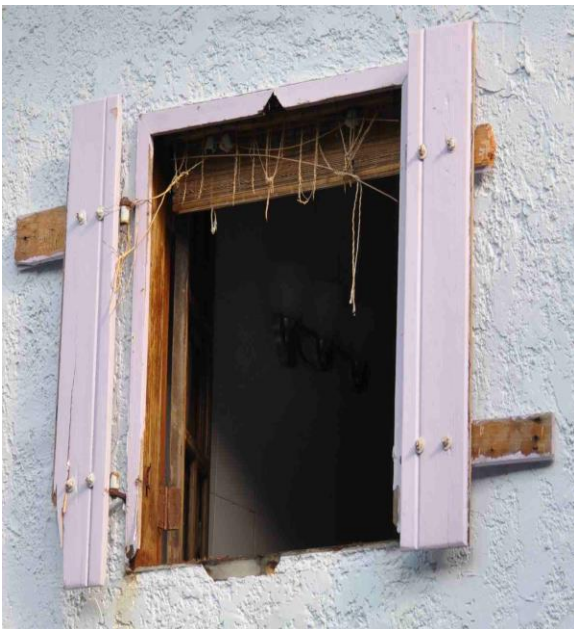
**Figure 9. Damaged traditional-type shutter.**

Hurricane Shutter Design Considerations for Florida, published by APA – The Engineered Wood Association (APA T460, 2013), provides guidance for constructing and installing wood panel shutters. If wood panels are installed, it is important to adequately anchor them so that they do not become wind-borne debris. Figure 9 shows traditional shutters made from thick wood boards. This type of shutter provides substantial resistance to wind-borne debris, provided the hardware and connecting bolts are not corroded and the shutters are adequately latched. As shown in Figure 9, the boards were inadequately bolted.

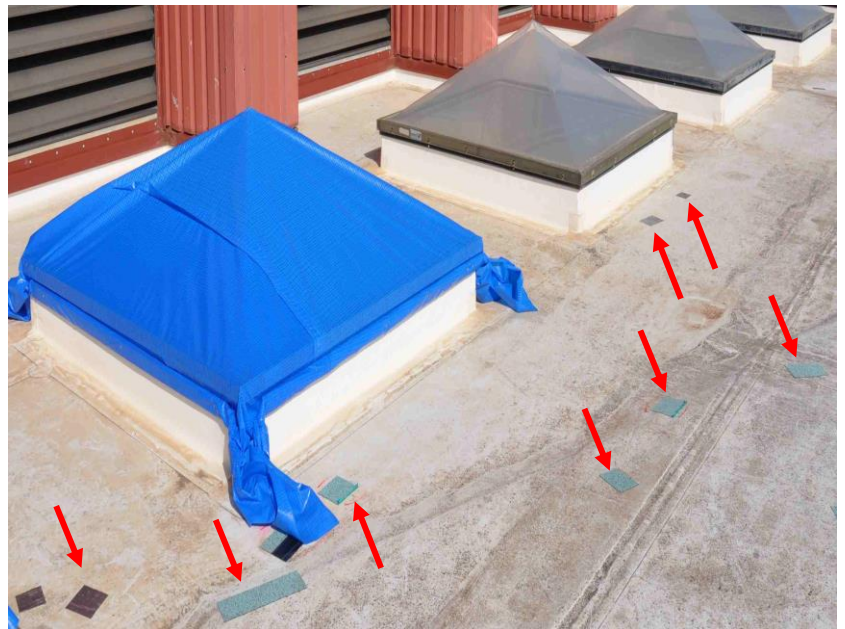
**Figure 10. Skylight damaged by wind-borne debris. The red arrows indicate patches where debris punctured the roof membrane.**

Skylights are also required to meet wind pressure and wind-borne debris criteria. At the airport terminal building shown in Figure 10, the skylights appeared to be adequately attached to their curbs, although some of the screws were corroded. A few of the skylights were broken by wind-borne debris, illustrating the importance of specifying skylights that have been tested to meet wind-borne debris criteria.
