# NISTIR 5950

## Study of Technology for Detecting Pre-Ignition Conditions of Cooking-Related Fires Associated with Electric and Gas Ranges and Cooktops, Final Report

*Prepared for:*  
**U. S. Consumer Product Safety Commission**  
Directorate for Engineering Sciences  
*Division of Electrical Engineering*  
Bethesda, MD 20814  
Contract No.: CPSC-IAG-95-1145

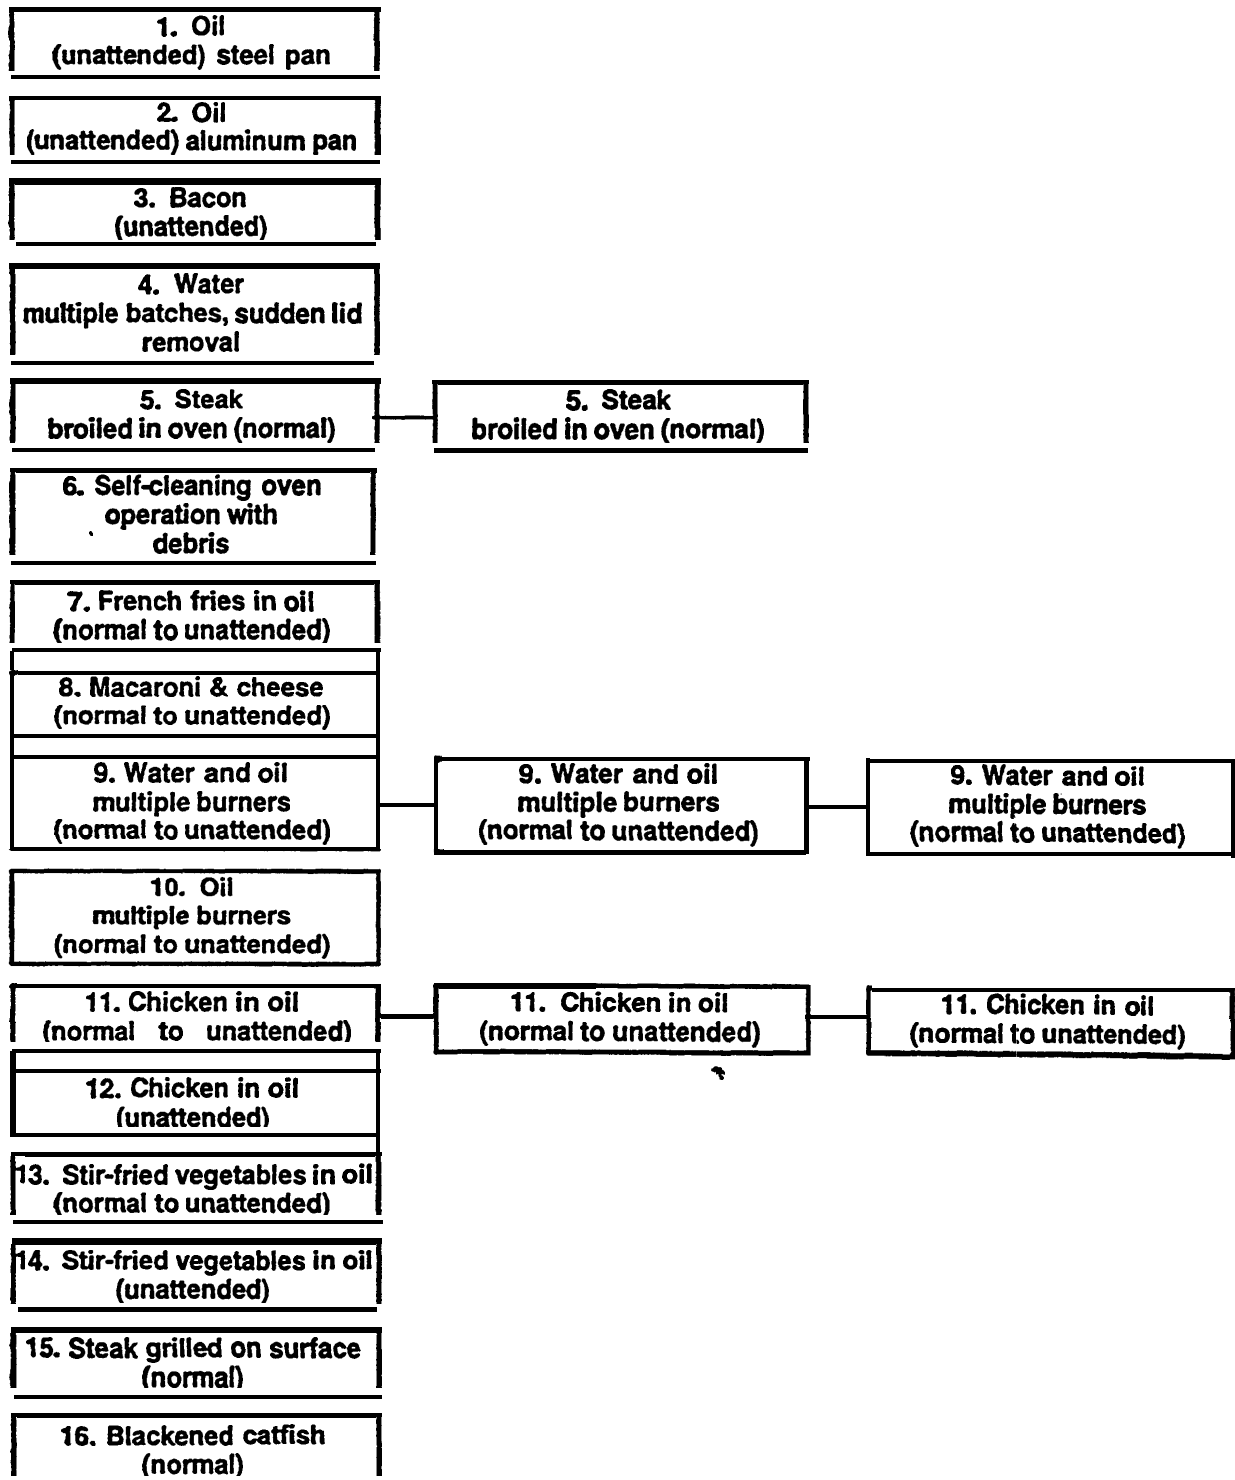
Figure 1. Categories of tests.

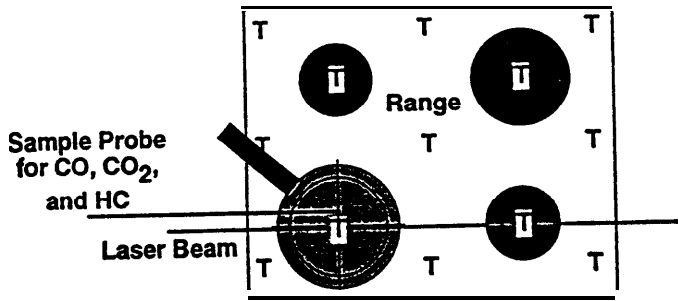
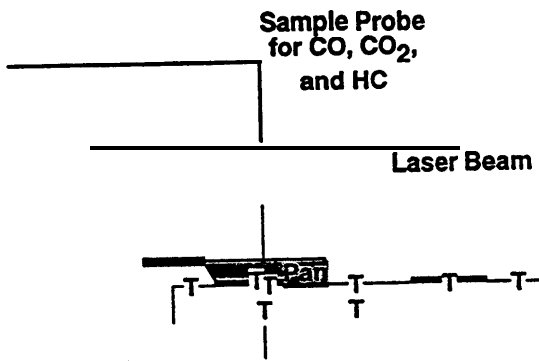
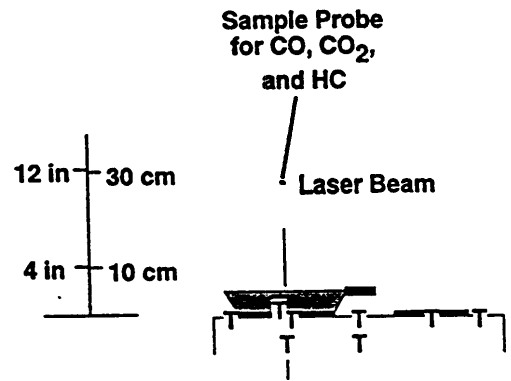
Range - Top View

Range - Front View

Range - Side View

Under-surface thermocouple applied for electric range A only

Thermocouples were used to measure temperatures in three general areas: near the food, around the range, and above the range. For the area near the food, thermocouples were placed at the center of each burner and contacted to the pan bottom if a pan was present. The contact was not through permanent fastening, but was ensured by spring loading the thermocouple. For electric range A, the thermocouple was located inside the center coil of the burner element and did not contact the element itself. For the gas range, the thermocouples were also bent in order to contact the pan bottom, and for protection, ceramic tubes were placed around the thermocouples in the vicinity where they passed through the flame. One thermocouple was placed in the food near the center of the pan. The pan and food thermocouples were all Omega model number KMQSS-020(G)-12 [stainless-steel sheathed, 0.51 mm (0.020 in) sheath diameter, K-type (Chromel-Alumel), grounded, 30 cm (12 in) long]. For range A, additional thermocouples were located on the drip pan centered below the burner and on the surface beneath the drip pan centered below the burner.

For the area around the range, thermocouples were placed on the top surface at **left**, center, and right positions along the front and midway back from the front of the burner area of the range. For range A, a thermocouple was also placed beneath the top surface of the range at the center left to right and front to rear of the burner area. These locations are depicted in Figure 2. A thermocouple was placed on the upper **surface** inside the oven 5.5 cm (2.2 in) behind the door opening and centered across the oven.

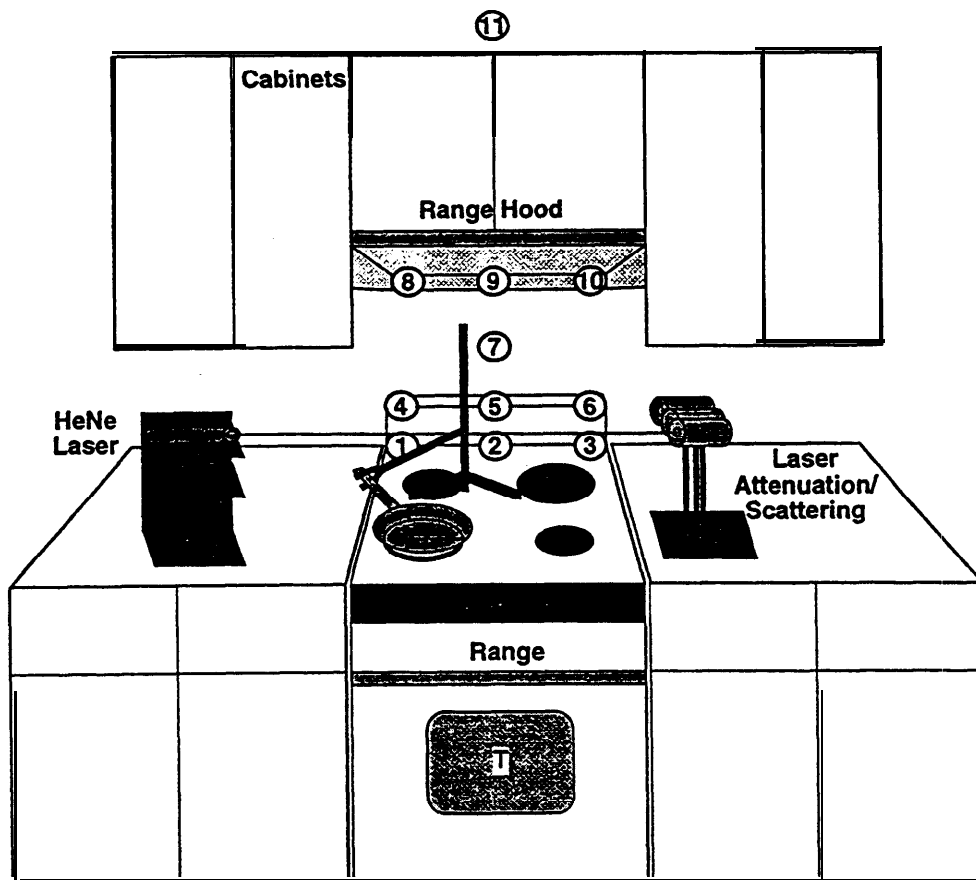
- ⑪ Sensor Housing Location
- T Thermocouple Location

Figure 3. Schematic of near-range configuration, instruments, sensors, and thermocouples.

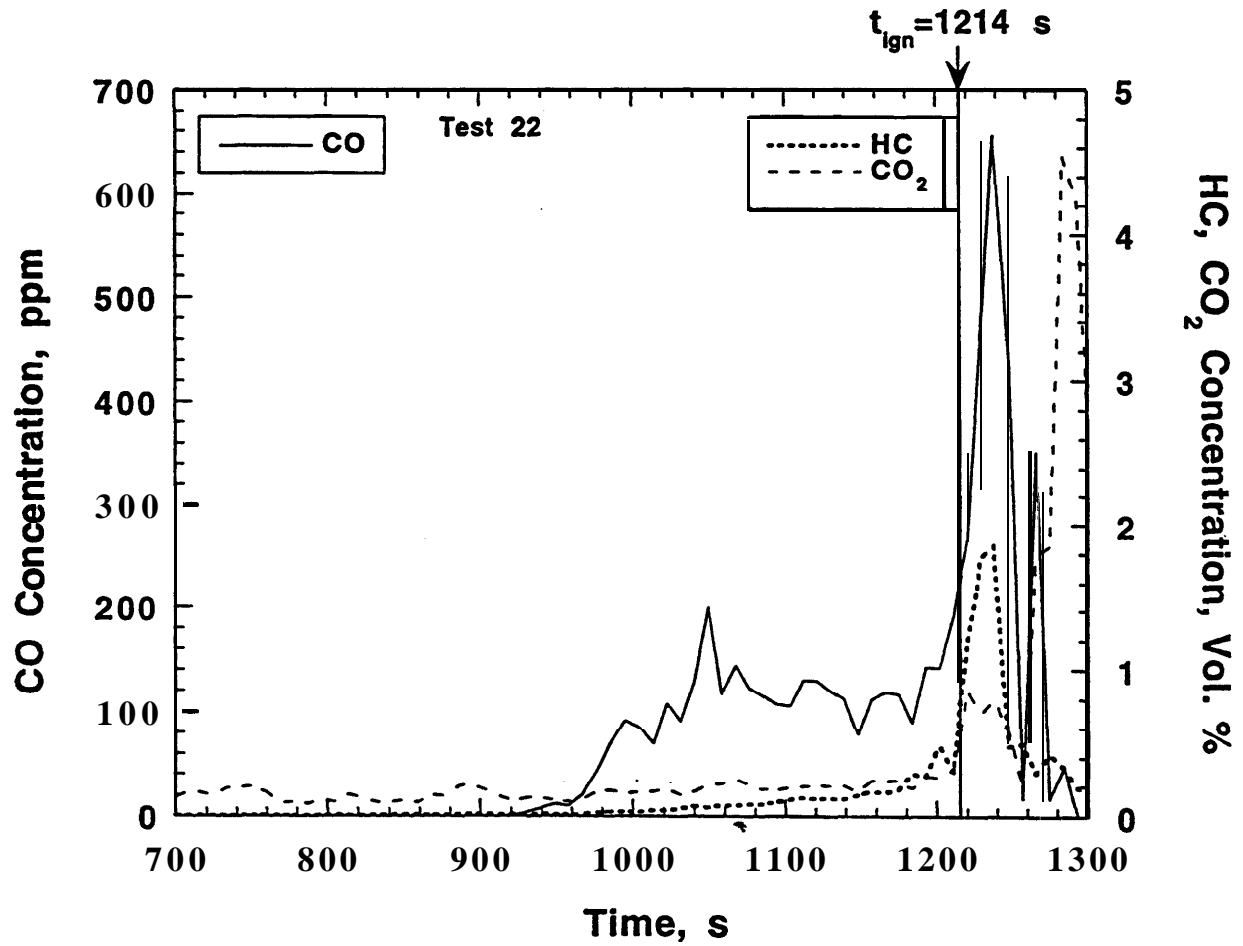
The results of gas-analyzer measurements for two tests are shown in Figures 5 and 6. Figure 5 is a plot of CO, CO<sub>2</sub>, and total-hydrocarbon concentrations versus time for a test of french-fried potatoes cooked in 500 mL of soybean oil. The concentrations of CO and CO<sub>2</sub> were measured on a dry basis (water removed). The concentration unit of parts per million is designated by ppm. The CO<sub>2</sub> concentration increased from an initial background level of 0.1%

Figure 5. CO, hydrocarbon, and CO<sub>2</sub> concentrations versus time for **french-fried** potatoes in soybean oil (**normal**→**unattended**).

to about 0.3% before ignition. The CO concentration increased from 0 ppm to about 200 ppm with all of the rise occurring in the 300 s preceding ignition. The hydrocarbon concentration increased from 0% to 0.5% over about the same period as CO. After ignition, CO and hydrocarbon concentrations continued to rise because the lid used to smother the fire increased interior pan and food temperatures and thus smoke production. The late peak of CO concentration reflects the use of the fire extinguisher to cool the pan and **extinguish** reignitions.

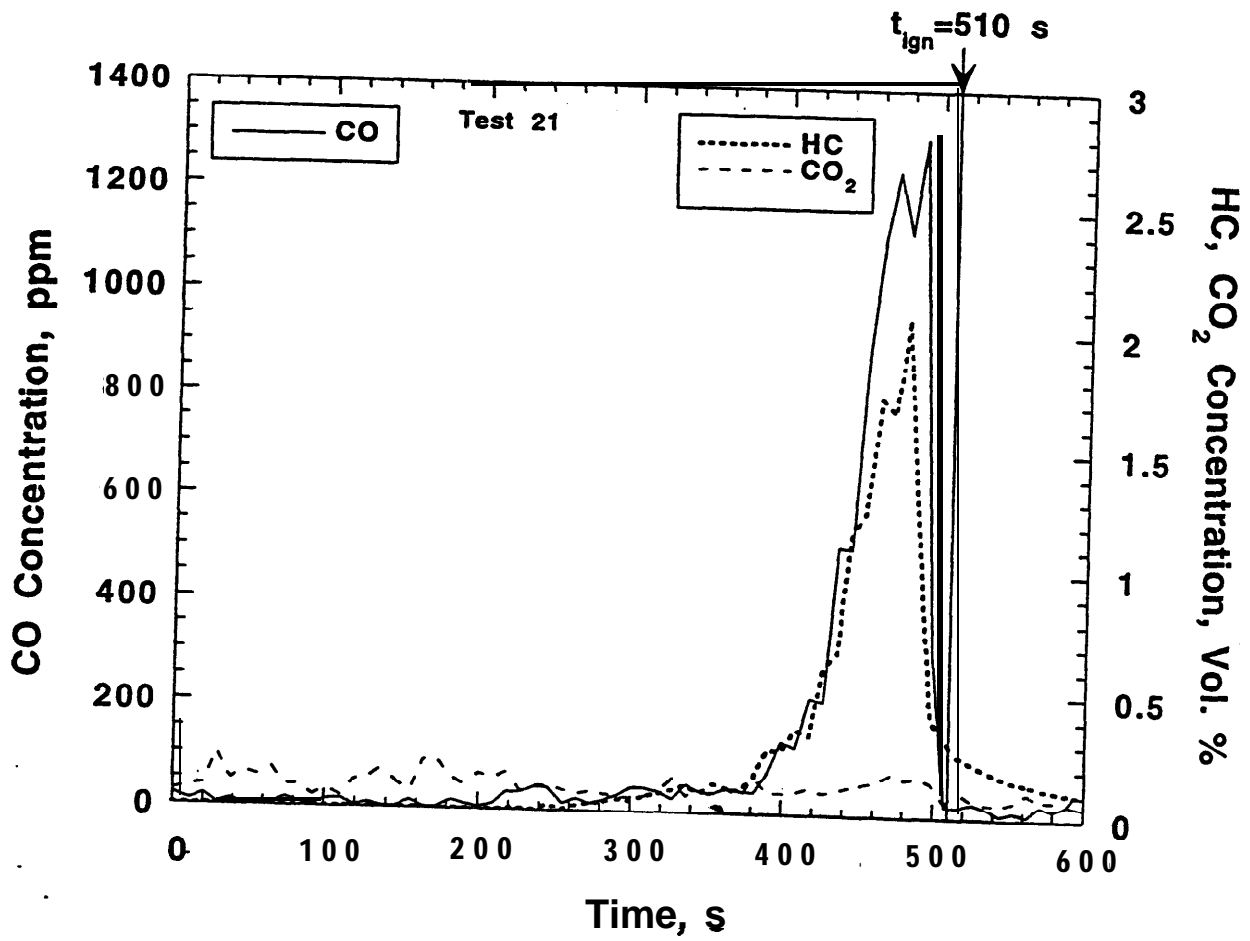
Figure 6 shows the corresponding results for a test of blackened catfish. The ignition line appears delayed relative to the analyzer signals because for this particular test, the food ignited about 30 s after the pan was removed from the hot burner and placed on a cold burner away from the gas sampling probe. The CO<sub>2</sub> concentration remained near its background level through 480 s when the pan was removed from the heat. No extinguisher was used so the CO<sub>2</sub> level remained low. The CO concentration increased **from** 0 ppm initially to about 1200 ppm at 480 s with most of the rise occurring after 380 s. The hydrocarbon concentration increased from 0% to 2% between 240 s and 480 s.

Figure 6. CO, hydrocarbon, and CO<sub>2</sub> concentrations versus time for blackened catfish (normal).

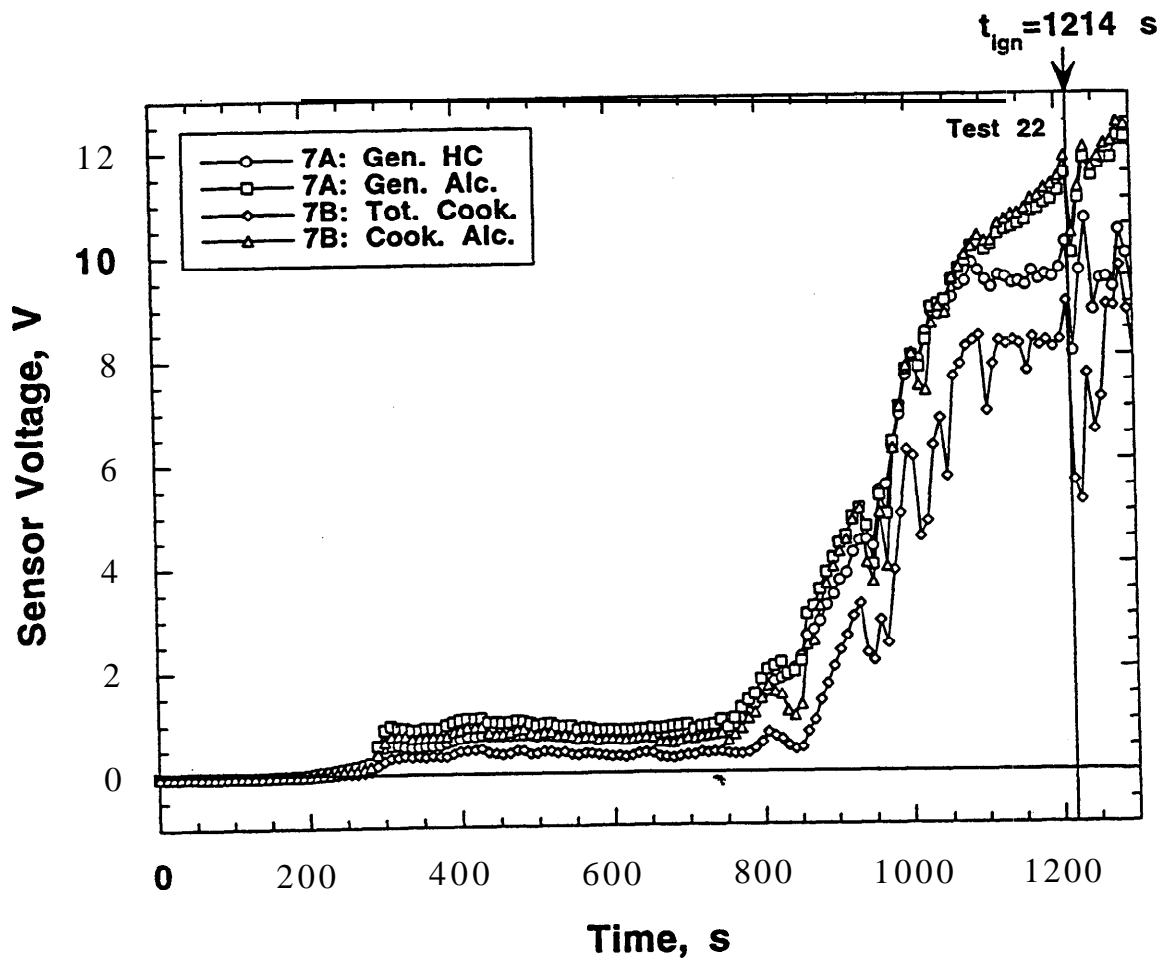
Figure 7. Site 7 hydrocarbon-sensor responses versus time for **french-fried** potatoes in soybean oil (**normal**→**unattended**).

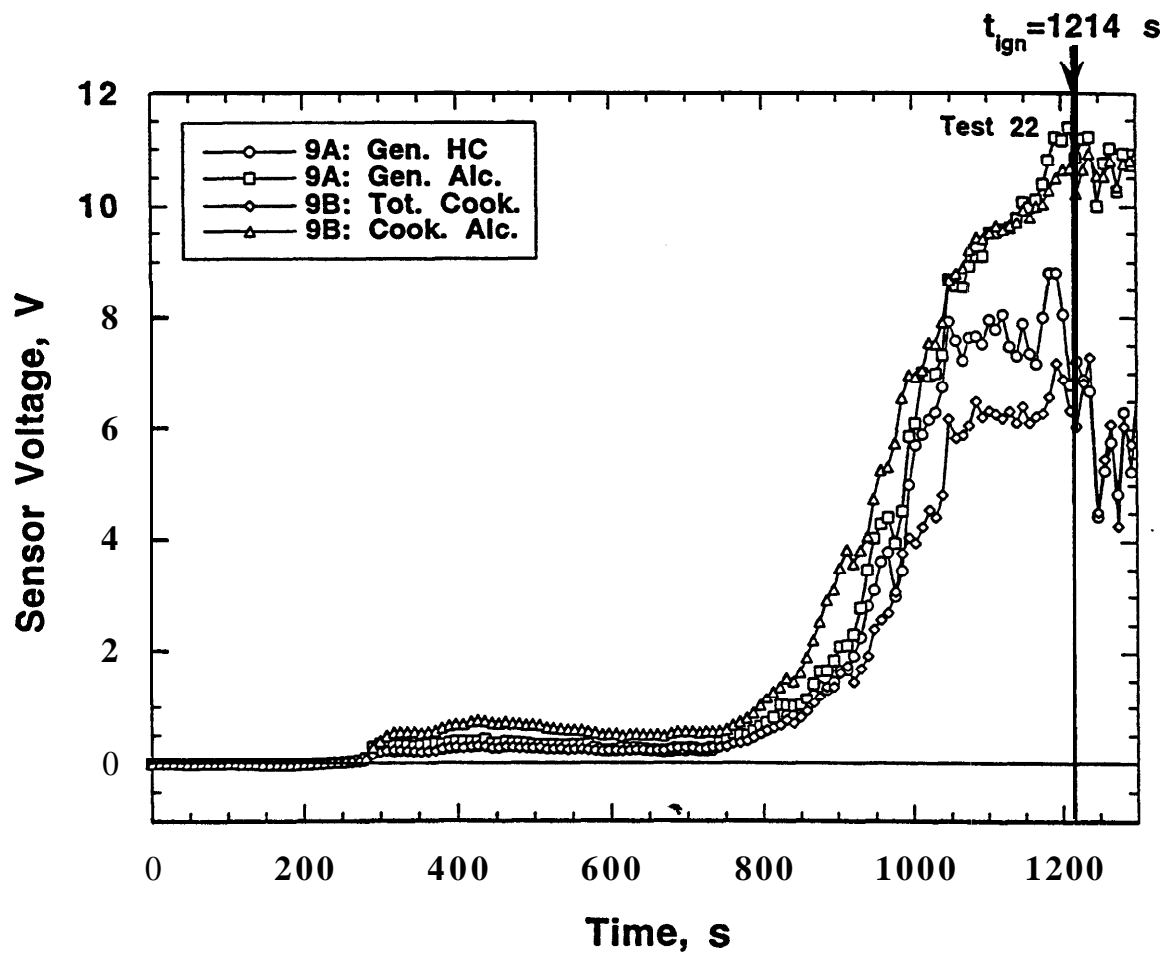
Figure 8. Site 9 hydrocarbon-sensor responses versus time for **french-fried** potatoes in soybean oil (**normal**→**unattended**).

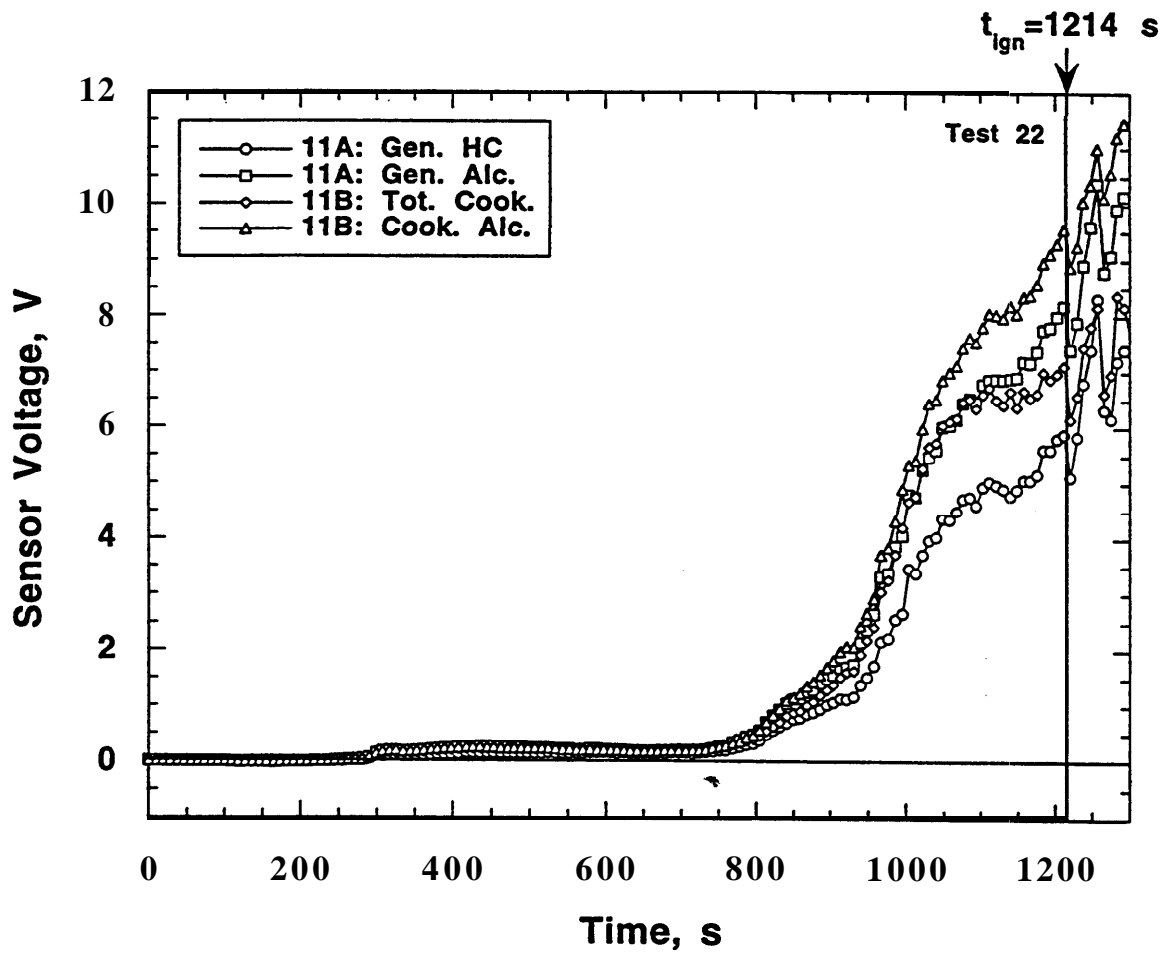
Figure 9. Site 11 hydrocarbon-sensor responses versus time for **french-fried** potatoes in soybean oil (**normal**→**unattended**).

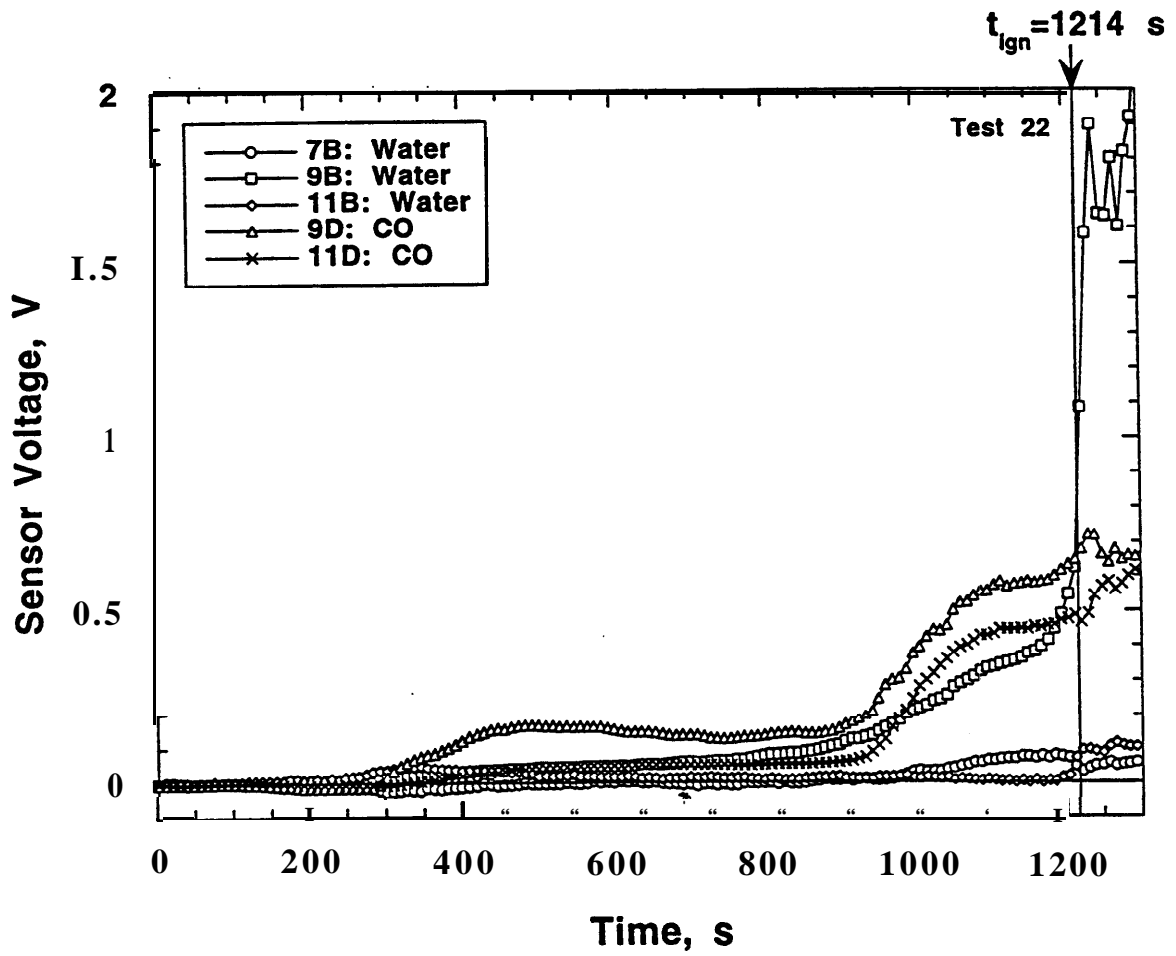
Figure 10. Sites 7, 9, 11 water-vapor and CO-sensor responses versus time for french-fried potatoes in soybean oil (normal→unattended).

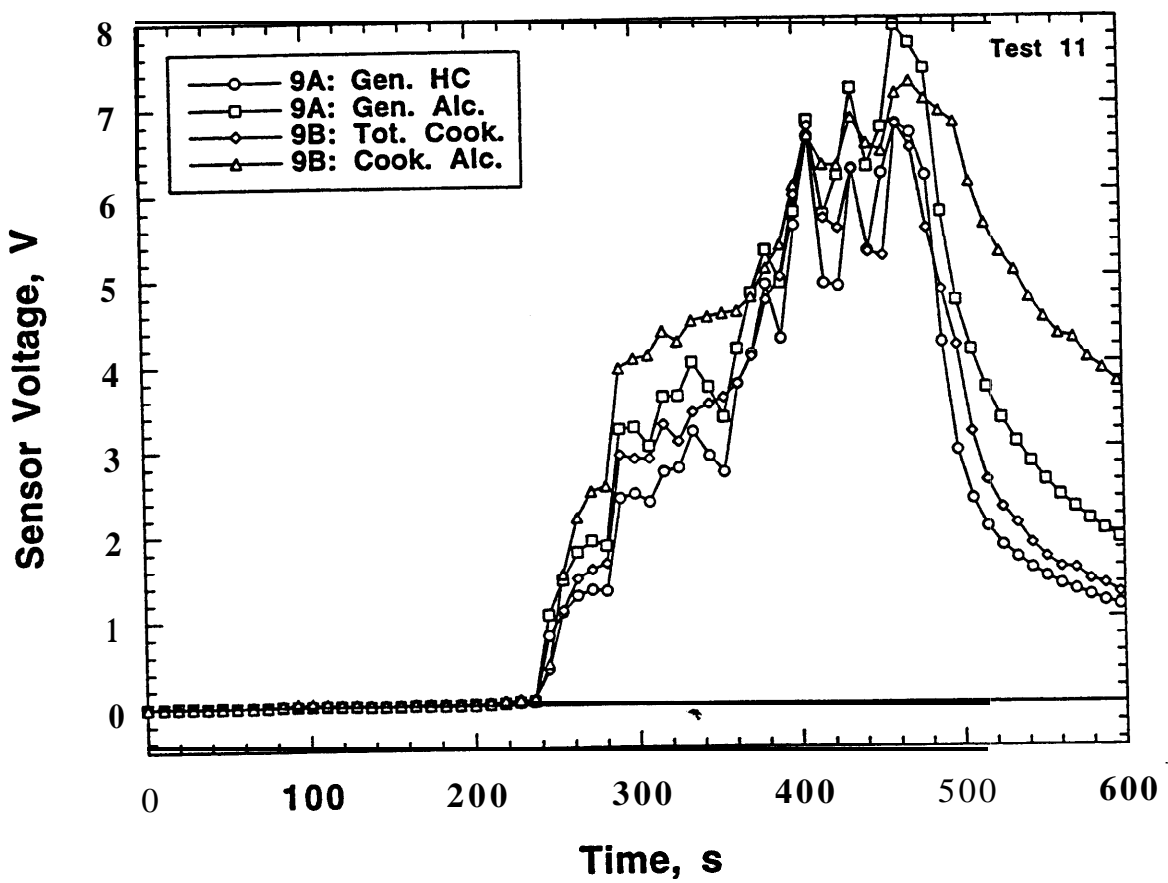
Figure 11. Site 9 hydrocarbon-sensor responses versus time for blackened **catfish** (normal).

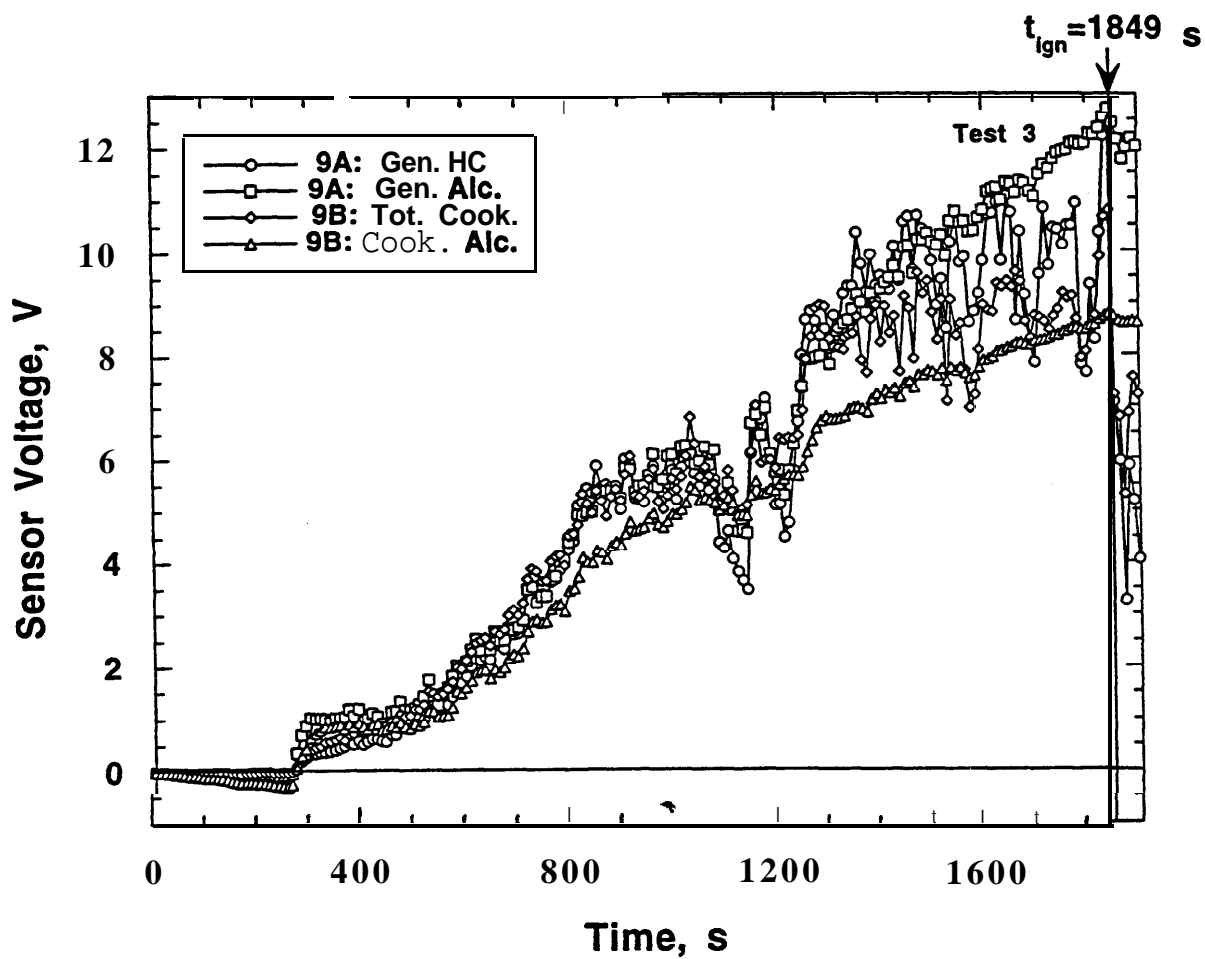
Figure 12. Site 9 hydrocarbon-sensor responses versus time for chicken in soybean oil (unattended).

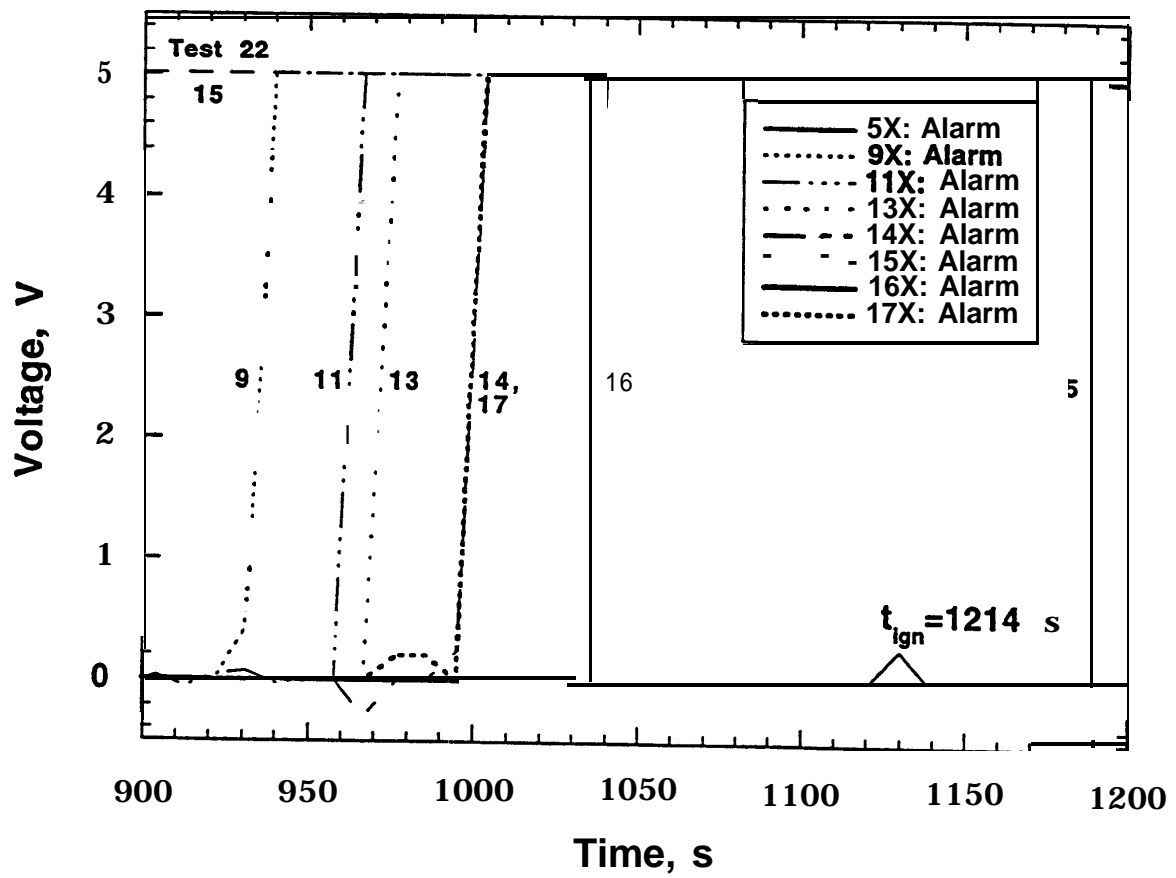
Figure 13. All photoelectric detector **alarm** signals versus time for **french-fried** potatoes in soybean oil (**normal**→**unattended**).

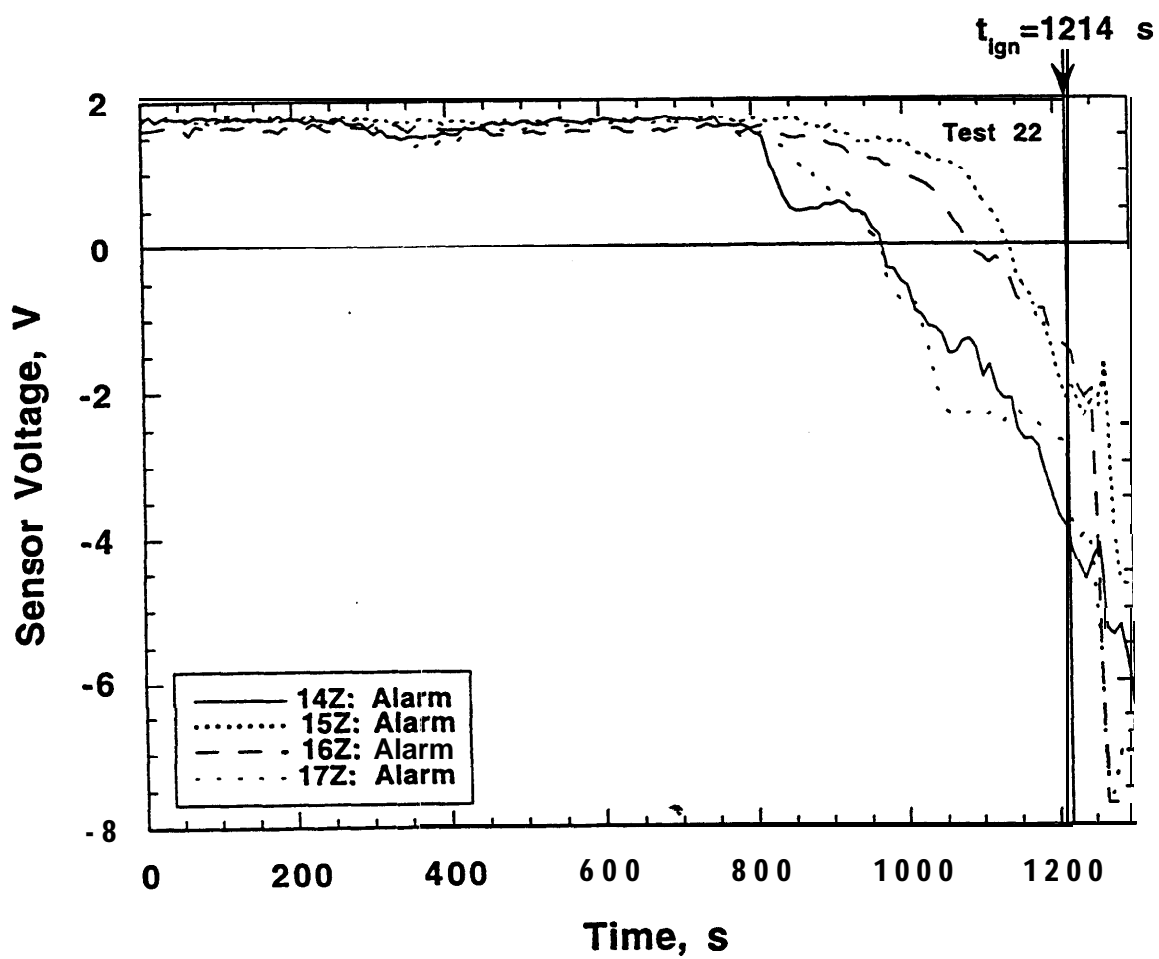
Figure 14. All ionization detector alarm signals versus time for french-fried potatoes in soybean oil (**normal**→**unattended**).

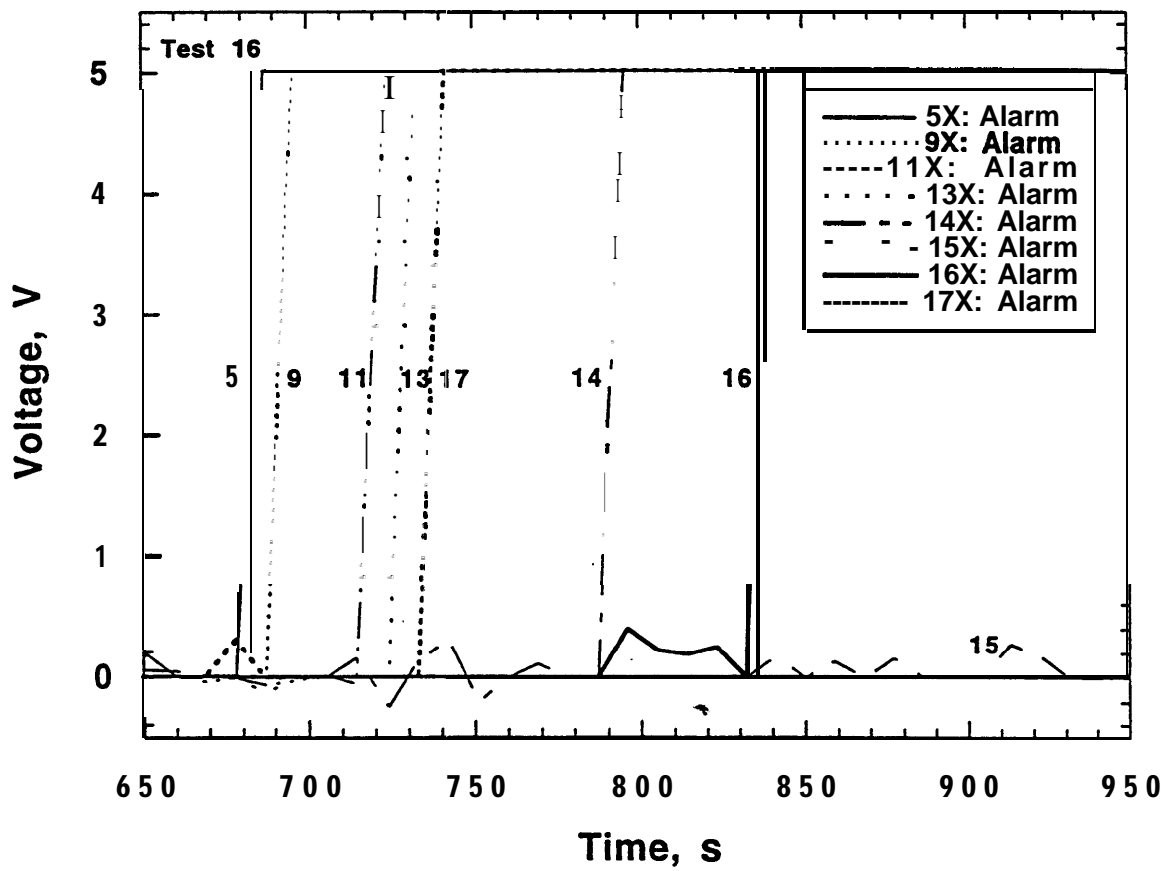
Figure 15. All photoelectric detector alarm signals versus time for broiled steak (normal).

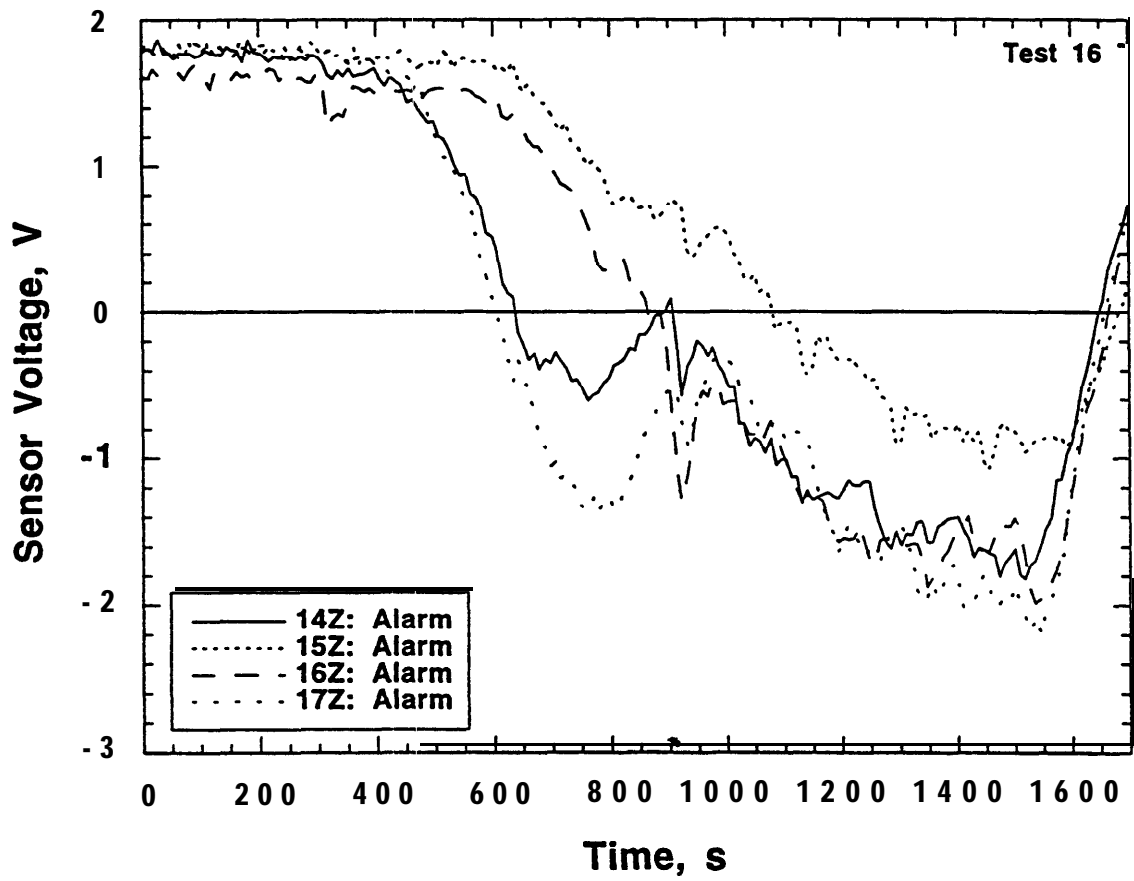
Figure 16. All ionization detector alarm signals versus time for broiled steak (normal).

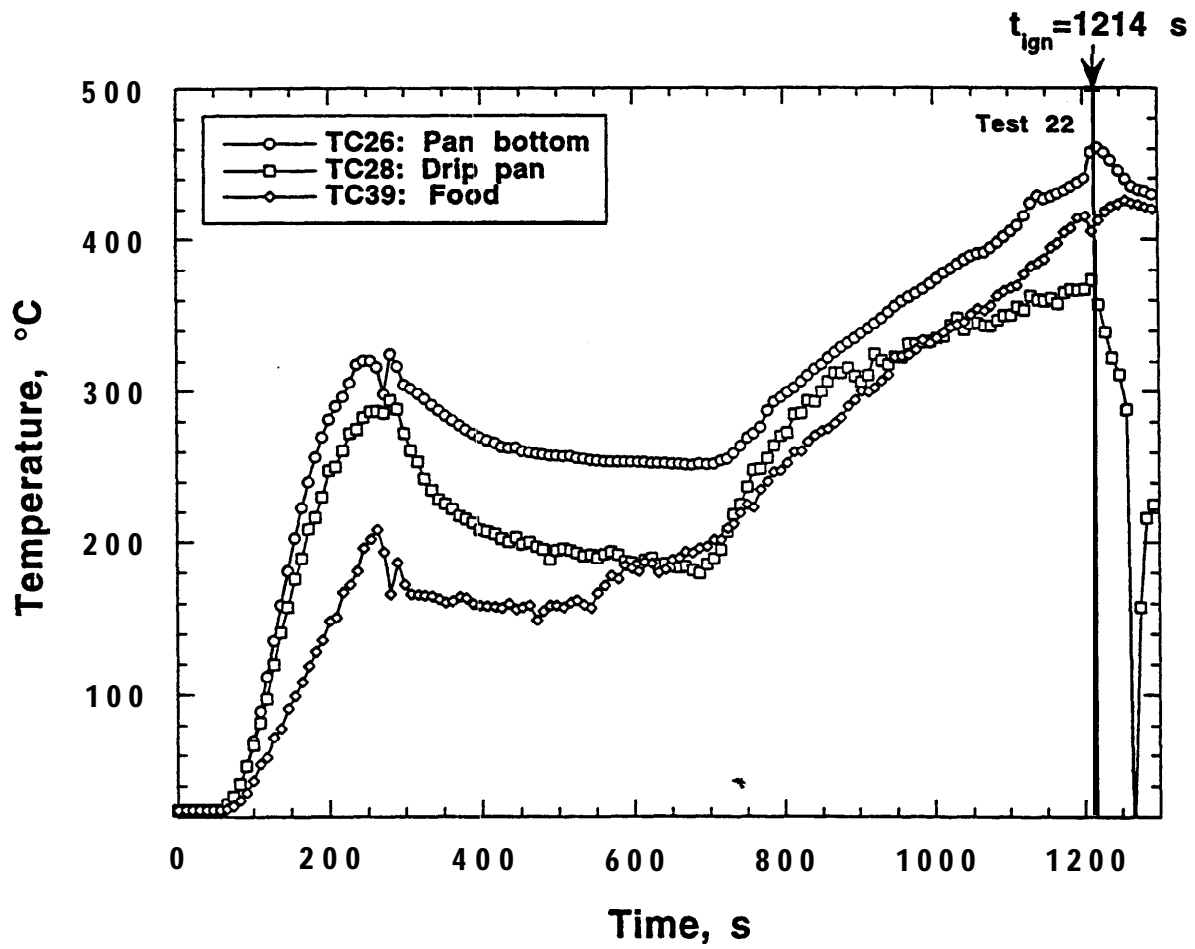
Figure 17. Temperatures near the pan versus time for french-fried potatoes in soybean oil (normal→unattended).

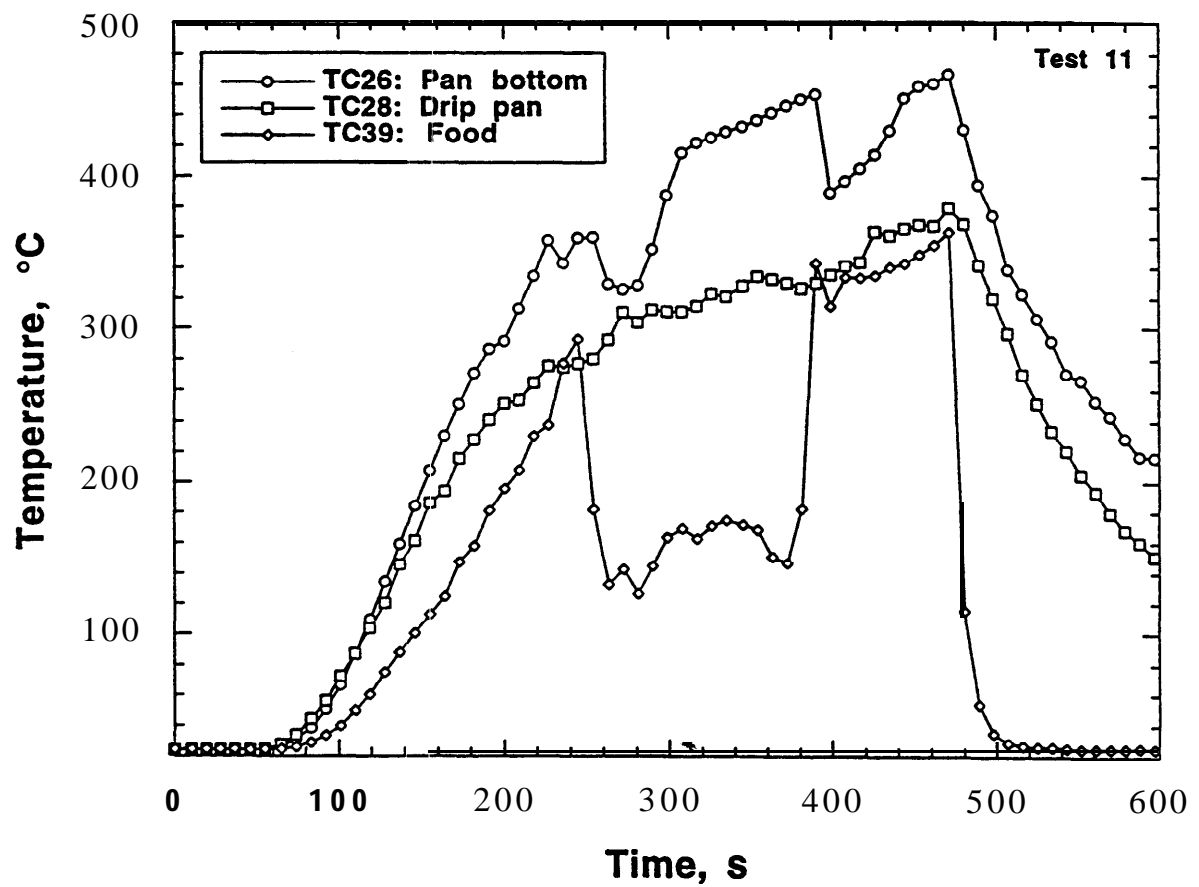
Figure 18. Temperatures near the pan versus time for blackened catfish (normal).

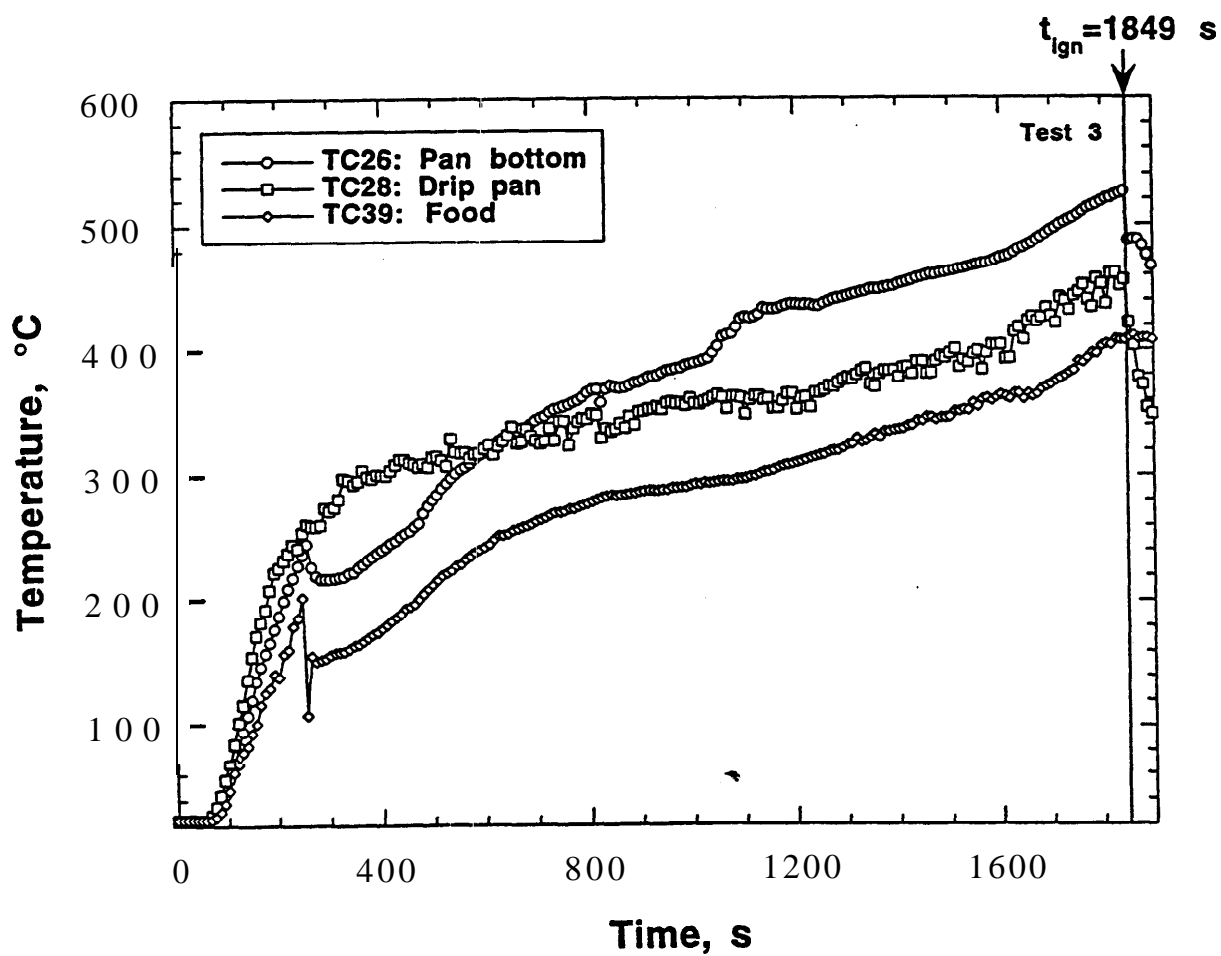
Figure 19. Temperatures near the pan versus time for chicken in soybean oil (unattended).

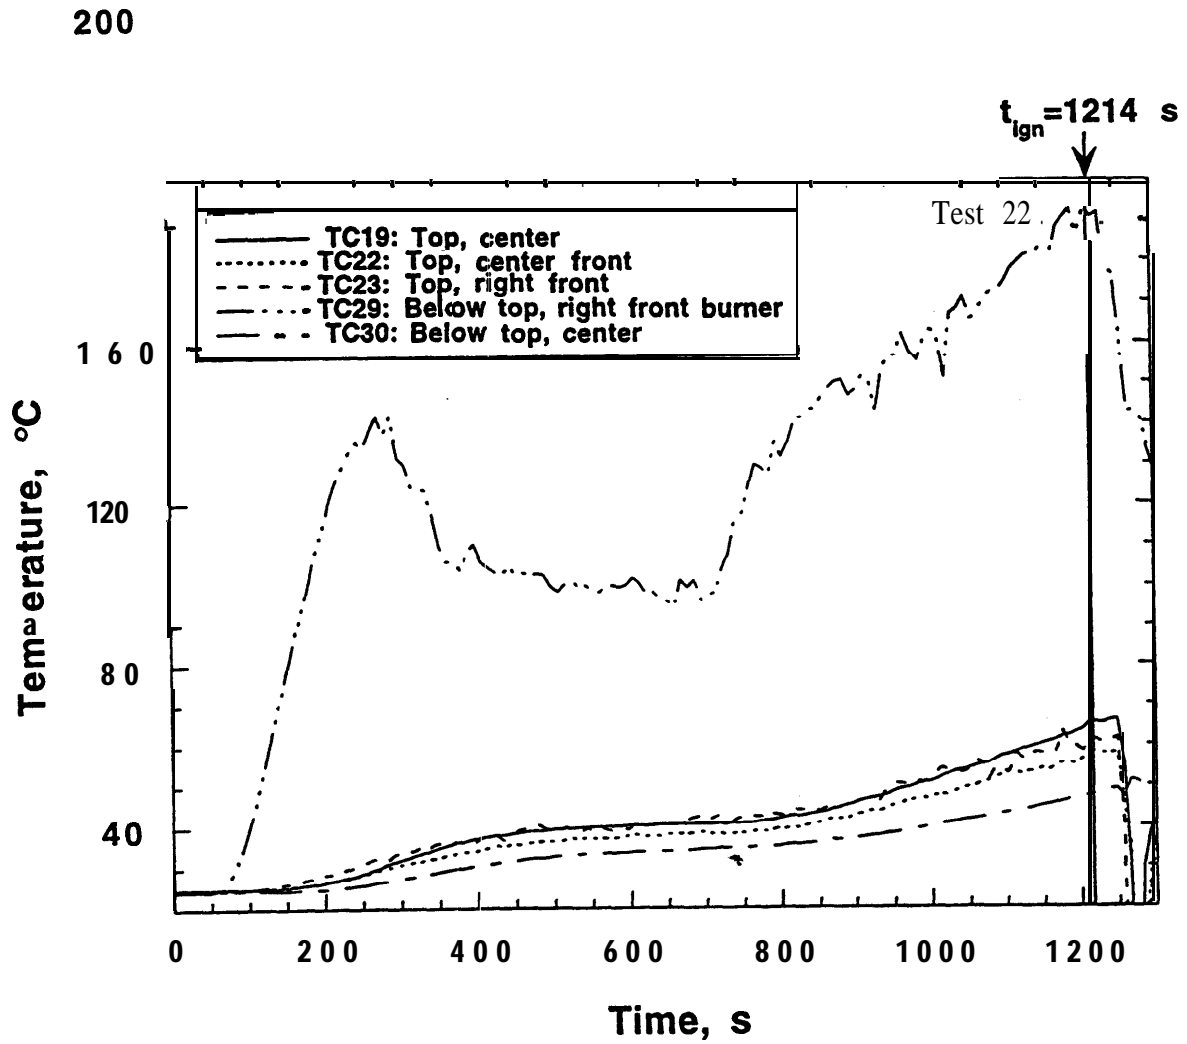
Figure 20. Temperature of the range versus time for **french-fried** potatoes in soybean oil (normal→unattended).
