# NISTIR 5950

## Study of Technology for Detecting Pre-Ignition Conditions of Cooking-Related Fires Associated with Electric and Gas Ranges and Cooktops, Final Report

*Prepared for:*  
**U. S. Consumer Product Safety Commission**  
Directorate for Engineering Sciences  
*Division of Electrical Engineering*  
Bethesda, MD 20814  
Contract No.: CPSC-IAG-95-1145

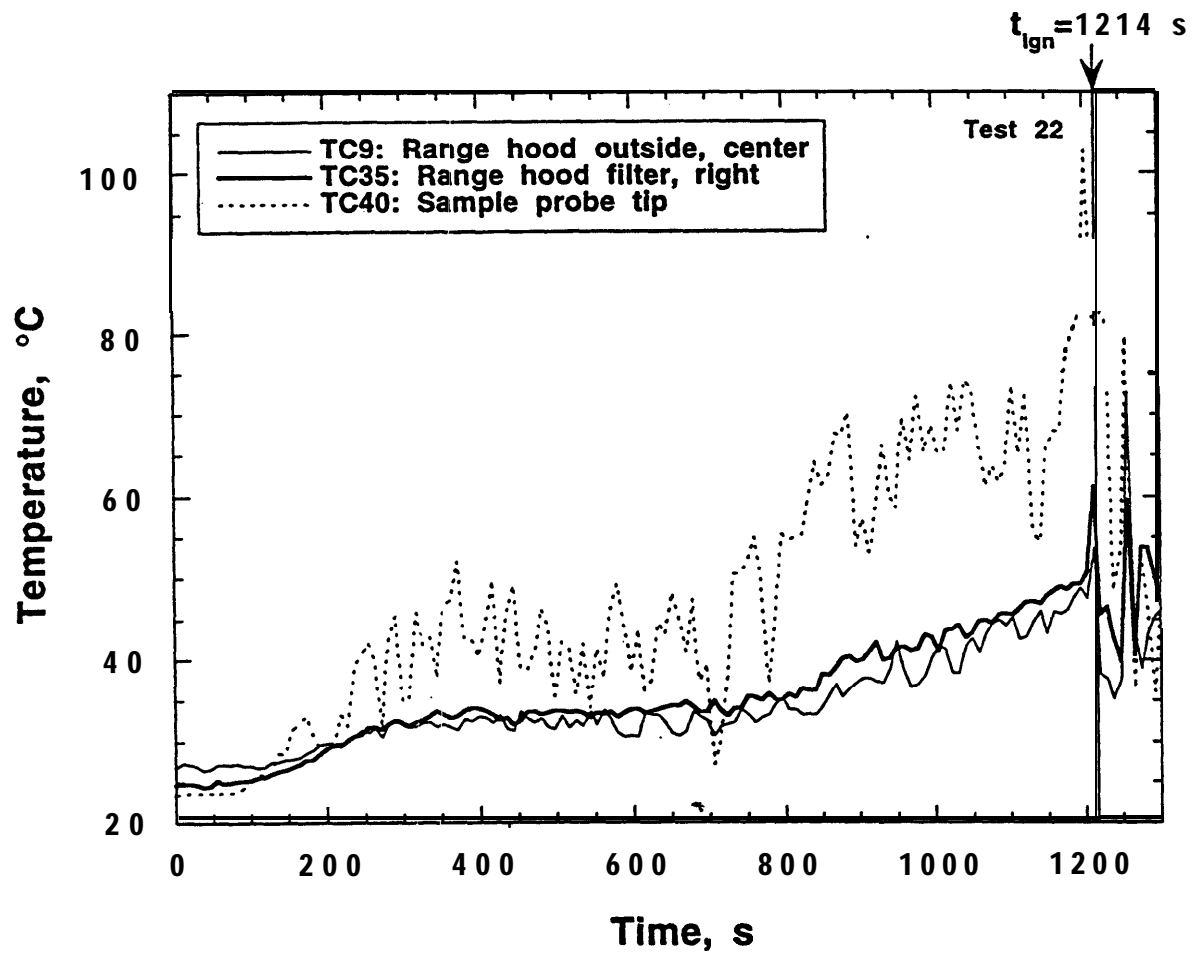
Figure 21. Temperatures above the range versus time for french-fried potatoes in soybean oil (normal→unattended).

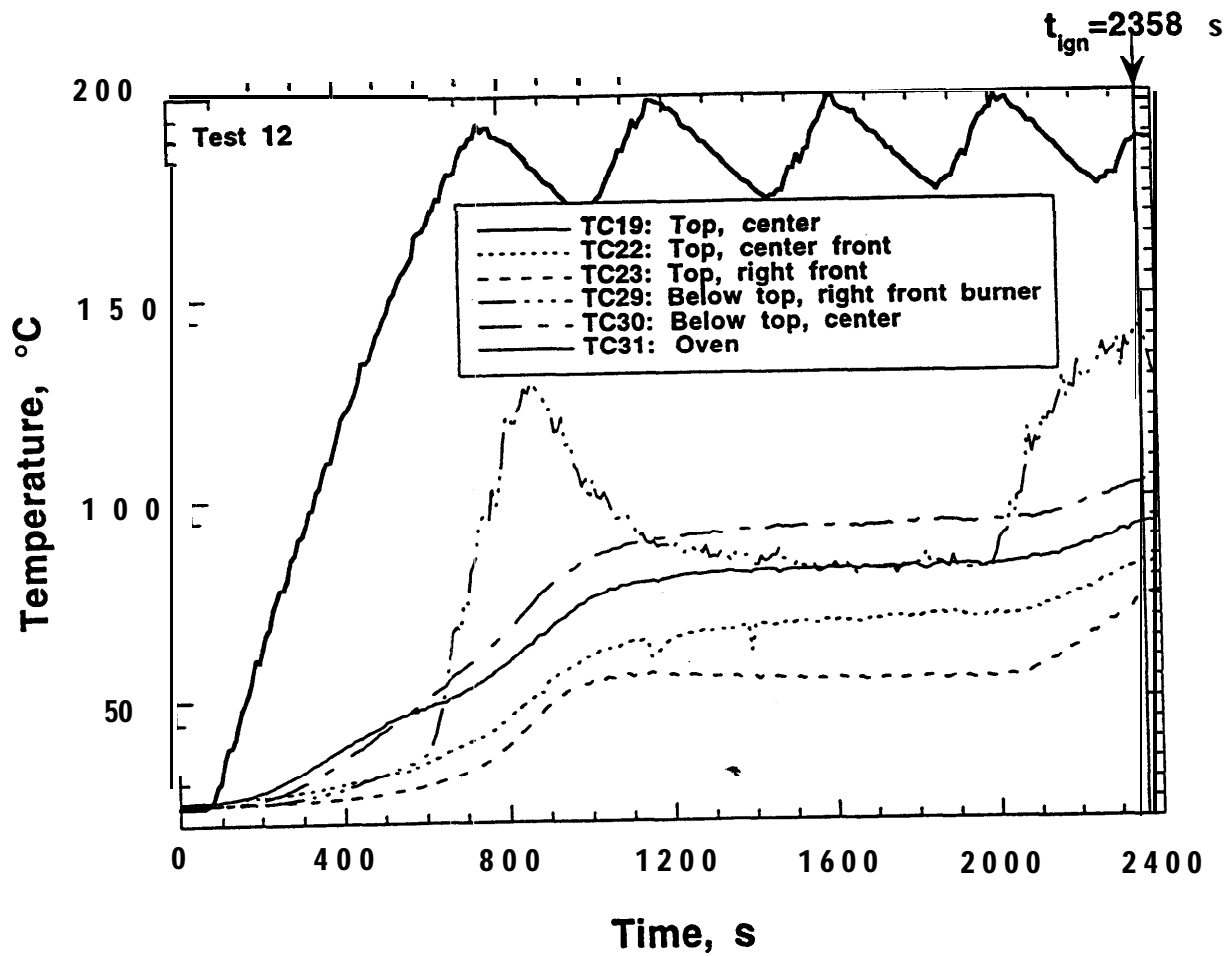
Figure 22. Temperatures of the range versus time for water and oil (normal→unattended).

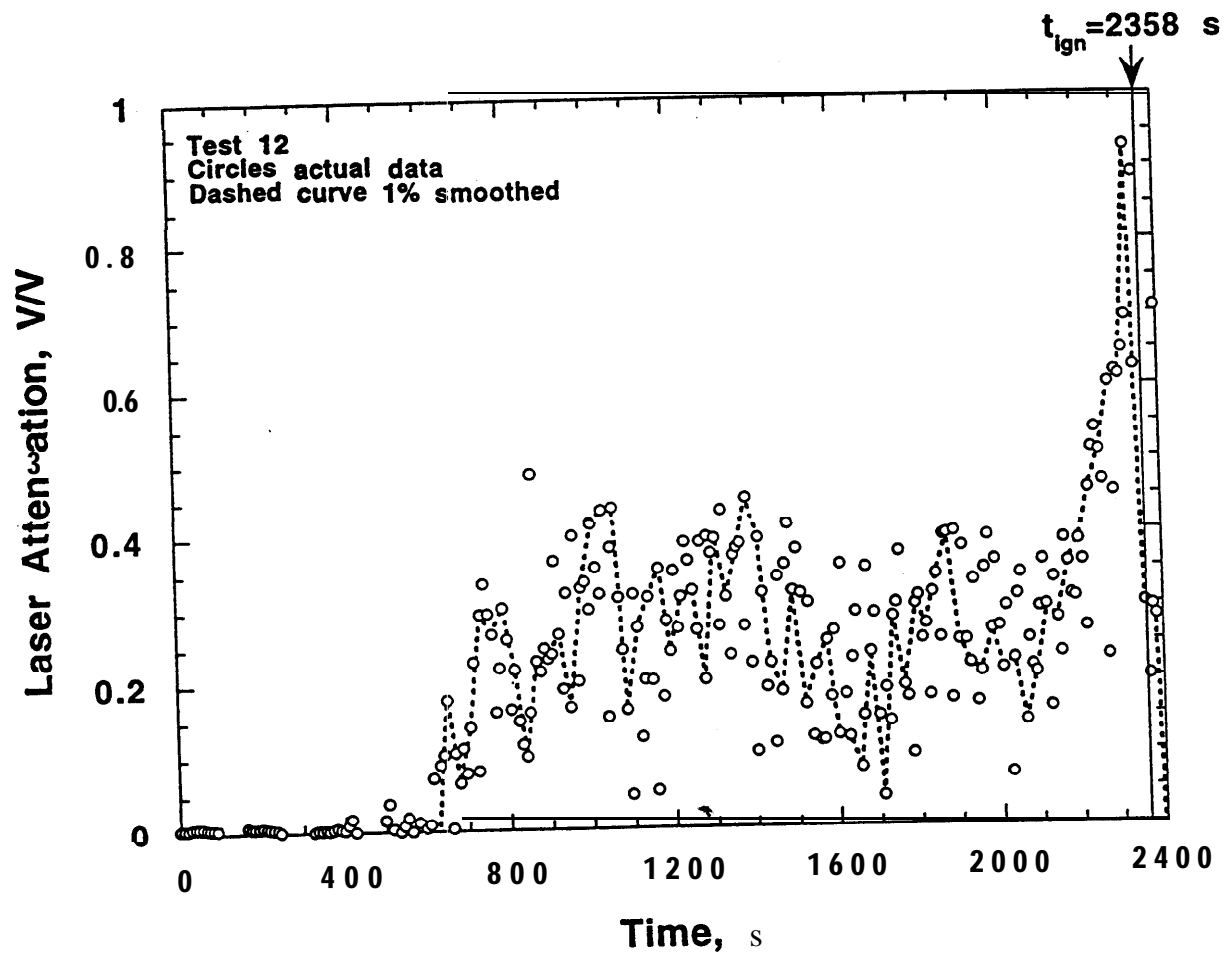
Figures **24** and **25** show laser-attenuation measurements versus time for tests of **french-fried potatoes** and water and oil, respectively: The circles represent the actual data points, and the curves were generated by partially smoothing the data. A 2% smooth, for example, replaces a data point with a point generated from a least-squares **curve** fit through the original point and the surrounding 2% of all of **the** data. Light-scattering measurements were found to be impractical due to very low **signal-to-noise** ratios.

Figure 25. Laser attenuation versus time for water and oil (normal→unattended).

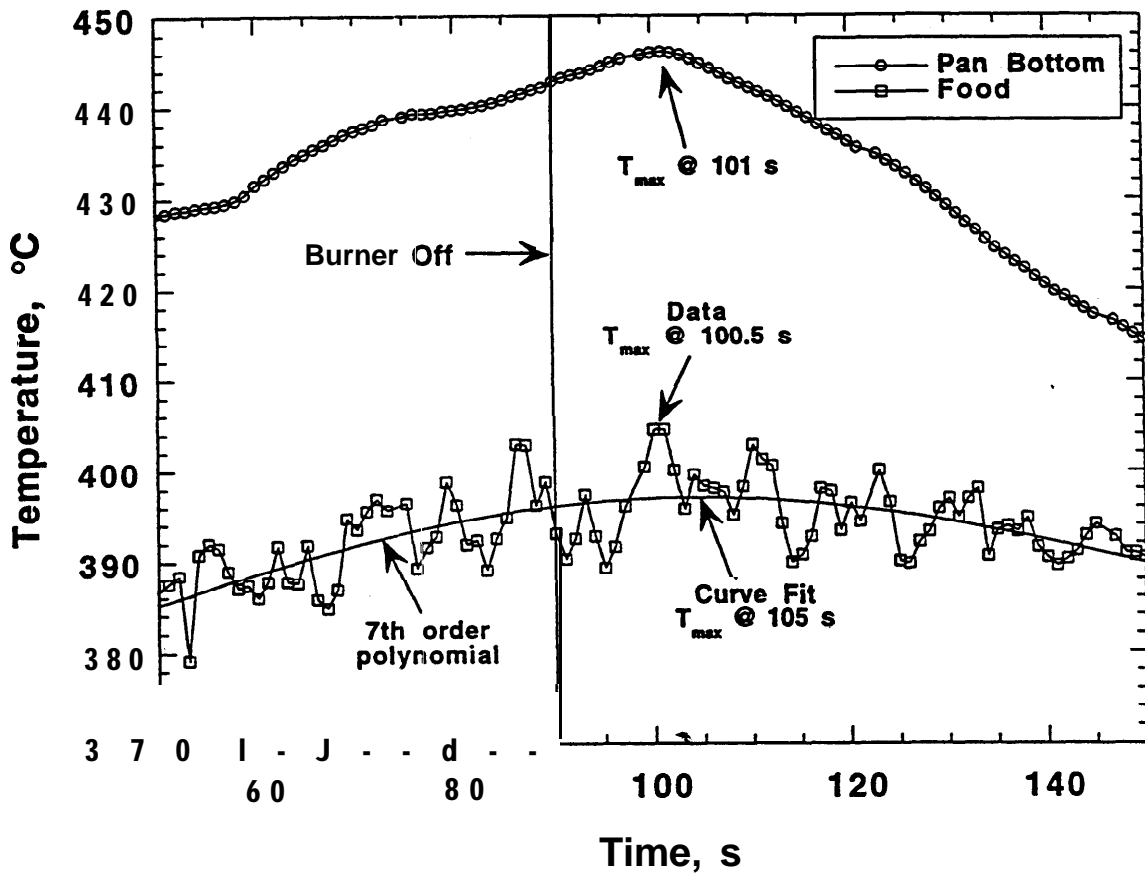
Figure 26. Pan-bottom temperature and food temperatures versus time for cooling-lag test of 500 mL oil on the **type-A** electric range.

Unless otherwise stated, all of the minima are from the 30 s preceding ignition. Thirty seconds was chosen as the pre-ignition time of primary focus based on the cooling-lag test on electric range A which indicated an 11 s delay before food and pan-bottom temperatures began to decrease after power was cut off. Figure 26 shows the pan-bottom and food temperatures versus time for the cooling-lag test. Thirty seconds provides nearly 20 s of additional time preceding ignition as an added safety factor.

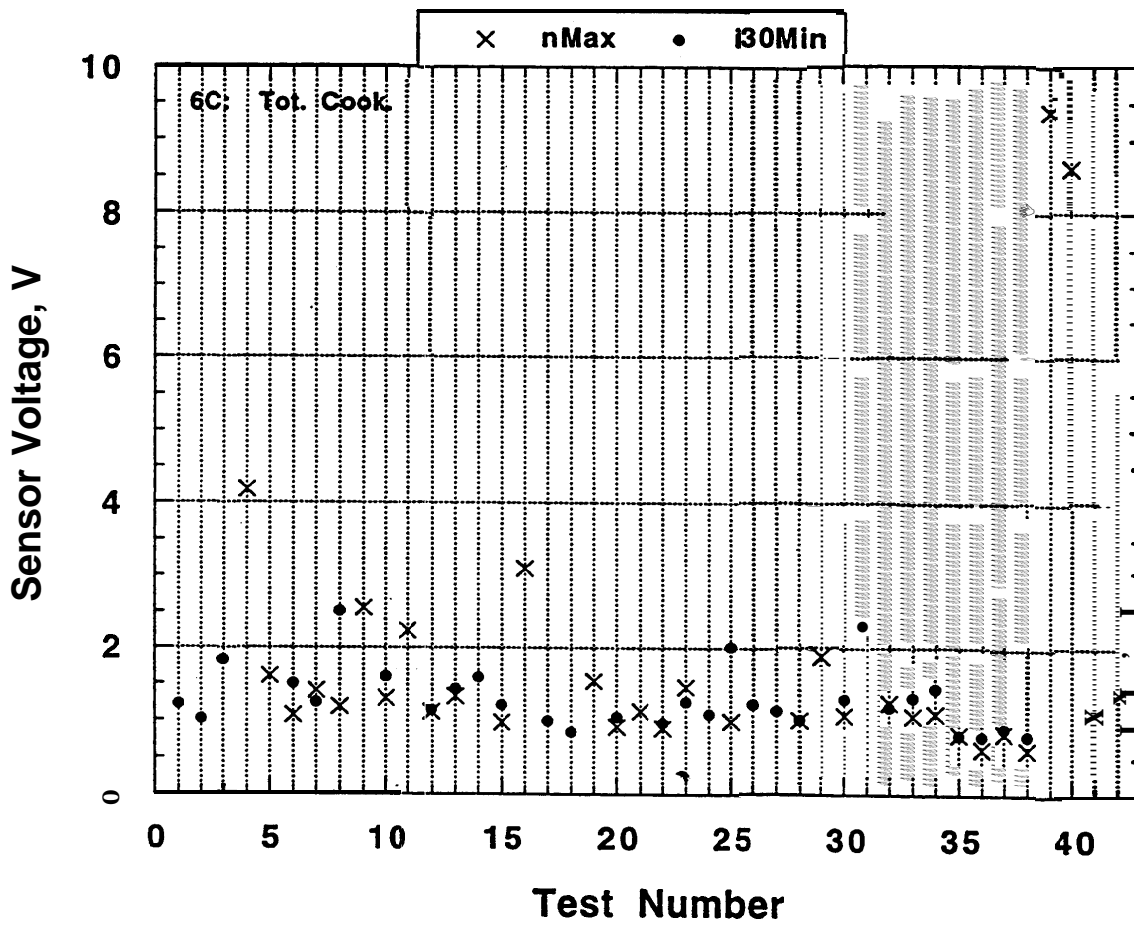
**Figures 27** and **28** are examples of sensor outputs that were found not to be especially **useful** for discriminating between **normal** and pre-ignition conditions. Figure 27 shows the normal maxima and pre-ignition minima for the total-cooking-gas sensor at site 6, which was located behind the focus burner on the splash panel of the range. On the plot, the individual test numbers are on the independent axis. Since the gas burner of focus was located on the opposite side of the range from the primary electric burner, data from the site 4 sensor replaced the site 6 data for the gas-range tests. The signals were generally weak with no clear separation between normal and pre-ignition conditions. This result was due to the relatively low height of the sensor above the range surface which prevented exposure to the majority of the cooking gases.

Figure 27. Site 6 total-cooking-gas sensor maximum normal and minimum ignition output 30 s before ignition versus test number. Data for the gas-range tests (35-38) are from the site 4 total-cooking-gas sensor.

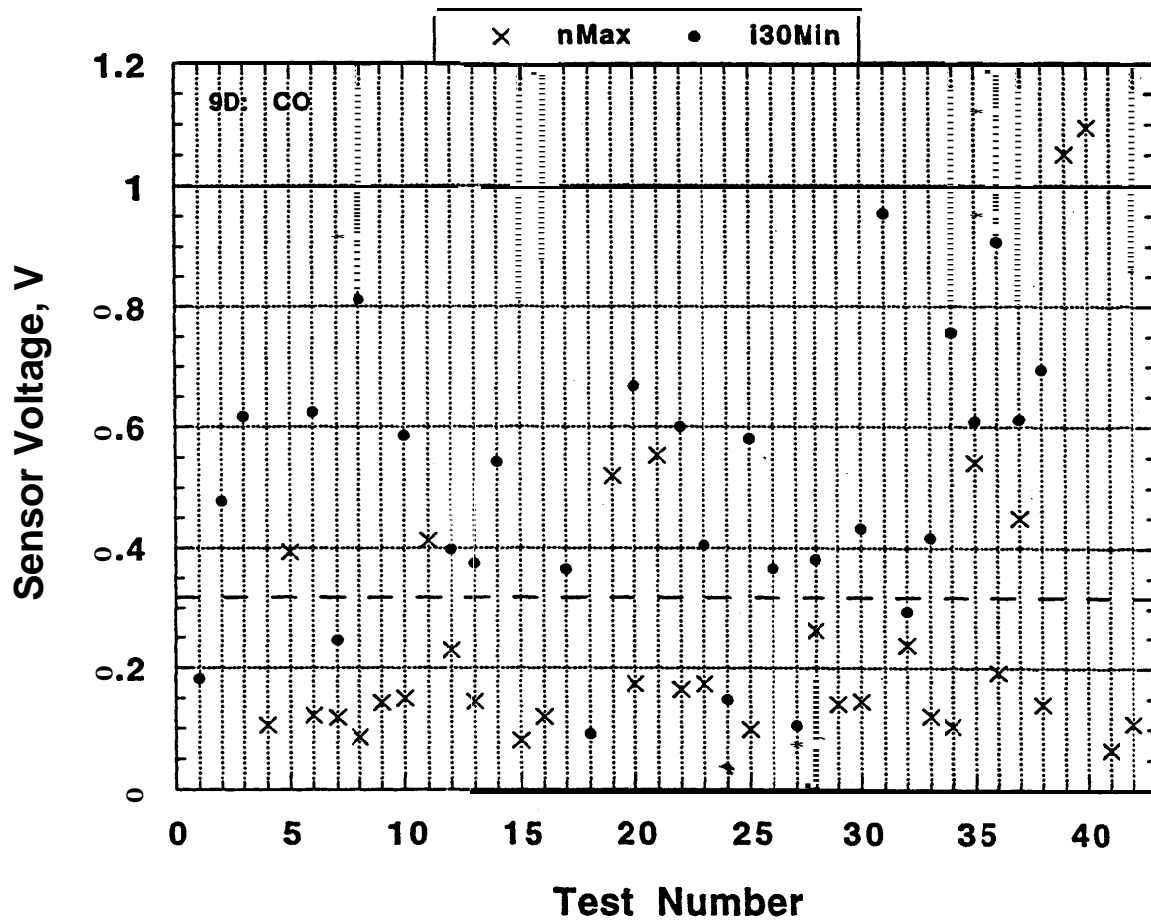
Figure 28 shows the response of the CO sensor located on the range hood at site 9. The regions of maximum normal points and minimum ignition points overlap substantially. For an

Figure 28. Site 9 carbon monoxide sensor maximum normal and minimum ignition output 30 s before ignition versus test number.

alarm threshold of 0.32 V, the sensor generated a 25% false-alarm rate and 20% failure-to-alarm rate. This sensor, while in one of the best locations for exposure to plume gases, did not show significant enough differences between normal and pre-ignition CO levels to make it a **good** candidate for a detection system.

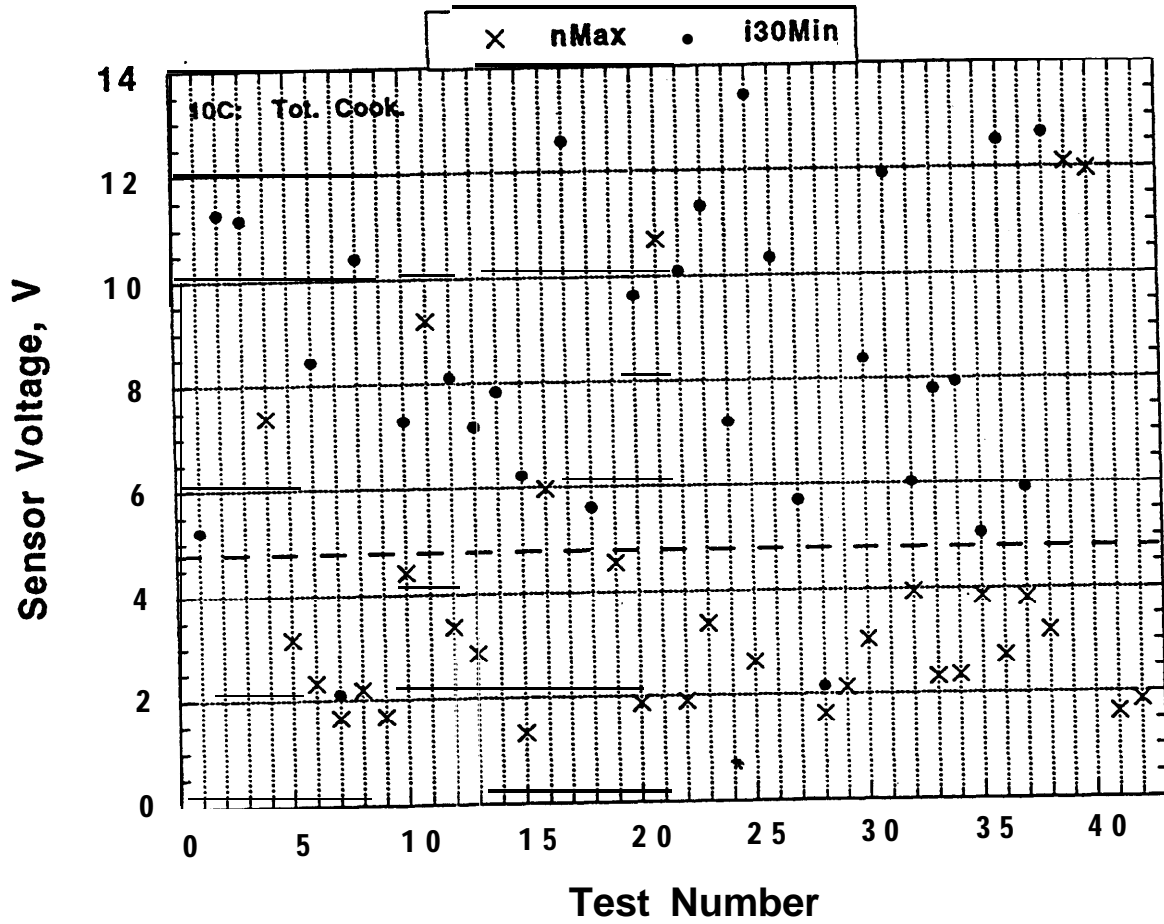
Figure 29. Site 10 total-cooking-gas sensor maximum normal and minimum ignition output 30 s before ignition **versus** test number. Data for the gas-range tests (35-38) are from the site 8 **total-cooking-gas** sensor.

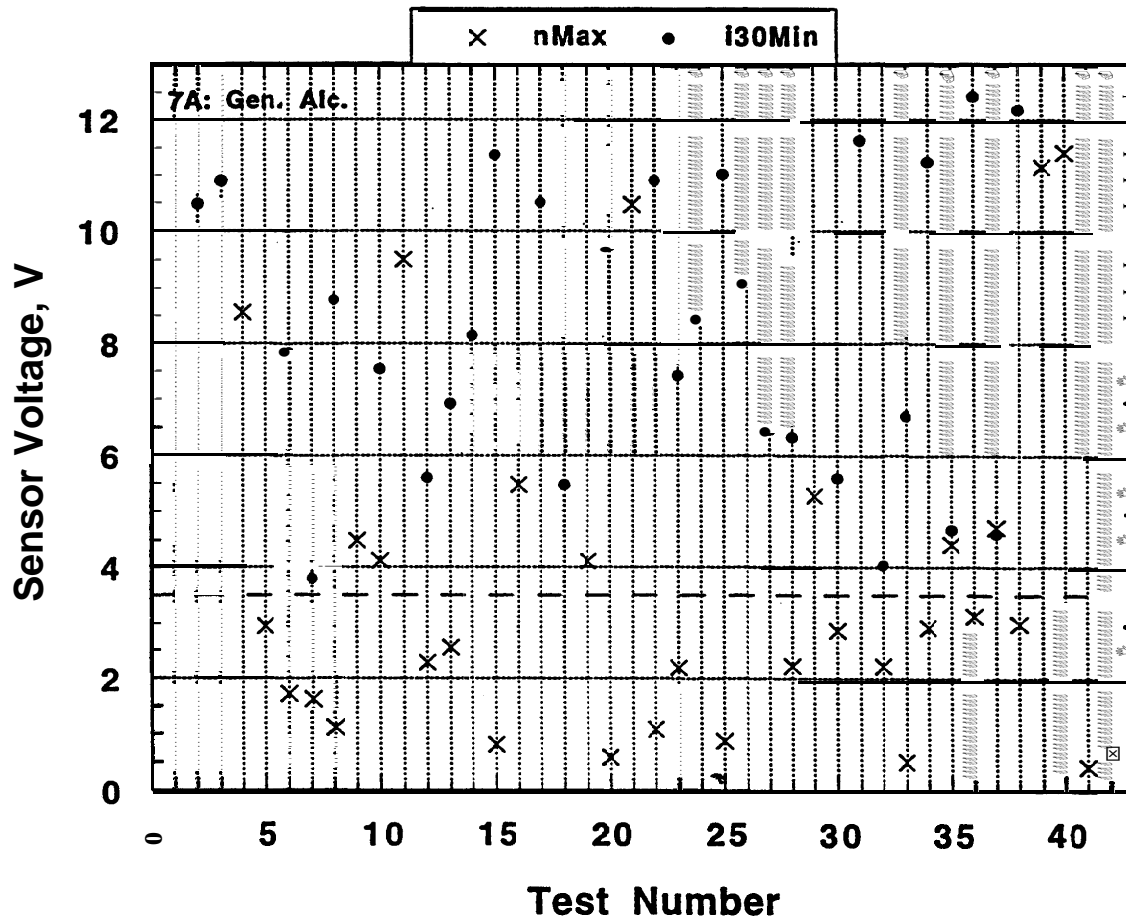
Figure 30. Site 7 general-alcohol sensor maximum normal and minimum ignition output 30 s before ignition versus test number.

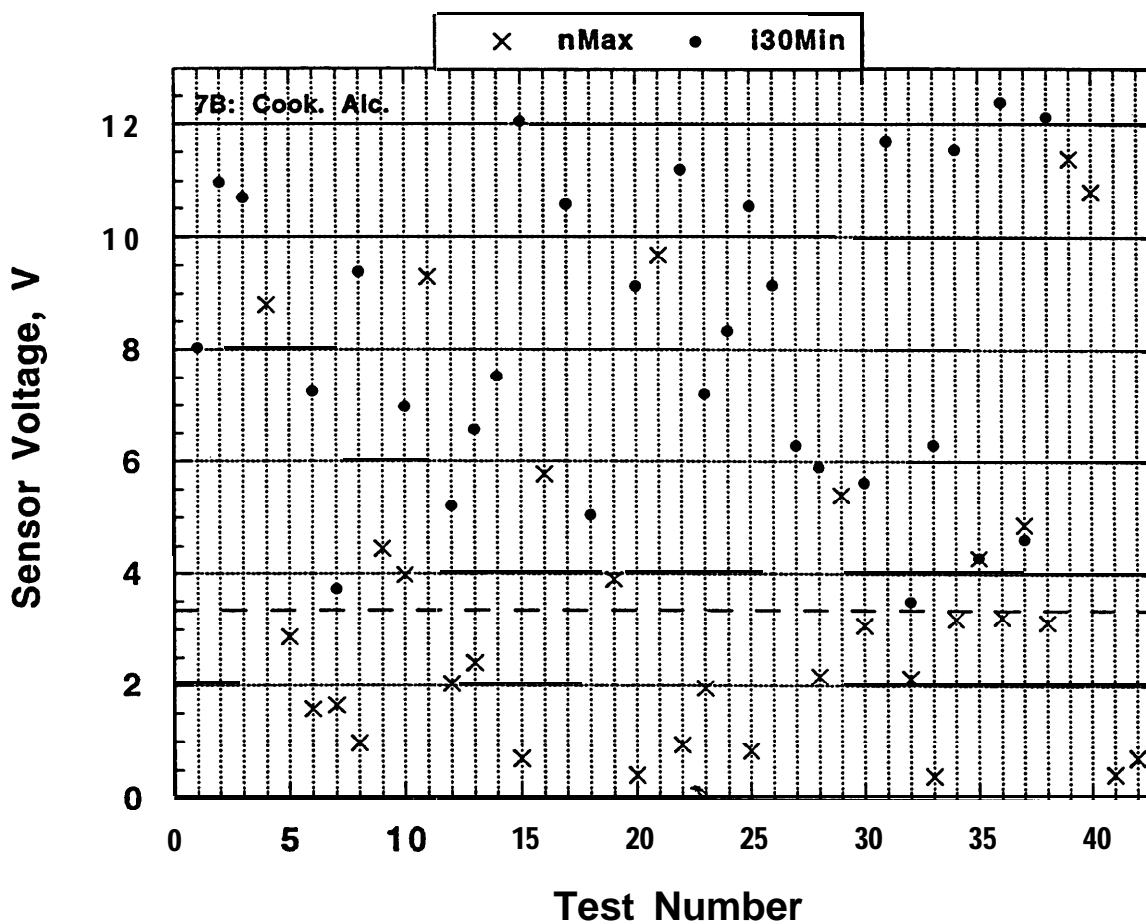
Figure 31. Site 7 cooking-alcohol sensor maximum normal and minimum ignition output 30 s before ignition **versus** test number.

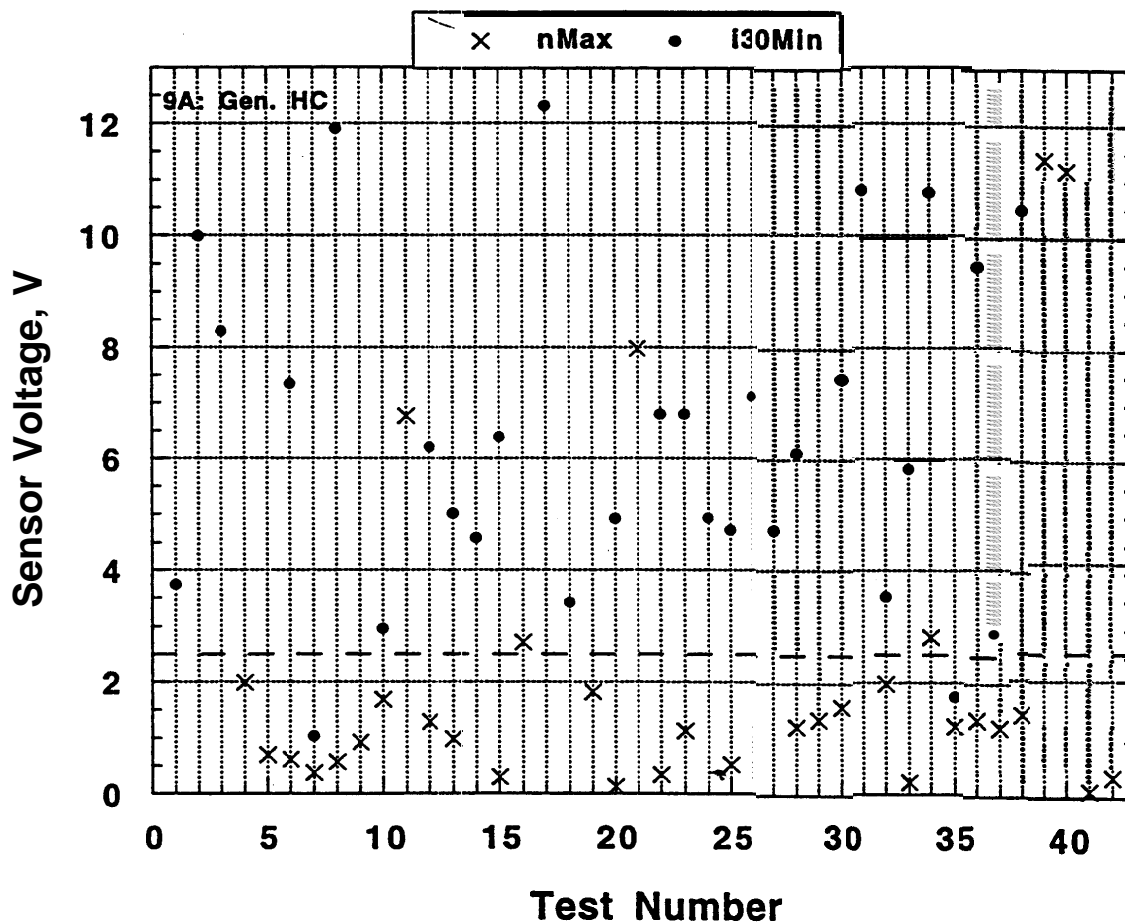
Figures 32 through 35 are for site 9 gas sensors. Figure 32 shows the general hydrocarbon-gas sensor's responses. For a threshold set at 2.5 V, two water-and-oil tests, 7 and 35, would result in failure to alarm. Test 35, however, did not proceed to ignition, and the data point results from the time when heating was stopped so only one failure to alarm is authentic. Catfish tests 11 and 21, steak test 16, self-cleaning tests 39 and 40, and normal-to-unattended chicken test 34 would all produce false alarms. Figure 33 shows the plot for the general-alcohol sensor at site 9. With a threshold of 3.1 V, this sensor would perform very similarly as the site 9 general-hydrocarbon sensor. The differences would be a false alarm for steak test 4 and no false alarm for chicken test 34. Figure 34 shows **the plot** for the site 9 total-cooking-gas sensor. With a threshold of 2.7 V, it **would** perform just as the site 9 general-alcohol sensor except steak test 16 would not produce a false alarm. Figure 35 shows the responses of the cooking-alcohol sensor at site 9. This sensor would produce no **failures-to-alarm** with an alarm threshold of 3.5 V. The only false alarms would occur for catfish tests 11 and 21, self-cleaning oven tests 39 and 40, and water test 19 with the smoking oil on the rear burner. This gas sensor had the best performance of the site 7 **and** 9 sensors discussed thus far.

Figure 32. Site 9 general-hydrocarbon sensor maximum normal and minimum ignition output 30 s before ignition versus test number.

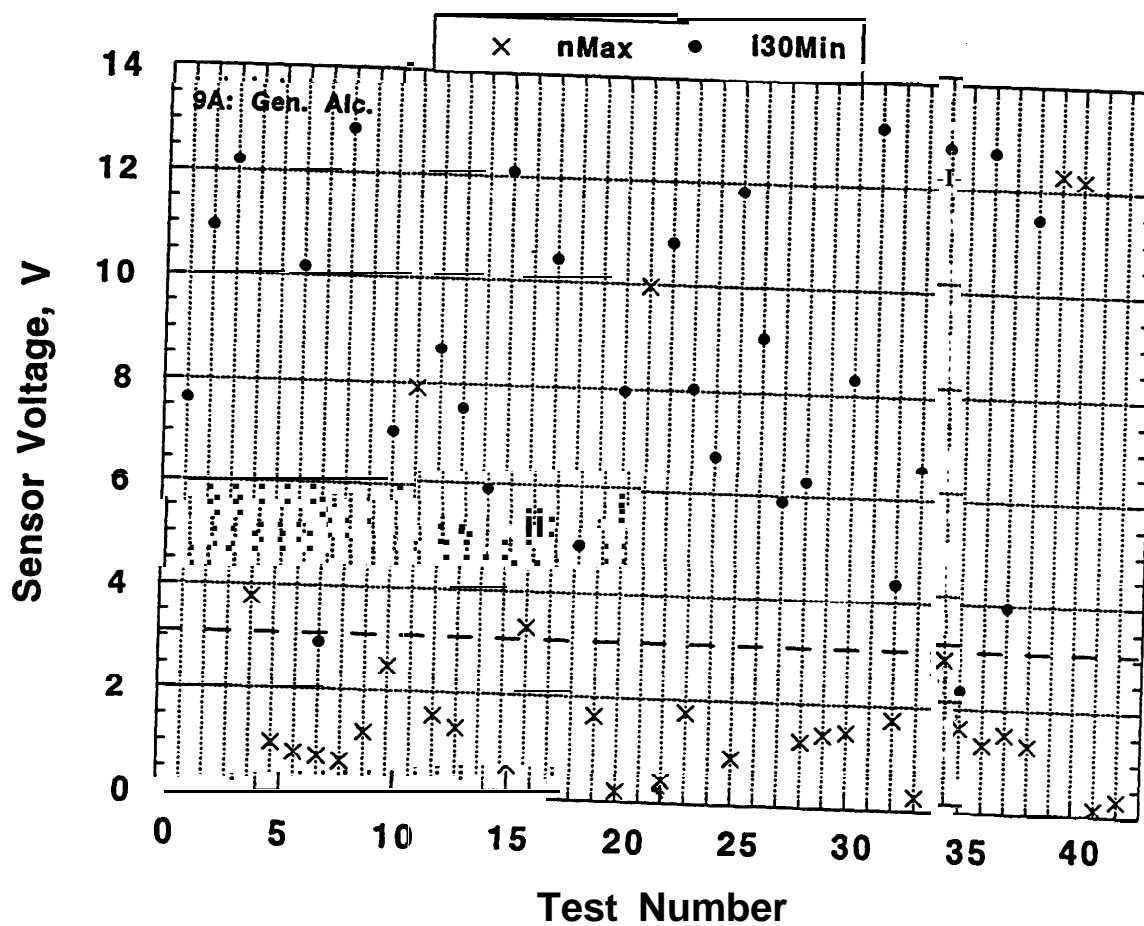
Figure 33. Site 9 general-alcohol sensor maximum **normal** and minimum ignition output 30 s before ignition **versus** test number.

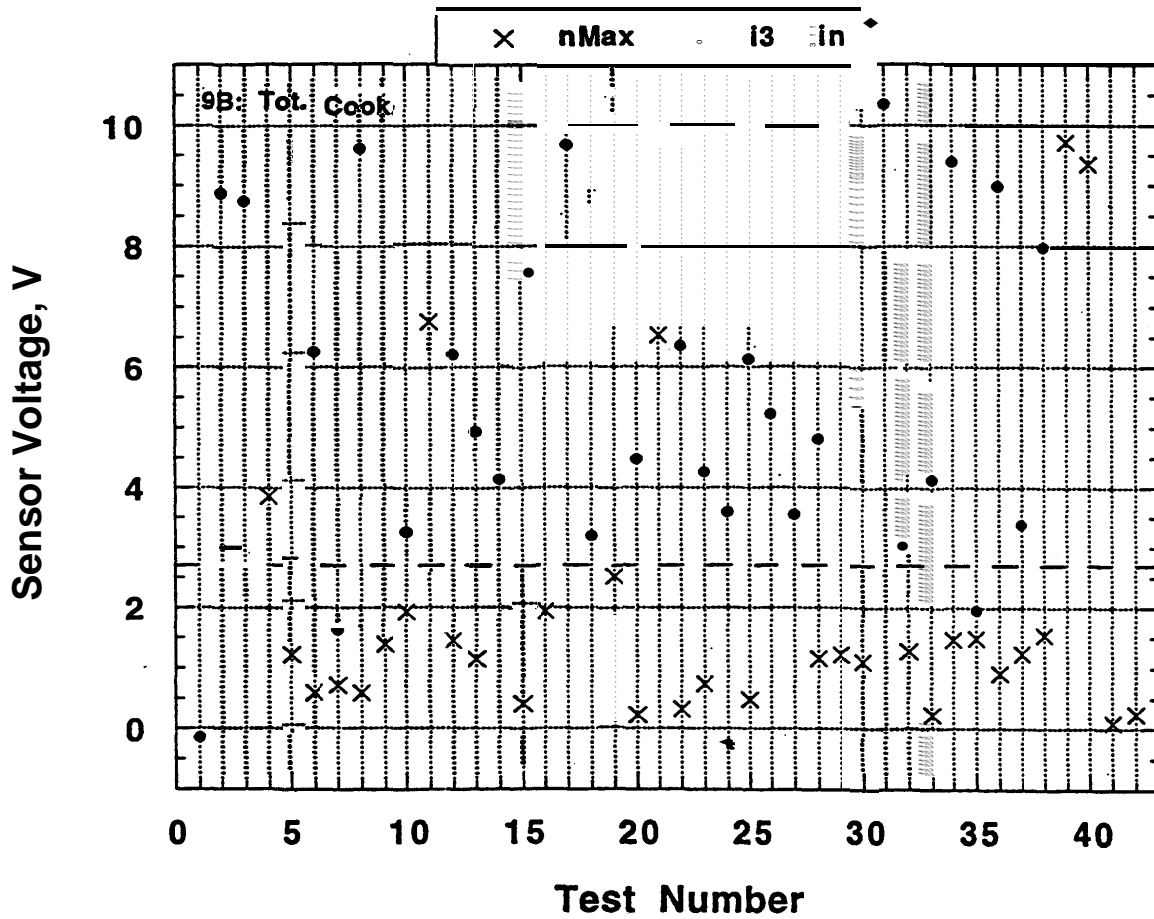
Figure 34. Site 9 total-cooking-gas sensor maximum normal and minimum ignition output 30 s before ignition versus test number.

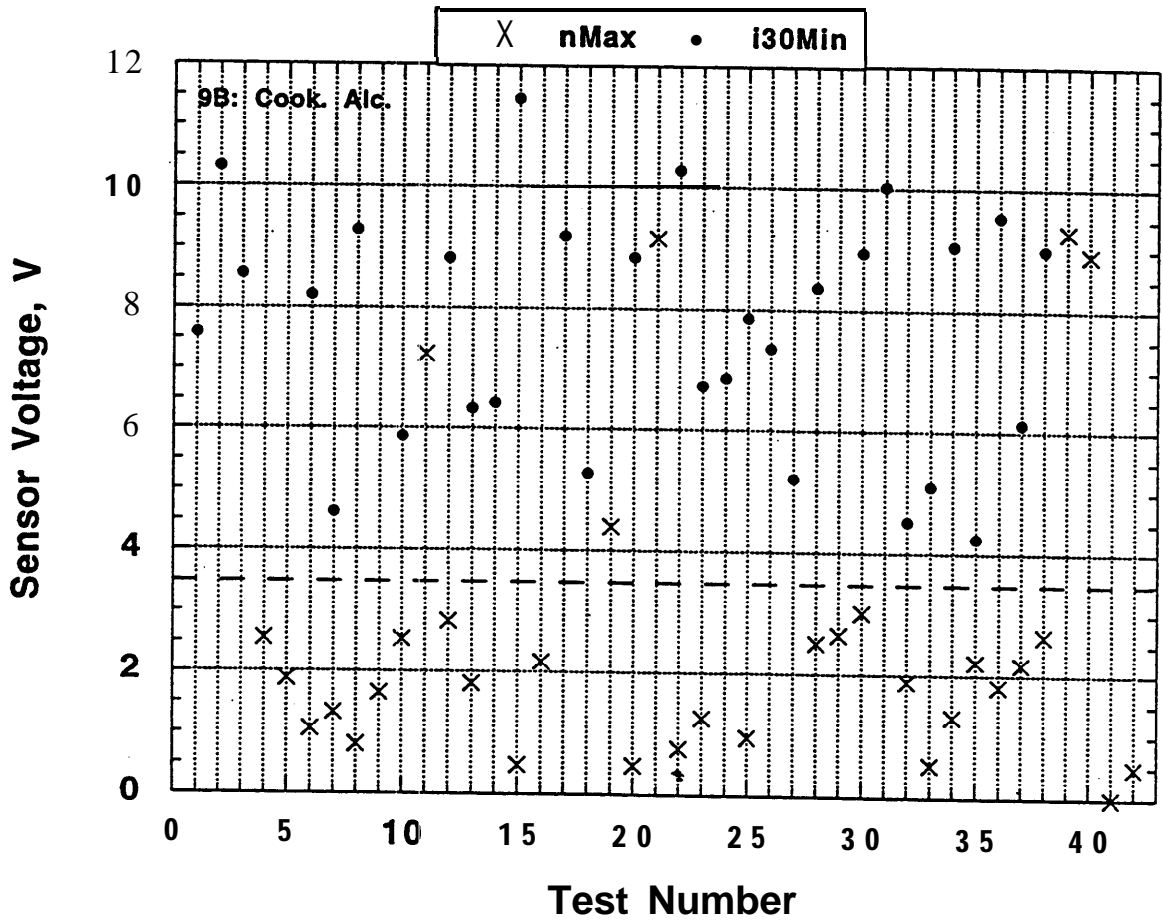
Figure 35. Site 9 cooking-alcohol sensor maximum normal and minimum ignition output 30 s before ignition versus test number.
