A **Framework** for a Restoration Vision for the Rio Grande

Hope for a **Living** River

by
William Fullerton
David Batts
Tetra Tech Inc.

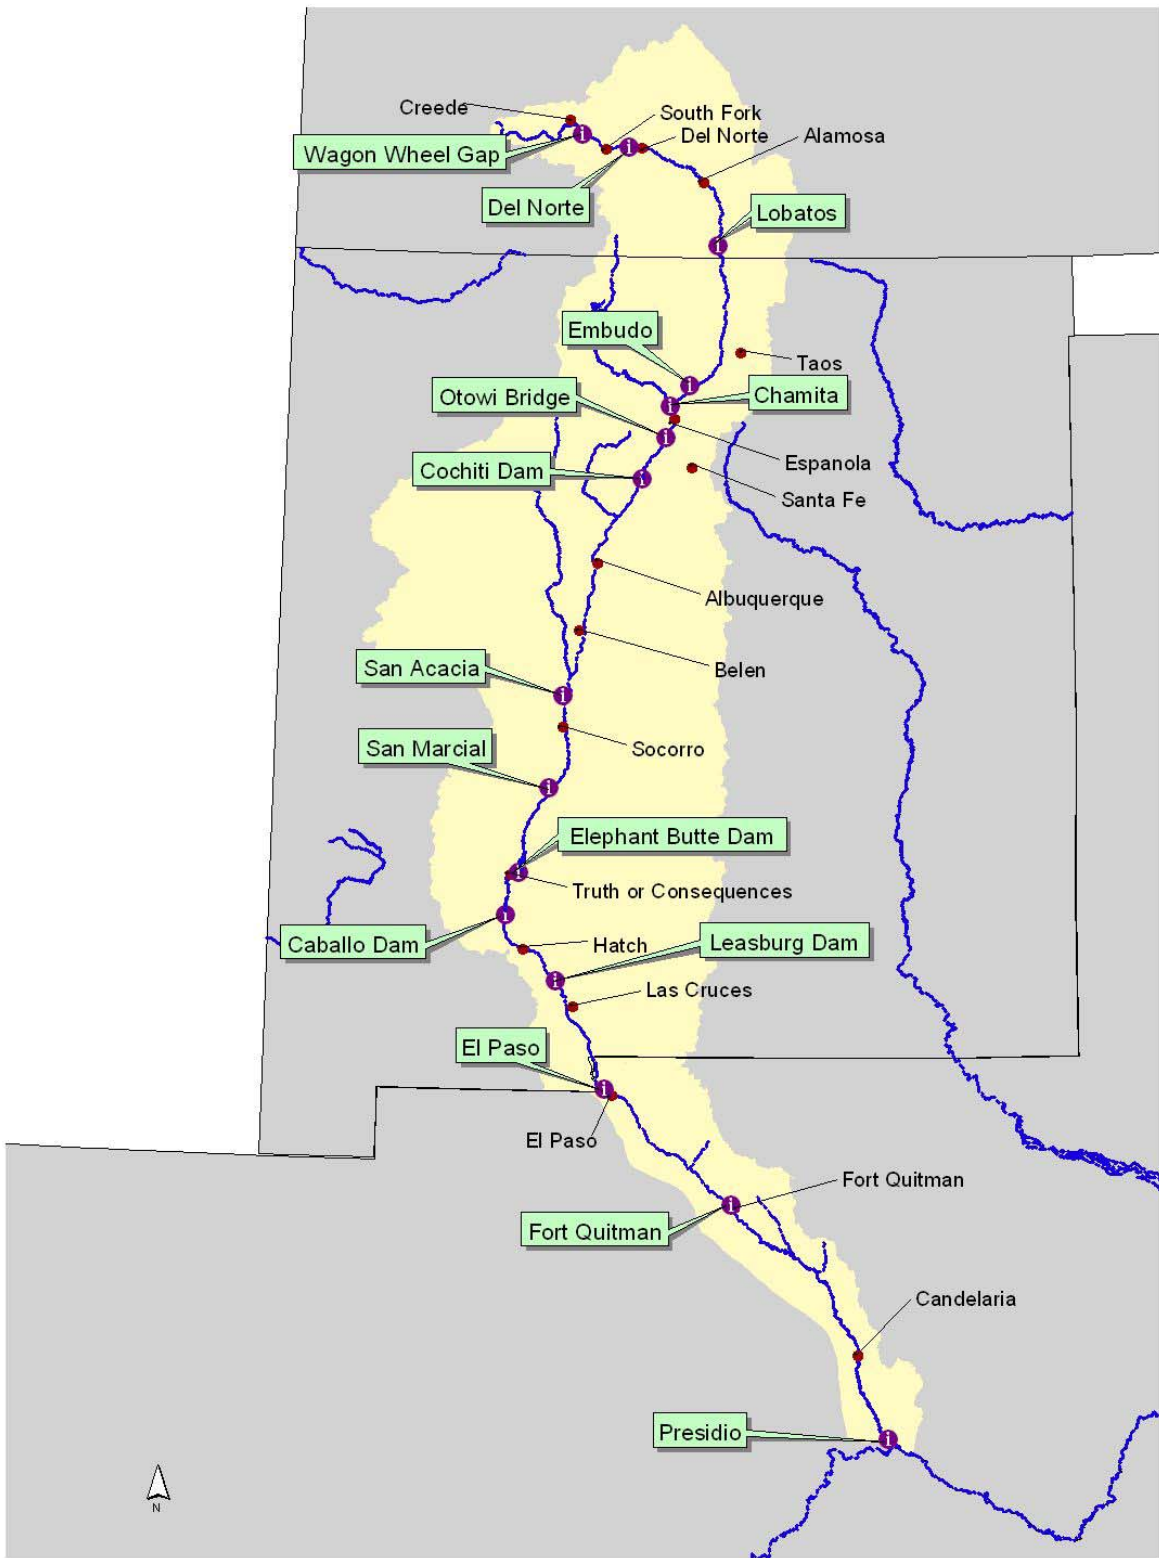
Figure 3.1 – Location of Stream Gages Used in the Hydrologic Analysis

Five gages were used to characterize the hydrology of this bioregion (**Table 3.1**). Wagon Wheel Gap represents the mountainous area (Reach 1). Del Norte and Lobatos Gages represent the upper and lower ends of the San Luis Valley (Reach 2). Del Norte is indicative of flows upstream of significant diversions in the San Luis Valley; the Alamosa Gage indicates conditions in the area most impacted by diversions; and the Lobatos Gage, below the Conejos River confluence and downstream of all the major diversions, represents the short portion of the river through the San Luis Hills (Reach 3). Flows in the Rio Grande Gorge (Reach 4), are defined by Lobatos at the upper end, and the Embudo Gage at the lower end.

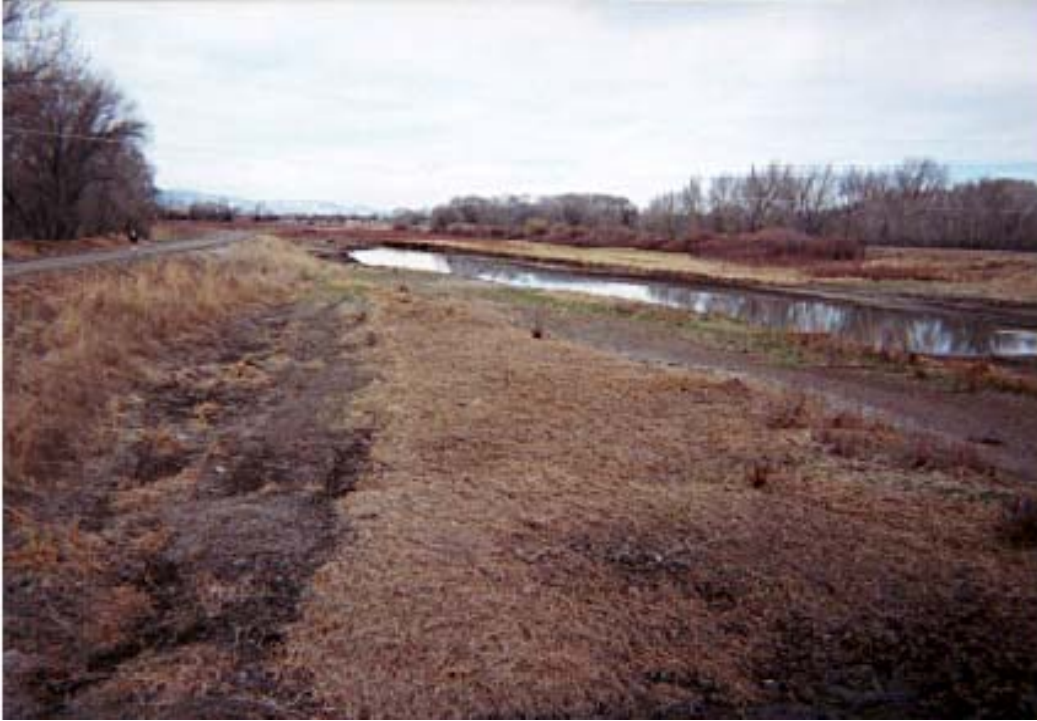
Photo 3.3 – Leveed section of the Rio Grande at Alamosa, Colorado (Reach 2)

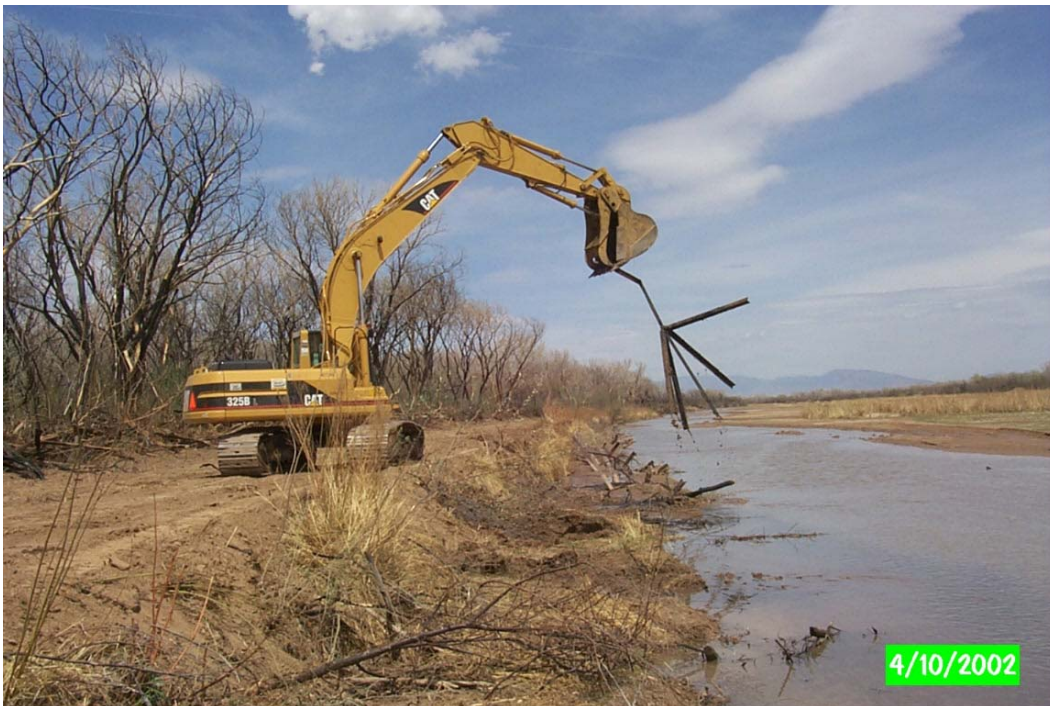
Photo 3.6 – Jetty jack removal near Los Lunas, New Mexico (Reach 11)

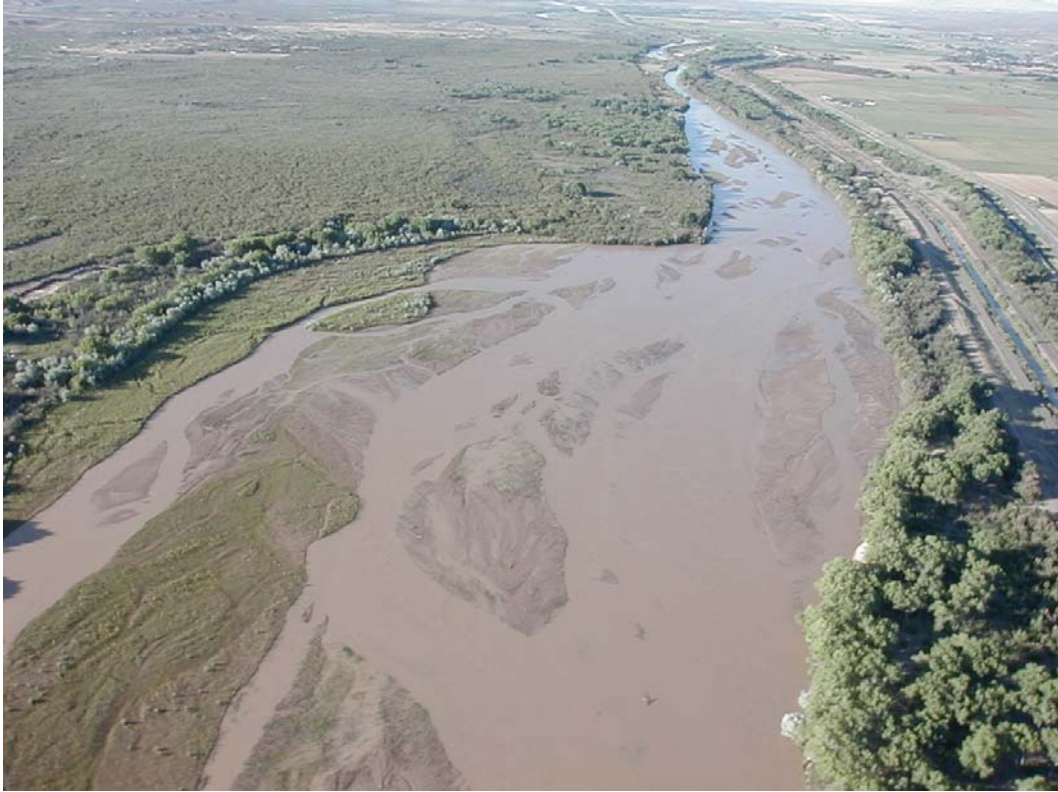
Photo 3.7 – Braided channel transitioning downstream to a channelized area (Reach 12)

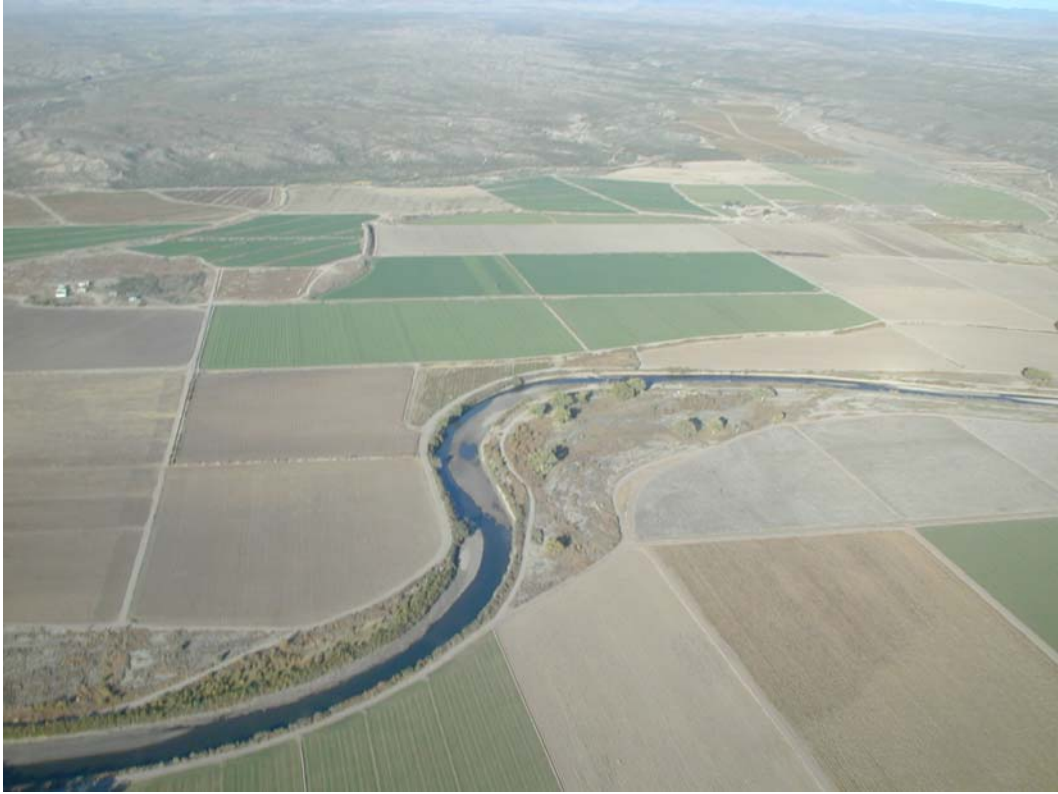
Photo 3.9 – Upper portion of the Rio Grande Canalization Project (Reach 16)

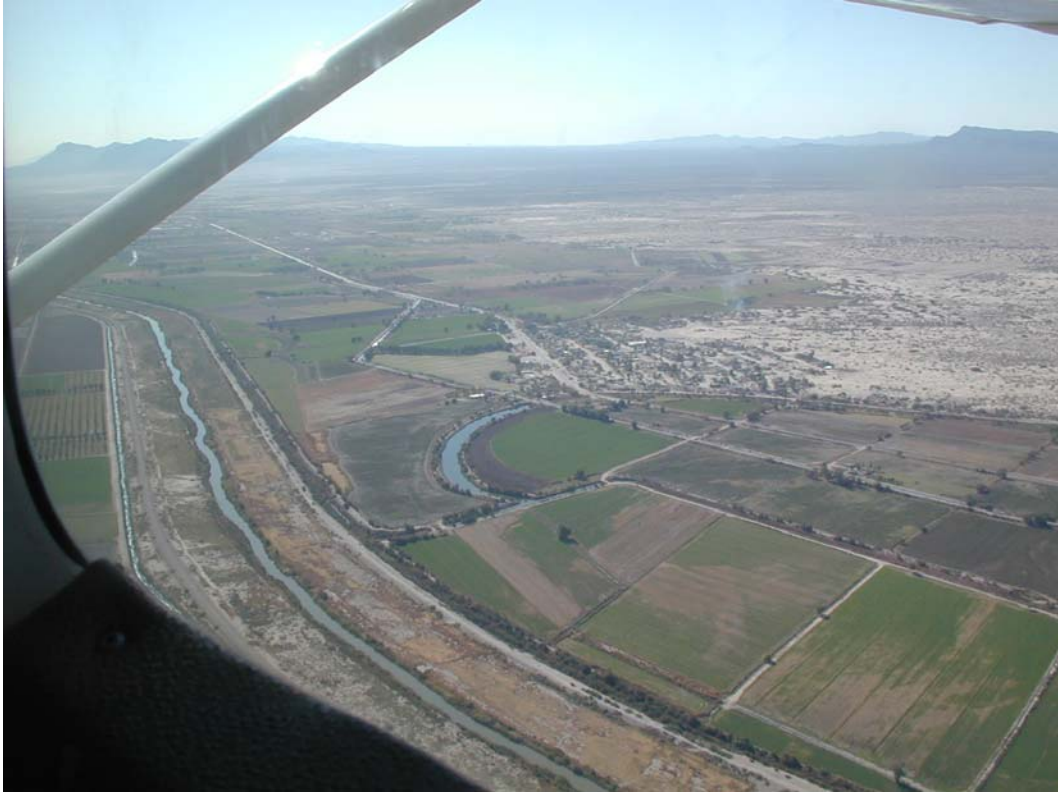
Photo 3.11 – Rio Grande Rectification Project (Reach 18)

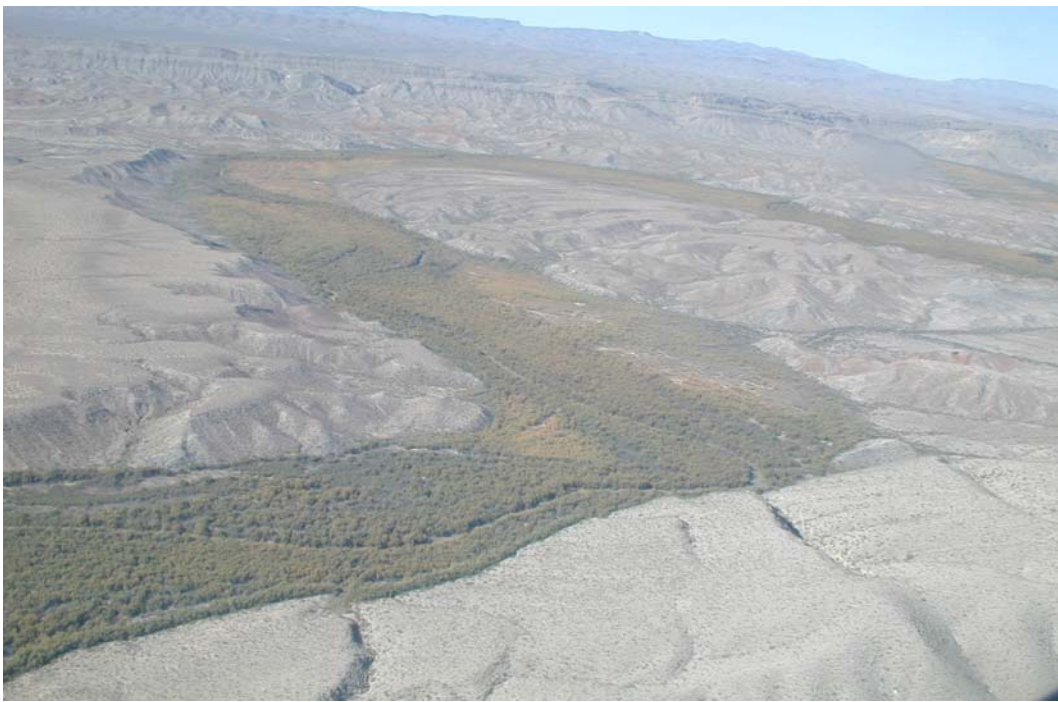
Photo 3.12 – Saltcedar monoculture in the “Forgotten Reach” (Reach 19)
