Clear-Water Abutment and Contraction Scour in the Coastal Plain and Piedmont Provinces of South Carolina, 1996-99

Water-Resources Investigations Report 03-4064

Prepared in cooperation with the
SOUTH CAROLINA DEPARTMENT OF TRANSPORTATION

By Stephen T. Benedict

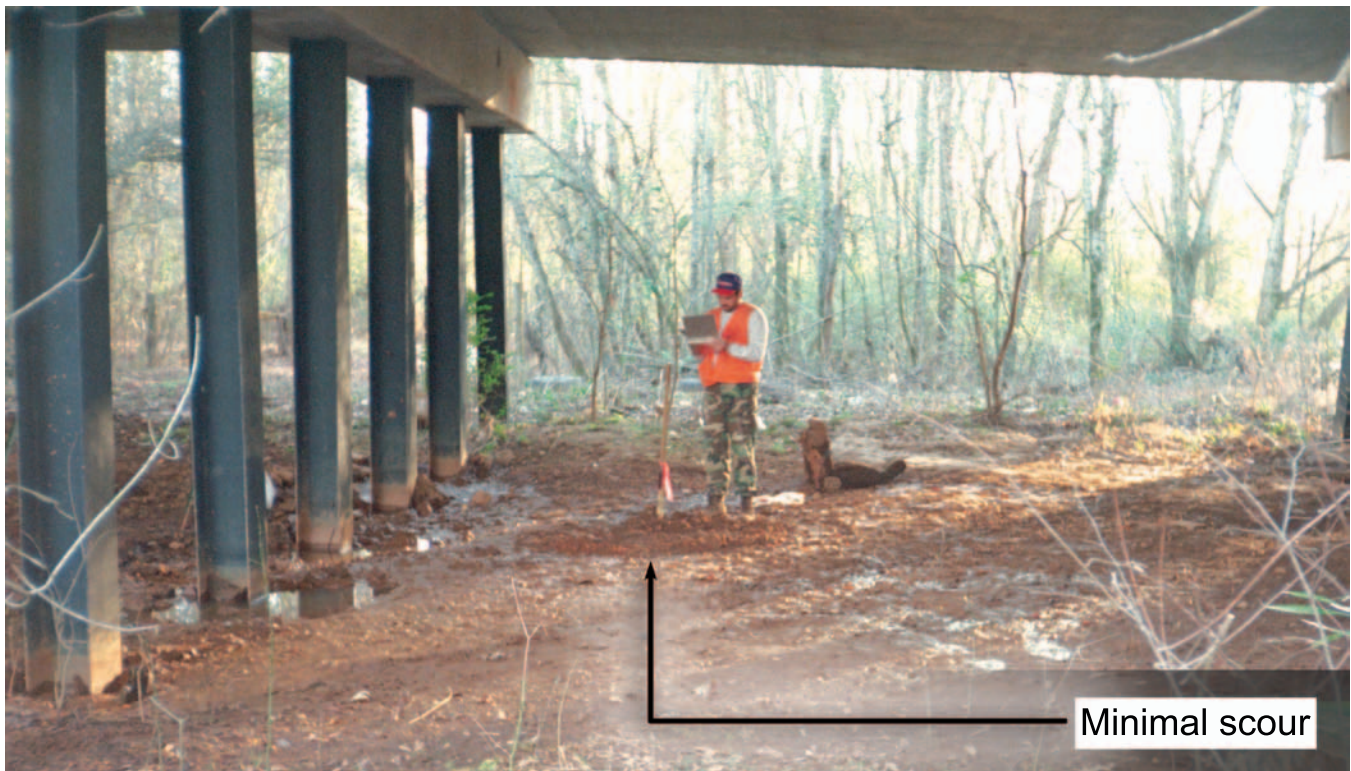
Figure 13. Example of minimal scour in the clayey soils of the Piedmont at Structure 047026300100 on Road S-263, crossing the Rocky River in Anderson County, South Carolina. (Photograph by the South Carolina District, U.S. Geological Survey, 1997.)

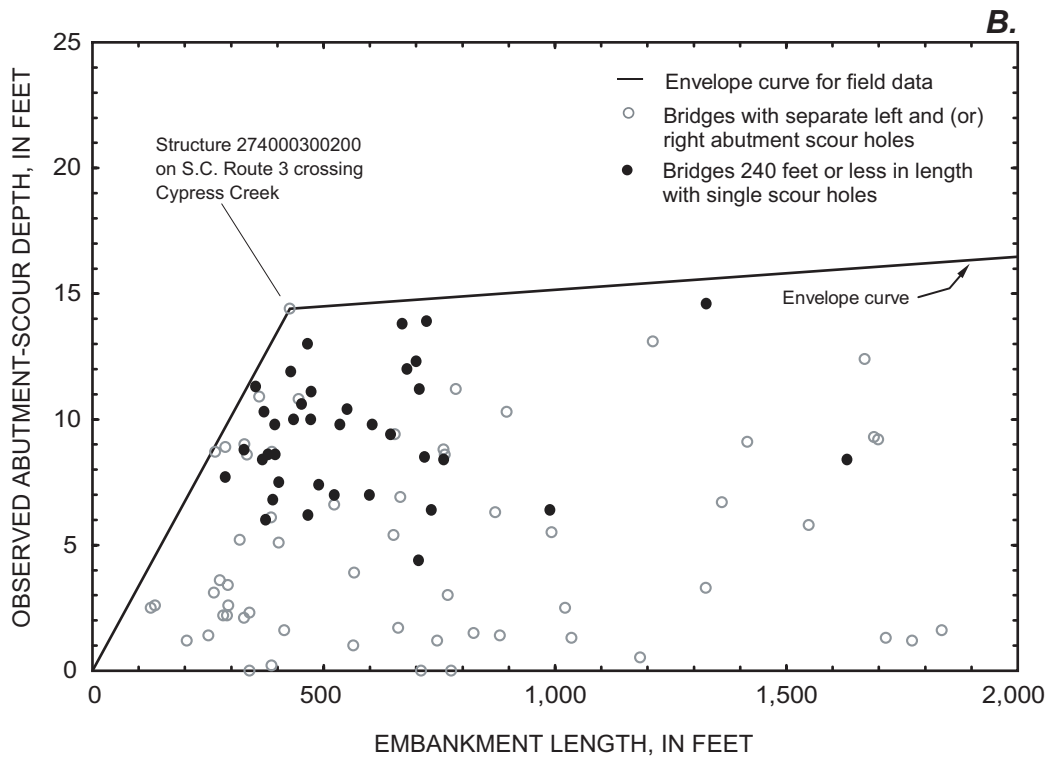
Figure 78. Relation of observed clear-water abutment-scour depth and the 100-year-flow embankment length identifying sites with bridge lengths of 240 feet or less and single scour holes in the Coastal Plain of South Carolina with a (A) complete horizontal axis and a (B) truncated horizontal axis.
