Common ADA Problems at Newly Constructed Lodging Facilities

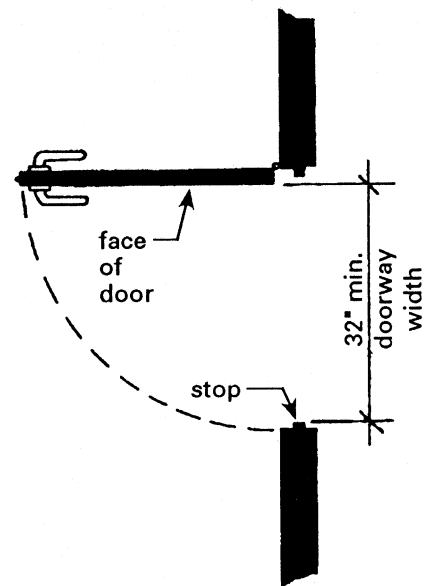
Measuring Clear Width

All doors and doorways (except shallow closets) into and within all guestrooms and suites (including guestroom bathrooms, kitchens, and connecting room doors) shall provide 32 inches of clear opening width measured when a hinged door is open 90 degrees or a sliding door is fully opened.

Doors and doorways into and within all guestrooms and suites, including bathroom doors and doorways, do not allow 32 inches of clear opening width.

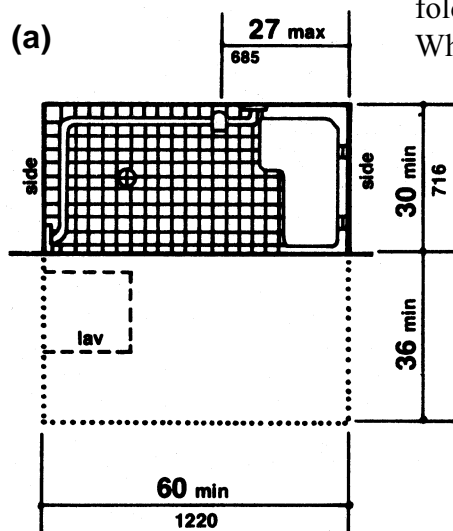
Fig. 57
Roll-in Shower
with Folding Seat

Lodging facilities must provide a specific number of accessible guest rooms based on the table provided below. Bathing facilities in these rooms must comply with the Standards. In addition, in lodging facilities with more than 50 guestrooms or suites, the facility must provide a specified number of accessible guestrooms that have a roll-in shower with a permanently attached fold-down seat. The roll-in shower in these rooms must comply with specific requirements contained in Figure 57 of the Standards, shown on this page.

ADA Standards 9.1.2; 9.2; 4.21; Figure 57(a) or (b).

In hotels, motels, or other lodging facilities of 50 or more sleeping rooms, no rooms with roll-in showers are provided, or the roll-in showers that are provided lack a permanently attached fold-down seat.

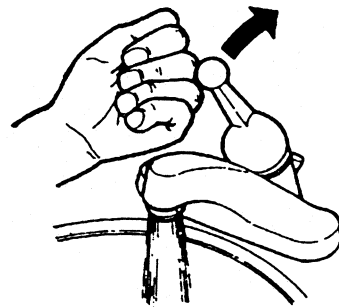
Handles, pulls, latches, locks, and other operating devices on accessible doors; faucets; fixed lamps; and drapery, heating, and air conditioning controls shall have a shape that is easy to grasp with one hand and does not require tight grasping, tight pinching, or twisting of the wrist to operate. Lever-operated mechanisms, push-type mechanisms, and U-shaped handles are acceptable designs. ADA Standards 4.13.9; 9.2.2(3); 9.2.2(5).

single-lever handle that is easy to reach and operable with one hand

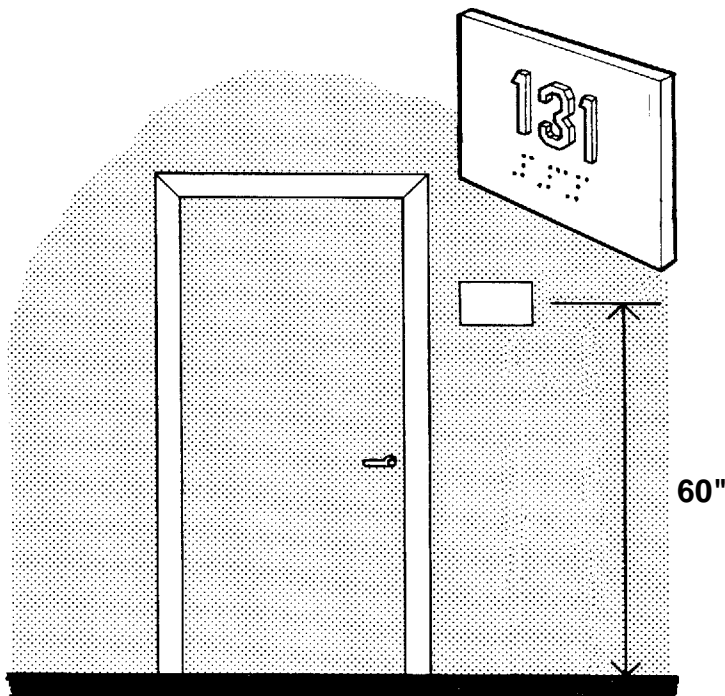
Signs that are provided for all permanent rooms and spaces in the lodging facility must be mounted on the wall (not the door) adjacent to the latch side of the door and centered 60 inches above the floor so that they can be easily located by persons who are blind or who have low vision. Signs must include the same information in Braille, with raised lettering that forms a high contrast with the background of the sign. Signs should not be made of reflective materials such as brass, silver, gold, glass, or mirrored surfaces unless there is an additional properly located sign that complies with the Standards. ADA Standards 4.1.3(16)(a); 4.30.4; 4.30.5.

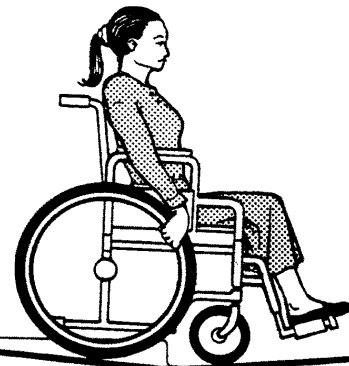
At least one route that is a minimum of 36 inches wide without steps, stairs, or other abrupt level changes must be provided within the boundary of the lodging facility's property from an accessible entrance to the building to public transportation stops, accessible parking spaces, accessible passenger pick-up/drop-off areas, if provided, and public streets or sidewalks. Once inside the facility, an accessible route must be provided between an accessible entrance, lobby and the various accessible elements and spaces in the lodging facility. ADA Standards 4.1.2 (1); 4.1.3(1); 4.3.

At least one route that is a minimum of 36 inches wide without steps, stairs, or other abrupt level changes must be provided
