General  
Technical  
Report  
FPL-GTR-114

# Inspection of Timber Bridges Using Stress Wave Timing Nondestructive Evaluation Tools

## A Guide for Use and Interpretation

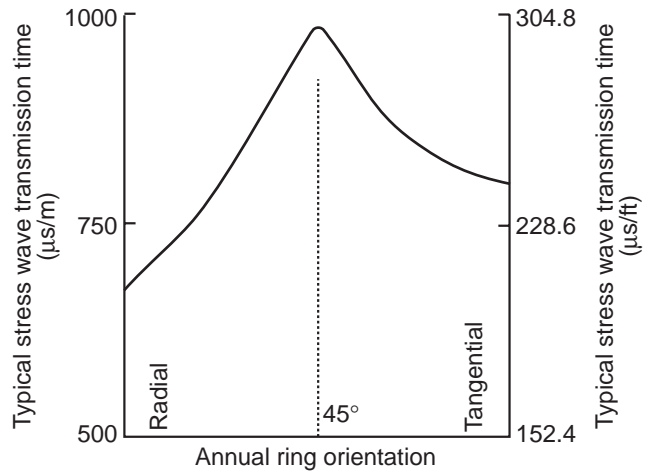
**Figure 4—Transverse stress wave transmission time compared with annual ring orientation.**

Figure 4 show the stress wave transmission time for wood of good quality at 12% moisture content. These values can vary ±10% for species variation. These times are based on an assumed stress wave transmission time of 668 μs/m radially, 800 μs/m tangentially, and 995 μs/m at 45° to grain.

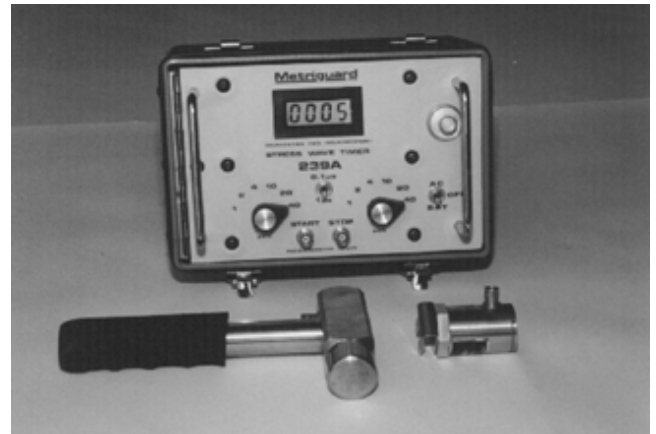
Figure 9—Metriguard Model 239A Stress Wave Timer.

- **Metriguard Model 239A Stress Wave Timer (Fig. 9)**

**Method of Operation**—A mechanical stress wave is induced in a member by a hammer or other means and is detected with accelerometers at two points along the propagation path (Fig. 7). The timer starts when the wave front arrives at the first accelerometer. The timer stops when the wave front arrives at the second accelerometer and displays the propagation time between accelerometers in microseconds.

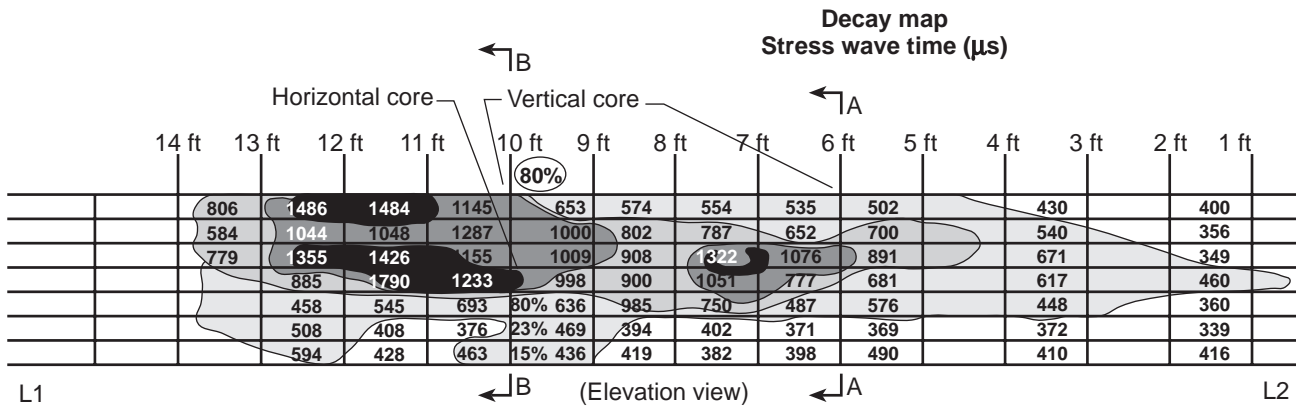
Figure 16—Examples of summary form (top) and data summary form (sections)(bottom).

When data have been gathered, it is useful to present them in an easy to read manner. Figure 16 illustrates various data summary forms. From these, the presence and extent of degradation can readily be seen.
