Evaluation of Sub-Sea Physical Environmental Data for the Beaufort Sea OCS and Incorporation into a Geographic Information System (GIS) Database

By Warren L. Horowitz, Oceanographer, MMS Alaska OCS Region

Locations of past Shallow Hazard Site Surveys and Pipeline Route Surveys for the Beaufort Sea Federal Outer Continental Shelf, Alaska

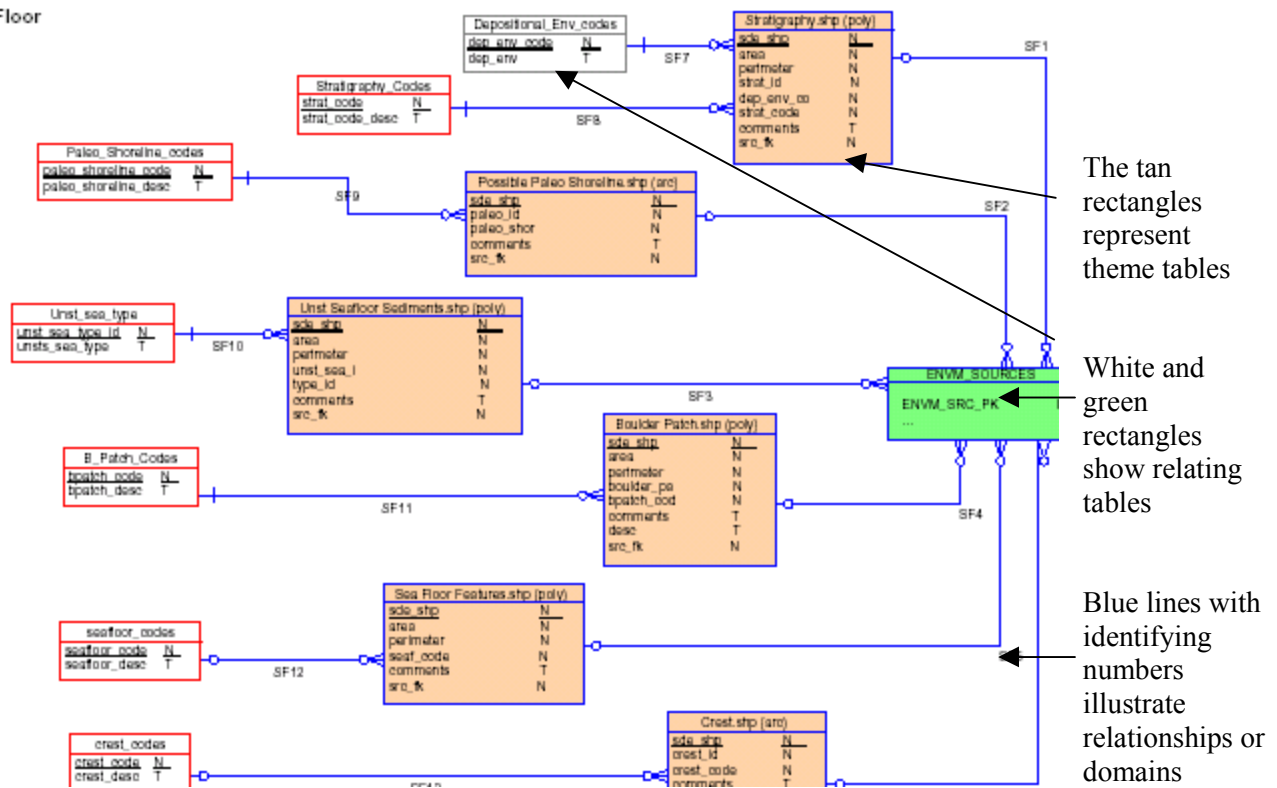
Sea Floor

Page one of the [Database Documentation.pdf](#) document is the E.R.D. The E.R.D illustrates how the tables of the Geohazards Database are structured. Displayed below is a small portion of the E.R.D showing the table relationships for the “Seafloor Features”.

The E.R.D. has been constructed with “links” to the Data Dictionary, Domains and Relationships tables within this document.

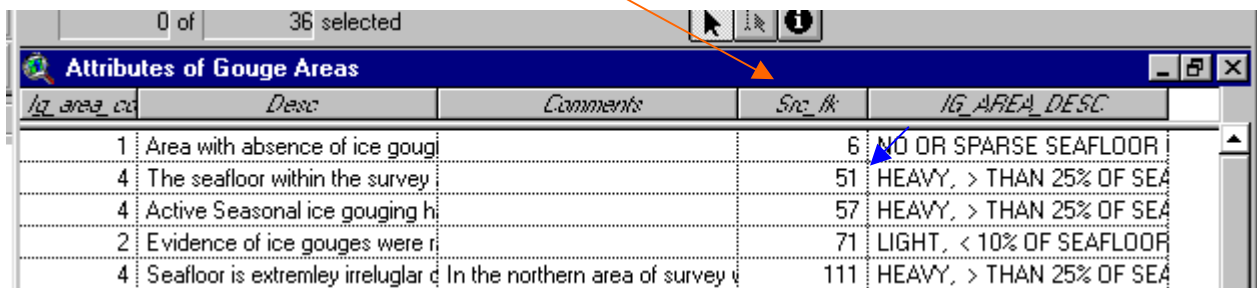
All the relationships are based on the values of a common field found in both tables. Regarding the relationship with Environmental Sources Meta Data, most themes in the Geohazards Dataset have a Src_FK Field (*Source Foreign Key field*).

Iq_area_cd	Desc	Comments	Src_fk	IG_AREA_DESC
1	Area with absence of ice gouging		6	NO OR SPARSE SEAFLOOR
4	The seafloor within the survey		51	HEAVY, > THAN 25% OF SEA
4	Active Seasonal ice gouging hi		57	HEAVY, > THAN 25% OF SEA
2	Evidence of ice gouges were r		71	LIGHT, < 10% OF SEAFLOOR
4	Seafloor is extremlly irreglar d	In the northern area of survey v	111	HEAVY, > THAN 25% OF SEA

The common field in the Geohazards.mdb Microsoft Access Database is the sn_envm_src_pk field of the envm_sources table. This data link shows the source map used to generate data.

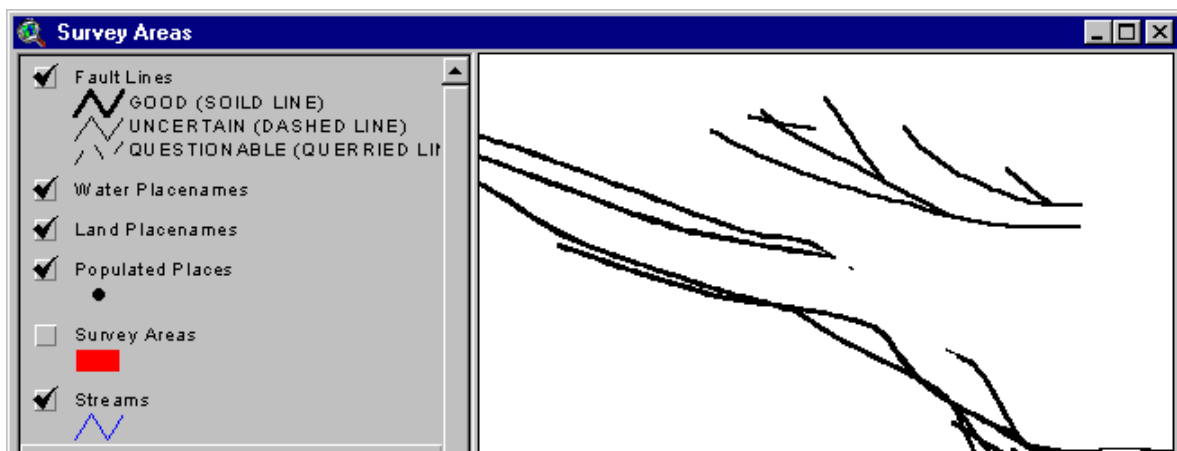
The fault lines should resemble those shown below:

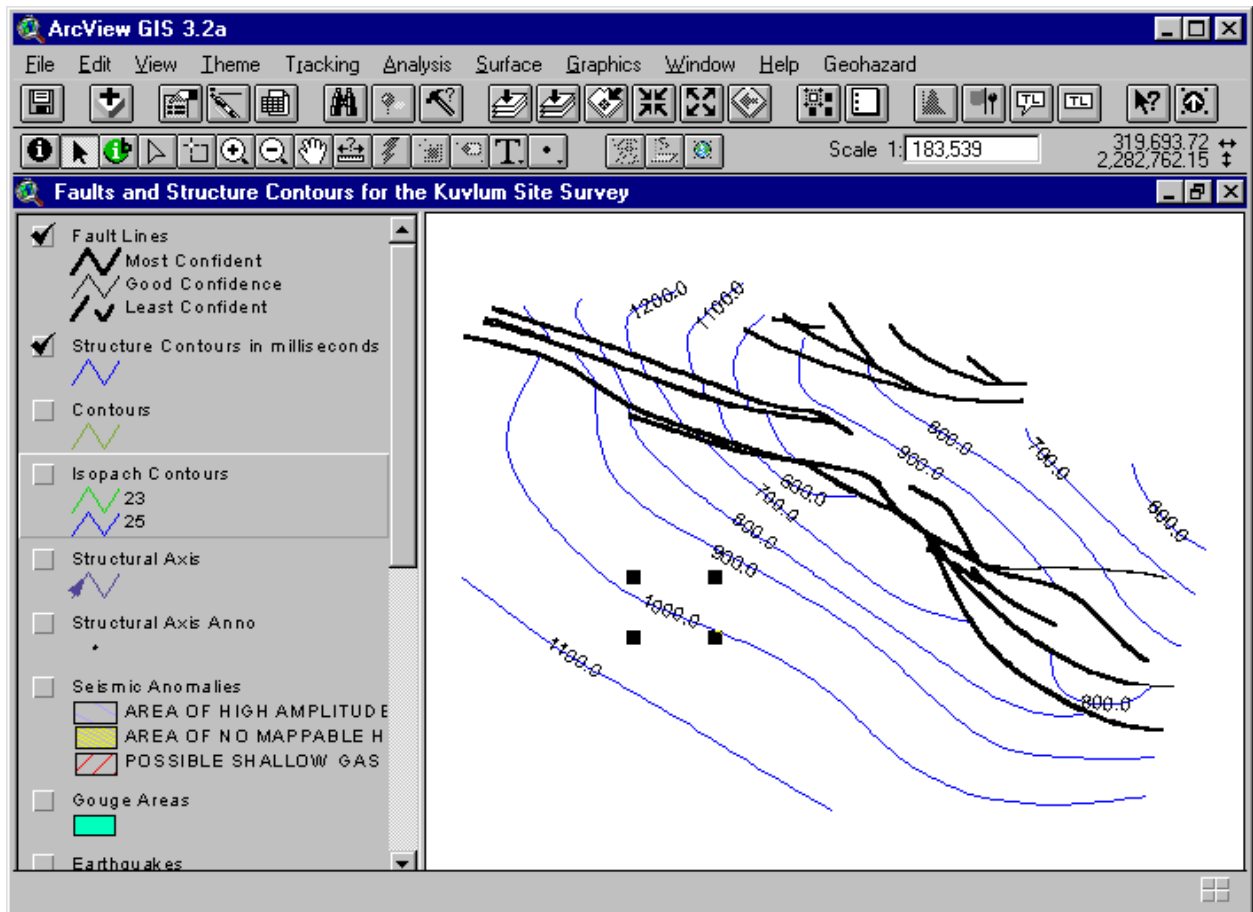
STRUCTURE CONTOURS

The structure contours should resemble those shown on the following page.

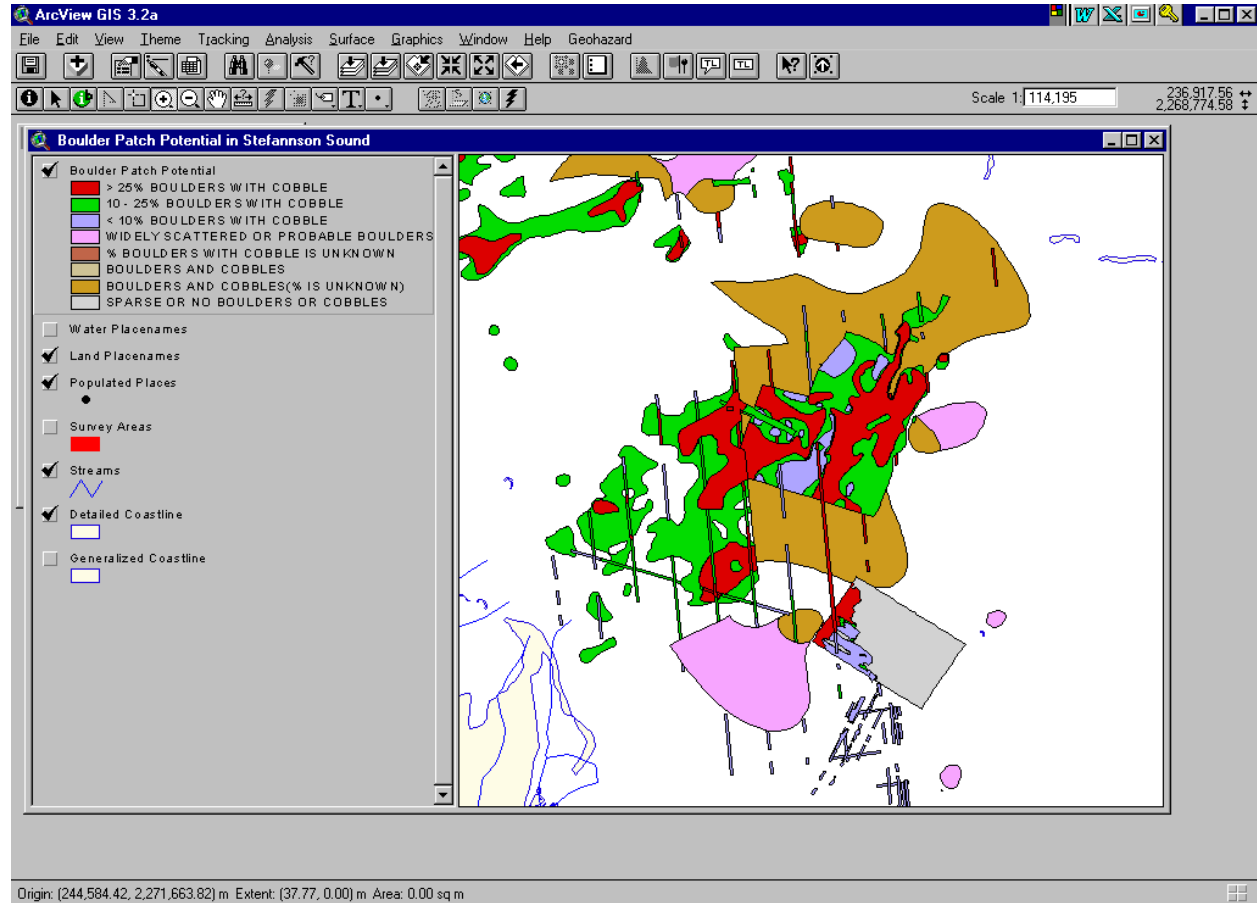
Case Example 3: Display the Boulder Patch In the Liberty Area

The Boulder Patch can be displayed effectively by presenting the data based upon the boulder patch description (field name = BPATCH_DESC)

The Boulder Patch is found where the Flaxman Member of the Gubik Formation crops out on the sea floor. The Boulder Patch is an area of cobble and small boulder lag that provides a substratum for a diverse assortment of invertebrates and several species of kelp. Side Scan Sonar and Fathometer geophysical instruments were used in site-specific and pipeline surveys to collect data on the density and distribution of boulders in the Boulder Patch. Divers and Remotely Operated Vehicles (ROVs) were used to verify the concentration of boulders and to collect additional data on associated kelp and invertebrate organisms. *Laminaria solidungula* is the predominate species of algae found in the Boulder Patch. Sub-Bottom Profiler seismic data indicate that boulders on the shelf are located where Holocene sediments are absent, so the area surrounding the Boulder Patch is considered to be a non-depositional environment. Ice

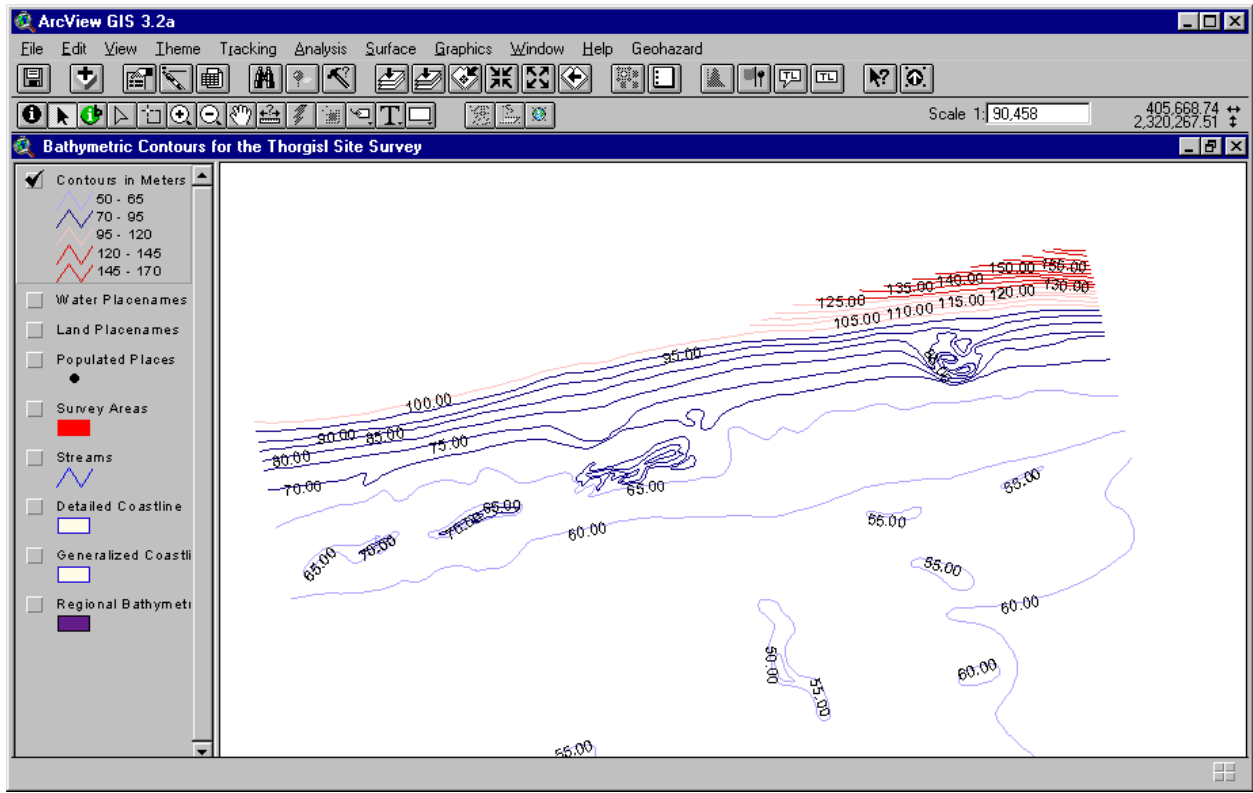
Case Example 4: Display Bathymetry for the Thorgisl Site Specific Survey

Bathymetry data for the surveys display the measurement of water depths as either lines (contours) or as points (spots).
