## ABATEMENT OF ELECTRICAL HAZARDS BY RELOCATING VAULTS

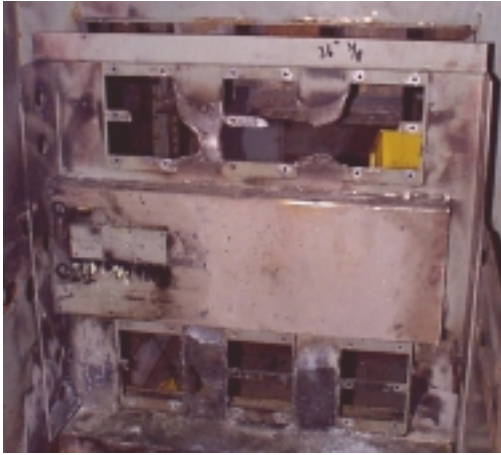
Remnants of exploded switchgear

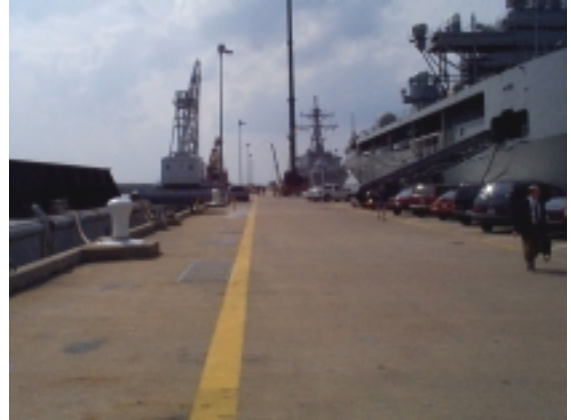
The under-pier vaults were exposed to leakage of seawater (below left), condensation and temperature variations due to changing amounts of moisture in them. This situation resulted in corrosion. The corrosion created an electrical shock, fire, and explosion hazard for high voltage transformers, switchgear, circuit breakers and cables in the vault. Navy Hazard Abatement Program Funds were approved and used to relocate electrical equipment from the vaults beneath the piers to the top of the piers. Relocating the electrical equipment from under the piers greatly decreased the risk of electrical shock to electrical maintenance workers and improved access to, working conditions inside, and exit from the vaults. Relocation also improved the life expectancy of electrical equipment in the vaults due to reduced dampness and corrosion and the elimination of extreme temperature variations in the vaults.
