# Common ADA Errors and Omissions in New Construction and Alterations

## Introduction

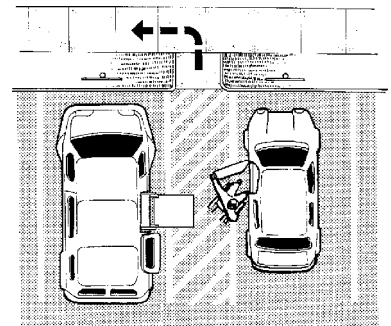
**There is no accessible route from accessible parking to an accessible entrance.**

A person using a wheelchair, scooter, or walker has no way of getting from the accessible parking space to the building entrance. Often when there is an inaccessible walkway provided for others, wheelchair users must use a roadway or vehicular route which can be dangerous.

4.6.3\* Parking Spaces. ...Parking access aisles shall be part of an accessible route to the building or facility entrance and shall comply with 4.3.

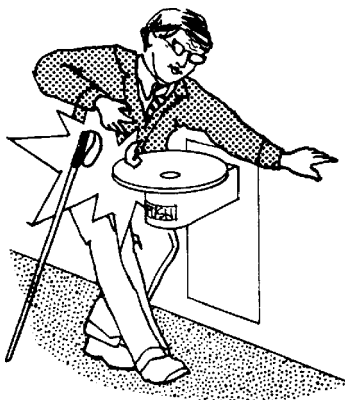
**Objects protrude into circulation paths from the side or from posts.**

**Objects that overhang circulation paths do not provide clear headroom.**

People who are blind or who have low vision can be seriously injured when they cannot detect an object by using the sweep of their cane.

4.4.1\* General. Objects projecting from walls (for example, telephones) with their leading edges between 27 in and 80 in (685mm and 2030 mm) above the finished floor shall protrude no more than 4 in (100 mm) into walks, halls, corridors, passageways, or aisles (see Fig. 8(a)). Objects mounted with their leading edges at or below 27 in (685 mm) above the finished floor may protrude any amount (see Fig. 8(a) and (b)). Free-standing objects mounted on posts or pylons may overhang 12 in (305 mm) maximum from 27 in to 80 in (685 mm to 2030 mm) above the ground or finished floor (see Fig. 8(c) and (d)). Protruding objects shall not reduce the clear width of an accessible route or maneuvering space (see Fig.8(e)).

4.4.2 Head Room. Walks, halls, corridors, passageways, aisles, or other circulation spaces shall have 80 in (2030 mm) minimum clear head room (see Fig. 8(a)). If vertical clearance of an area adjoining an accessible route is reduced to less than 80 in (nominal dimension), a barrier to warn blind or visually-impaired persons shall be provided (see Fig. 8(c-1)).

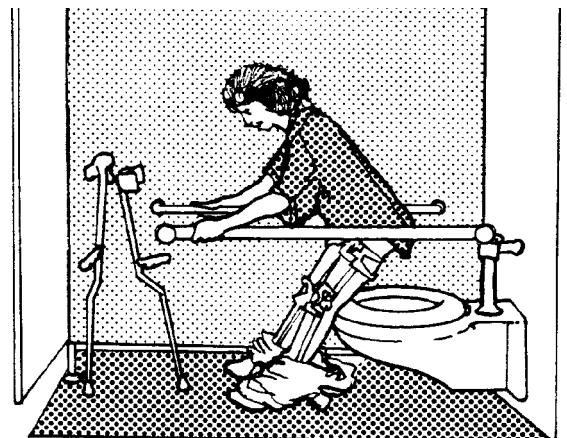
**Toilet rooms with 6 or more toilet stalls lack a 36" wide "ambulatory" toilet stall.**

Too few accessible stalls are provided for people with mobility disabilities. People who walk with crutches, a cane, a walker, or who have limited balance generally find it easier and safer to use a stall that has parallel grab bars.

4.22.4, 4.23.4 Water Closets. If toilet stalls are provided, then at least one shall be a standard toilet stall complying with 4.17; where 6 or more stalls are provided, in addition to the stall complying with 4.17.3, at least one stall 36 in (915 mm) wide with an outward swinging, self-closing door and parallel grab bars complying with Fig. 30(d) and 4.26 shall be provided. Water closets in such stalls shall comply with 4.16. If water closets are not in stalls, then at least one shall comply with 4.16.

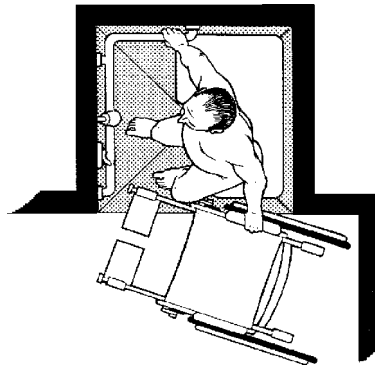
**When a transfer shower is used, it is often larger than the required 36" x 36" size.**

People with disabilities may be injured when using a transfer shower that is too large. Users may slide off the seat and fall onto the floor of the shower while reaching for the shower controls and hand-held showerhead.

4.21.2 Size and Clearances. Except as specified in 9.1.2, shower stall size and clear floor space shall comply with Fig. 35(a) or (b). The shower stall in Fig. 35(a) shall be 36 in by 36 in (915 mm by 915 mm). Shower stalls required by 9.1.2 shall comply with Fig. 57(a) or (b). The shower stall in Fig. 35(b) will fit into the space required for a bathtub.

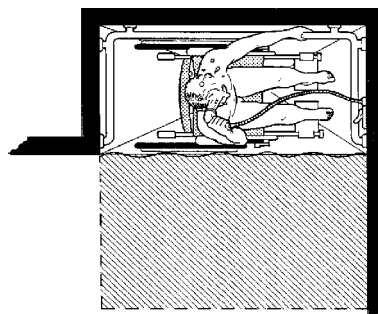
**In hotels, motels, or other lodging facilities of 50 or more sleeping rooms, no rooms with roll-in showers are provided, or the roll-in showers that are provided lack a fold-down seat.**

People who must use a roll-in shower or a shower with a fold-down seat cannot bathe. When a roll-in shower is provided without a folding seat, guests may resort to using guest room furniture in the shower.

9.1.2 Accessible Units, Sleeping Rooms, and Suites. Accessible sleeping rooms or suites that comply with the requirements of 9.2 (Requirements for Accessible Units, Sleeping Rooms, and Suites) shall be provided in conformance with the table below. In addition, in hotels, of 50 or more sleeping rooms or suites, additional accessible sleeping rooms or suites that include a roll-in shower shall also be provided in conformance with the table below. Such accommodations shall comply with the requirements of 9.2, 4.21, and Figure 57(a) or (b).

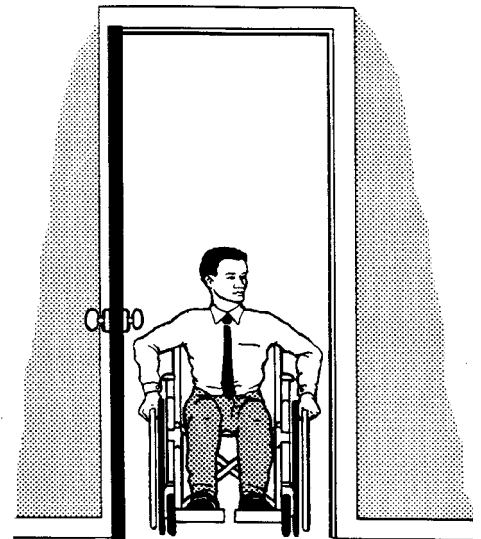
**Doors into and within guest rooms that are not accessible guest rooms do not provide at least 32" clear opening width.**

People who use a wheelchair, scooter, or walker are unable to enter standard guest rooms and are excluded from accommodations when accessible guestrooms are occupied.

9.4 Other Sleeping Rooms and Suites. Doors and doorways designed to allow passage into and within all sleeping units or other covered units shall comply with 4.13.5.
